MONITORING YEAR 1 ANNUAL REPORT

DEEP MEADOW MITIGATION SITE

Union County, NC

DMS Project No. 97131

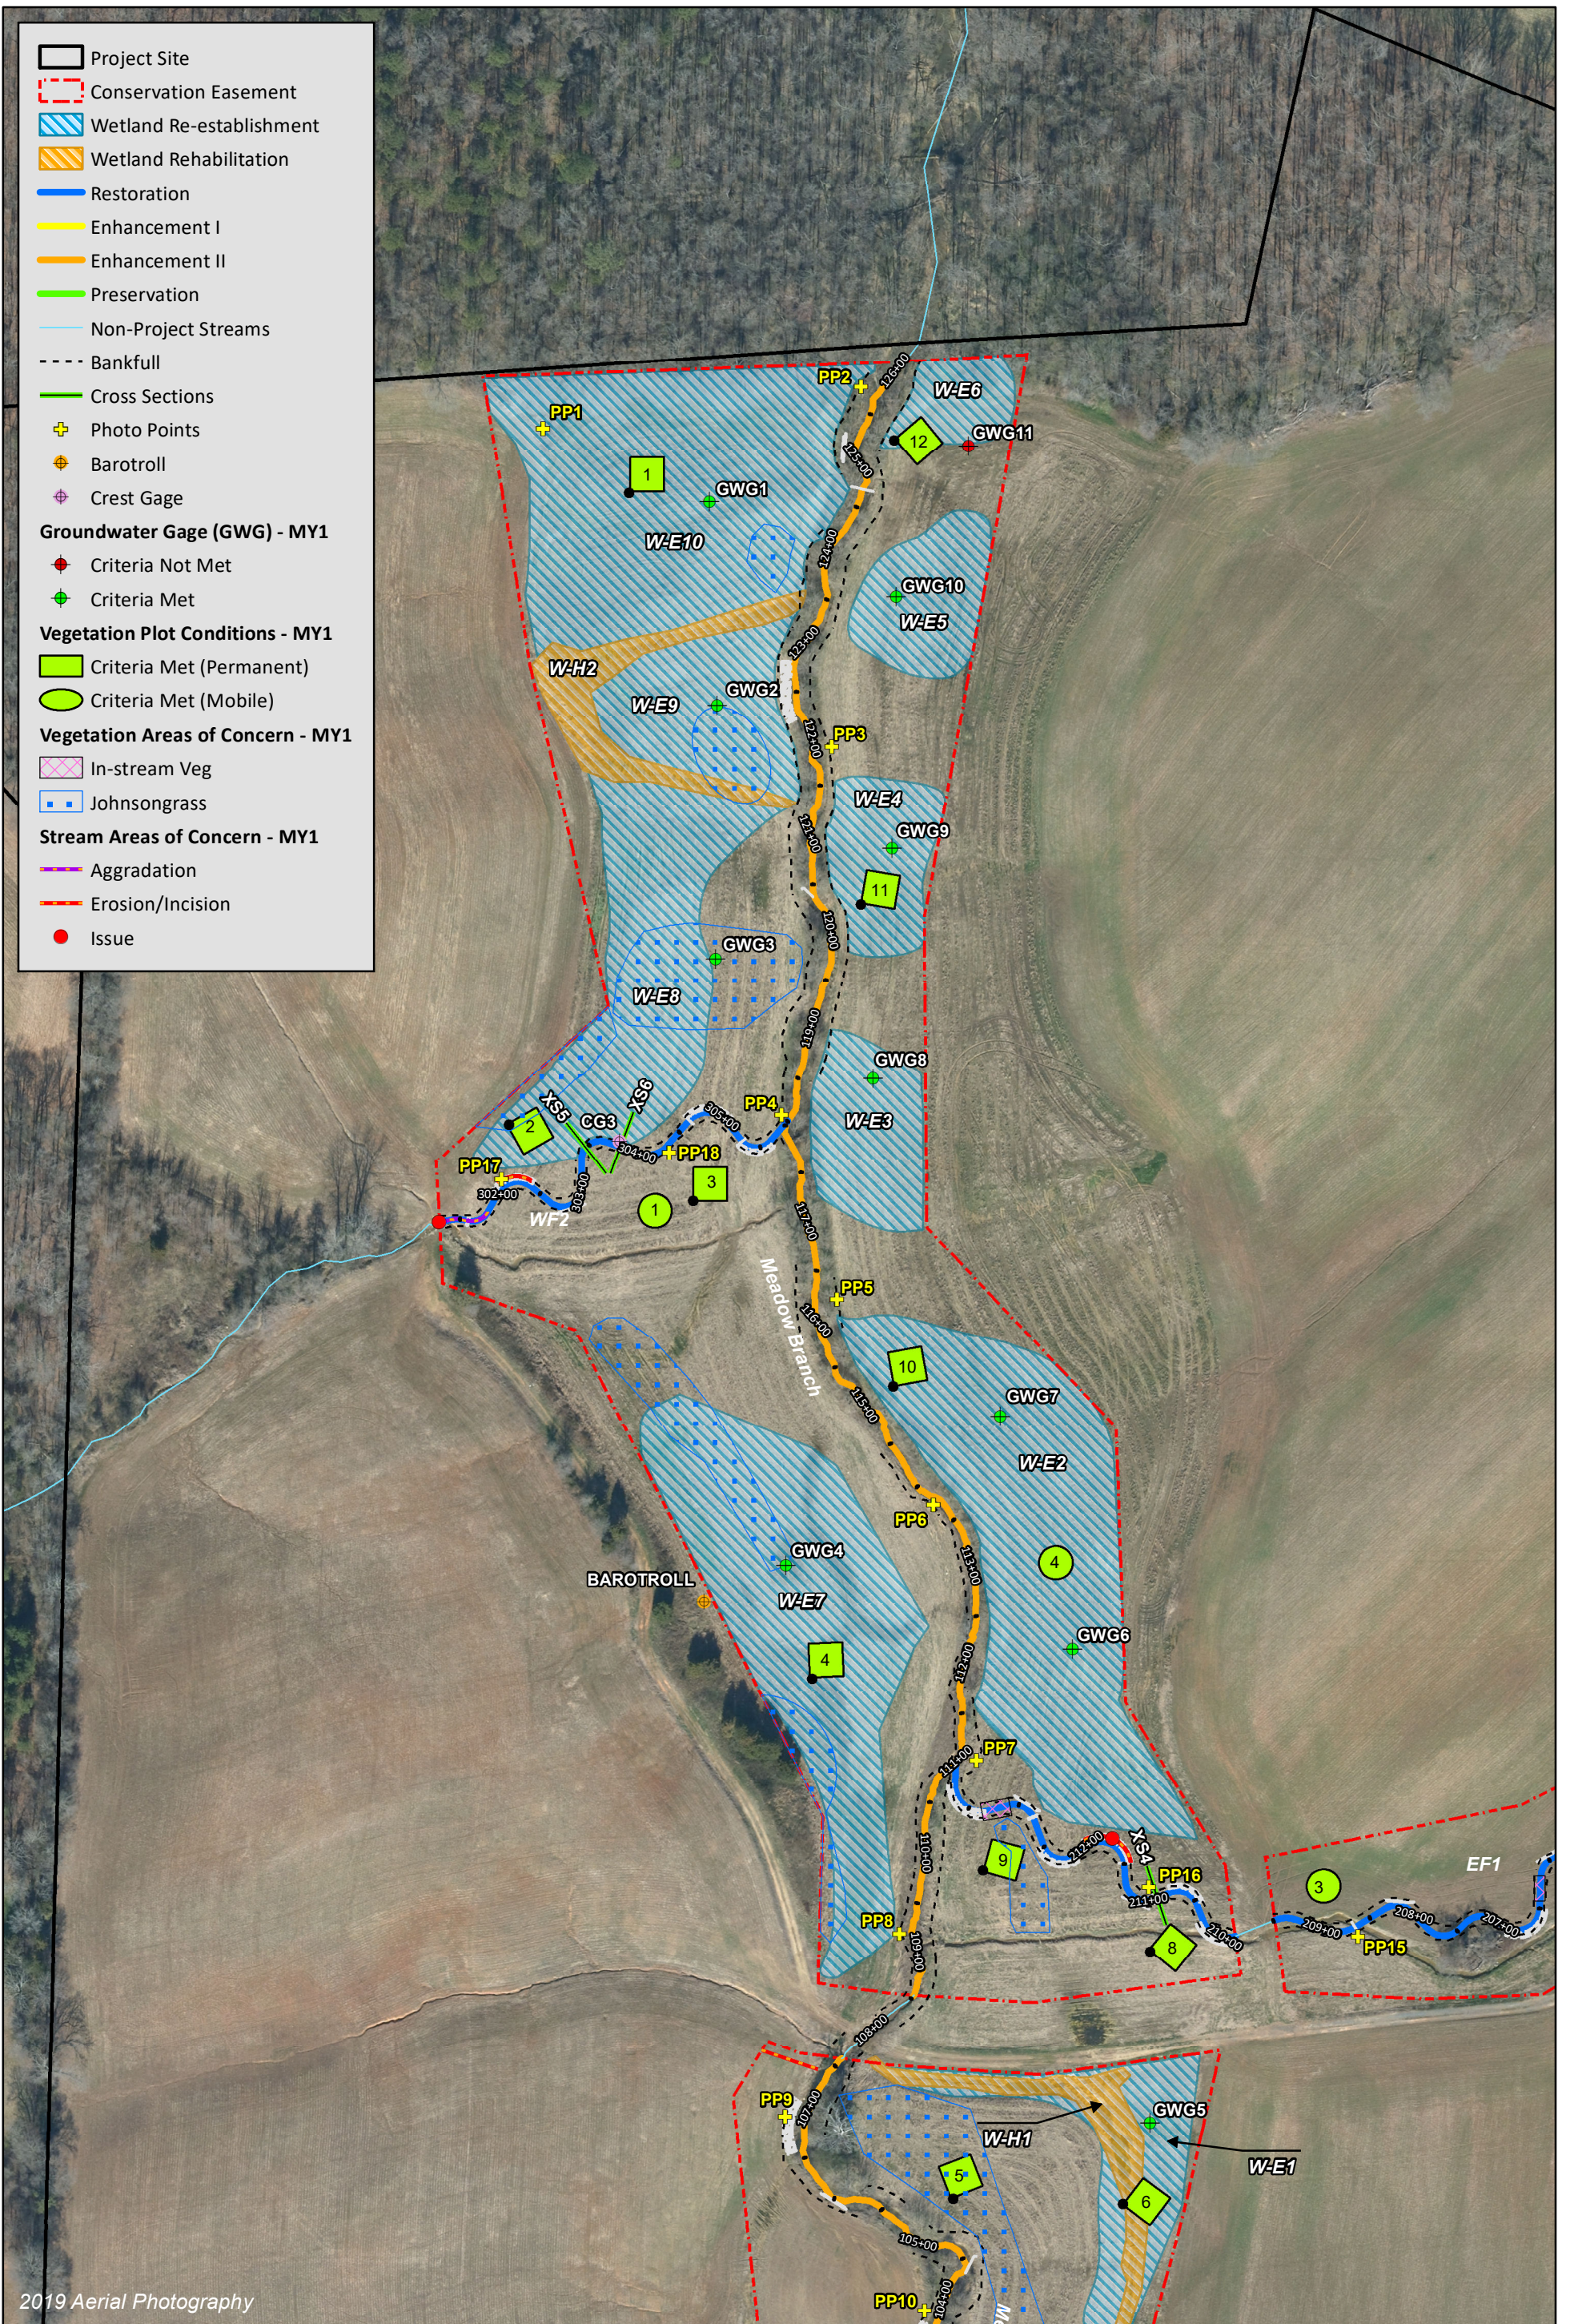
Figure 3.1 Current Condition Plan View
 Deep Meadow Mitigation Site
 DMS Project No. 97131
 Monitoring Year 1 - 2020
 Union County, NC

Stream areas of concern that are noted in this report and on the CCPV figures will continue to be monitored in future years for signs of accelerated instability. If instability is observed, the area will be addressed and evaluated for effectiveness in the MY2 report. Please refer to Appendix 2 for stream stability tables, area of concern photos, and CCPV Figures 3.0 – 3.2.

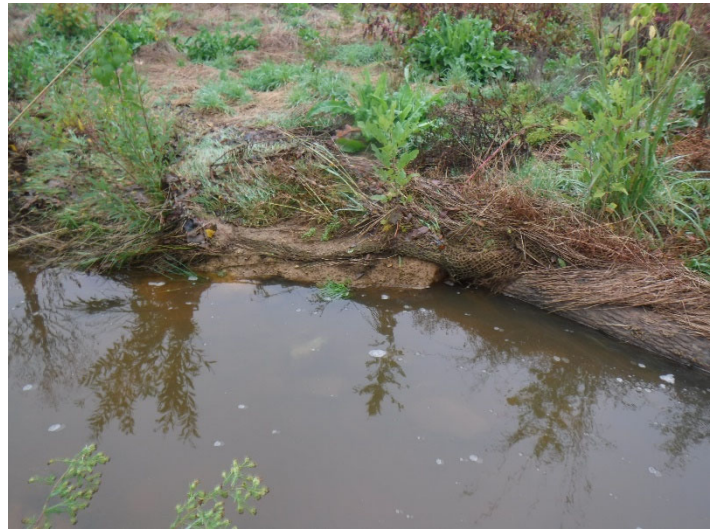
EF1 Slight Scour Right Bank Station 203+50 (11/13/2020)

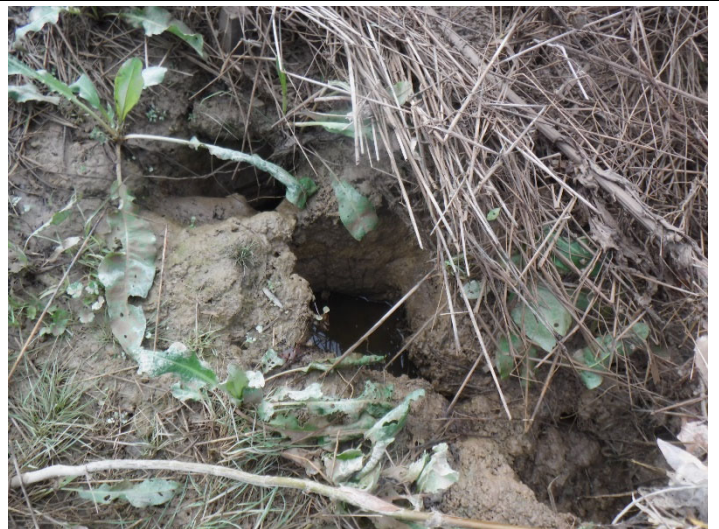
EF1 Issue: Bank Eroding behind structure 211+70- 212+00 (11/13/2020)

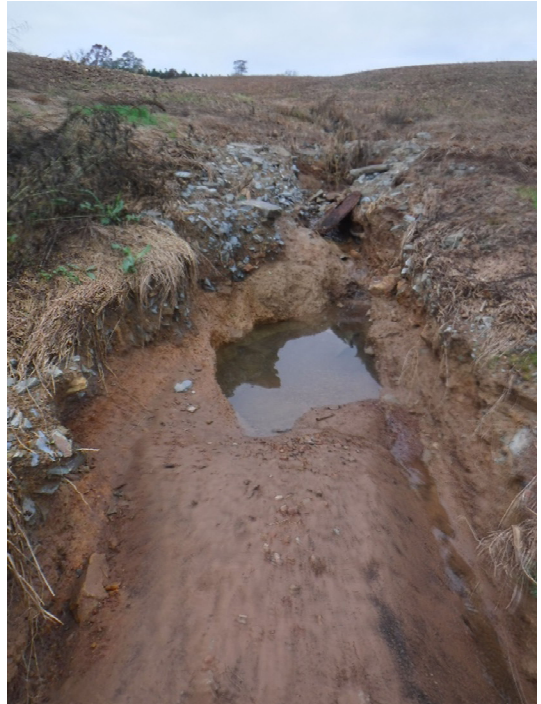
Scoured channel running from agricultural field into CE before flowing into Meadow Branch near station 107+50 (11/13/2020)

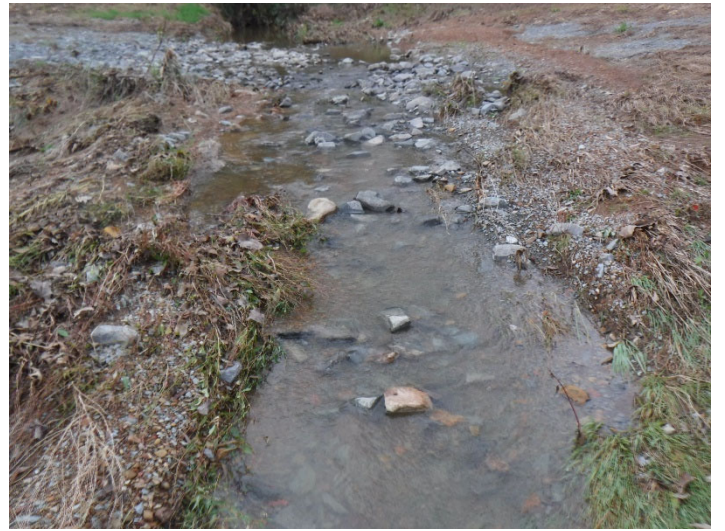
Issue: WF2 channel crossing being washed down stream causing aggradation (11/13/2020)

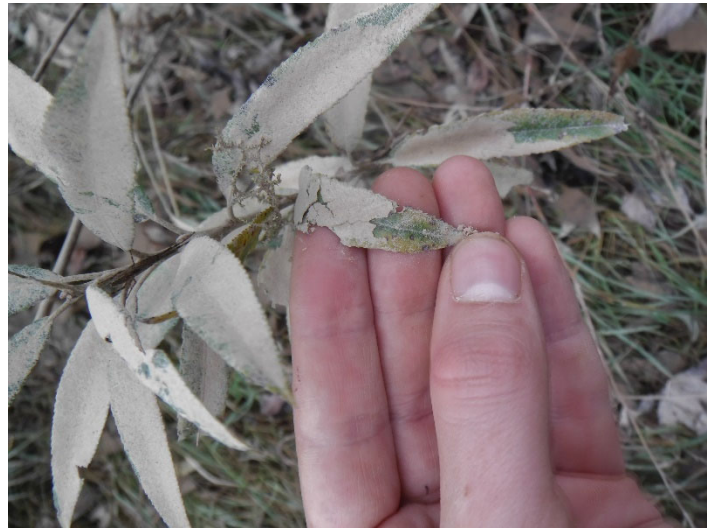
Sediment deposit on bank of WF1 (11/13/2020)
