MONITORING YEAR 2 ANNUAL REPORT

DEEP MEADOW MITIGATION SITE

Union County, NC

DMS Project No. 97131

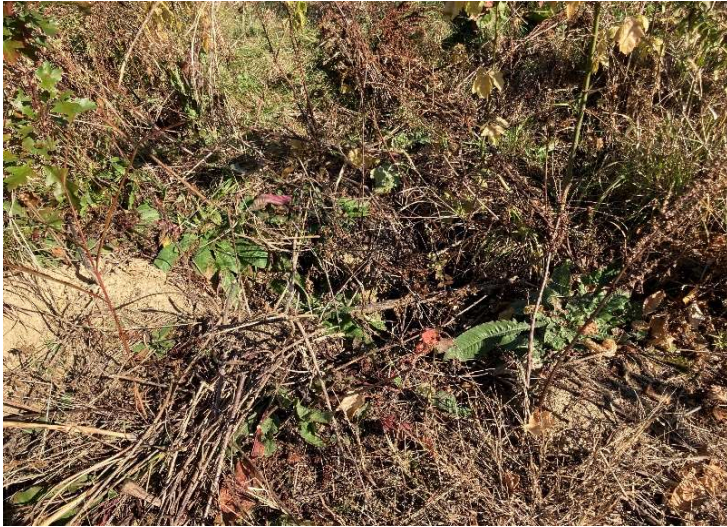
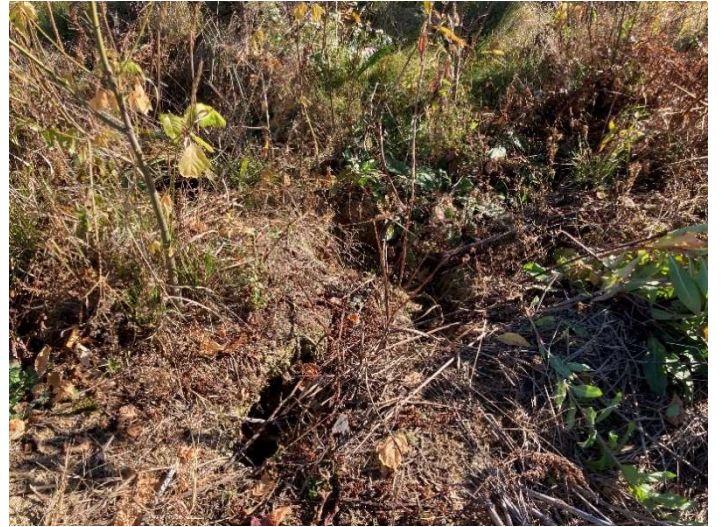
EF1: Bank Eroding behind structure at 211+70 - 212+00 (11/09/2021)

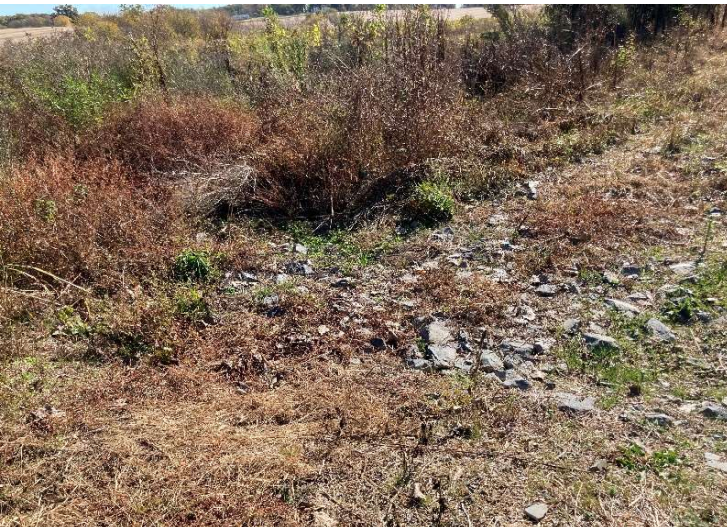
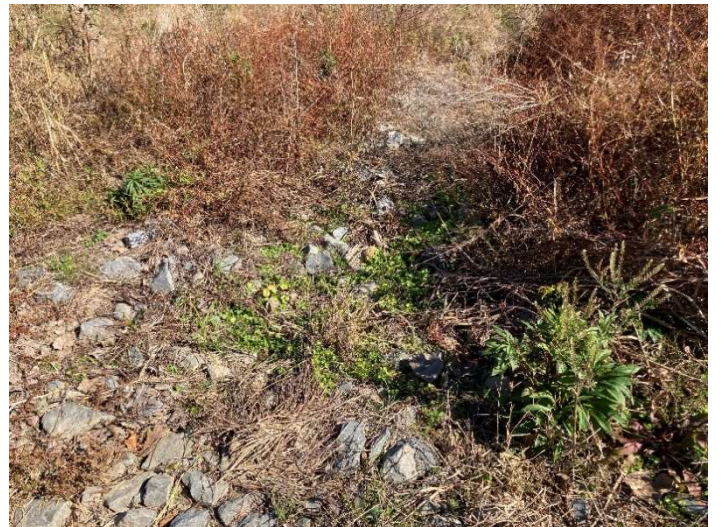
WF2: Gravel from crossing washing into stream at 301+00 (11/09/2021)

WF2: Aggradation in channel at 301+00 - 302+00 (11/09/2021)

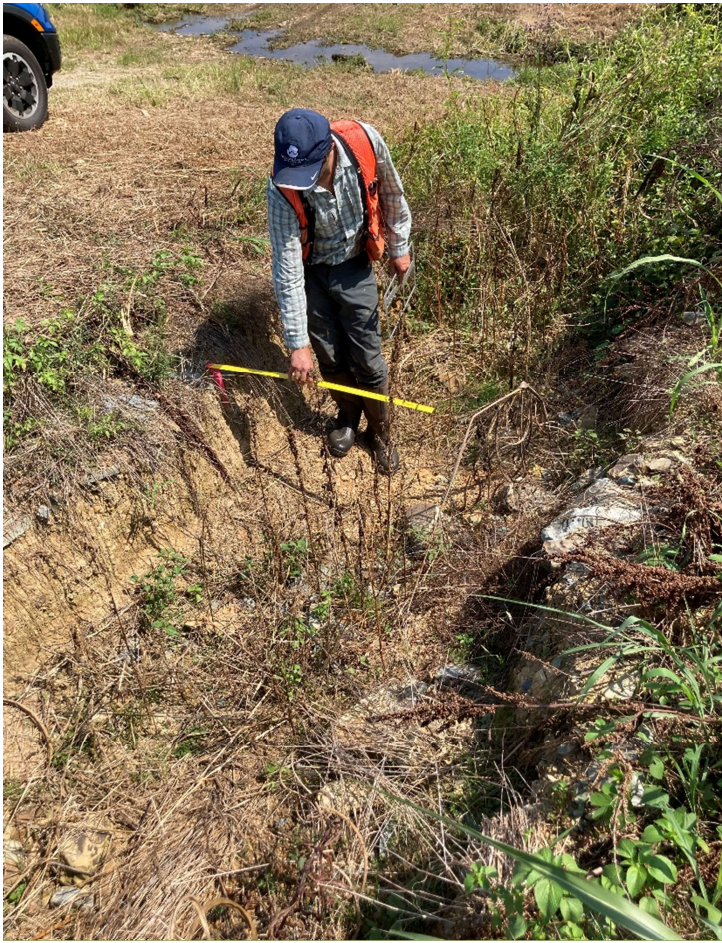
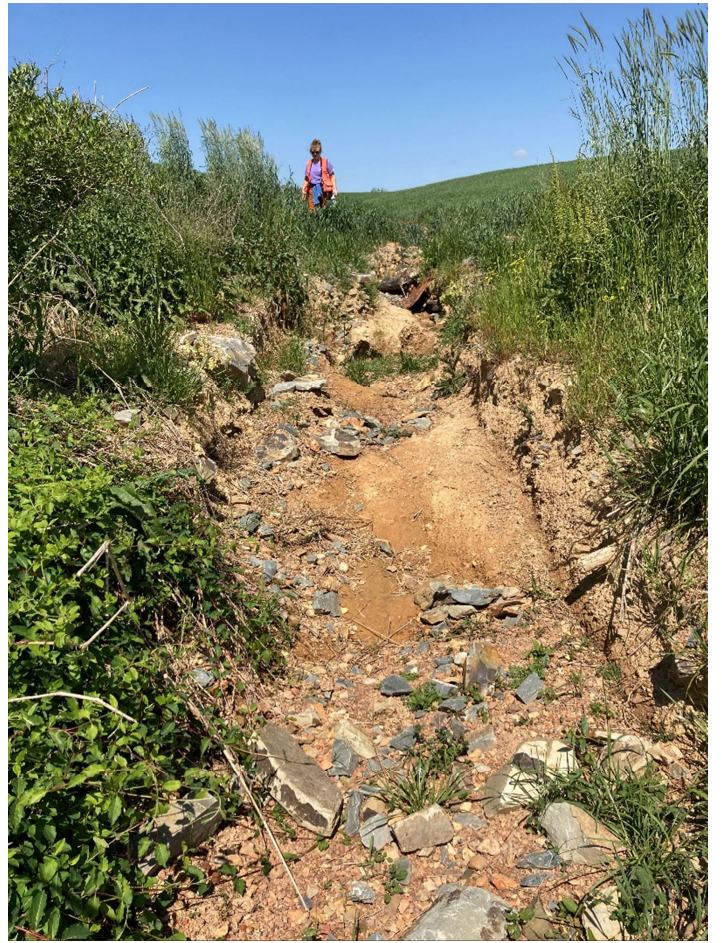
DMS' Comment: Section 1.4.5 Stream Areas of Concern and Management Activity: Wildlands notes that the gully outside of the easement across from the ford crossing on Meadow Branch has continued to erode. Thank you for providing photos of this area. It is understood that Wildlands is working with the property owner to stabilize this area and prevent excess sediment from entering the stream. As this issue was also noted in the MY1 report (2020), can Wildlands estimate a date for this floodplain stabilization work?

Meadow Branch: Erosion gully running from agricultural field into CE before flowing into Meadow Branch at 107+50 (05/19/2021)

Wildlands' Response: Floodplain stabilization work began outside the easement boundaries in early December of 2021. Wildlands will begin stabilization work within the easement boundaries in the first quarter of 2022. Wildlands plans to monitor this area closely in Monitoring Year 3.

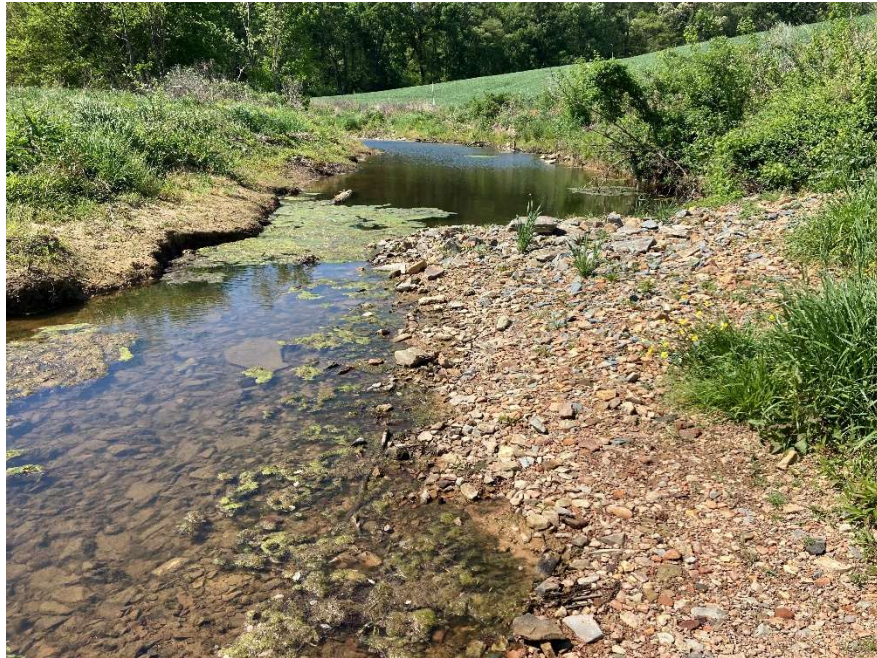
Meadow Branch: Deposition from erosion gully into Meadow Branch at 107+50 (05/19/2021)

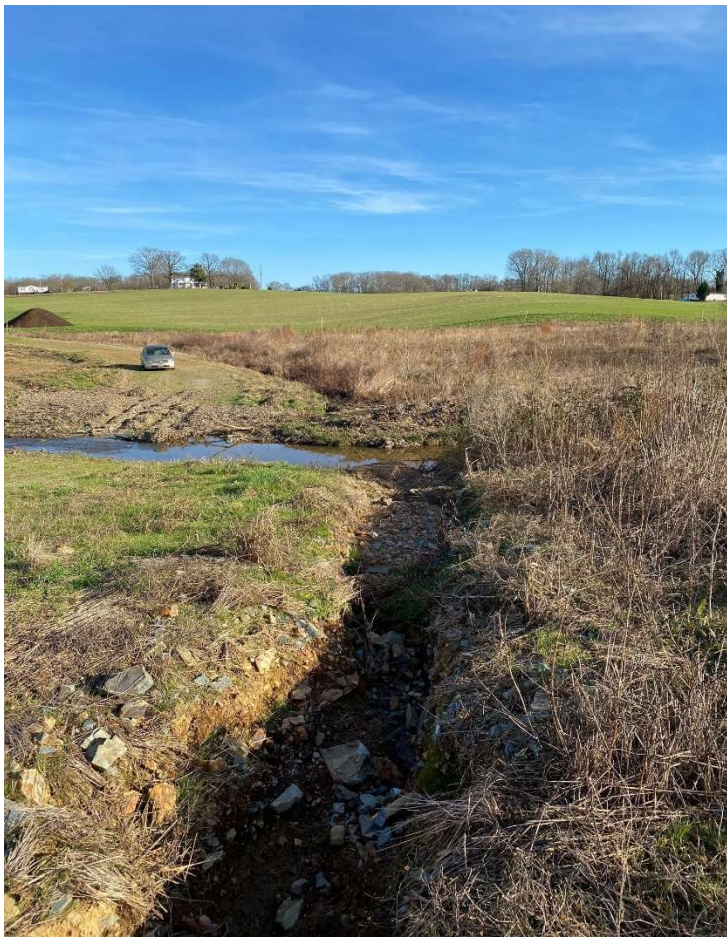
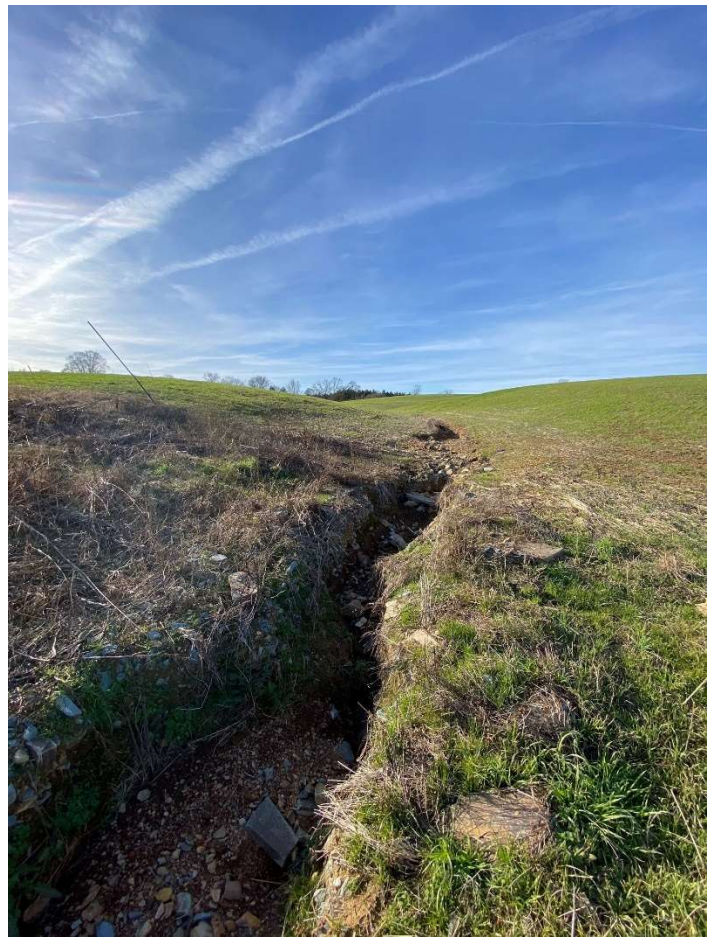
Meadow Branch: Partially filled in erosion gully outside of CE at 107+50 (01/12/2022)

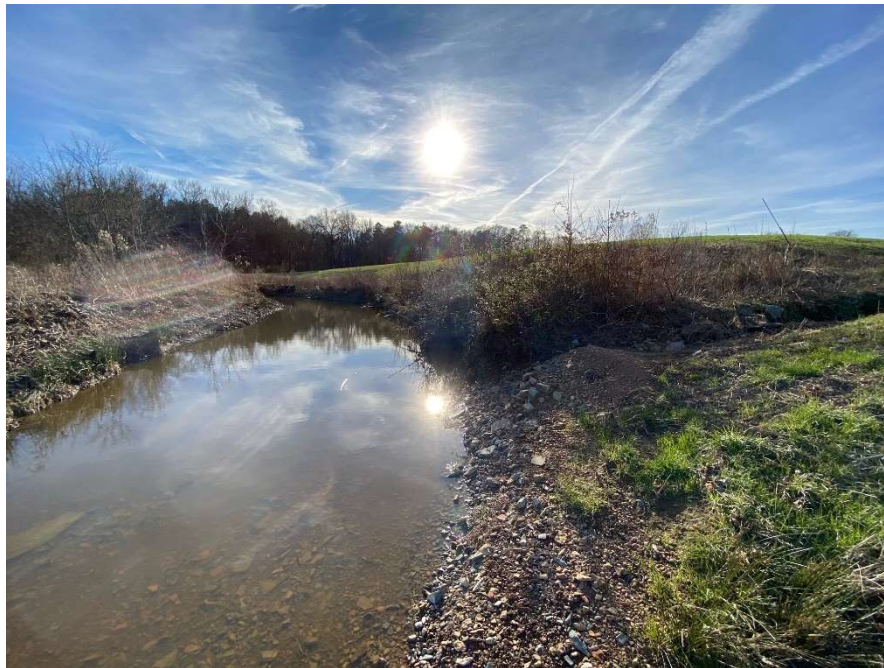
Meadow Branch: Deposition from partially filled in erosion gully into Meadow Branch at 107+50 (01/12/2022)

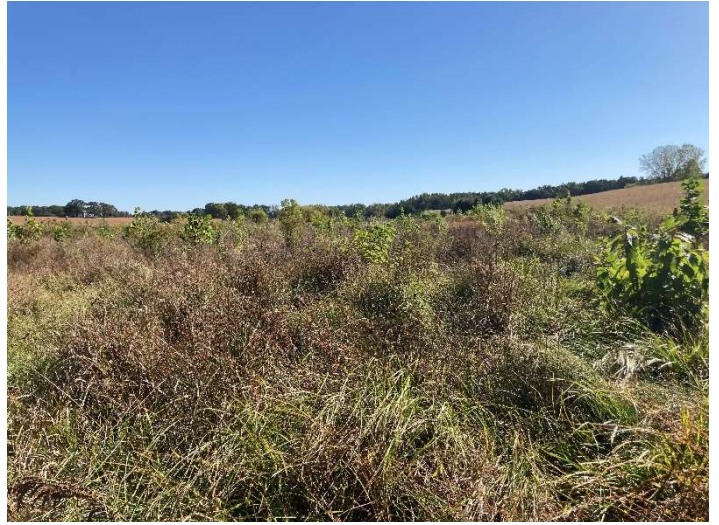
Meadow Branch: In-Stream vegetation at 116+00 (10/18/2021)

Meadow Branch: In-Stream vegetation at 110+00 (10/18/2021)
