# MONITORING YEAR 4 ANNUAL REPORT

## DEEP MEADOW MITIGATION SITE

Union County, NC  
Yadkin River Basin  
HUC 03040105

DMS Project No. 97131  
NC DEQ Contract No. 6887  
DWR Certification No. 18-0264  
USACE Action ID No. SAW-2012-01107  
Data Collection Period: January 2023 – November 2023

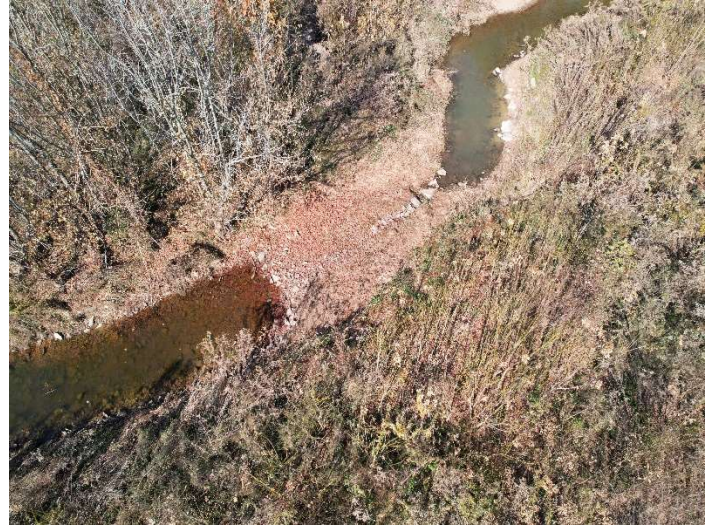
Based on MY4 visual assessments, restoration reaches WF2 and EF1 are 100% stable and performing as intended. Minimal areas of concern were observed on Meadow Branch and included recurring beaver dams and localized segments of aggradation. At the upstream section of Meadow Branch near Station 101+80, a mid-channel bar has developed where a recurring beaver dam was located. The dam has been removed several times in MY2, MY3, and MY4, but currently the remnant aggradation persists. Wildlands will continue to monitor this area in MY5. While Asian spiderwort (*Murdannia keisak*) on the Site was greatly reduced in MY4, several short segments of in-stream vegetation and deposition were documented on Meadow Branch. Currently, these areas are having no negative impact on the stream's overall function and stability. They will likely dissipate as winter storms continue to mobilize sediment.

**Meadow Branch, station 121+15, aerial photo** – In-stream vegetation and associated aggradation (11/7/2023)

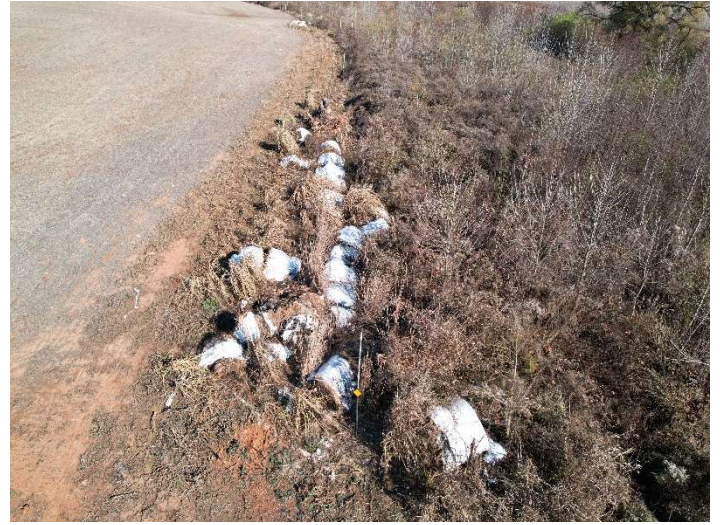
**DMS' Comment:** There are numerous 'abandoned' large hay bales/rolls along the right floodplain of EF1 along the easement, wrapped in torn/degrading white plastic. Most of these are just outside the easement line; however, there are still two broken bales clearly inside the easement.

**Between Platted Corners 2 and 3, aerial photo – Easement encroachment, haybales within easement (11/28/2023)**

- Replaced missing and damaged easement signs and posts.
- Added PVC markers to easement posts for visibility above vegetation.
- Added or replaced horse tape as a visual boundary for easement to deter future encroachment occurrences.
- Confirmed that approximately 18 - 24 inches of the CMP outlet at the crossing on EF-1 lies within the easement limits.
- Contacted landowner about mowing encroachment and herbicidal overspray on easement vegetation.
- Met with the landowner on December 12, 2023, and discussed the removal of the hay bales from the easement. The landowner agreed to remove them. A Site visit on January 4<sup>th</sup> revealed that the hay bales had been removed from the easement.

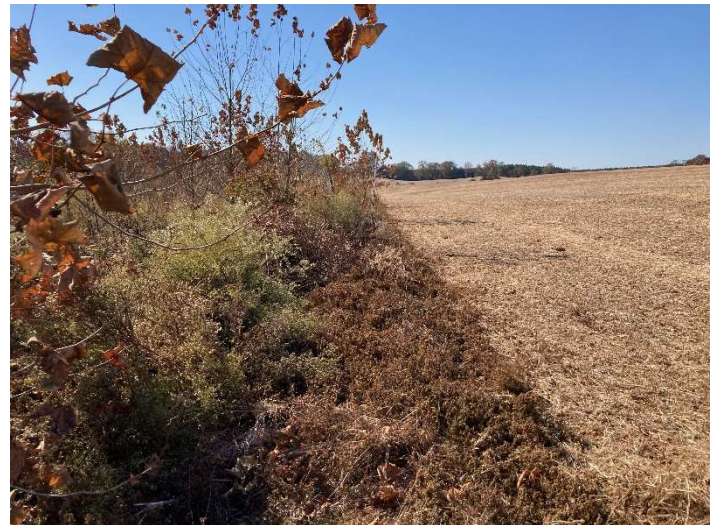
**Between Platted Corners 5 and 6 – Herbicidal overspray (11/7/2023)**

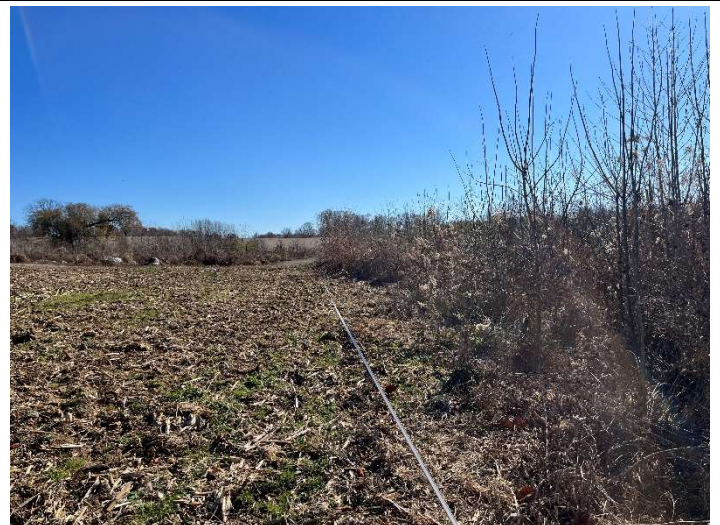
**DMS' Comment:** The horse tape is sagging pretty low (a foot or two off the ground) between corners 26 and 27, this is a 186-LF segment. Recommend placing a post in between these corners to support the tape as this is a heavily trafficked area.

**Between Platted Corners 26 and 27 – Mowing and scalloping (11/28/2023)**

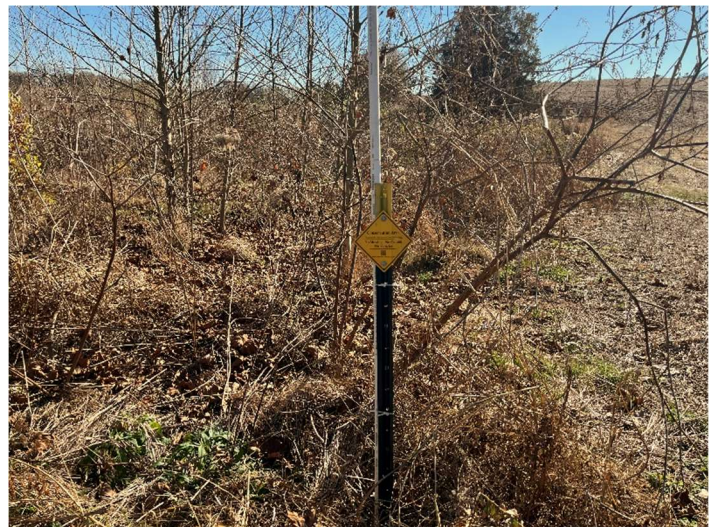
**Easement Corner 17** – New PVC marker and sign (11/29/2023)

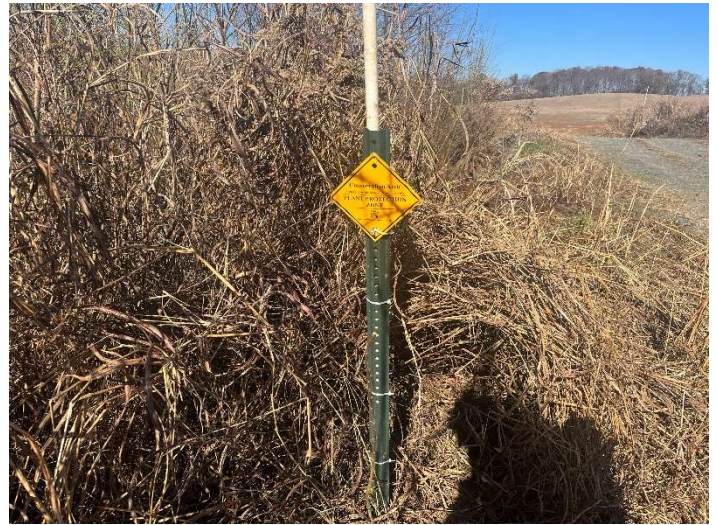
**Easement Corner 10 – New PVC marker (11/29/2023)**

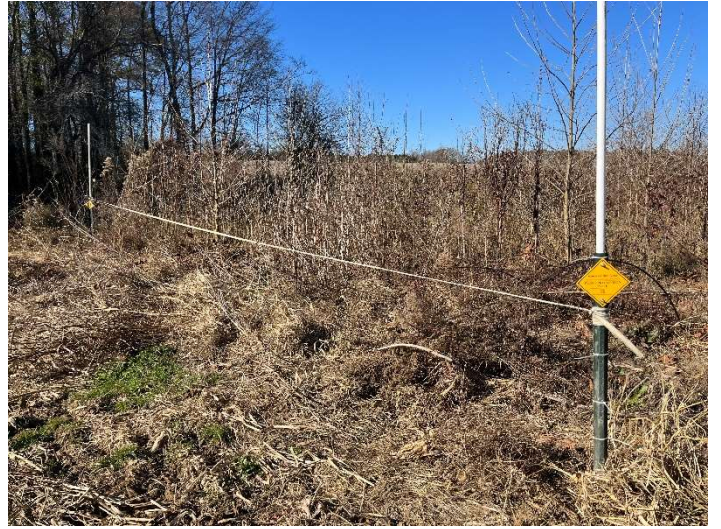
**Between Easement Corners 31 and 33 – New horse tape (11/29/2023)**
