# **MONITORING YEAR 1 ANNUAL REPORT**

## **DEVIL'S RACETRACK MITIGATION SITE**

Johnston County, NC  
DENR Contract 003989  
NCEEP Project Number 95021

Data Collection Period: July 2014 - September 2014  
Draft Submission Date: December 31, 2014  
Final Submission Date: January 16, 2015

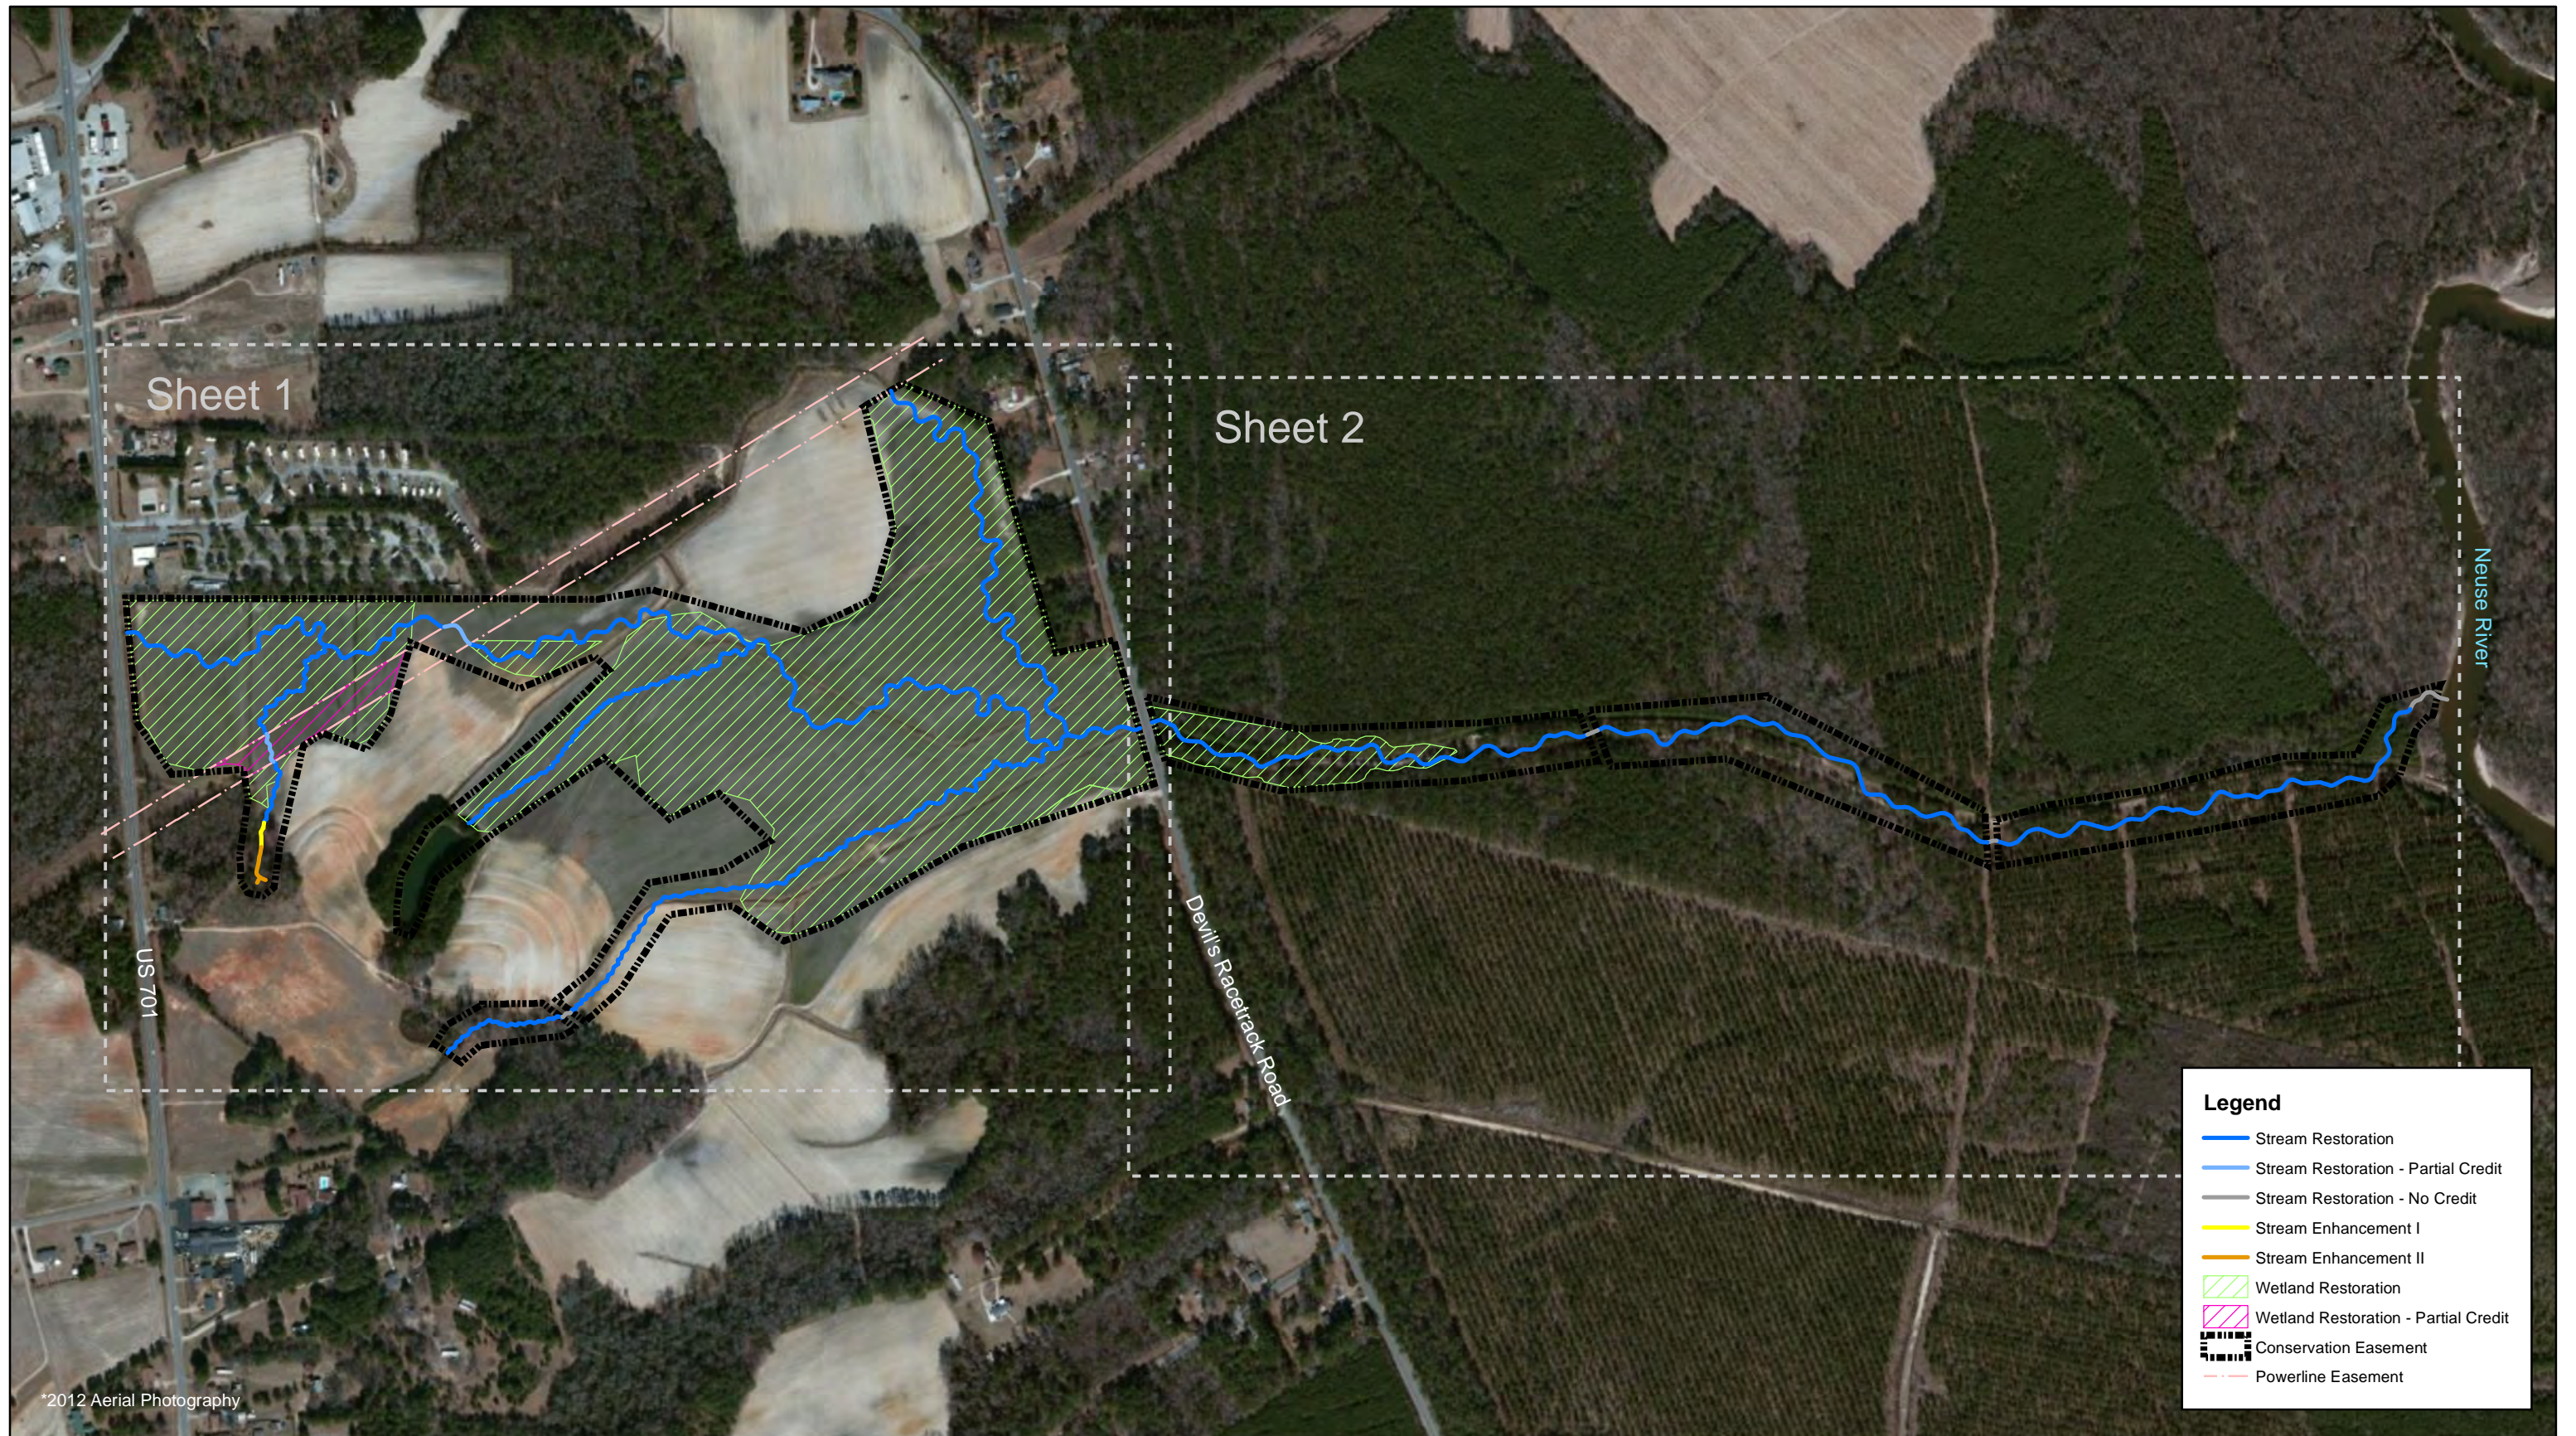
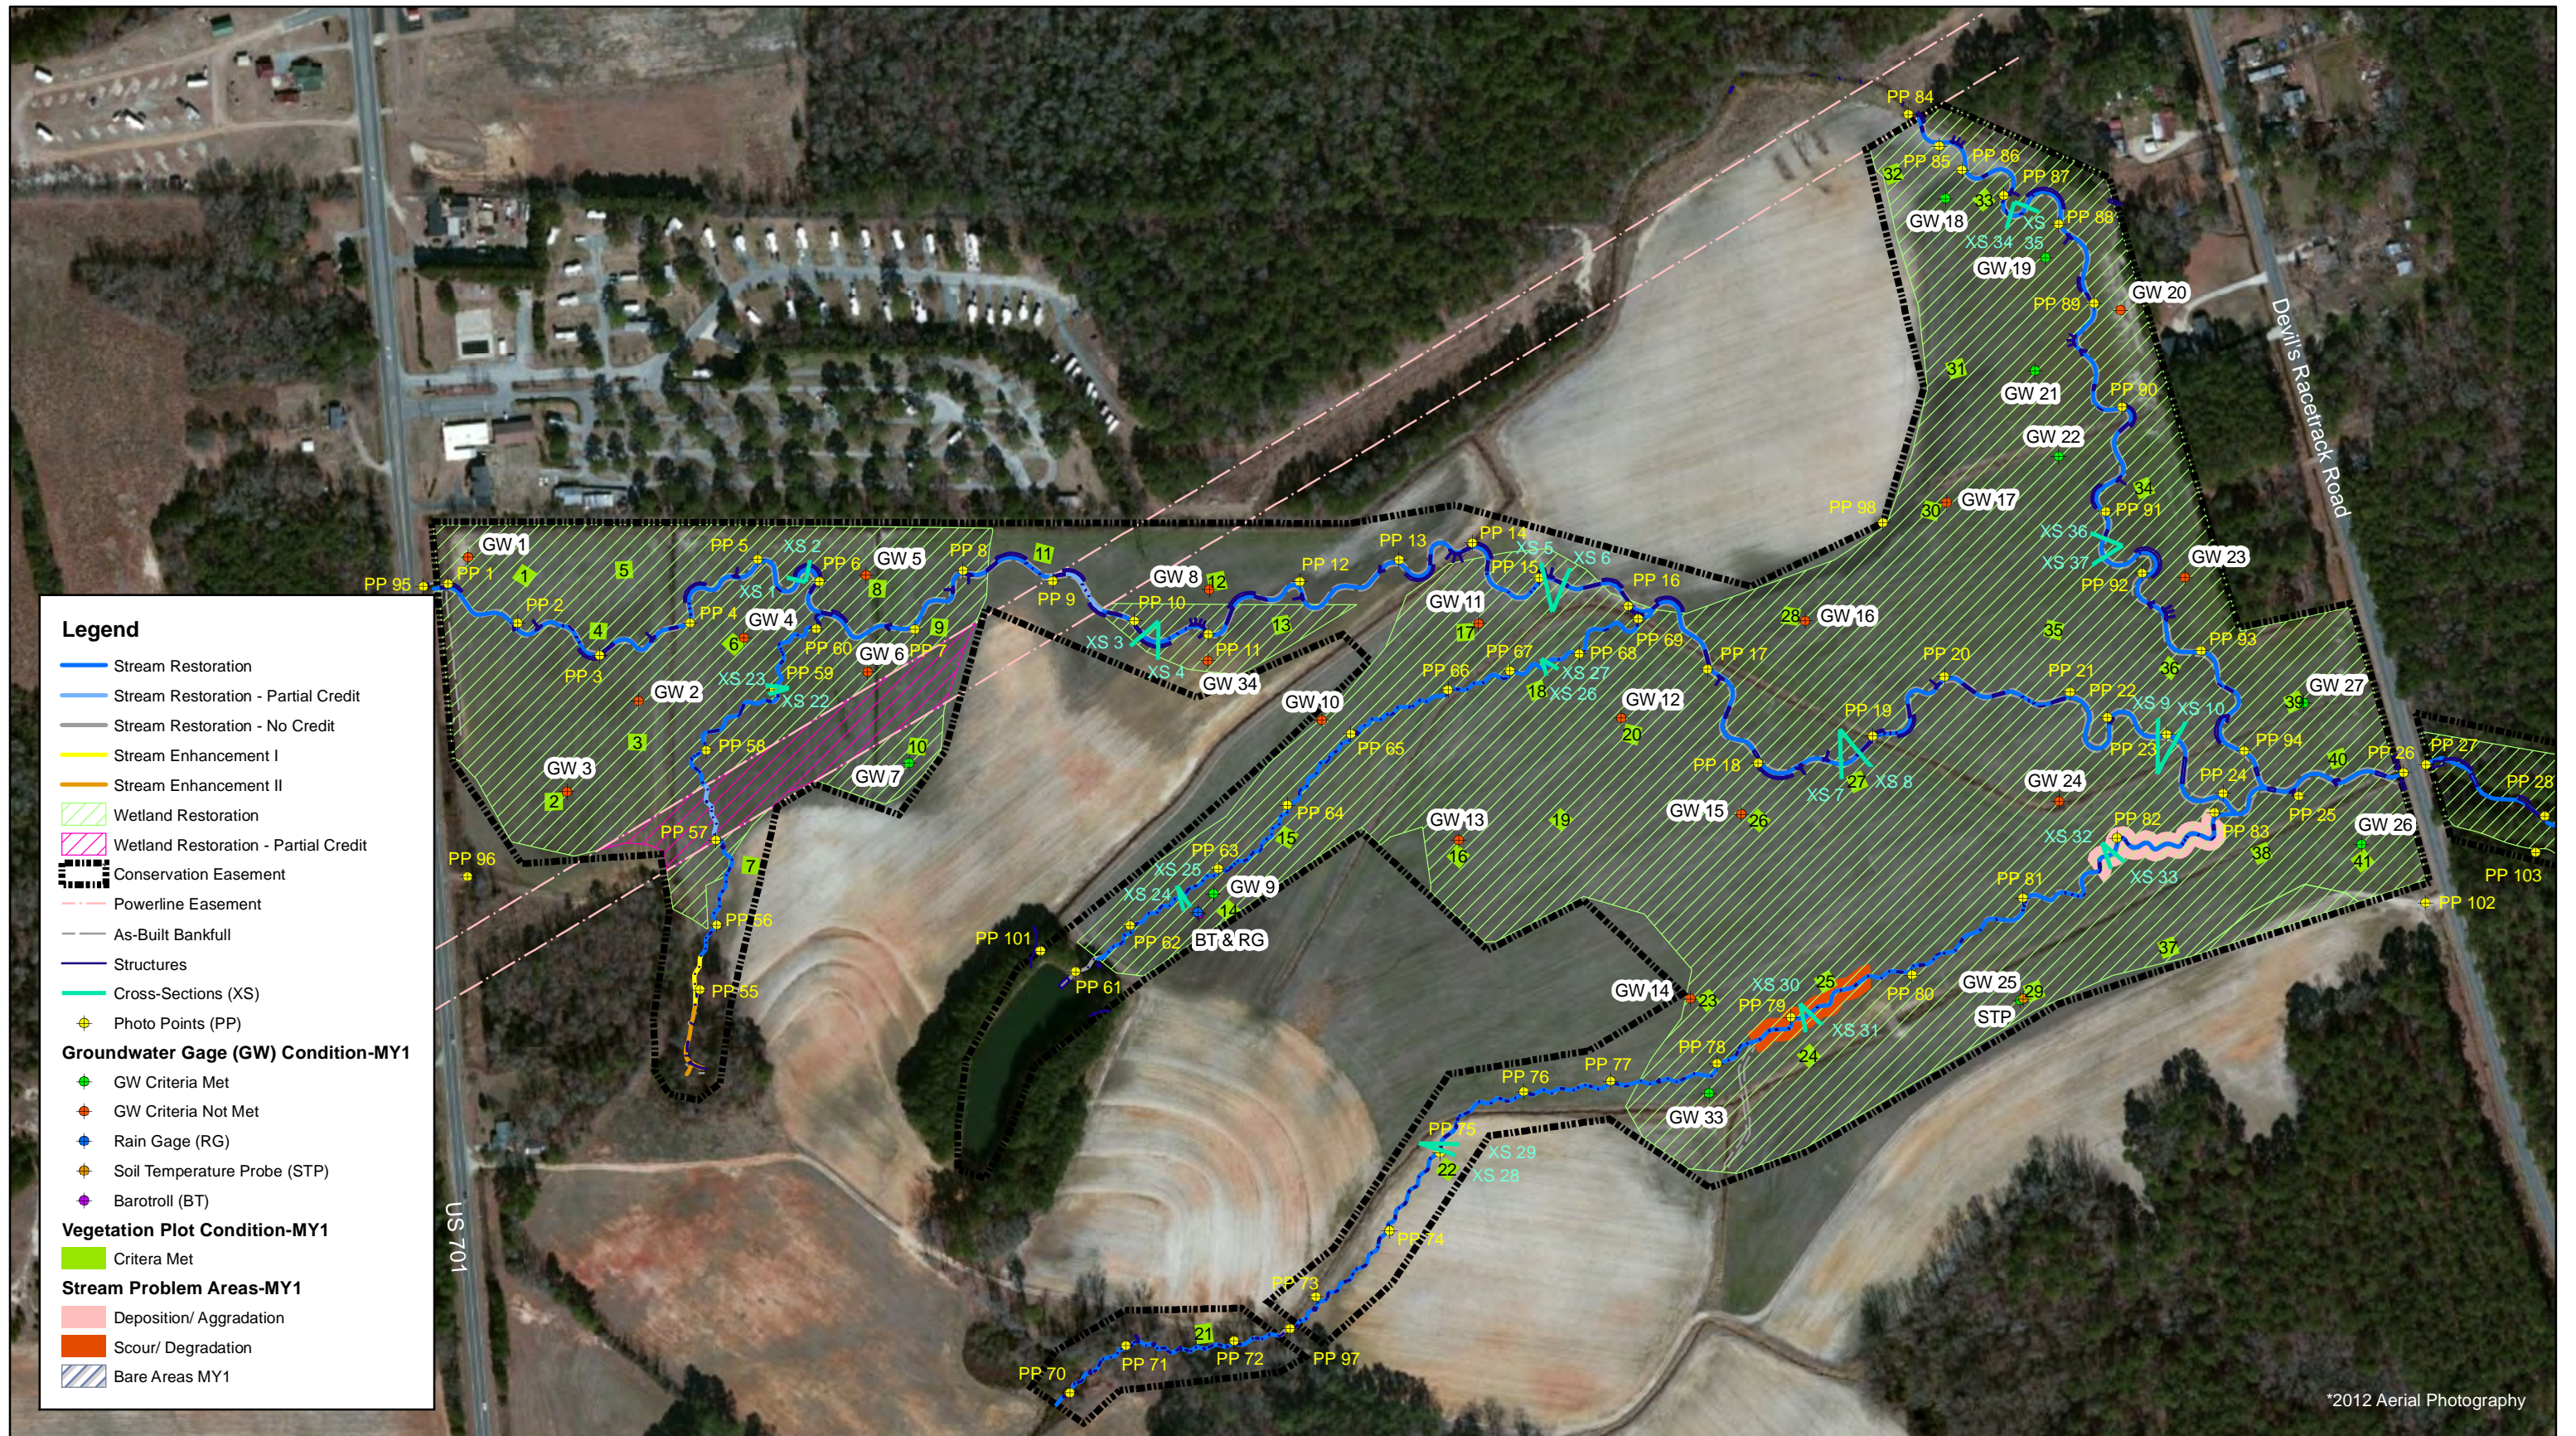
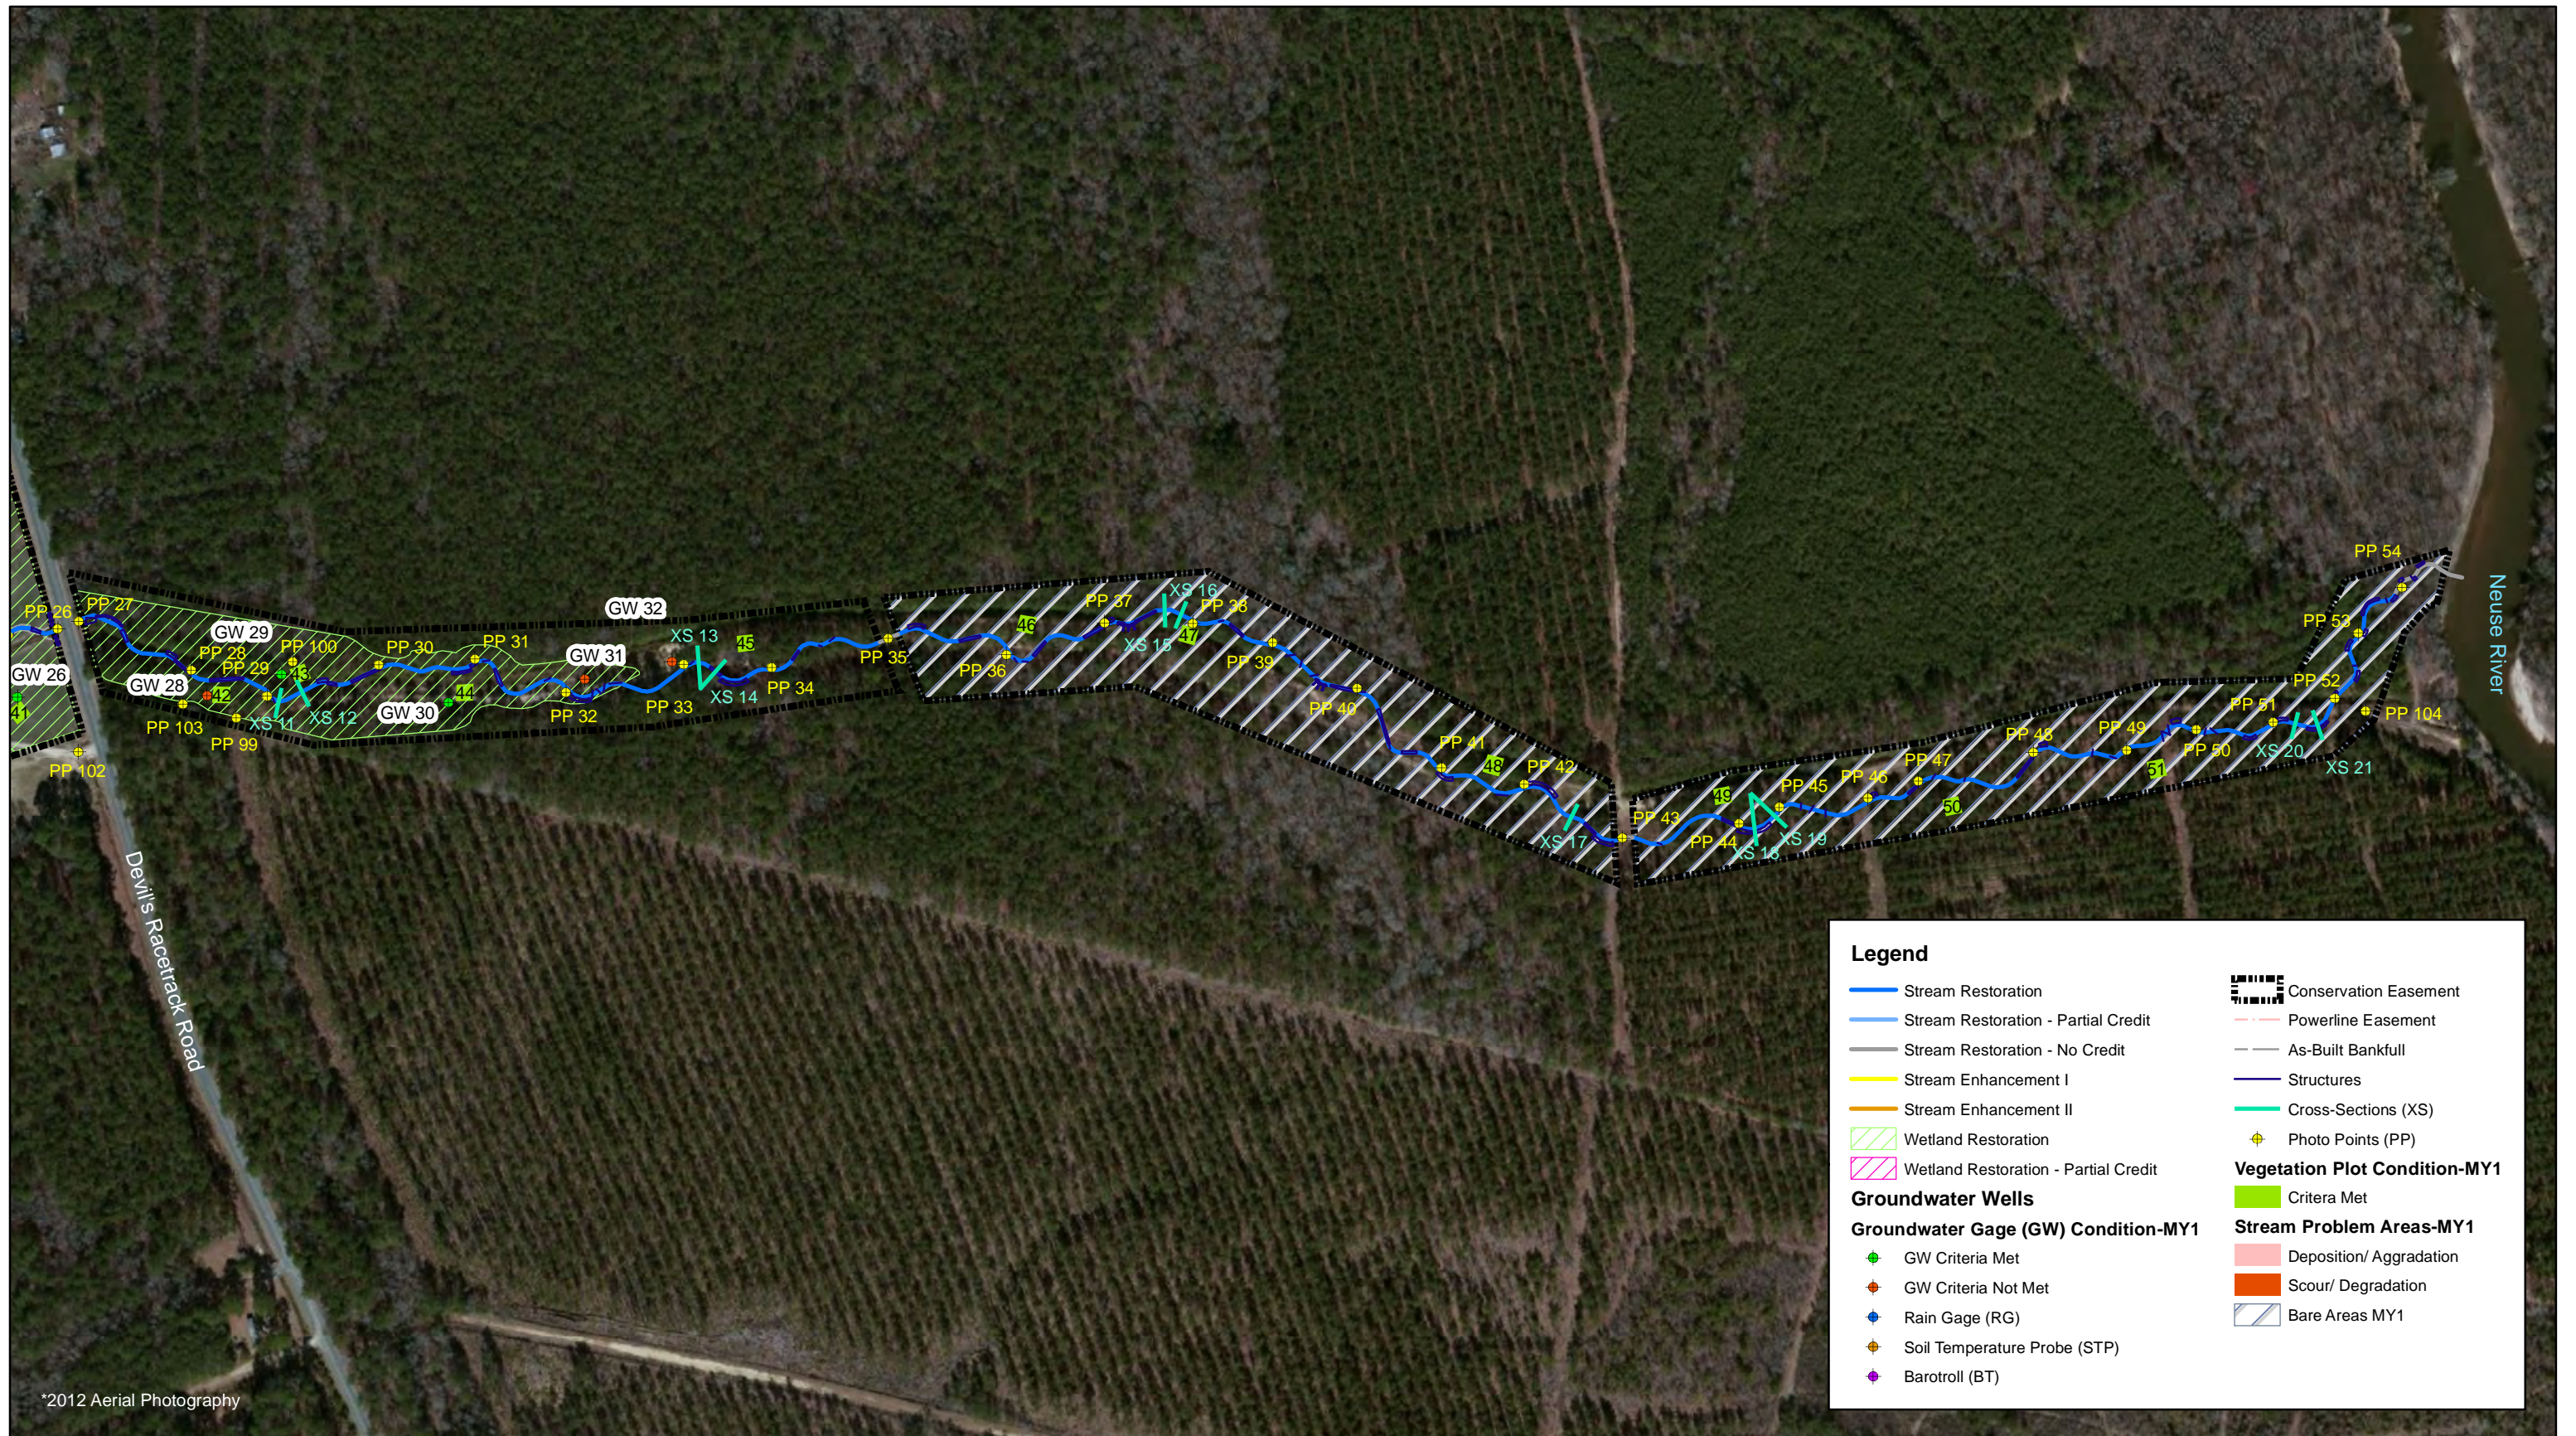
Figure 3.0 Integrated Current Condition Plan View  
 (Key)  
 Devil's Racetrack Mitigation Site  
 NCEEP Project No. 95021  
 Monitoring Year 1 - 2014  
 Johnston County, NC

Along the lower section of Devil's Racetrack-East, there are several bare areas (15.5% of the planted acreage). In these bare areas, the planted trees appear healthy and volunteer trees have sprouted, but grasses are not well established. This area was graded down several feet during construction which removed the top soil, leaving a more acidic subsoil. Wildlands has incorporated liquid and pelletized lime into the soil and we expect pH to decrease over the next year to two years providing better herbaceous growing conditions. This area will be monitored, and any additional actions deemed necessary to promote grass growth will be taken. Refer to Appendix 2 for the vegetation condition assessment table, Integrated Current Condition Plan View (CCPV), and reference photographs.

The downstream portion of Southeast Branch (Station 325+35 to 328+45) experienced minor aggradation following construction due to runoff from adjacent agricultural fields. Herbaceous cover has since established within the easement area that filters runoff and captures sediment prior to entering the stream channel. The middle section (Station 317+35 to 328+45) experienced moderate degradation due

to heavy flows during and immediately following construction. Minor repairs included sealing log drops and placing sod mats on eroded stream banks. These areas all appear to have stabilized following minor repair work and vegetation establishment.

No maintenance plan is necessary at this time. Wildlands will continue to monitor Southeast Branch and the floodplain area adjacent to the lower section of Devil's Racetrack-East. A maintenance plan will be developed if it becomes apparent that Southeast branch continues to have aggradation and degradation
