MONITORING YEAR 2 ANNUAL REPORT Final

DEVIL'S RACETRACK MITIGATION SITE

Johnston County, NC

NCDMS Project Number 95021

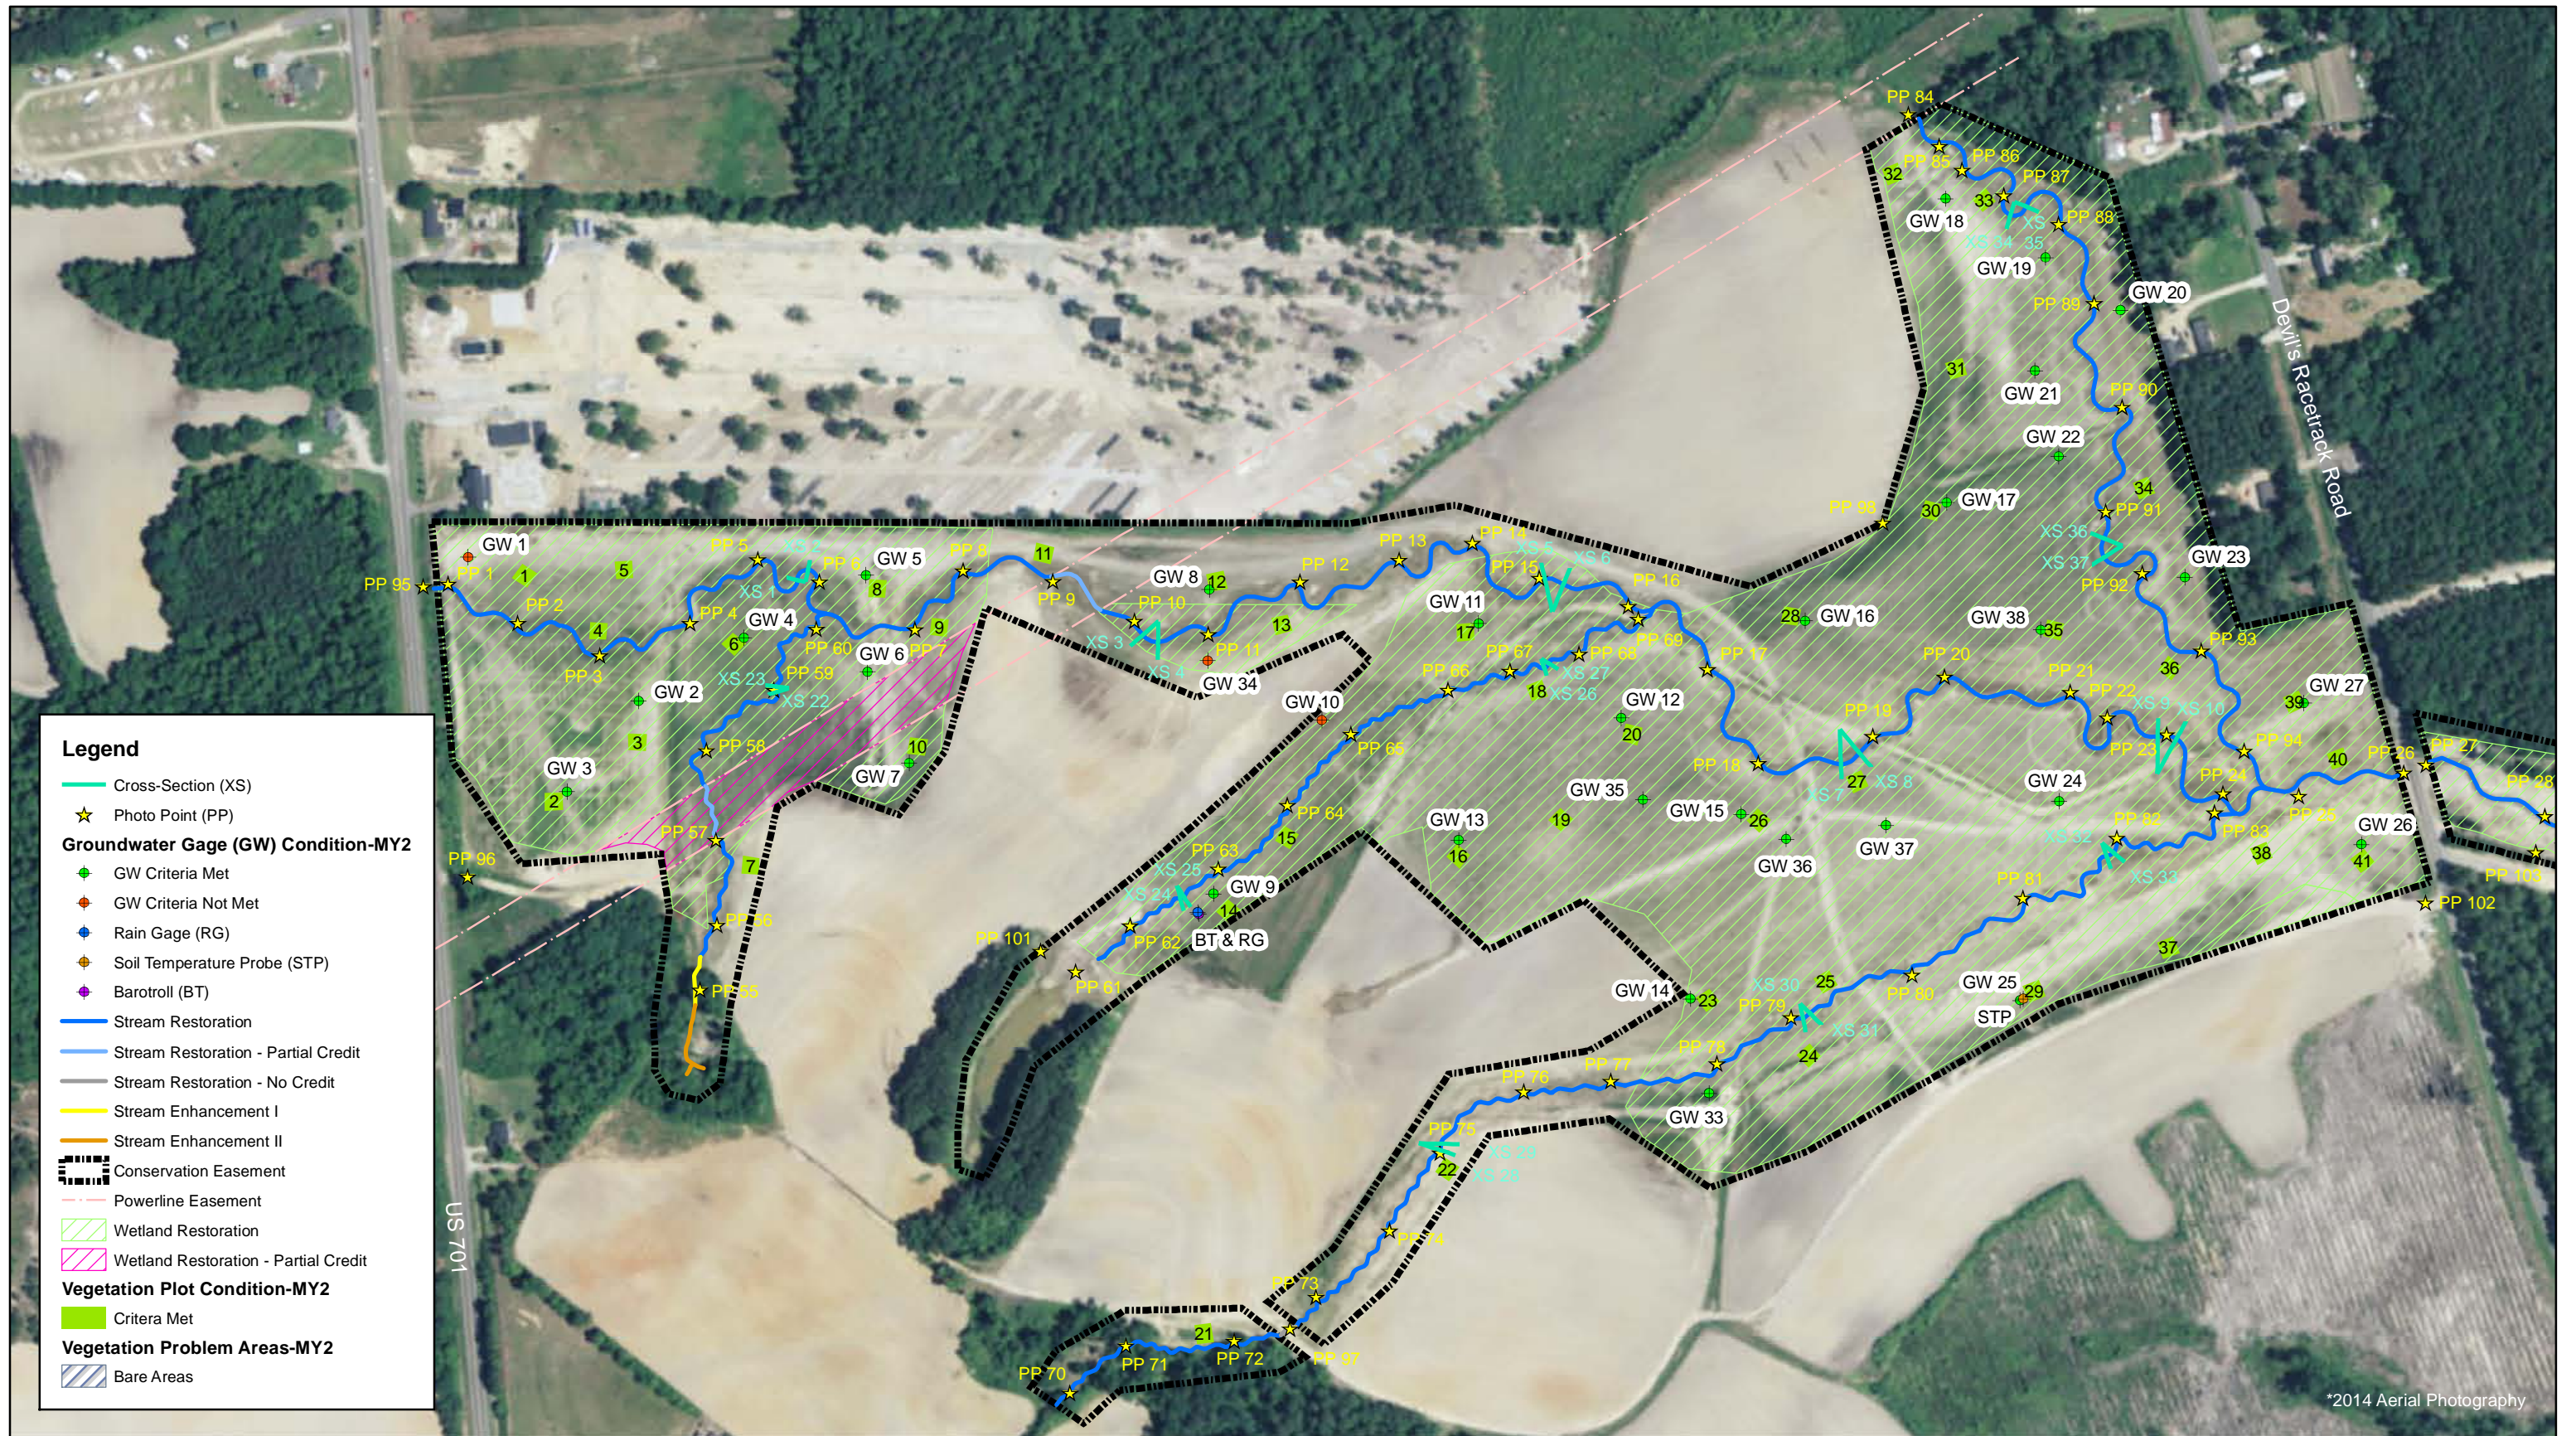
Figure 3.1 Integrated Current Condition Plan View
 (Sheet 1 of 2)
 Devil's Racetrack Mitigation Site
 NCDMS Project No. 95021
 Monitoring Year 2 - 2015
 Johnston County, NC

Along the lower section of Devil's Racetrack (East), there are several bare areas (approximately 15.5% of the planted acreage). In these bare areas, the planted trees appear healthy and volunteer trees have sprouted, but the herbaceous ground cover is still deficient and not well established. This area was graded down several feet during construction which removed the top soil, leaving a more acidic subsoil. Wildlands incorporated liquid and pelletized lime into the soil during construction with the expectation that the pH would increase over the first year or two and would provide better herbaceous growing conditions. As of MY2, this area still has low pH soils, but continues to improve as the herbaceous ground cover density develops. Additional permanent seed, temporary seed, lime, and fertilizer was added during MY2 to promote better ground cover. Wildlands will continue to monitor these areas and will reapply seed and soil amendments as necessary. Refer to Appendix 2 for the vegetation condition assessment table, the Integrated Current Condition Plan View (CCPV), and reference photographs.

developed if it becomes apparent that Southeast Branch continues to have aggradation and degradation problems. In addition, if the floodplain area adjacent to the lower portion of Devil's Racetrack (East) does not continue to improve herbaceous cover, Wildlands will develop a maintenance plan to establish grasses.

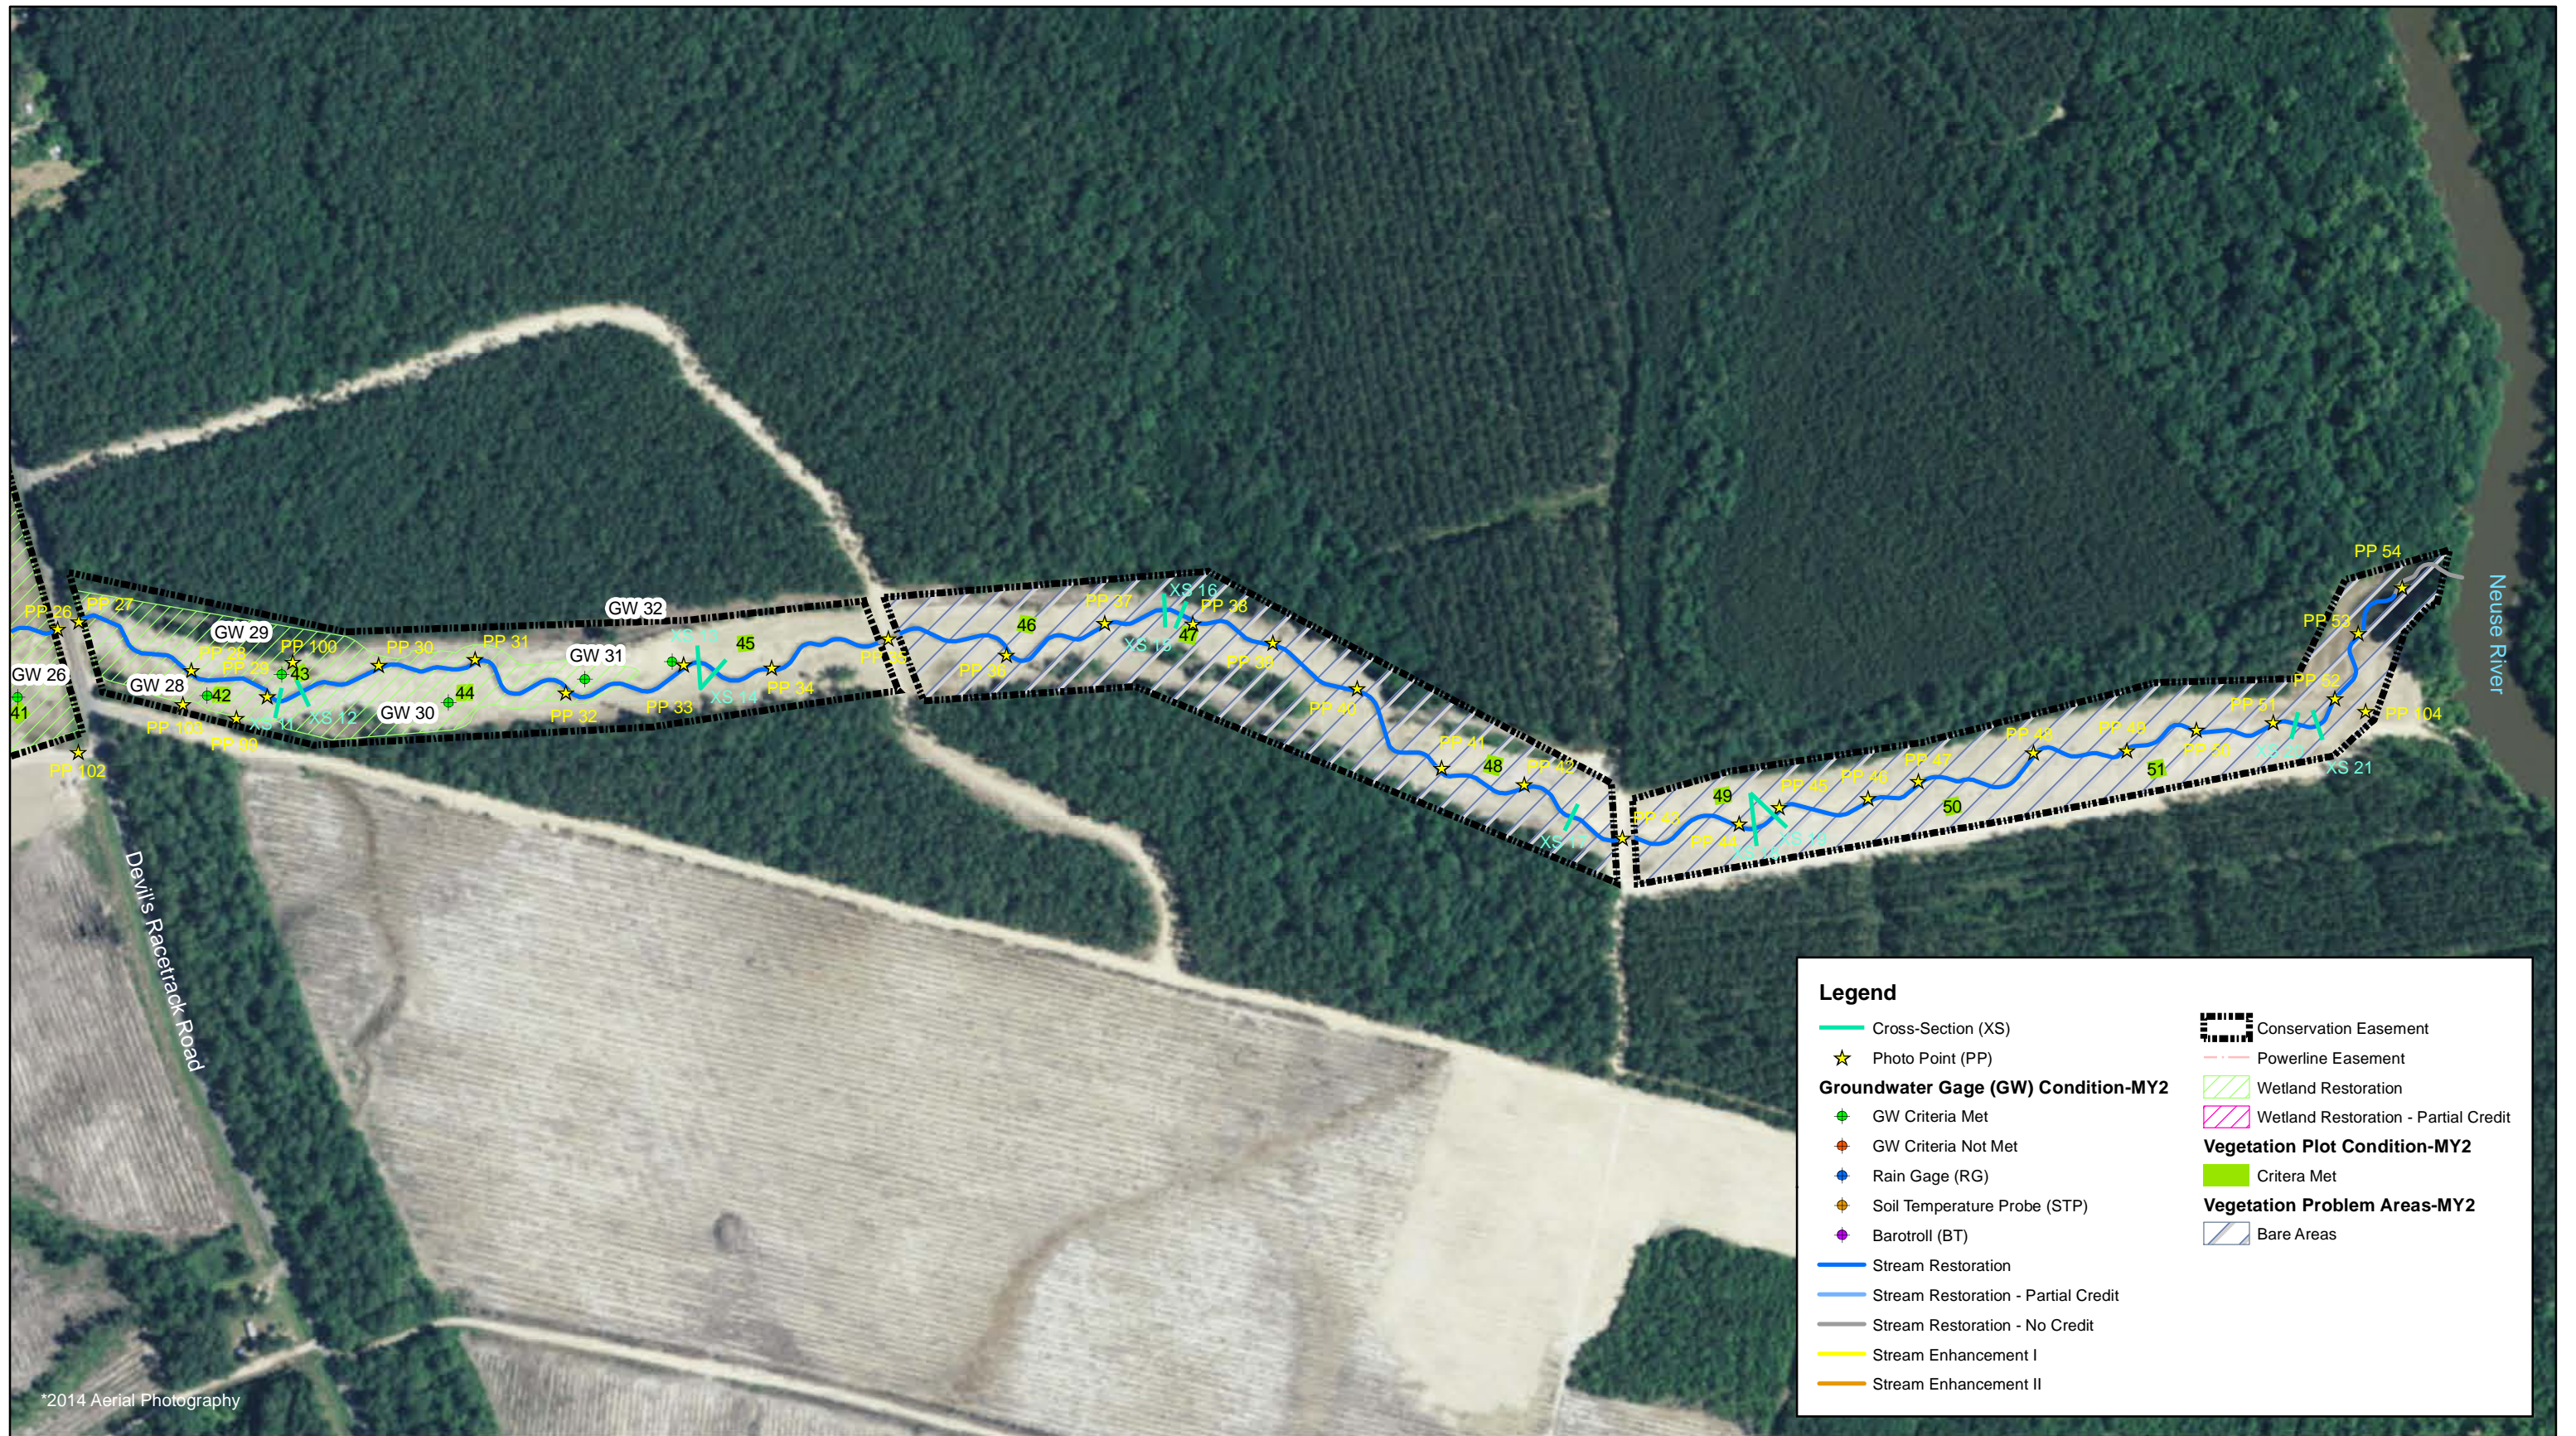
Figure 3.2 Integrated Current Condition Plan View
 (Sheet 2 of 2)
 Devil's Racetrack Mitigation Site
 NCDMS Project No. 95021
 Monitoring Year 2 - 2015
 Johnston County, NC

Southeast Branch also had minor repair work performed in the spring of 2015. Several areas between stations 309+00 and 315+00 required repairs to log grade control structures. These structures were sealed with native stone to stabilize them. Also, several meander bends were repaired by installing native sod mats and transplants for bank stabilization. Below this area where the stream slope decreases, sediment that had accumulated in the channel was removed and deposited on the adjacent, stabilized floodplain. Wildlands assumes that the sediment deposition resulted from runoff of the adjacent farm fields prior to the riparian buffer becoming well established. Wildlands will continue to monitor the sediment deposition along Southeast Branch in future monitoring years.
