**MONITORING YEAR 3
ANNUAL REPORT**
Final

DEVIL'S RACETRACK MITIGATION SITE

Johnston County, NC
NCDEQ Contract 003989
DMS Project Number 95021

DEVIL’S RACETRACK MITIGATION SITE
Monitoring Year 3 Annual Report

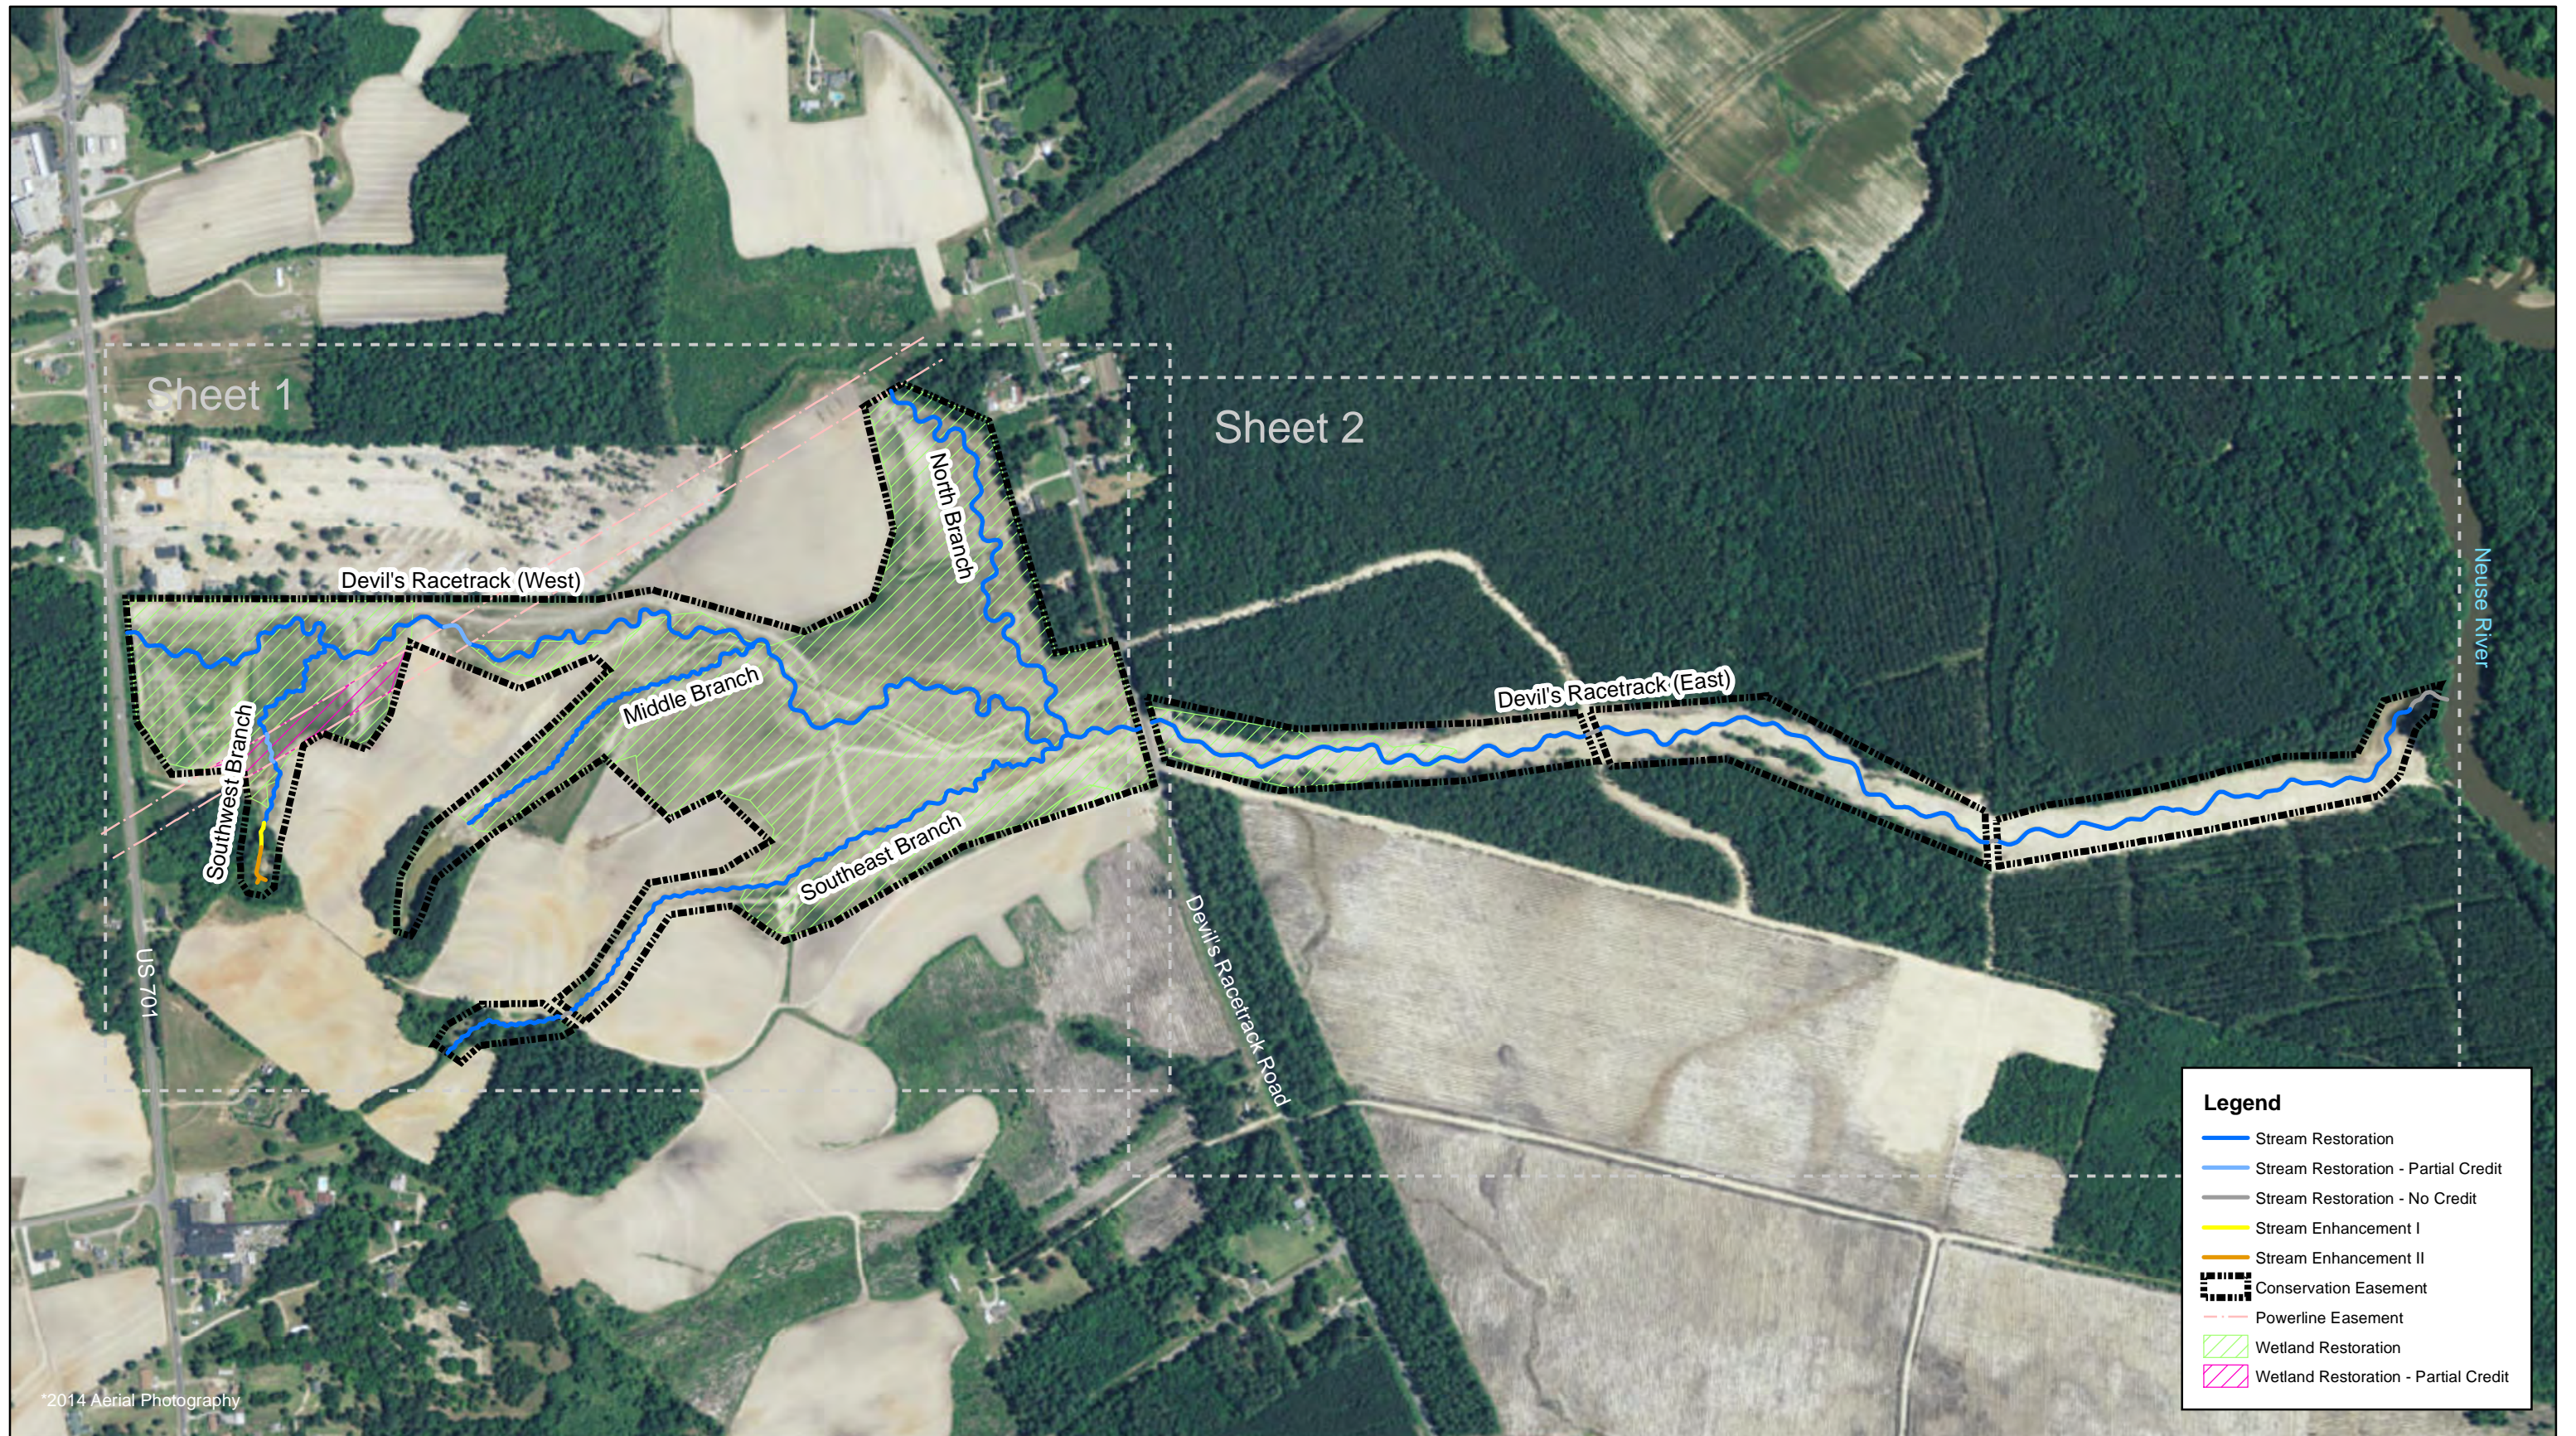
Figure 3.0 Integrated Current Condition Plan View
 (Key)
 Devil's Racetrack Mitigation Site
 DMS Project No. 95021
 Monitoring Year 3 - 2016
 Johnston County, NC

Along the lower section of Devil's Racetrack (East), there are several bare areas (approximately 15.5% of the planted acreage). In these bare areas, the planted trees appear healthy and volunteer trees have sprouted, but the herbaceous ground cover is still deficient and not well established. This area was graded down several feet during construction which removed the nutrient rich top soil, leaving a more acidic subsoil. Wildlands incorporated liquid and pelletized lime into the soil during construction with the expectation that the pH would increase over the first year or two and would provide better herbaceous growing conditions. As of MY3, this area still has low pH soils, but continues to improve as the herbaceous ground cover density develops. Additional permanent seed, temporary seed, lime, and fertilizer was added during MY3 to promote better ground cover. We applied a hydroseed mixture to a ½ test plot during MY3 however germination was poor likely due to the continuing low pH conditions. During MY4 Wildlands will continue to monitor these areas and will reapply seed and soil amendments as necessary. Refer to Appendix 2 for the vegetation condition assessment table, the Integrated Current Condition Plan View (CCPV), and reference photographs.
