MONITORING YEAR 4 ANNUAL REPORT

DEVIL'S RACETRACK MITIGATION SITE

Johnston County, NC

DMS Project Number 95021

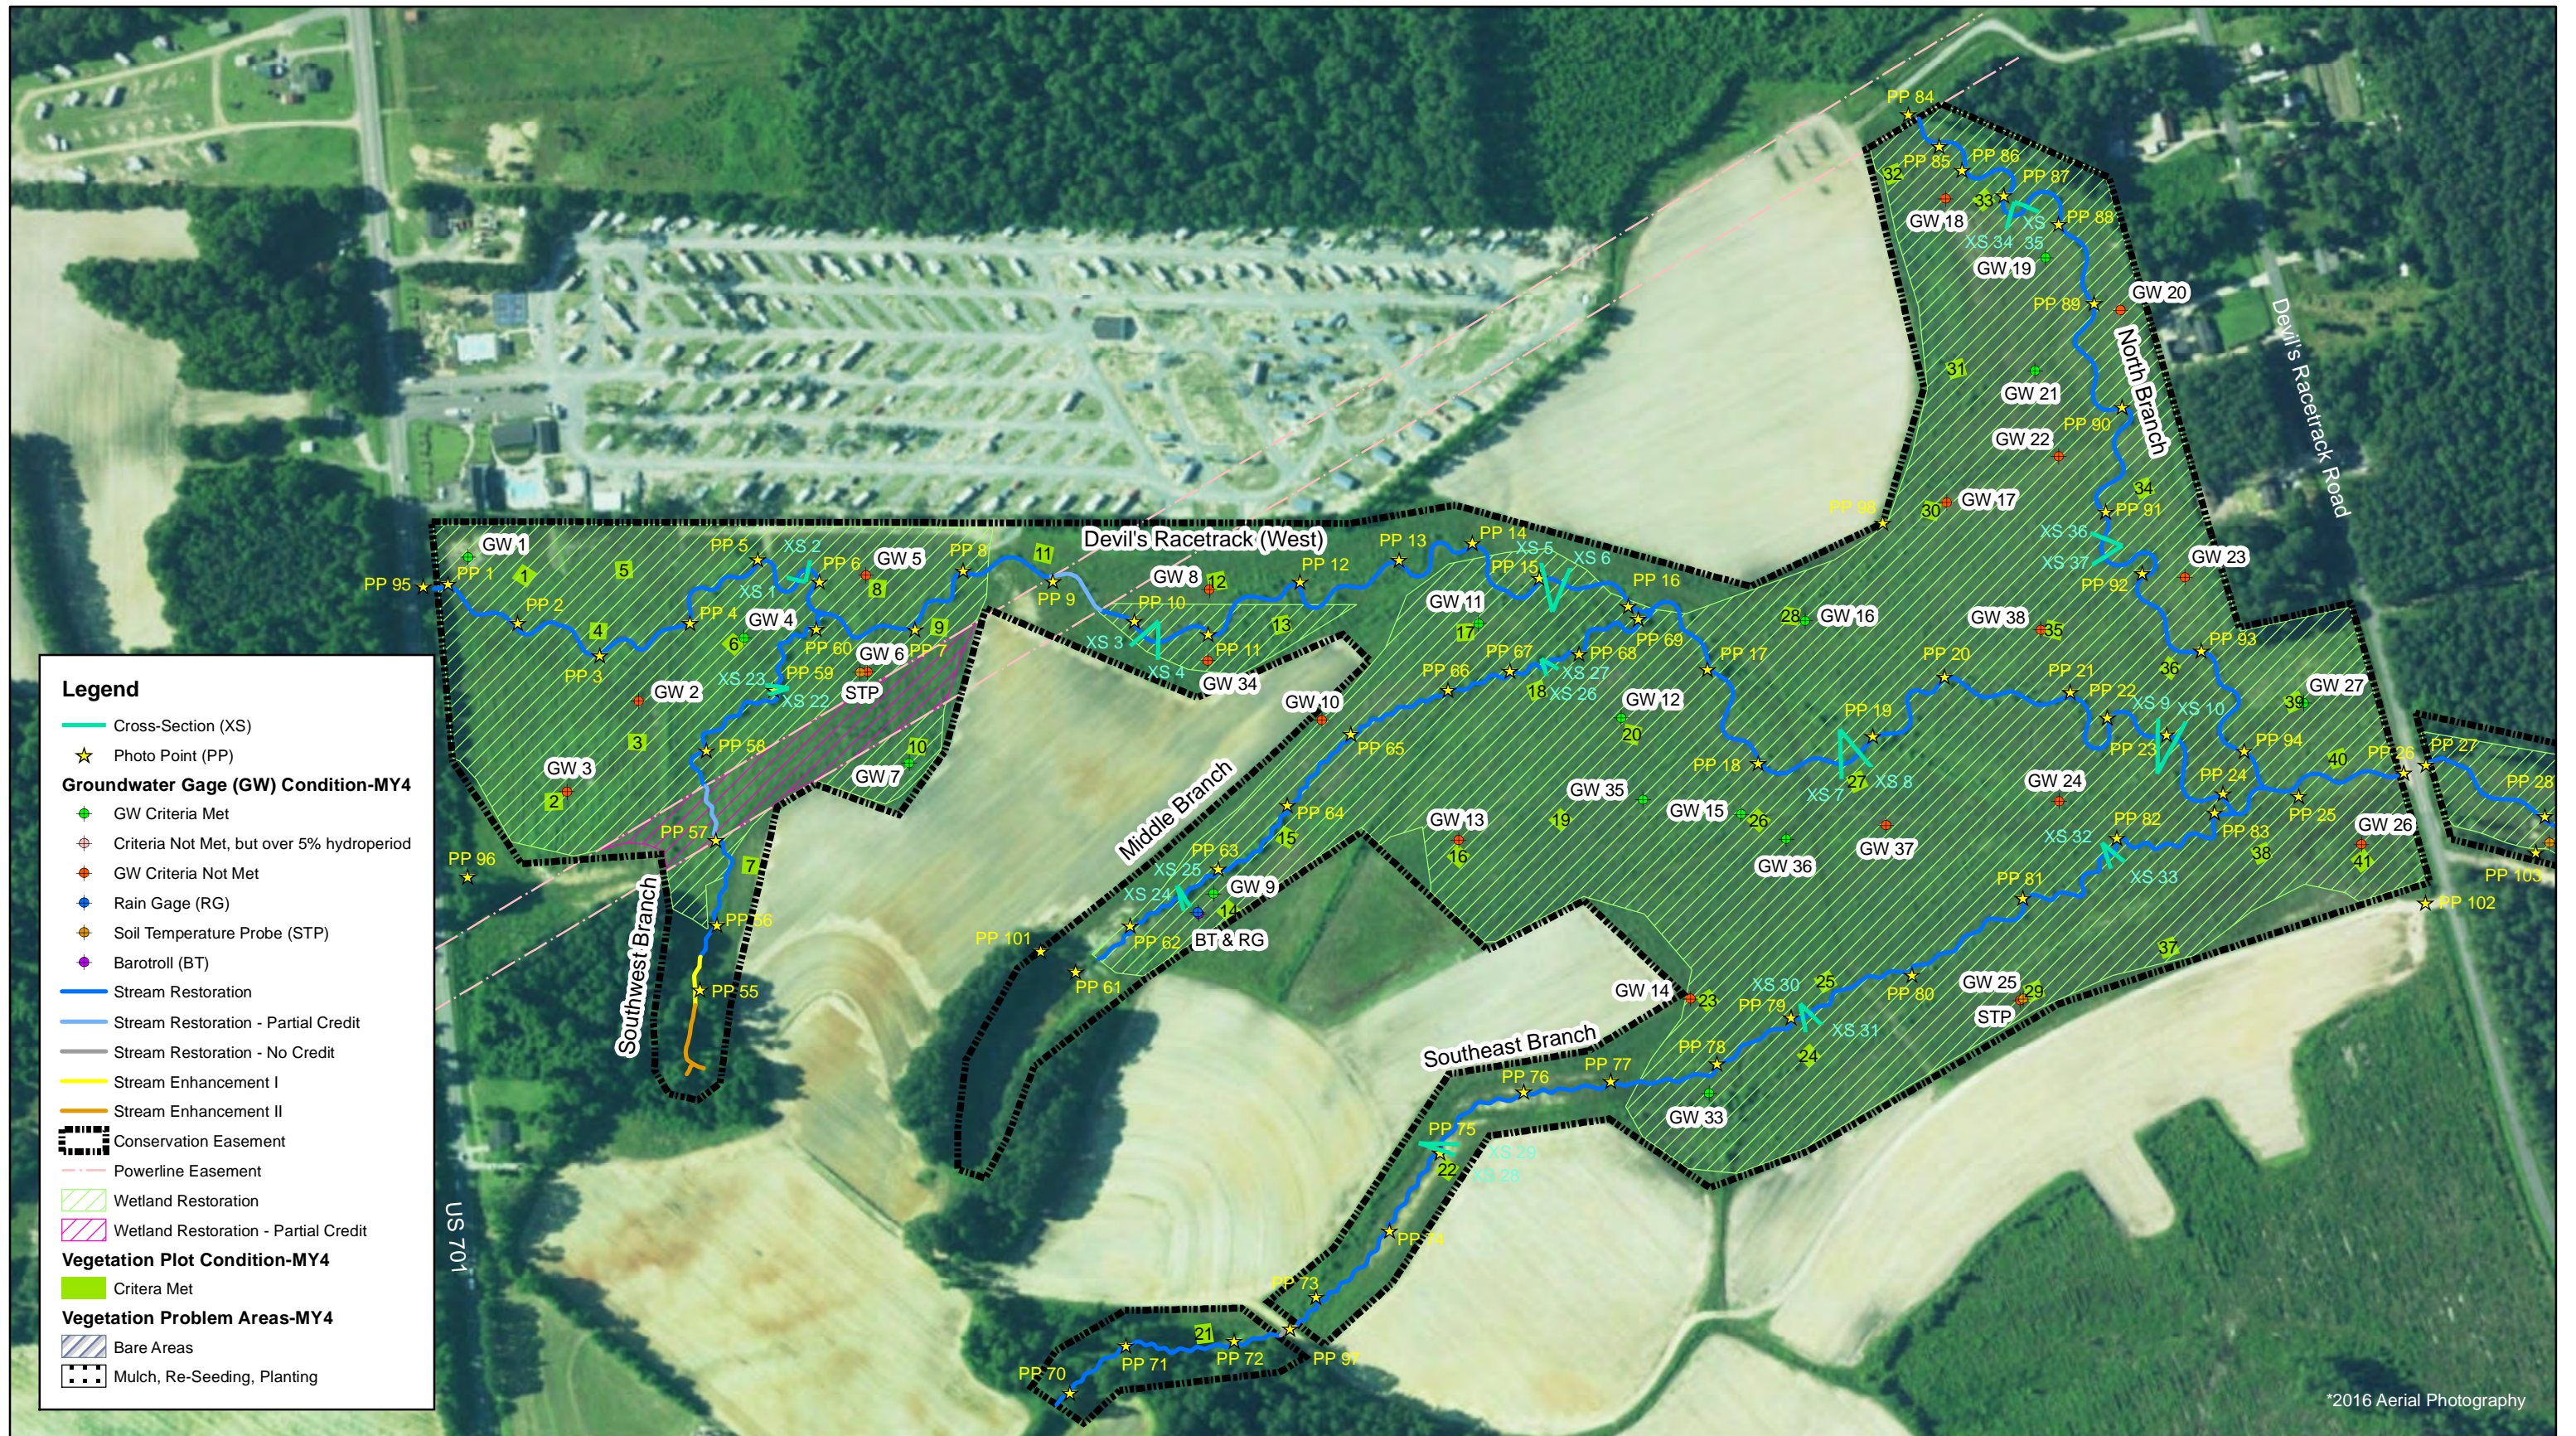
Figure 3.1 Integrated Current Condition Plan View
 (Sheet 1 of 2)
 Devil's Racetrack Mitigation Site
 DMS Project No. 95021
 Monitoring Year 4 - 2017
 Johnston County, NC

Along the lower section of Devil's Racetrack (East), there are a few bare areas totaling 4.8 acres (approximately 5.0% of the planted acreage). In these bare areas, the planted trees appear healthy and volunteer trees have sprouted, but the herbaceous ground cover is still deficient and not well established. This area was graded down several feet during construction which removed the nutrient rich top soil, leaving a more acidic subsoil. Wildlands incorporated liquid and pelletized lime into the soil during construction with the expectation that the pH would increase over the first year or two and would provide better herbaceous growing conditions. As of MY4, this area still has low pH soils, but continues to improve as the herbaceous ground cover density develops. In May hugel beds (small trenches filled with organic material and covered with straw or mulch to hold moisture) were installed at varying locations within the 4.8 acre problem area to help promote vegetation growth. A mixture of mulch, lime, fertilizer, and temporary and permanent grasses was applied in November to add organic matter to the surface of the excavated areas to promote herbaceous ground cover.

This winter supplemental tree planting will be performed in these areas as needed. Tree species that can tolerate lower pH levels will be planted. During MY5 Wildlands will continue to monitor these areas and will reapply seed and soil amendments as necessary. Refer to Appendix 2 for the vegetation condition assessment table, the Integrated Current Condition Plan View (CCPV), and reference photographs.
