MONITORING YEAR 6 ANNUAL REPORT FINAL

DEVIL'S RACETRACK MITIGATION SITE

Johnston County, NC
NCDEQ Contract 003989
DMS Project Number 95021
USACE Action ID Number 2012-00810
NCDWR Project Number 12-0747

Data Collection Period: March - November 2019
Draft Submission Date: December 20, 2019
Final Submission Date: February 20, 2020

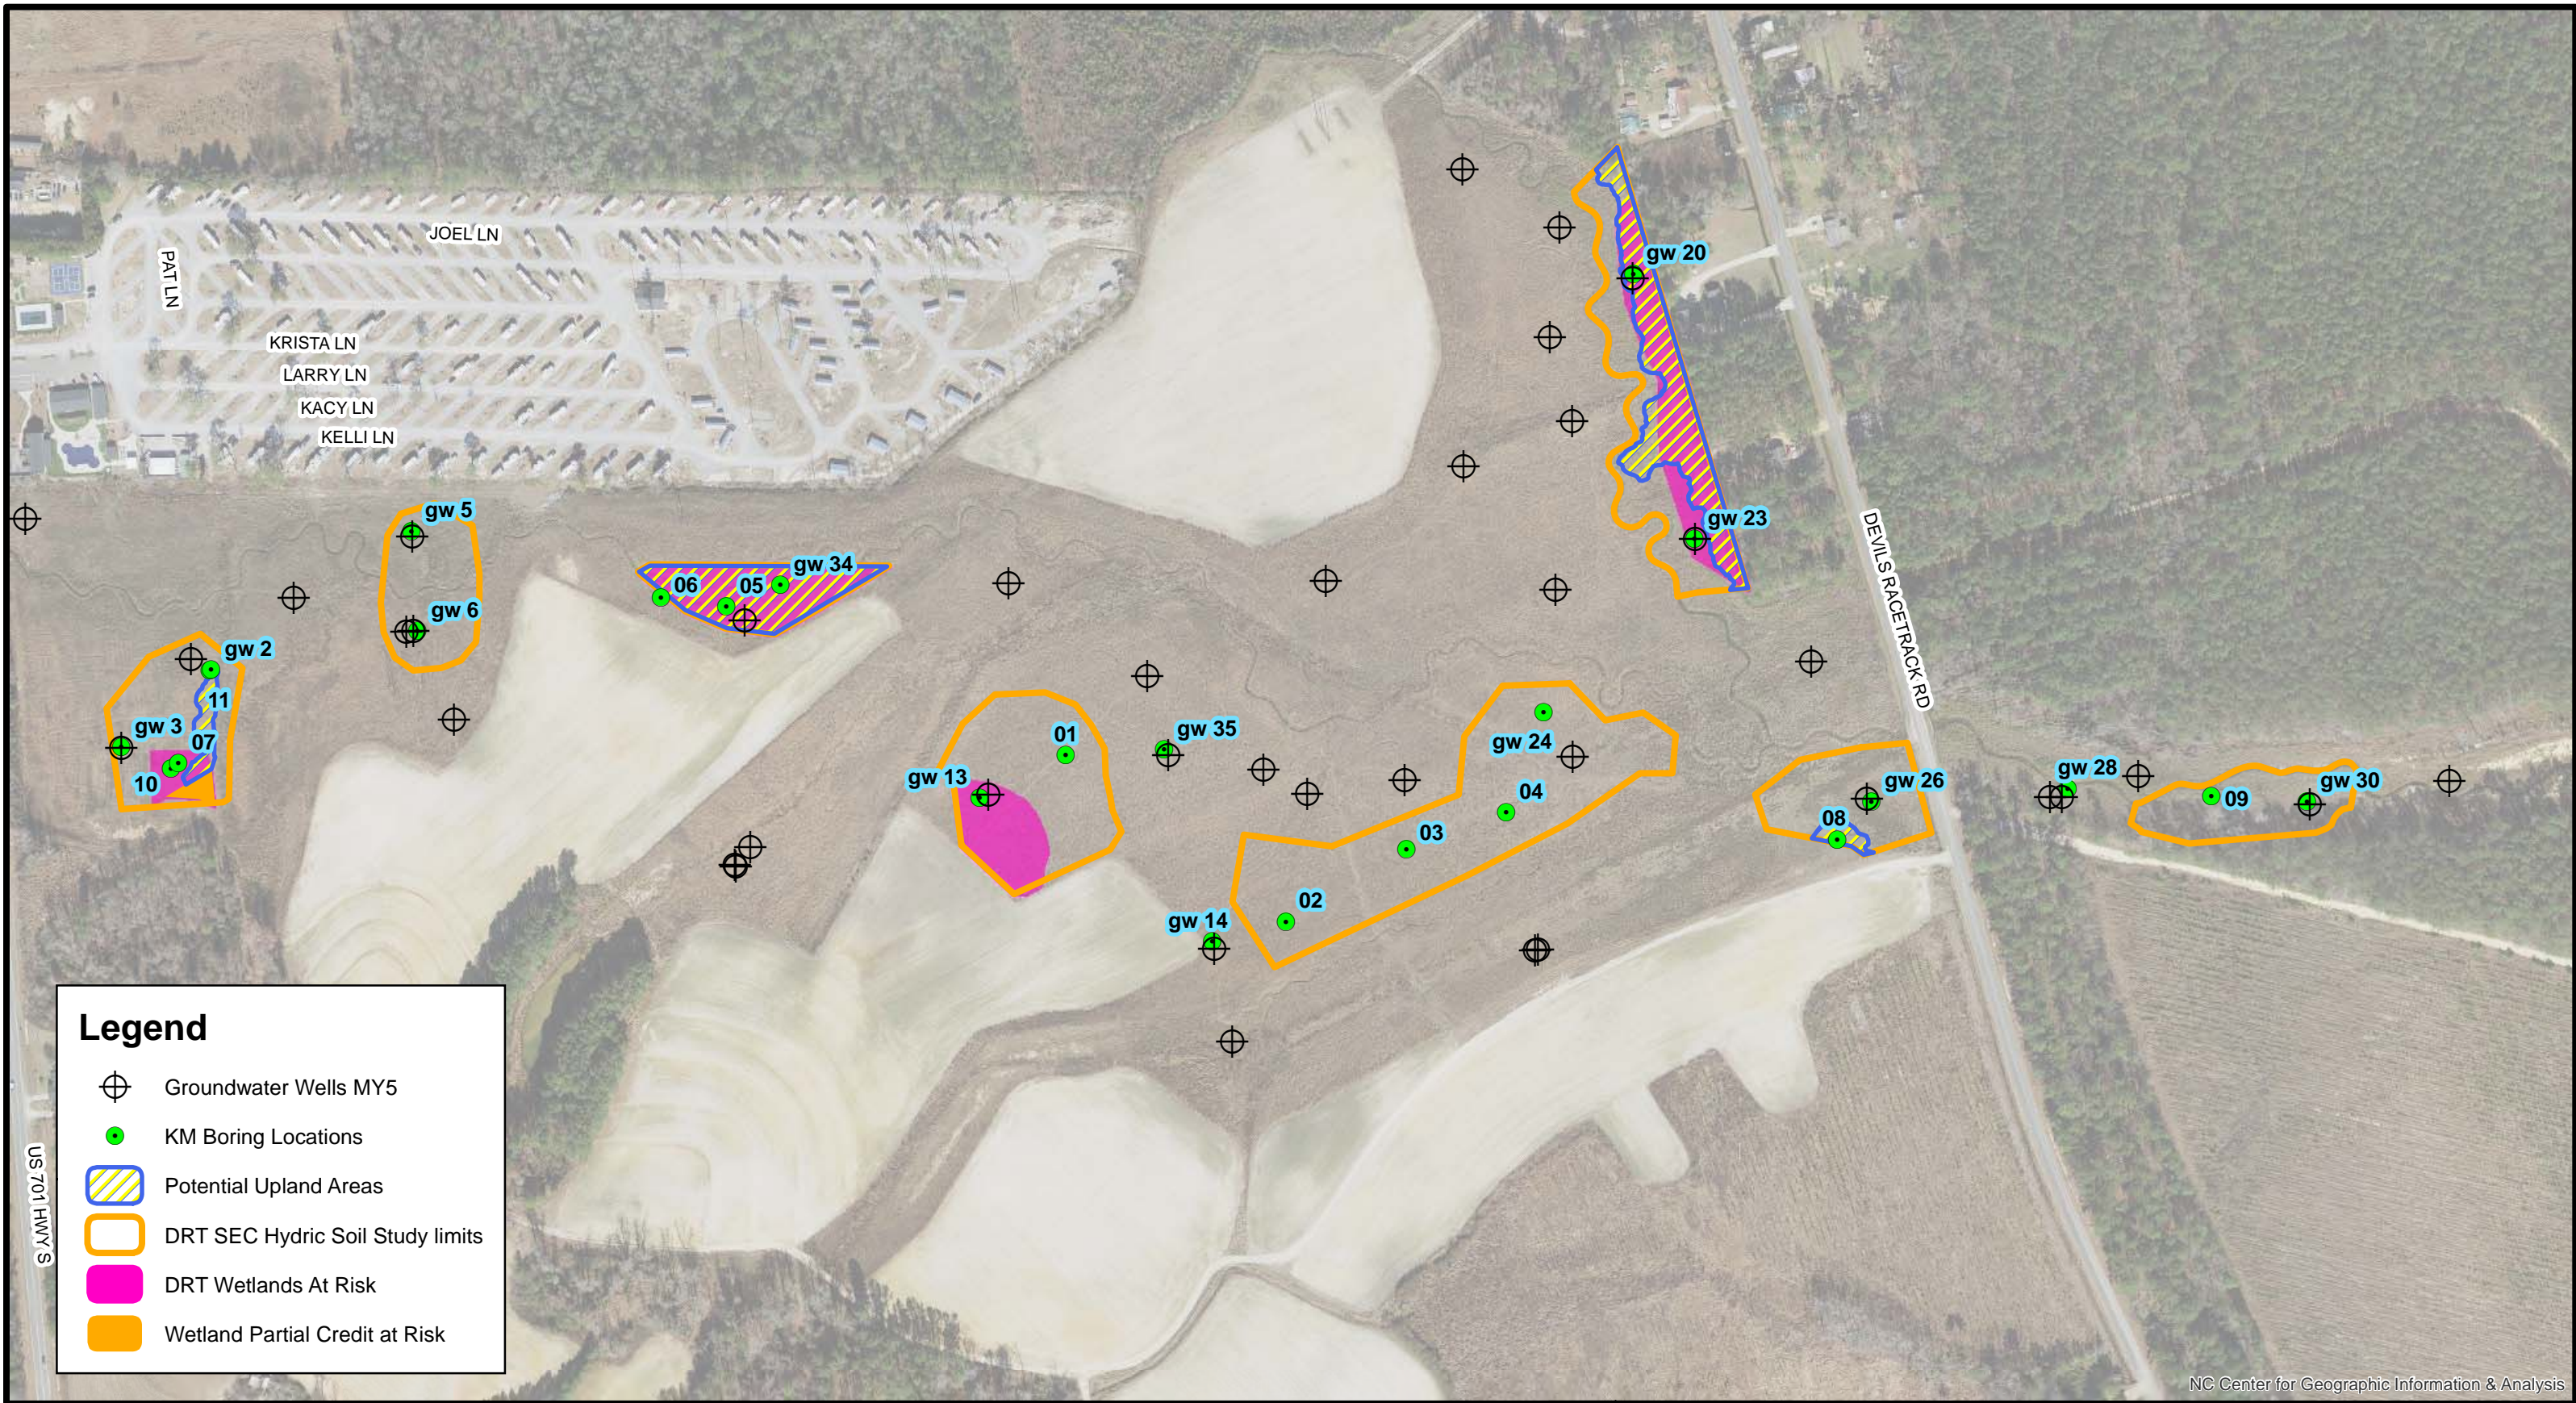
- (4) The elongated area south of GW20. This area contains hydric soils, but is slightly elevated above adjacent areas that are meeting aquic conditions but the ditch along the eastern property line is likely preventing adequate hydrology that would cause aquic conditions.

These areas are outlined in blue with yellow hatching on the attached S&EC Devils Racetrack Mitigation Site Map.

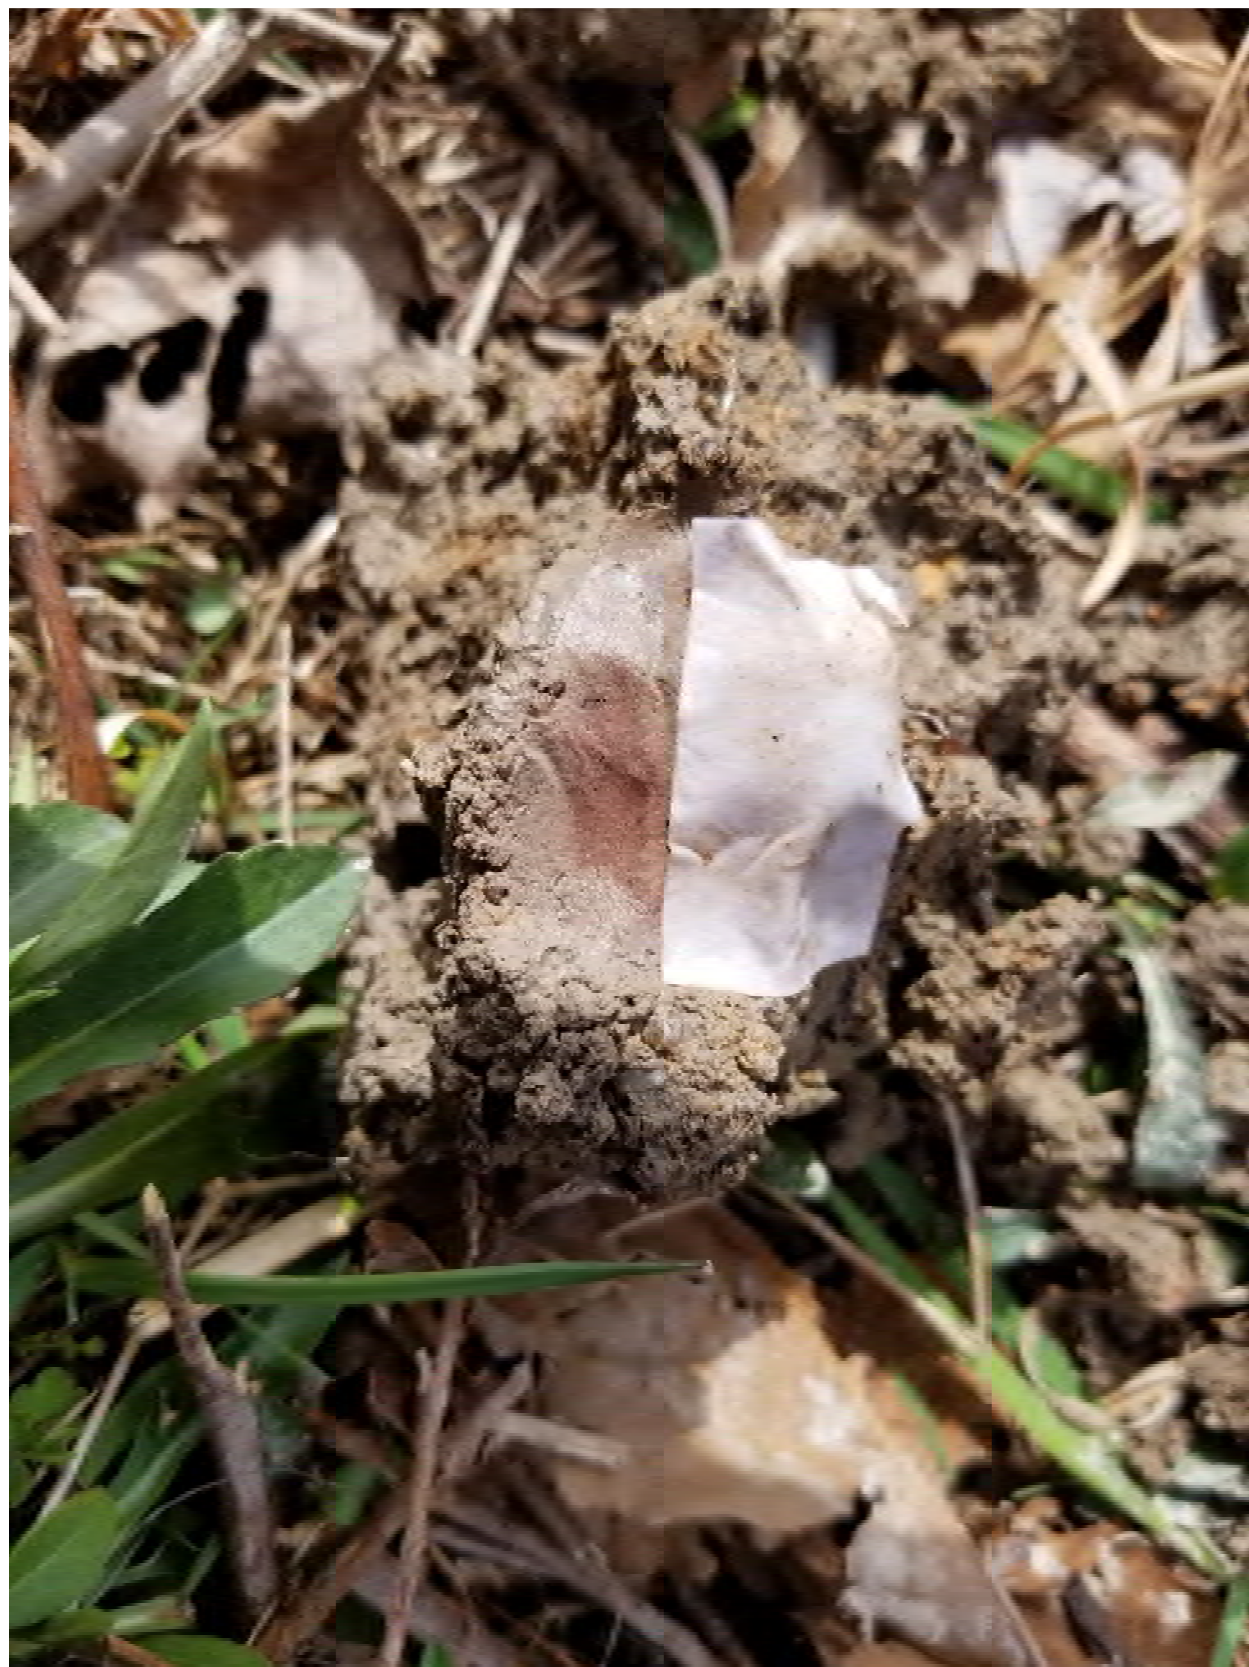
B3 Positive α, α' -dipyridyl

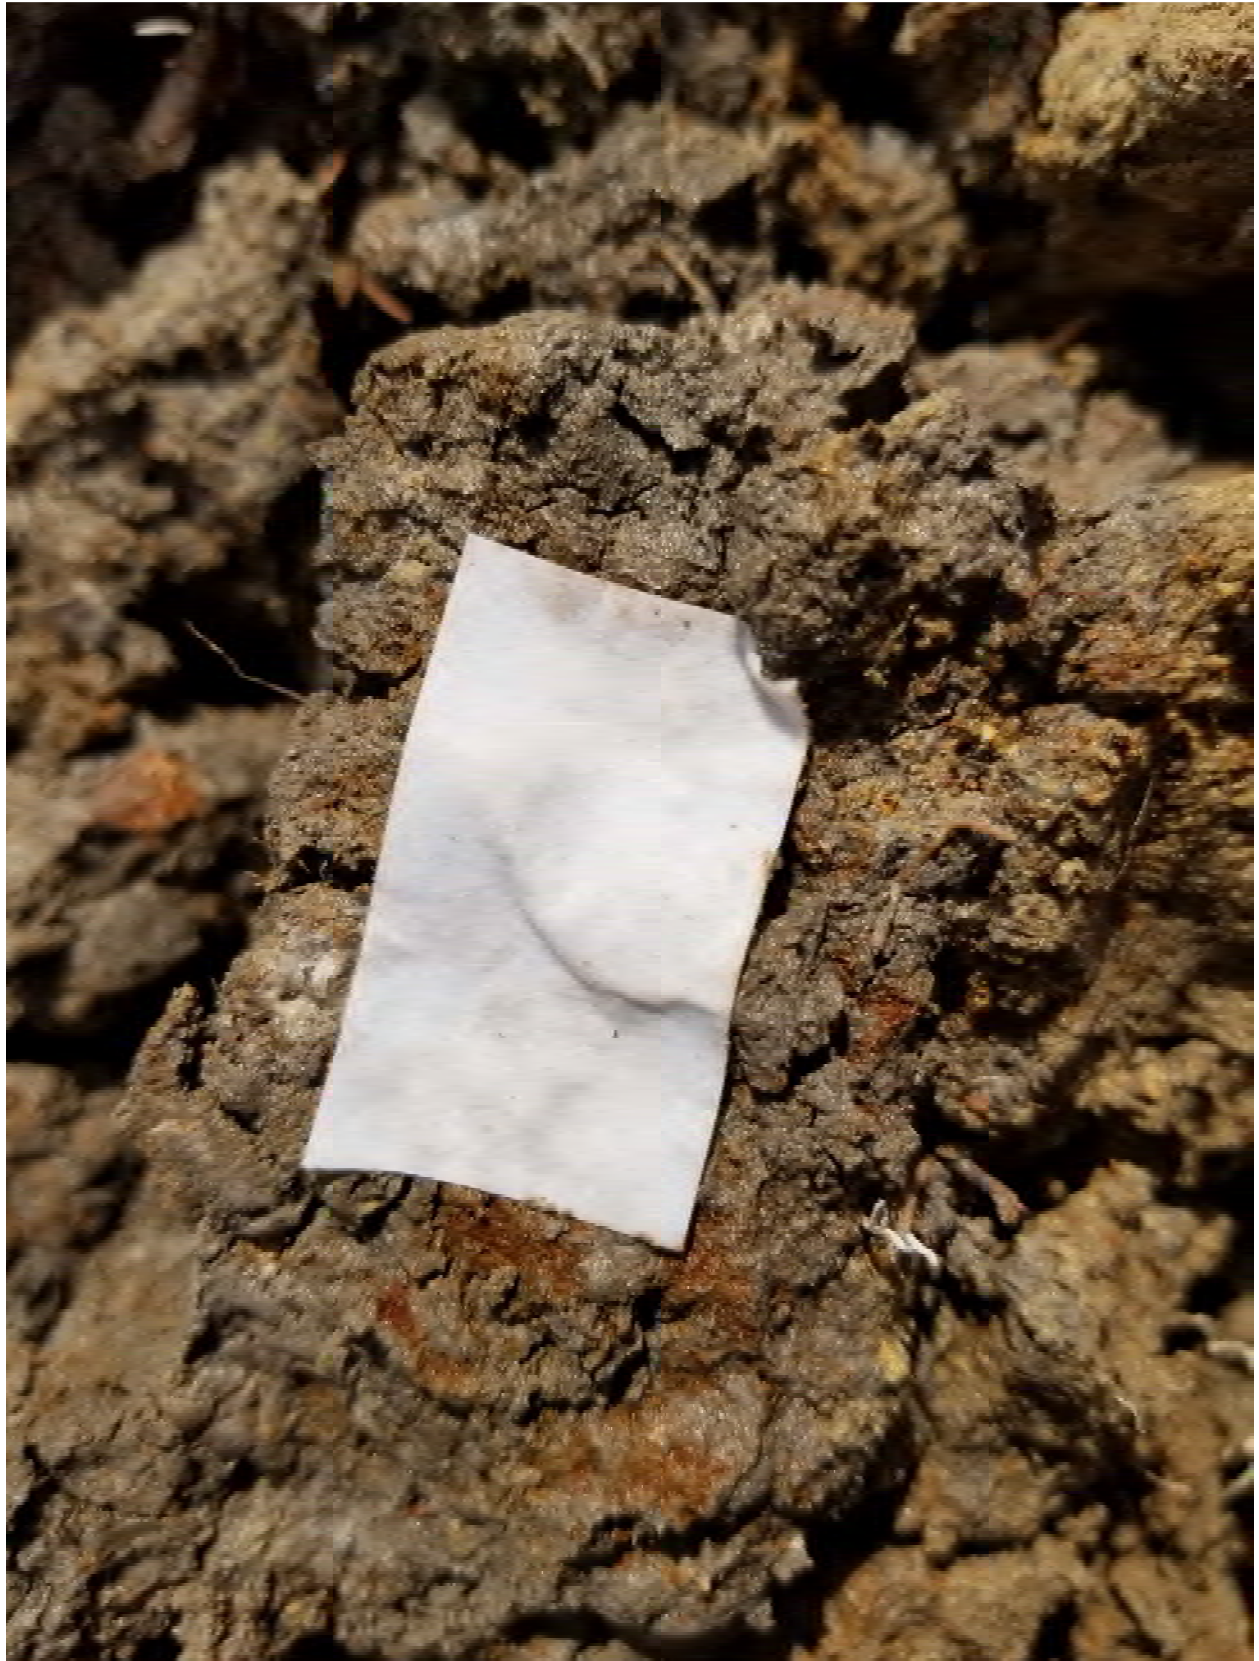
B5 6-12+” Positive α , α' -dipyridyl

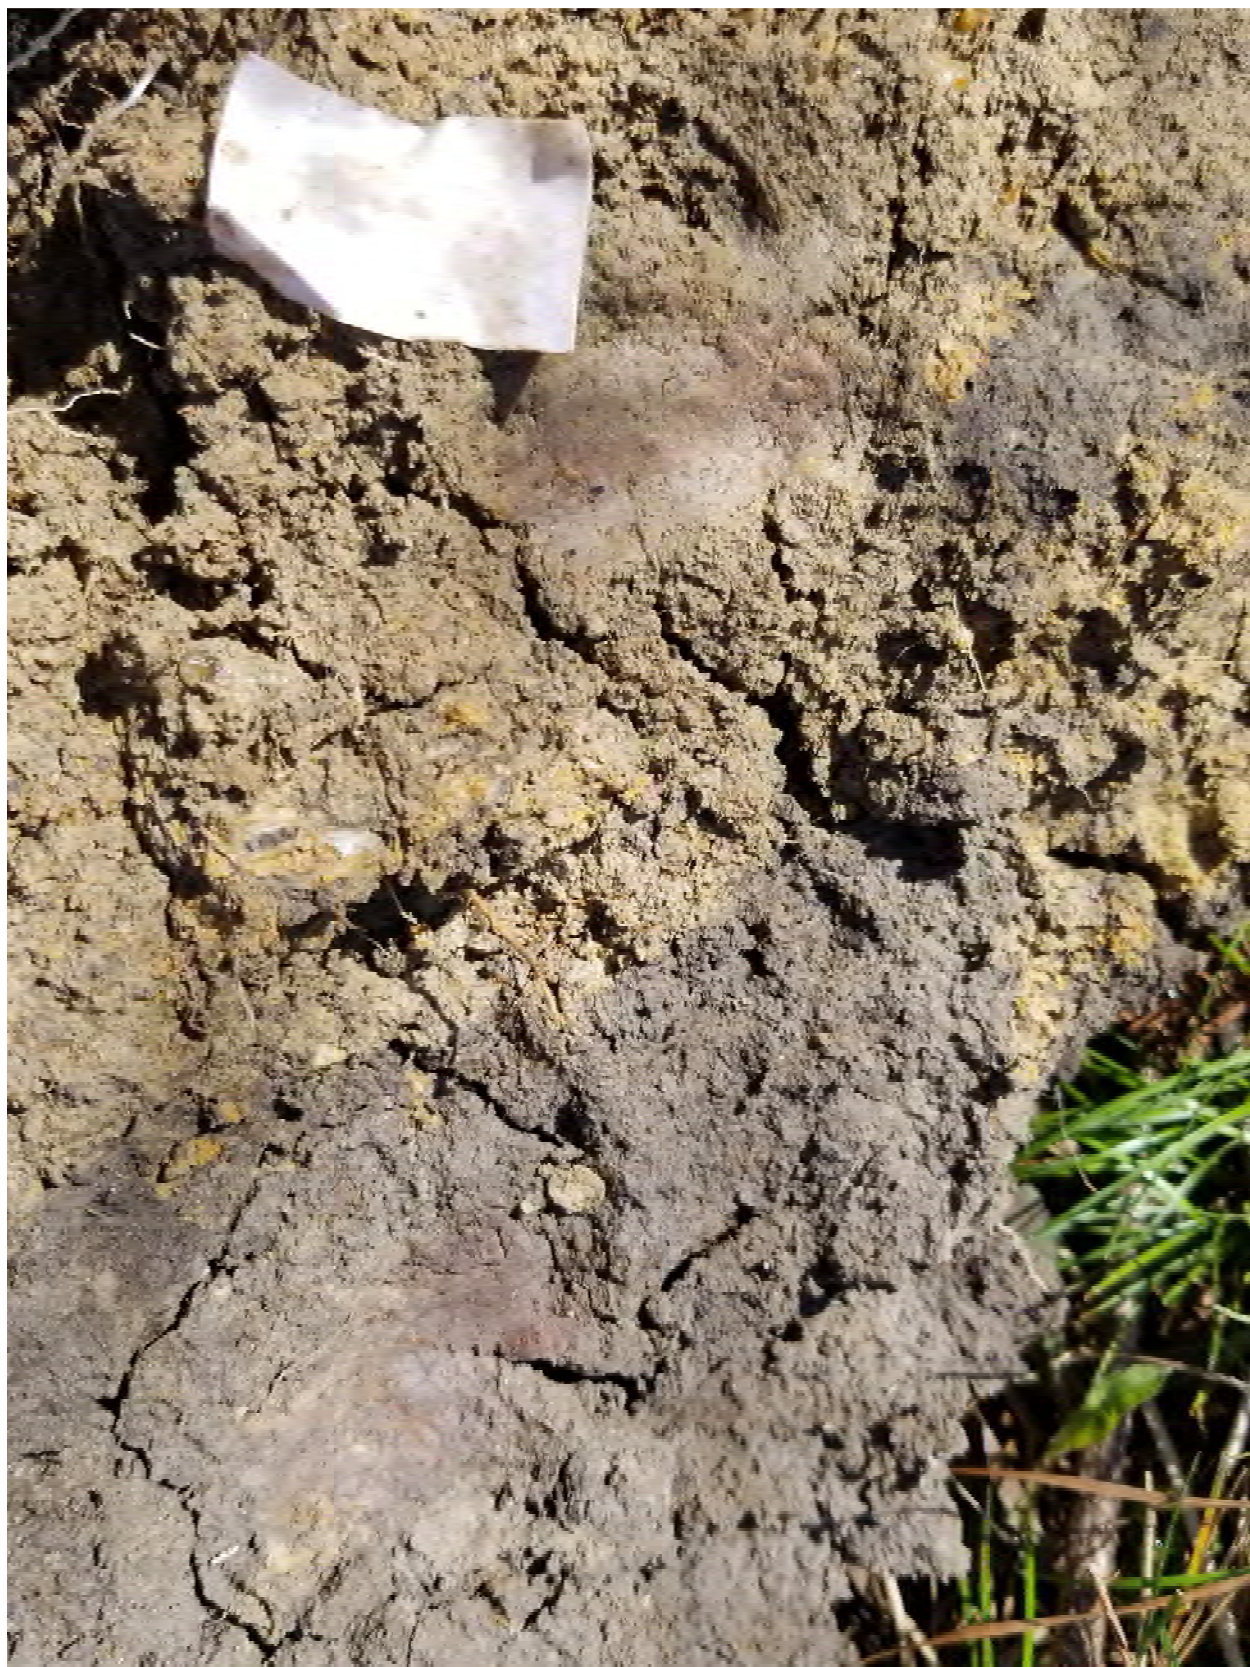
GW26 Positive α, α' -dipyridyl

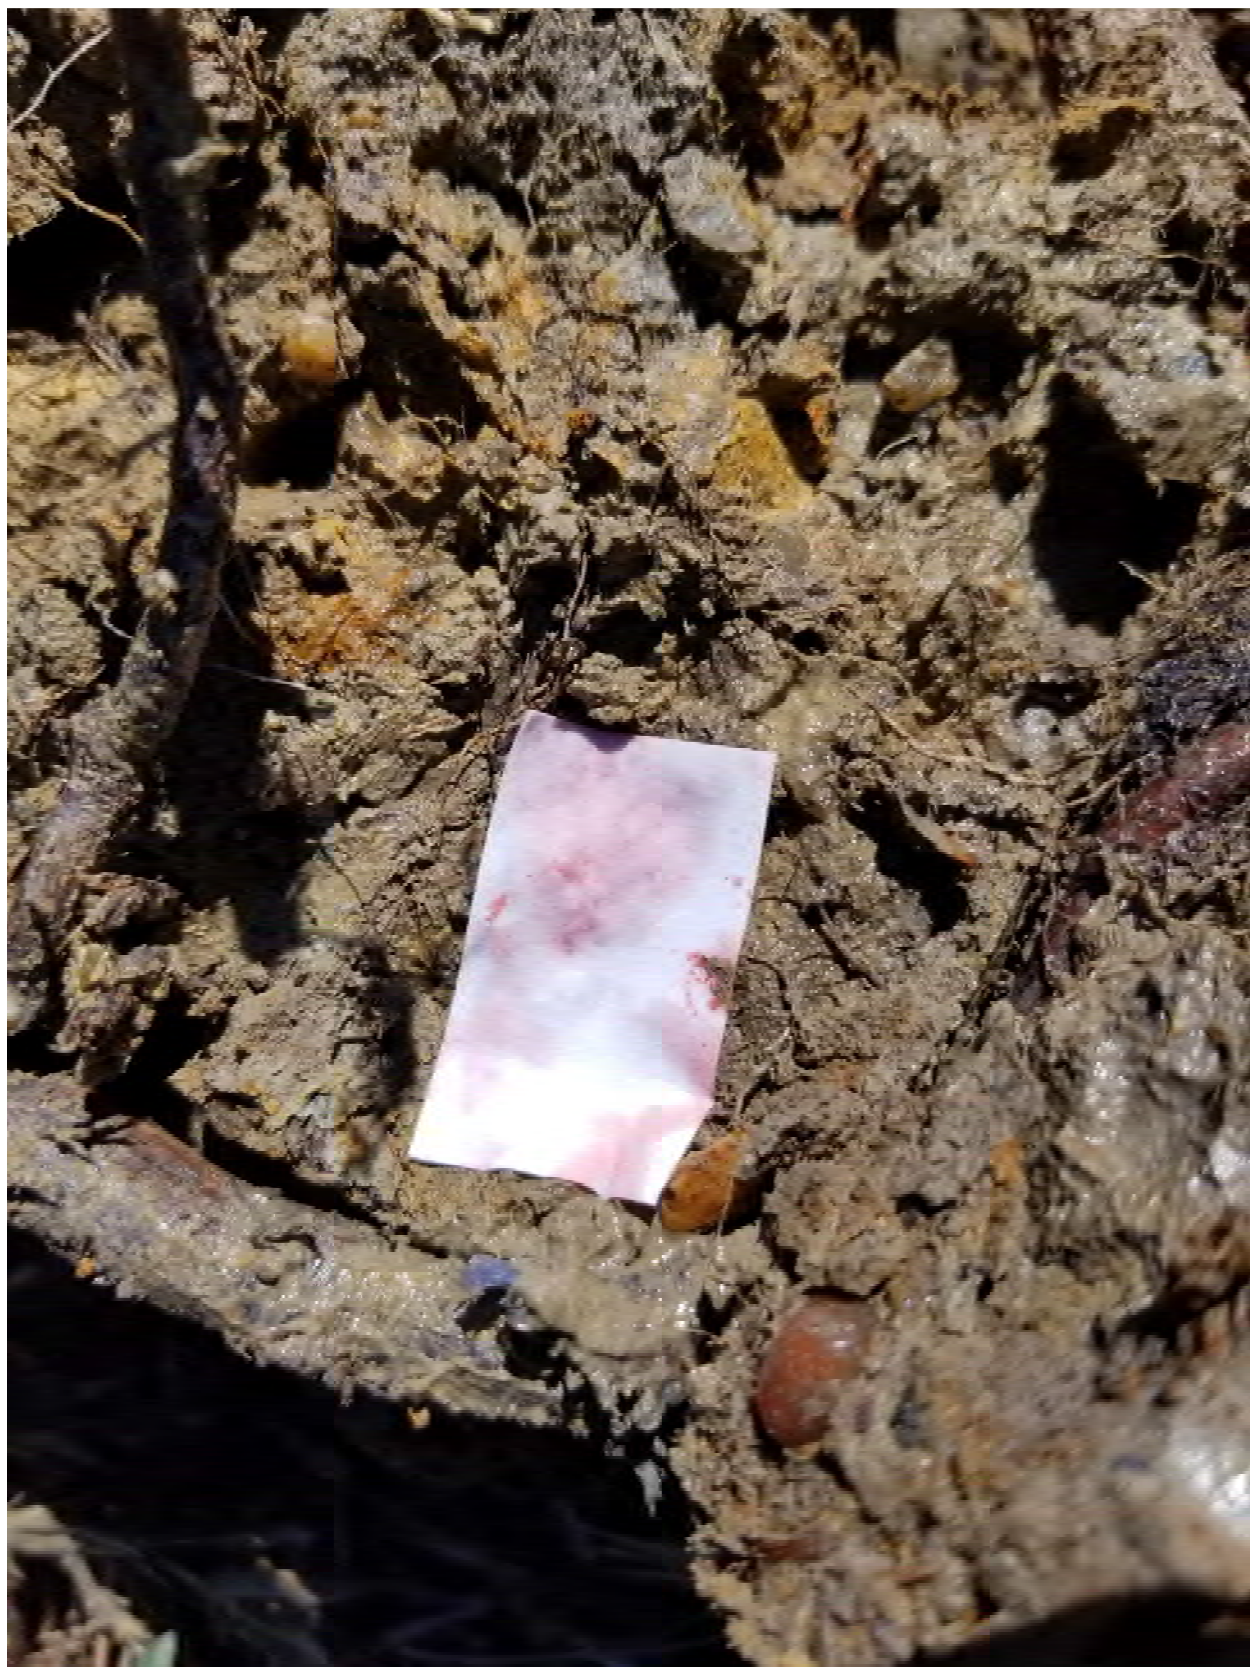
GW30 surface Positive α , α' -dipyridyl

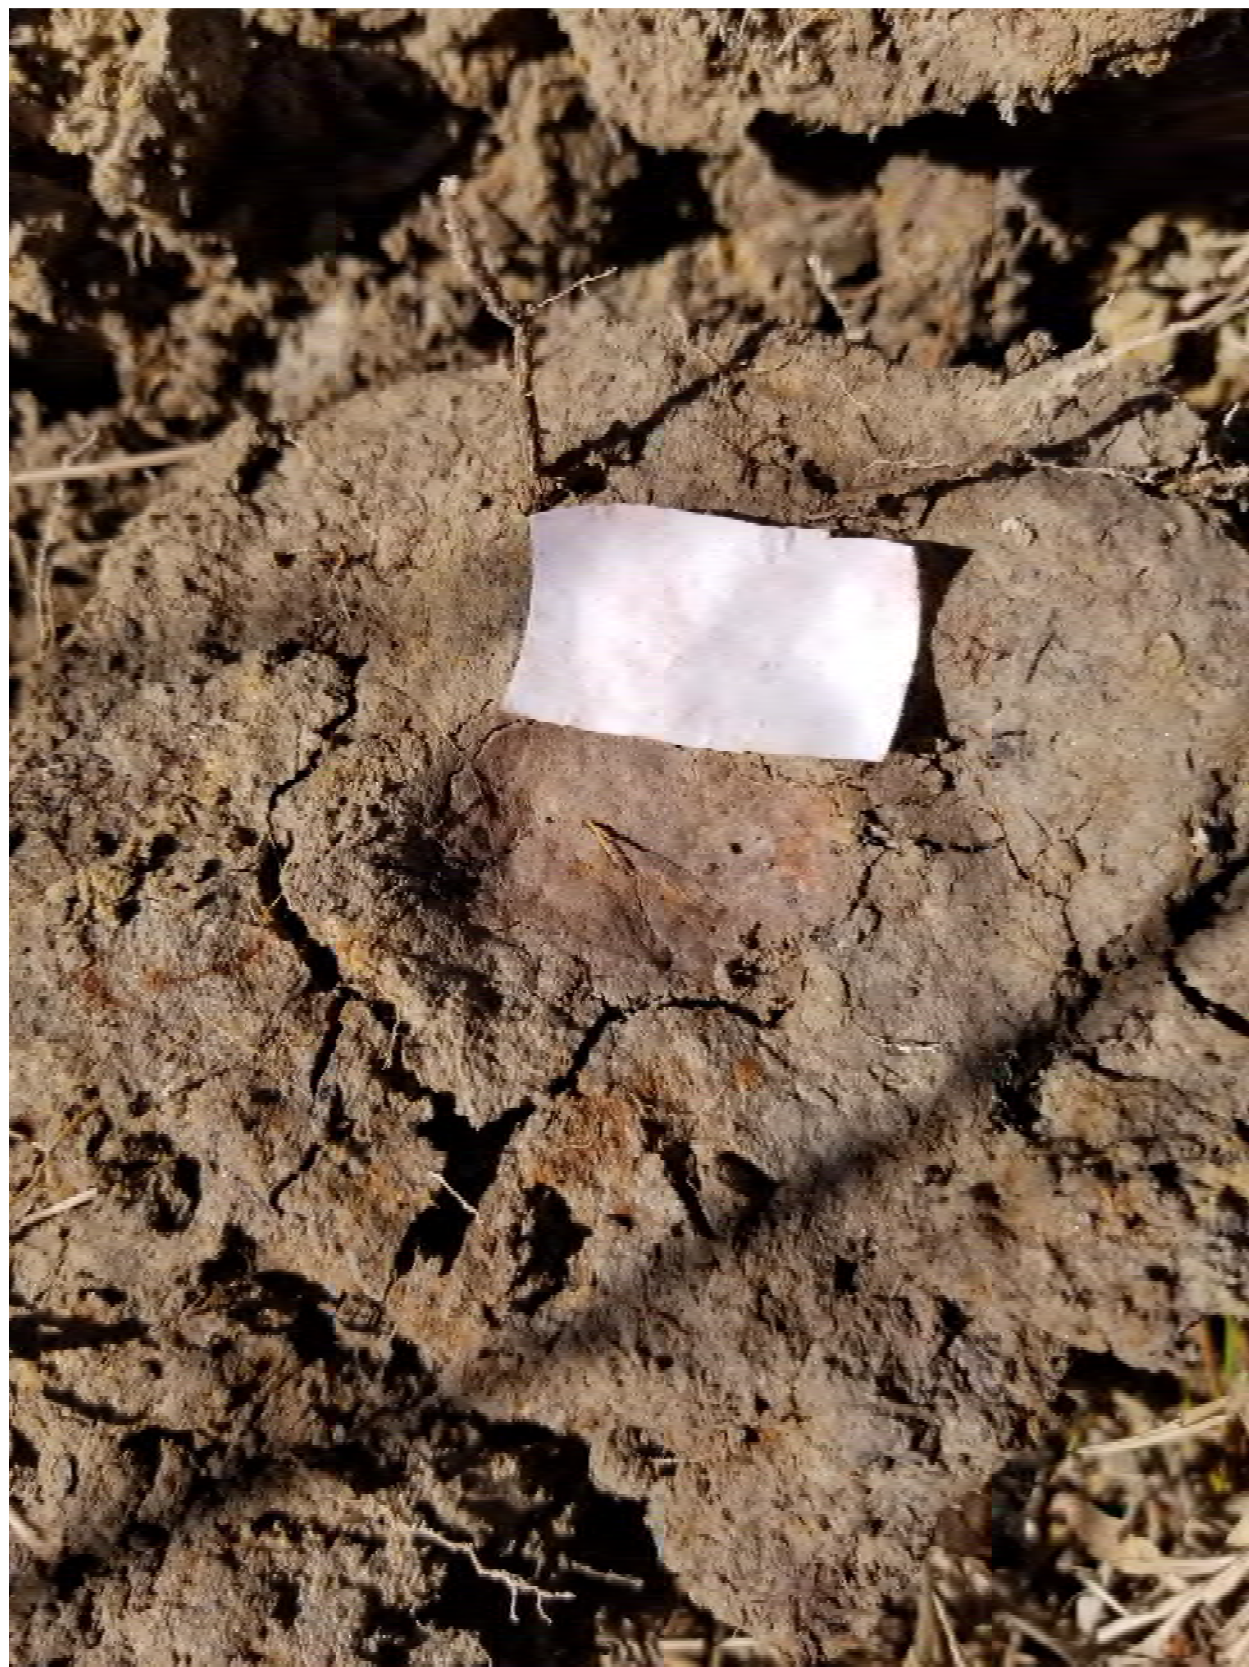
B9 surface Positive α, α' -dipyridyl

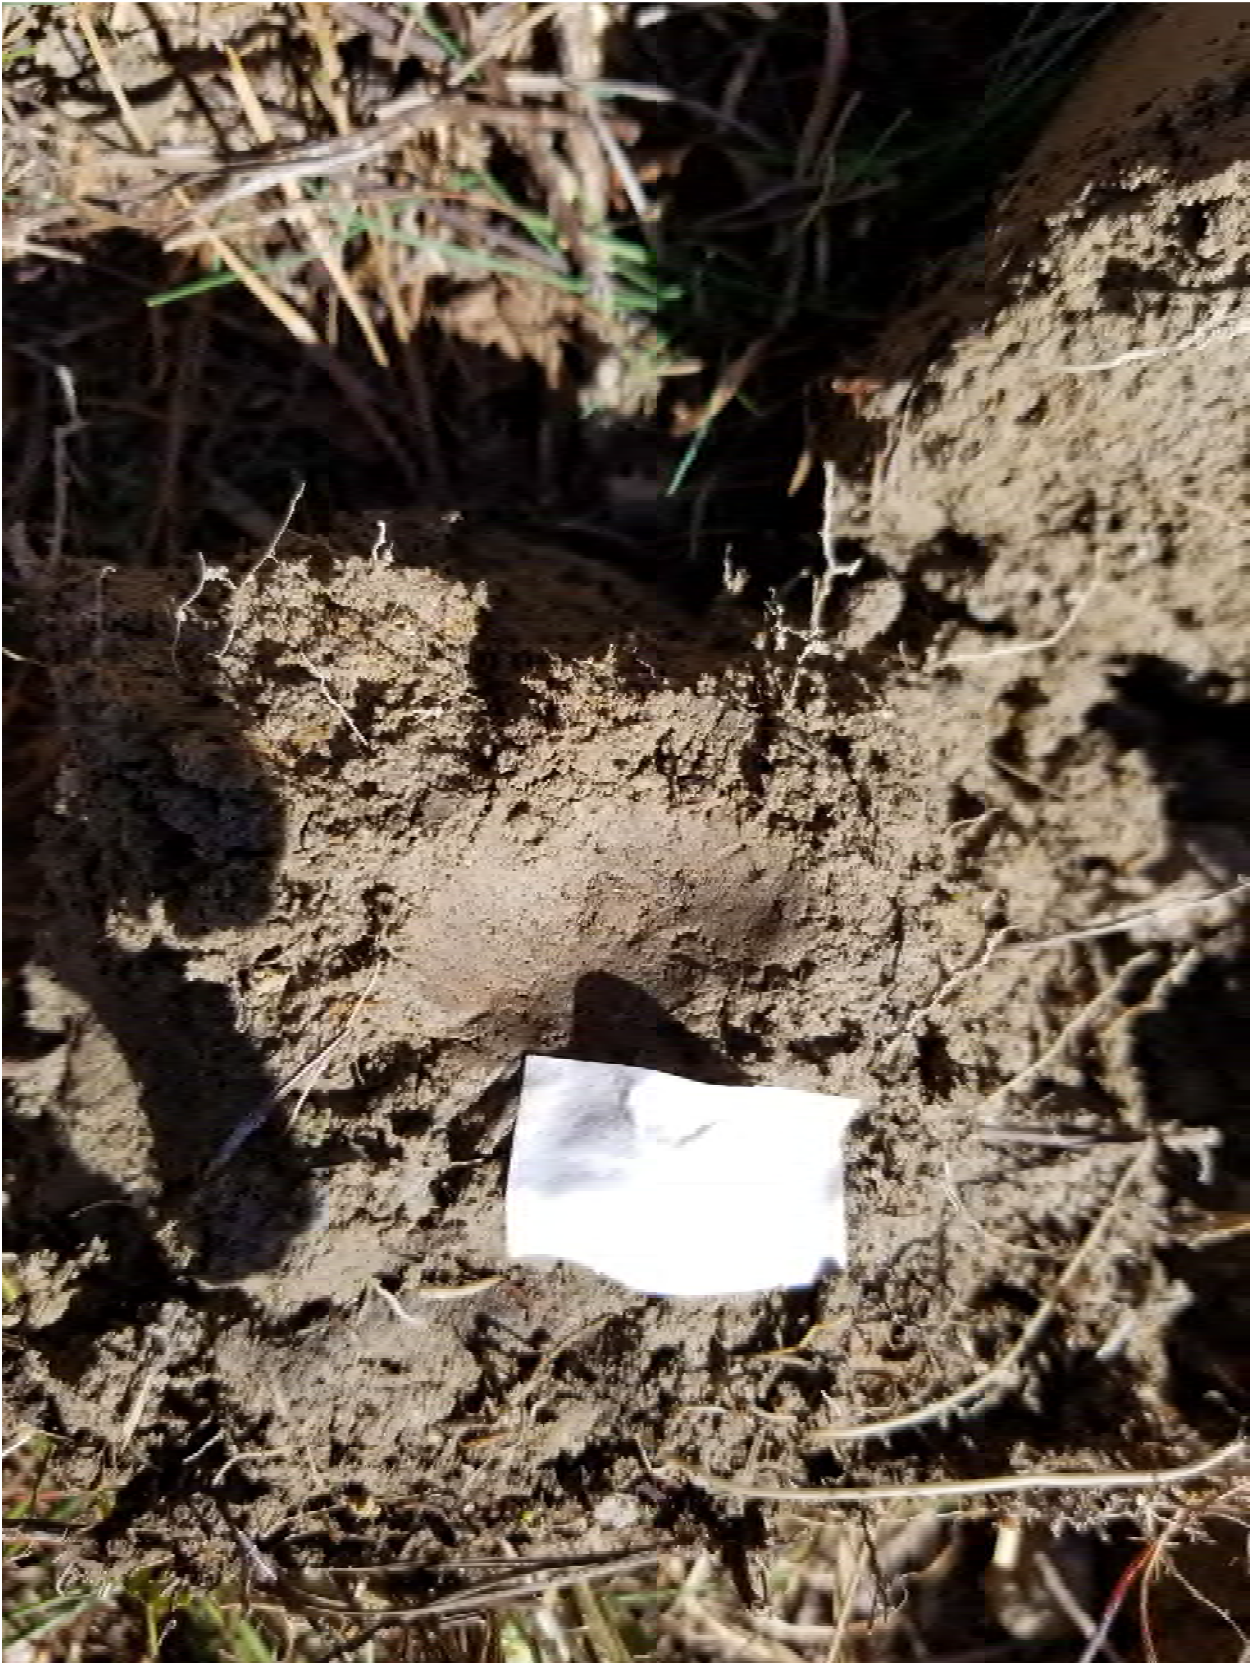
GW20 Negative α, α' -dipyridyl surface
