# **MONITORING YEAR 7 ANNUAL REPORT FINAL**

## **DEVIL'S RACETRACK MITIGATION SITE**

Johnston County, NC  
NCDEQ Contract 003989  
DMS Project Number 95021  
USACE Action ID Number 2012-00810  
NCDWR Project Number 12-0747

Data Collection Period: January - November 2020  
Draft Submission Date: December 21, 2020  
Final Submission Date: February 17, 2021

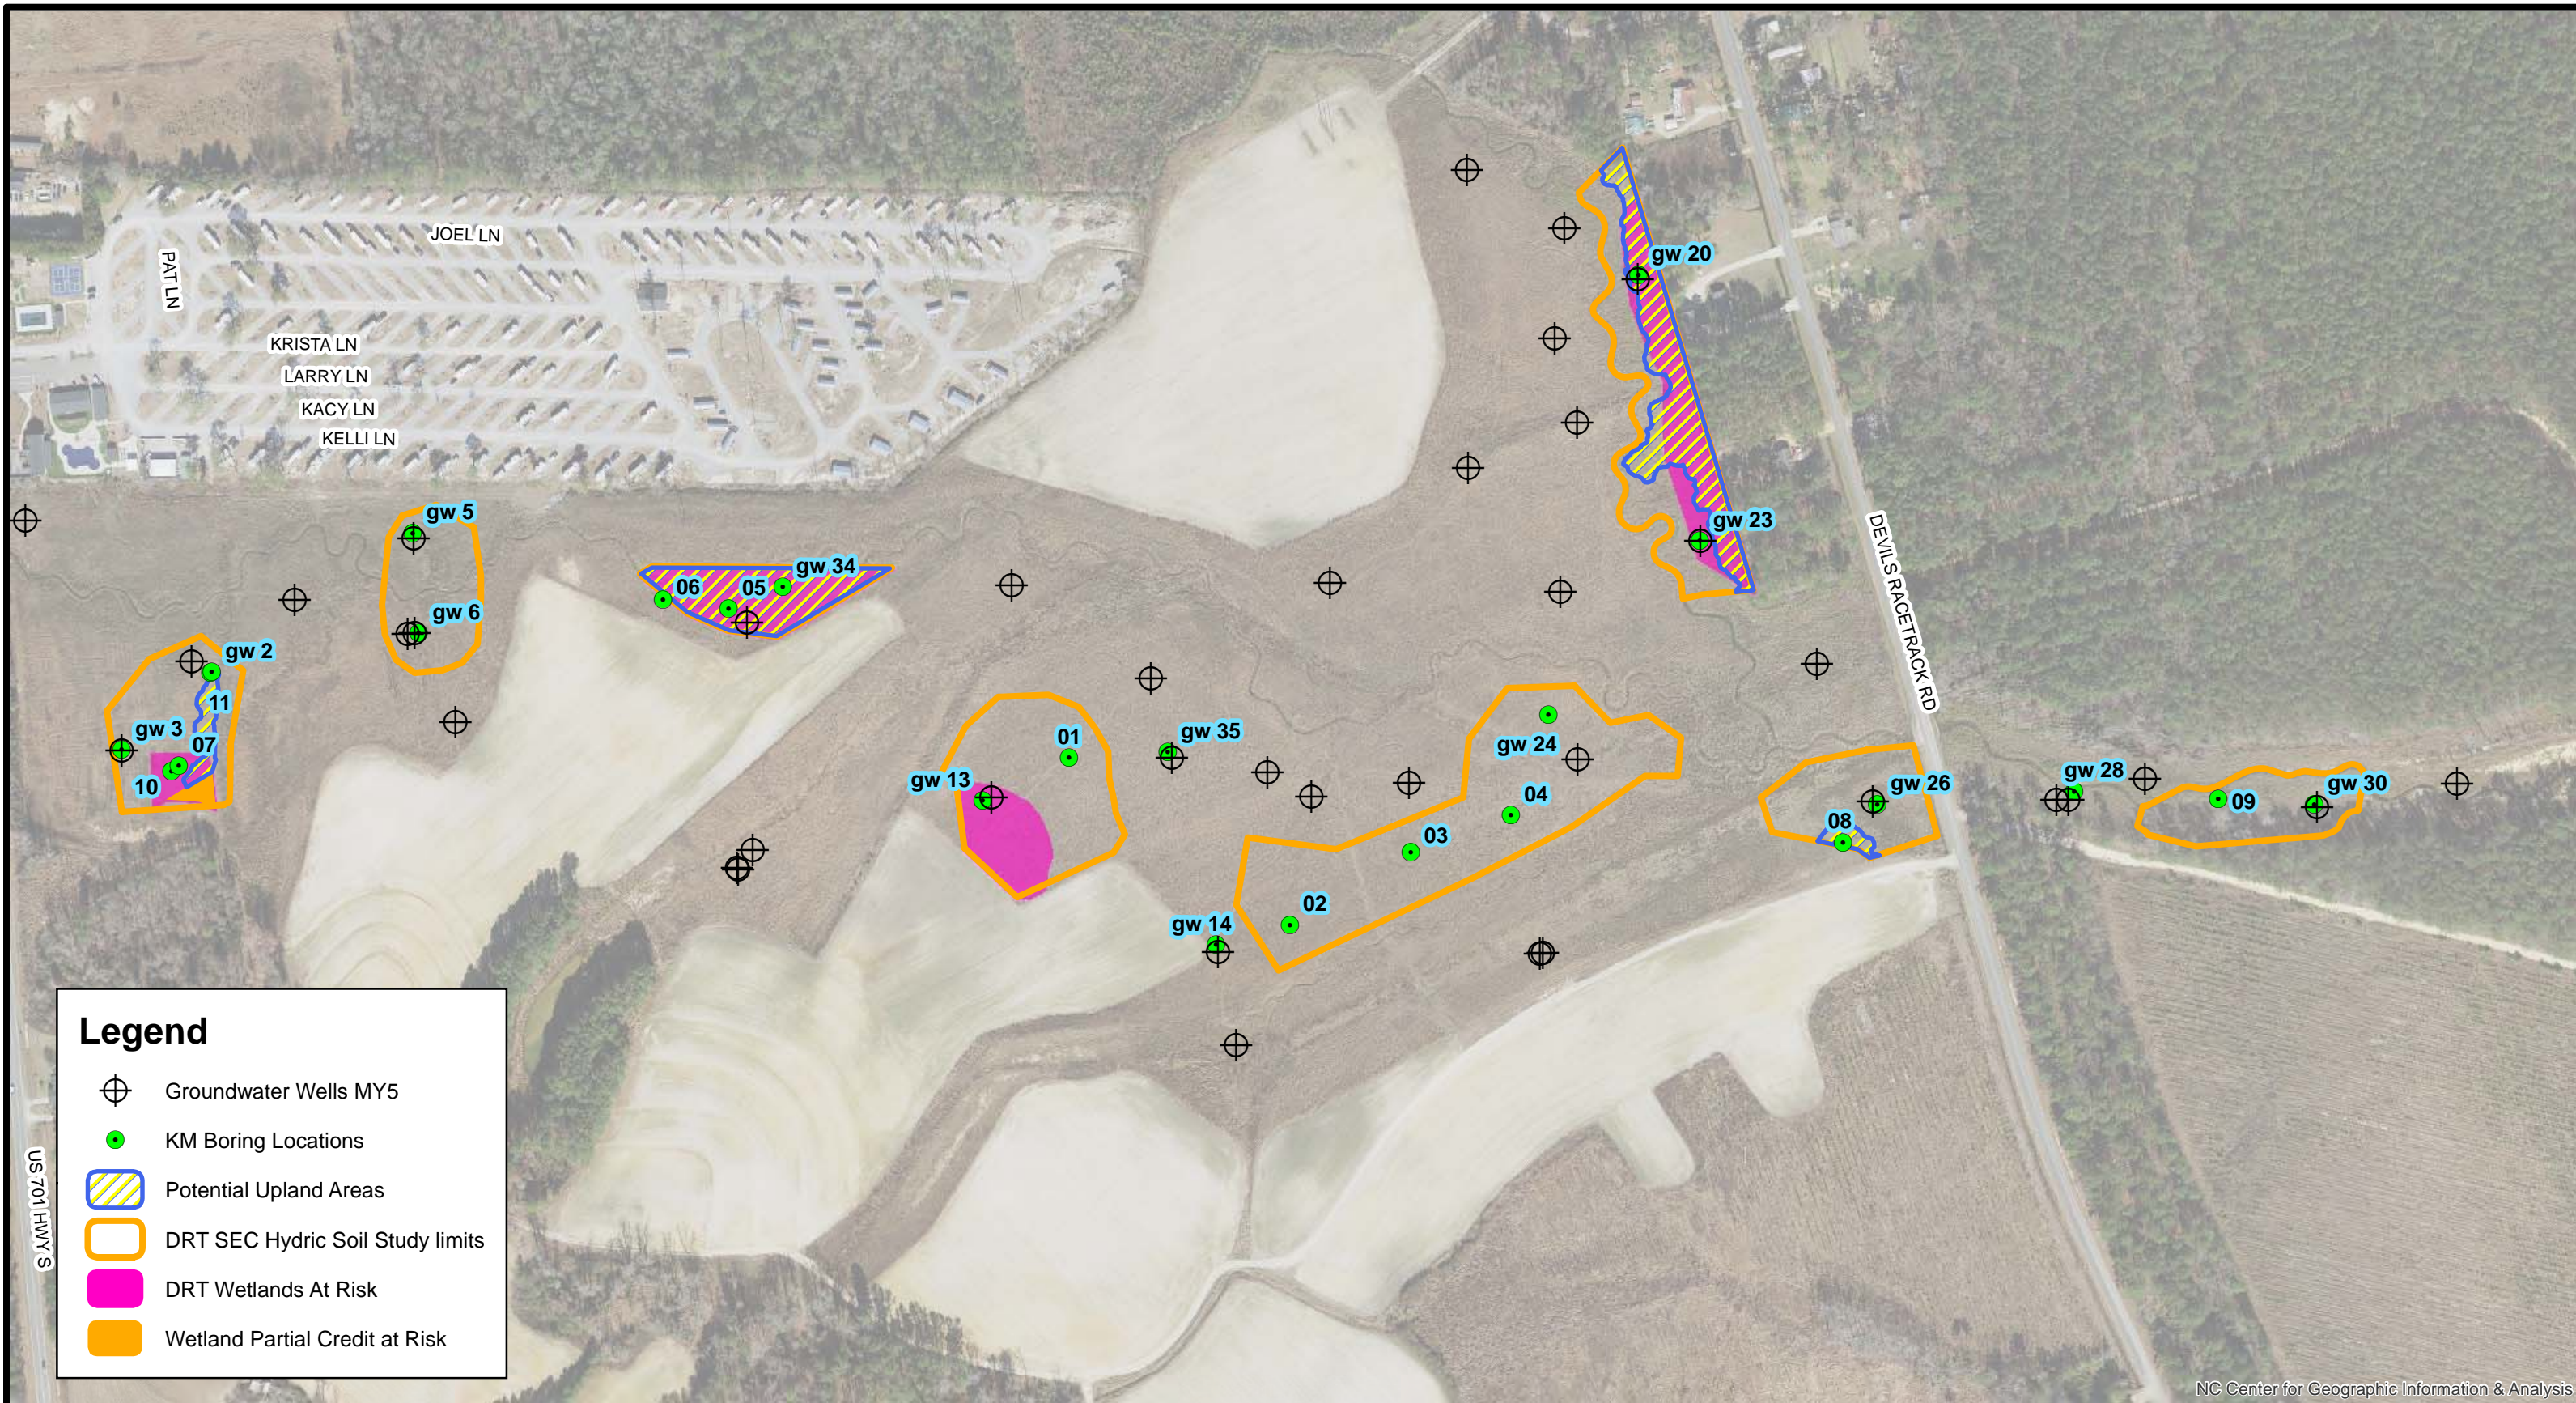
All but four areas evaluated appear to have hydric soil indicators that represent current aquic conditions, they are:

- (4) The elongated area south of GW20. This area contains hydric soils, but is slightly elevated above adjacent areas that are meeting aquic conditions but the ditch along the eastern property line is likely preventing adequate hydrology that would cause aquic conditions.

These areas are outlined in blue with yellow hatching on the attached S&EC Devils Racetrack Mitigation Site Map.

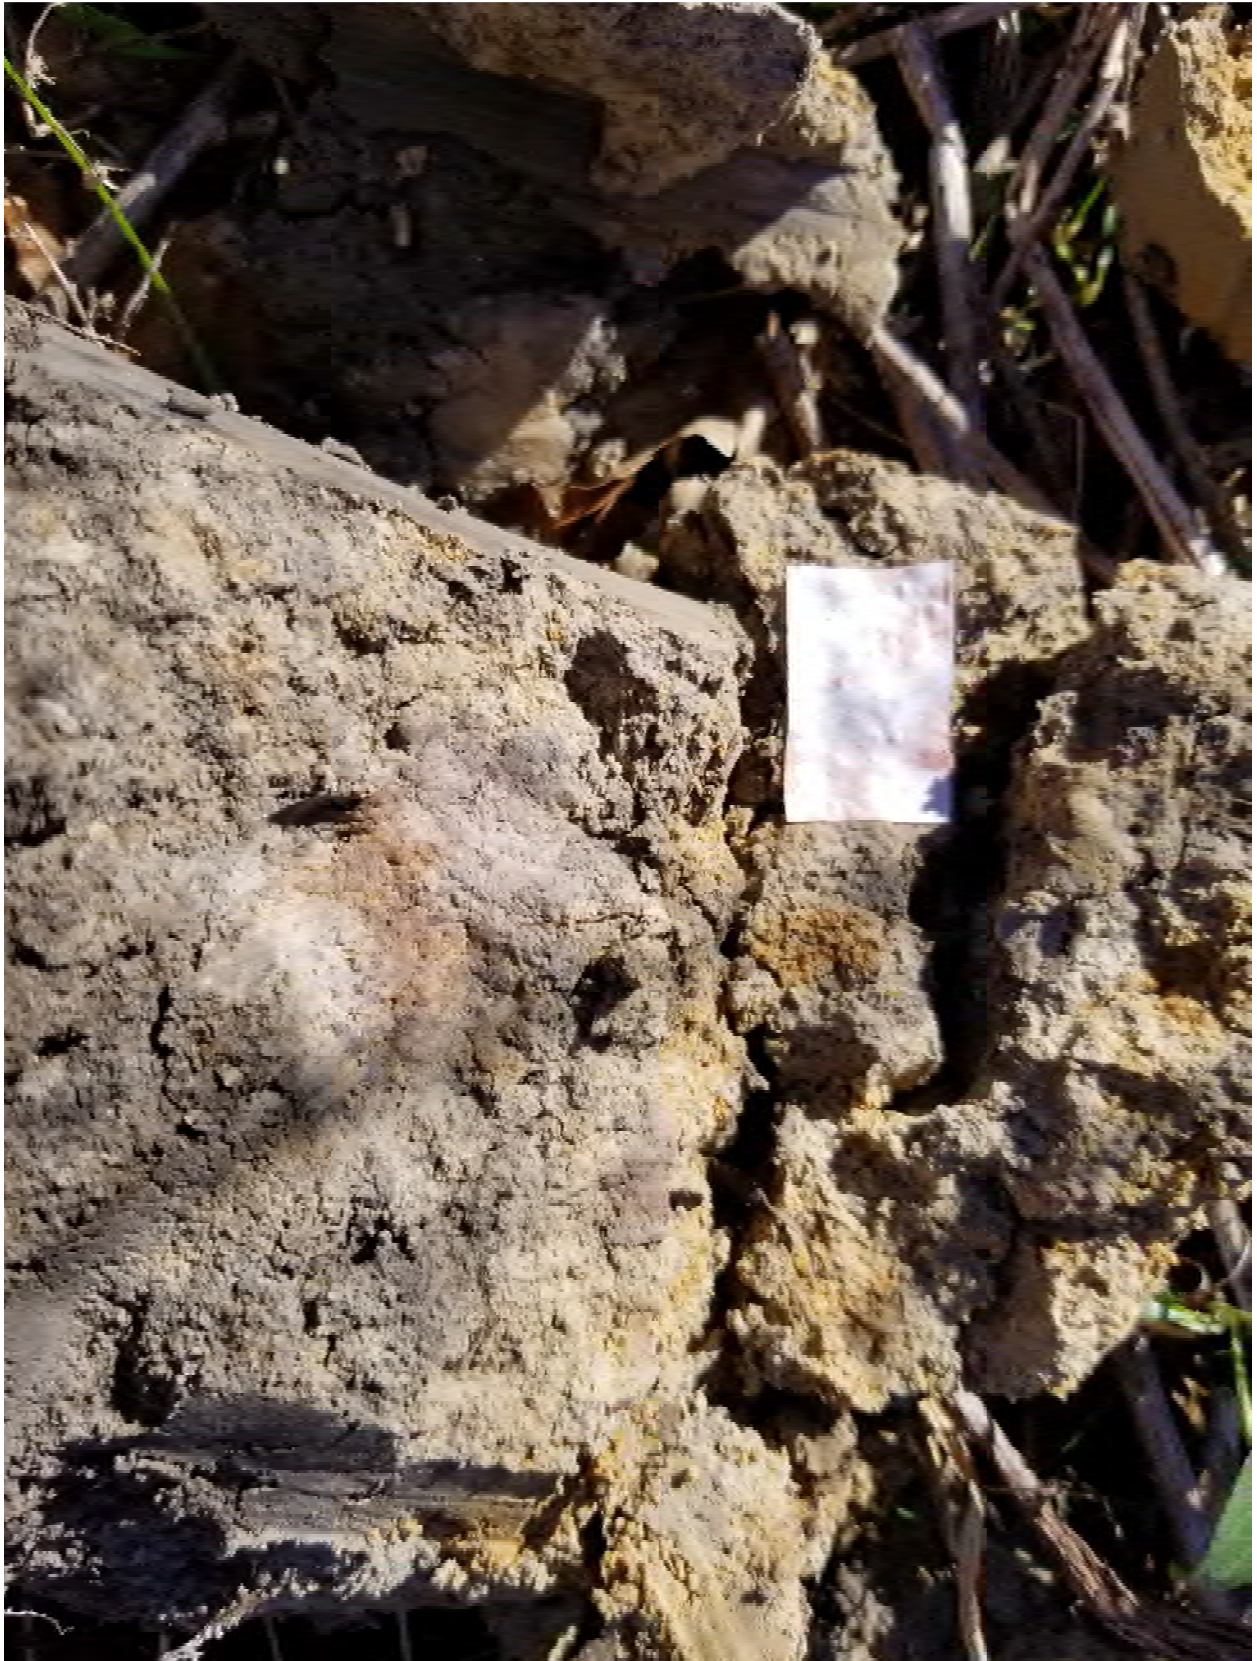
GW13 Bt Positive  $\alpha, \alpha'$ -dipyridyl

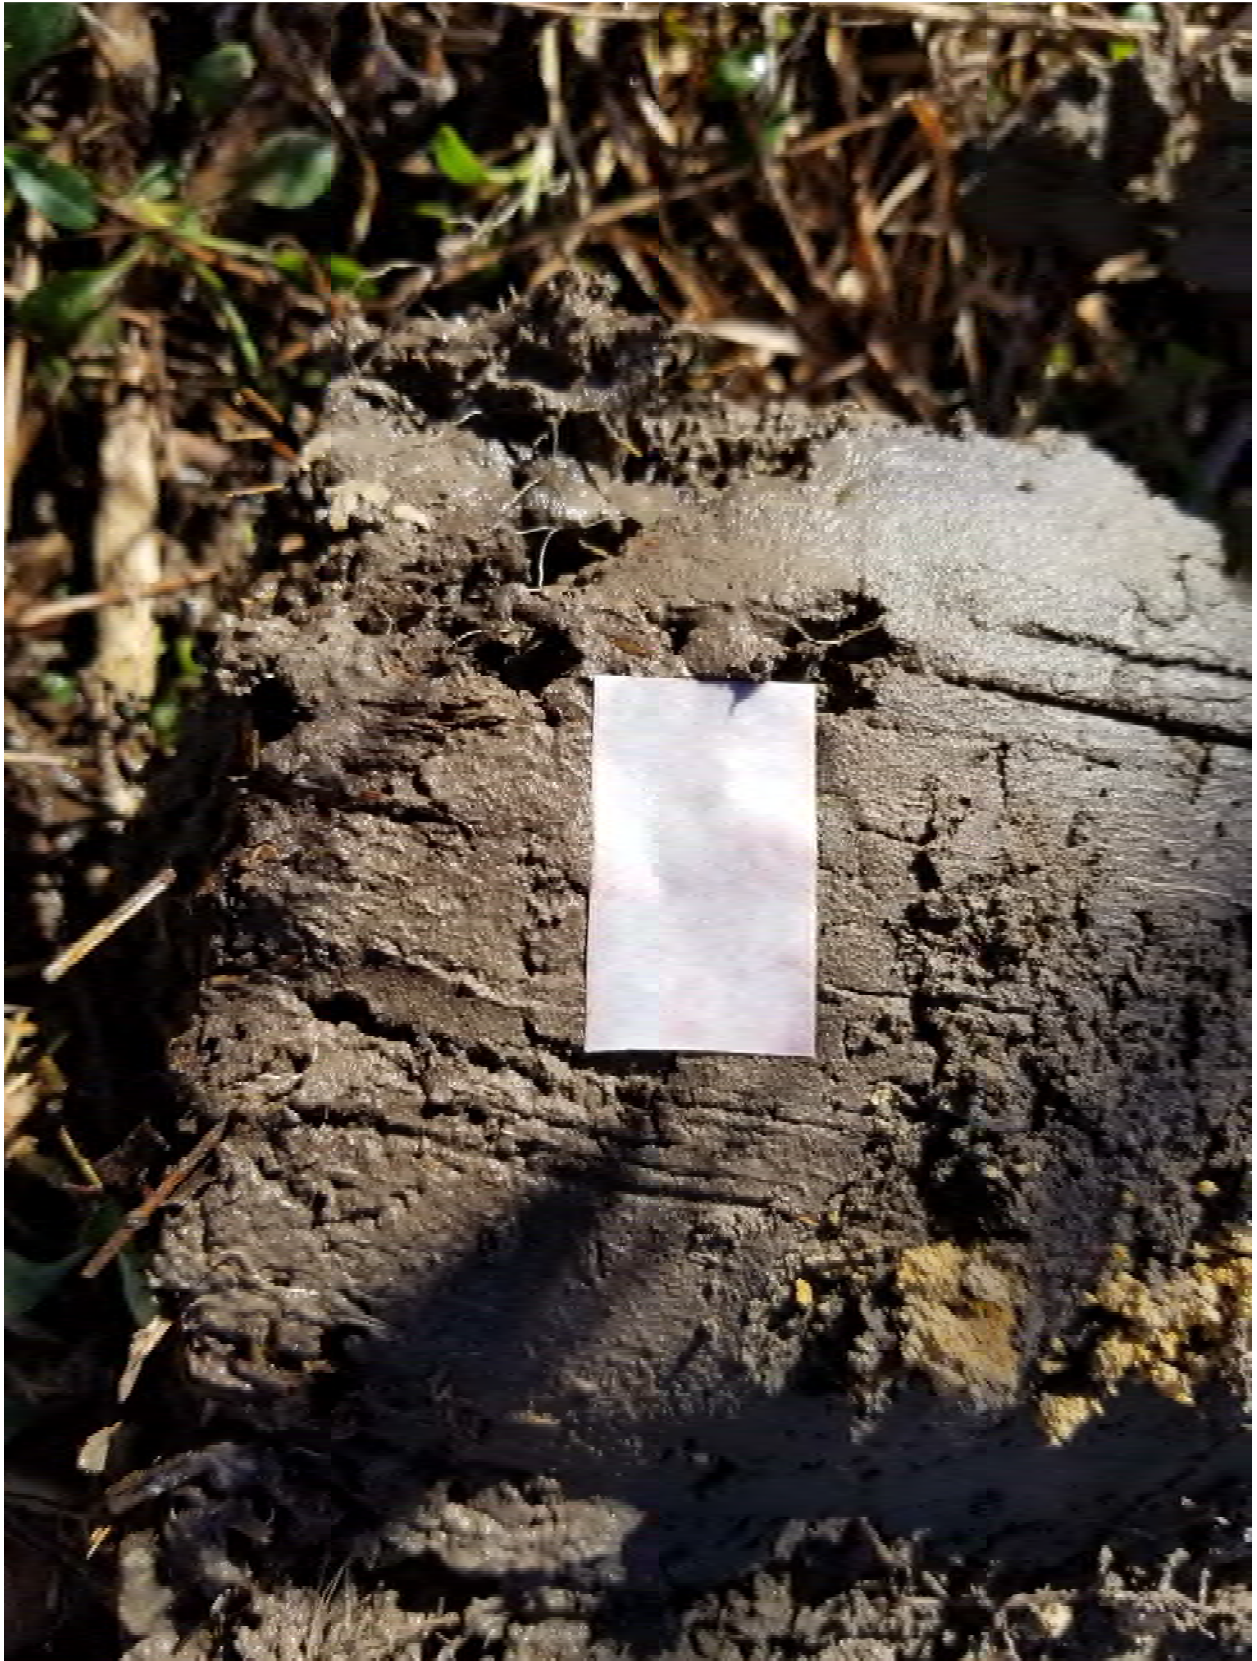
GW13 Weak Positive  $\alpha$ ,  $\alpha'$ -dipyridyl surface

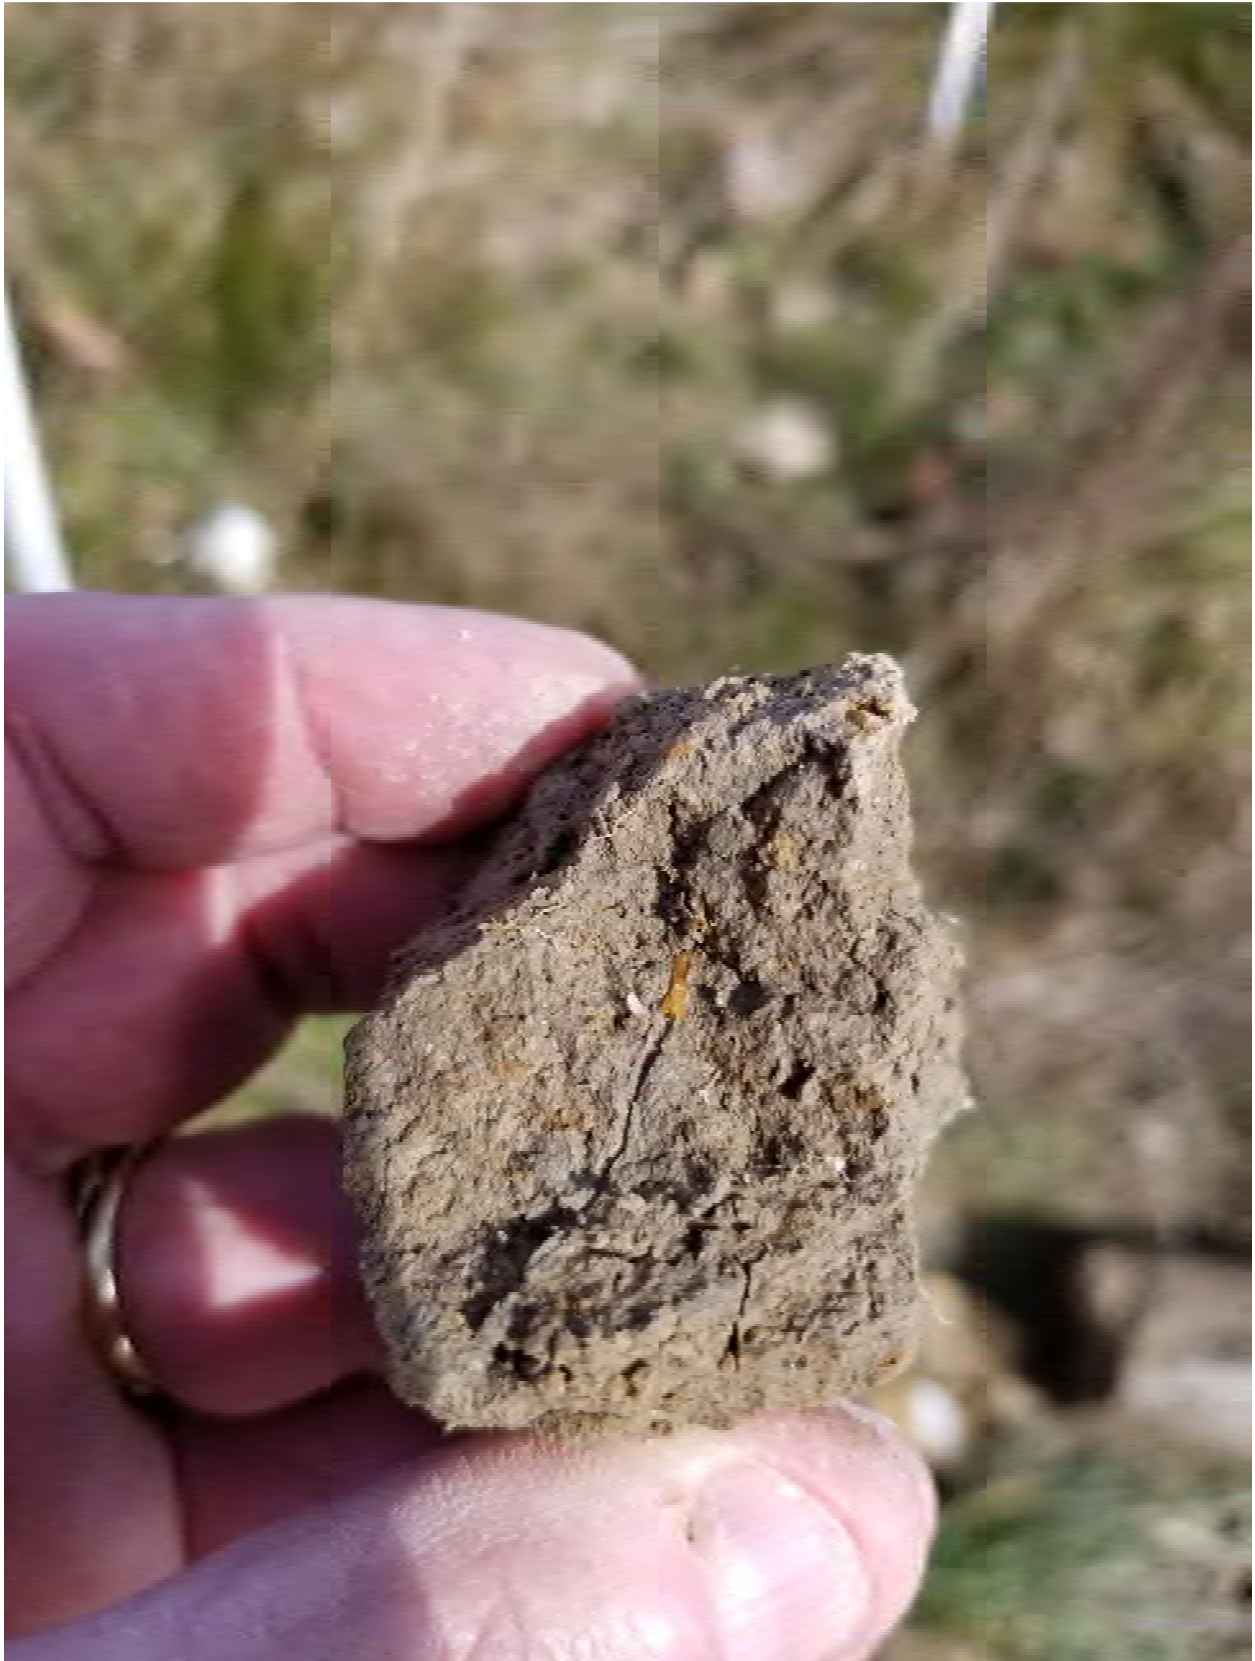
GW14 #2 Pore linings, small Masses but no Oxidized Rhizospheres

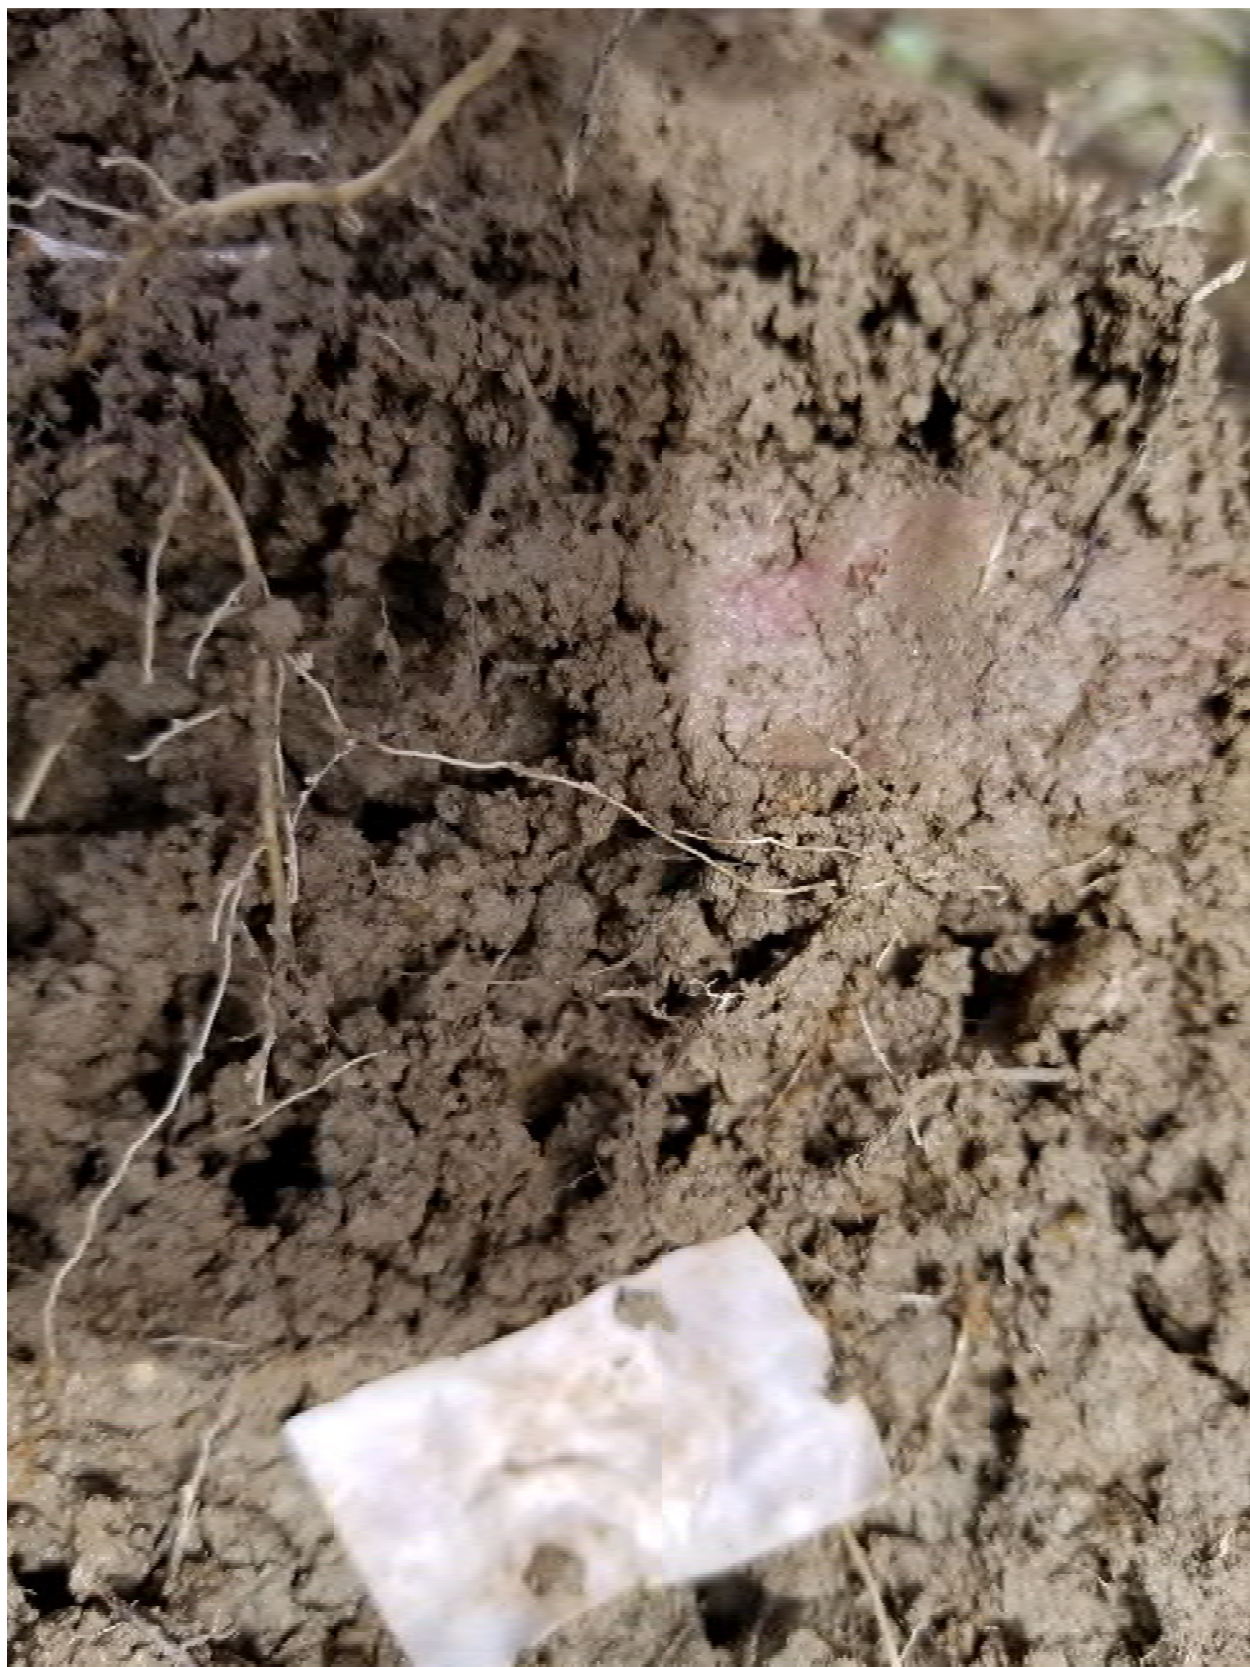
B2 Positive  $\alpha, \alpha'$ -dipyridyl

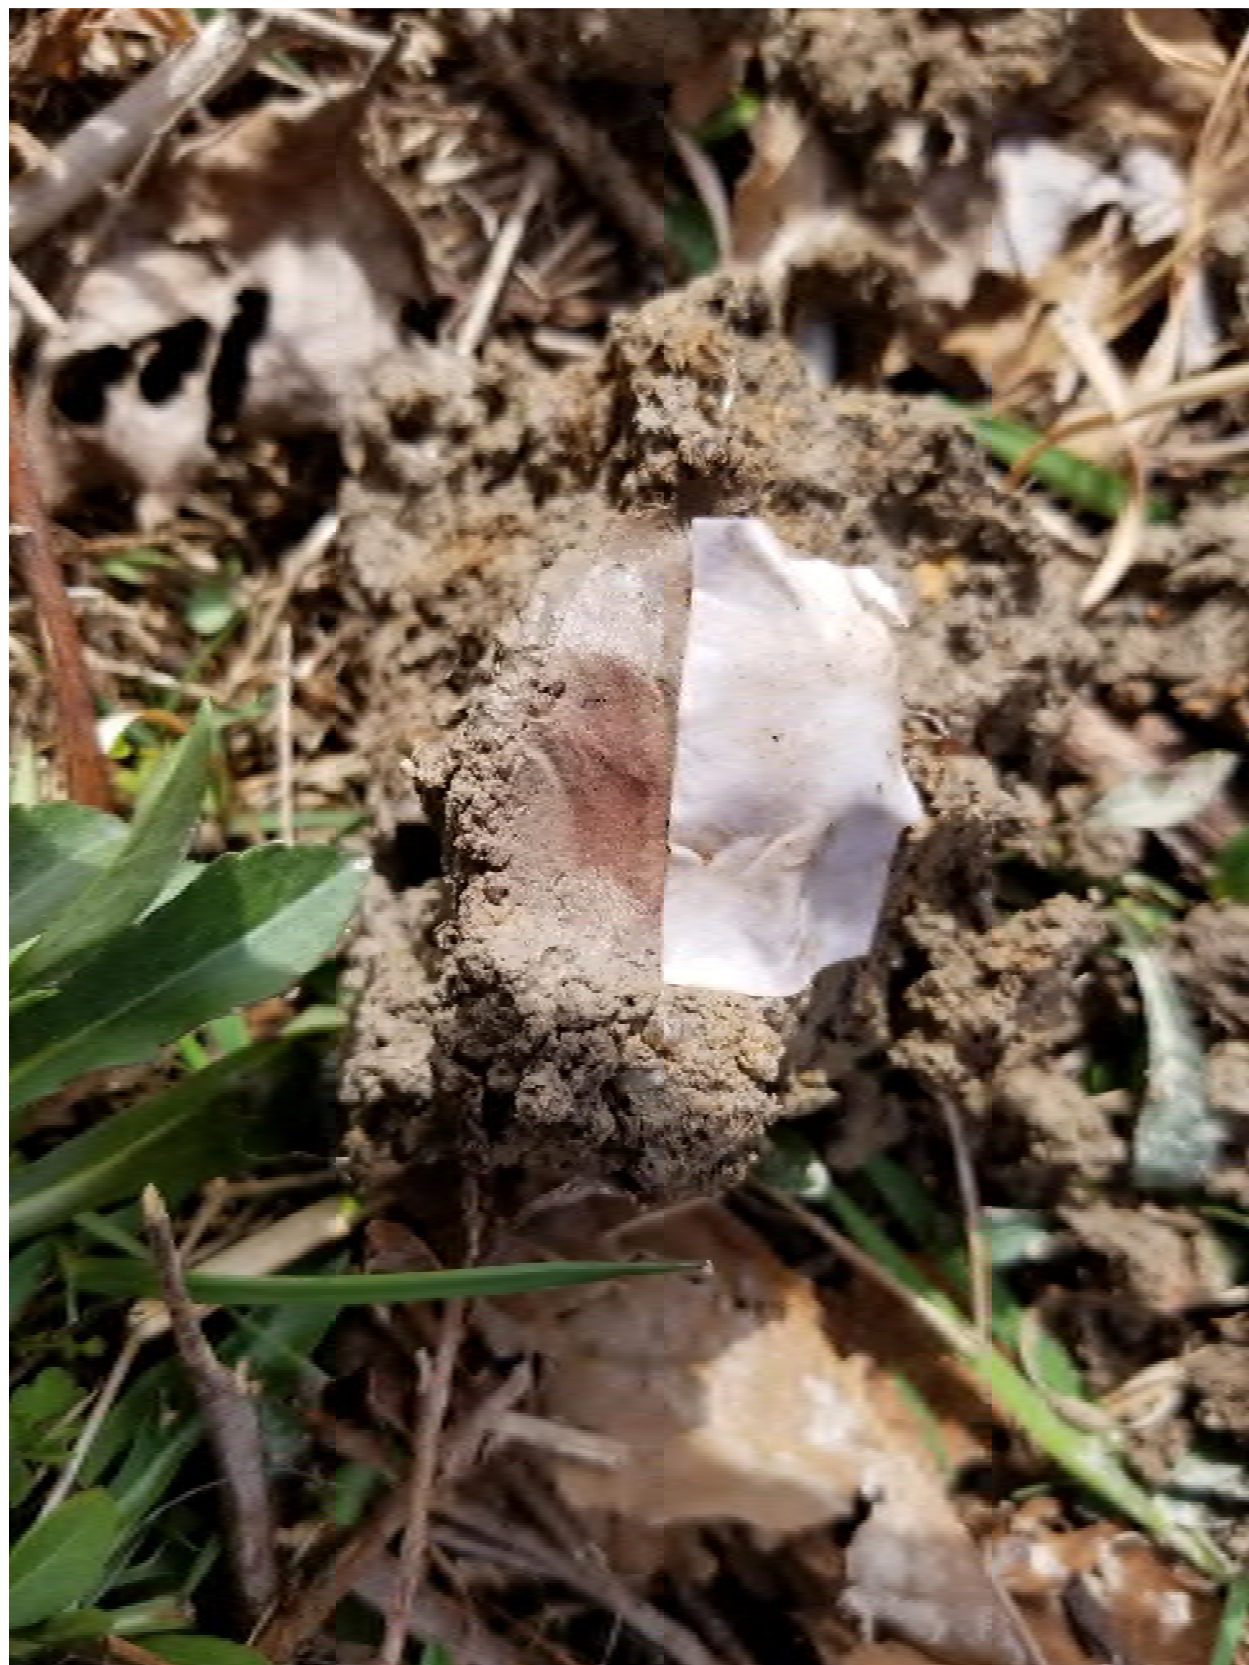
B3 Positive  $\alpha, \alpha'$ -dipyridyl

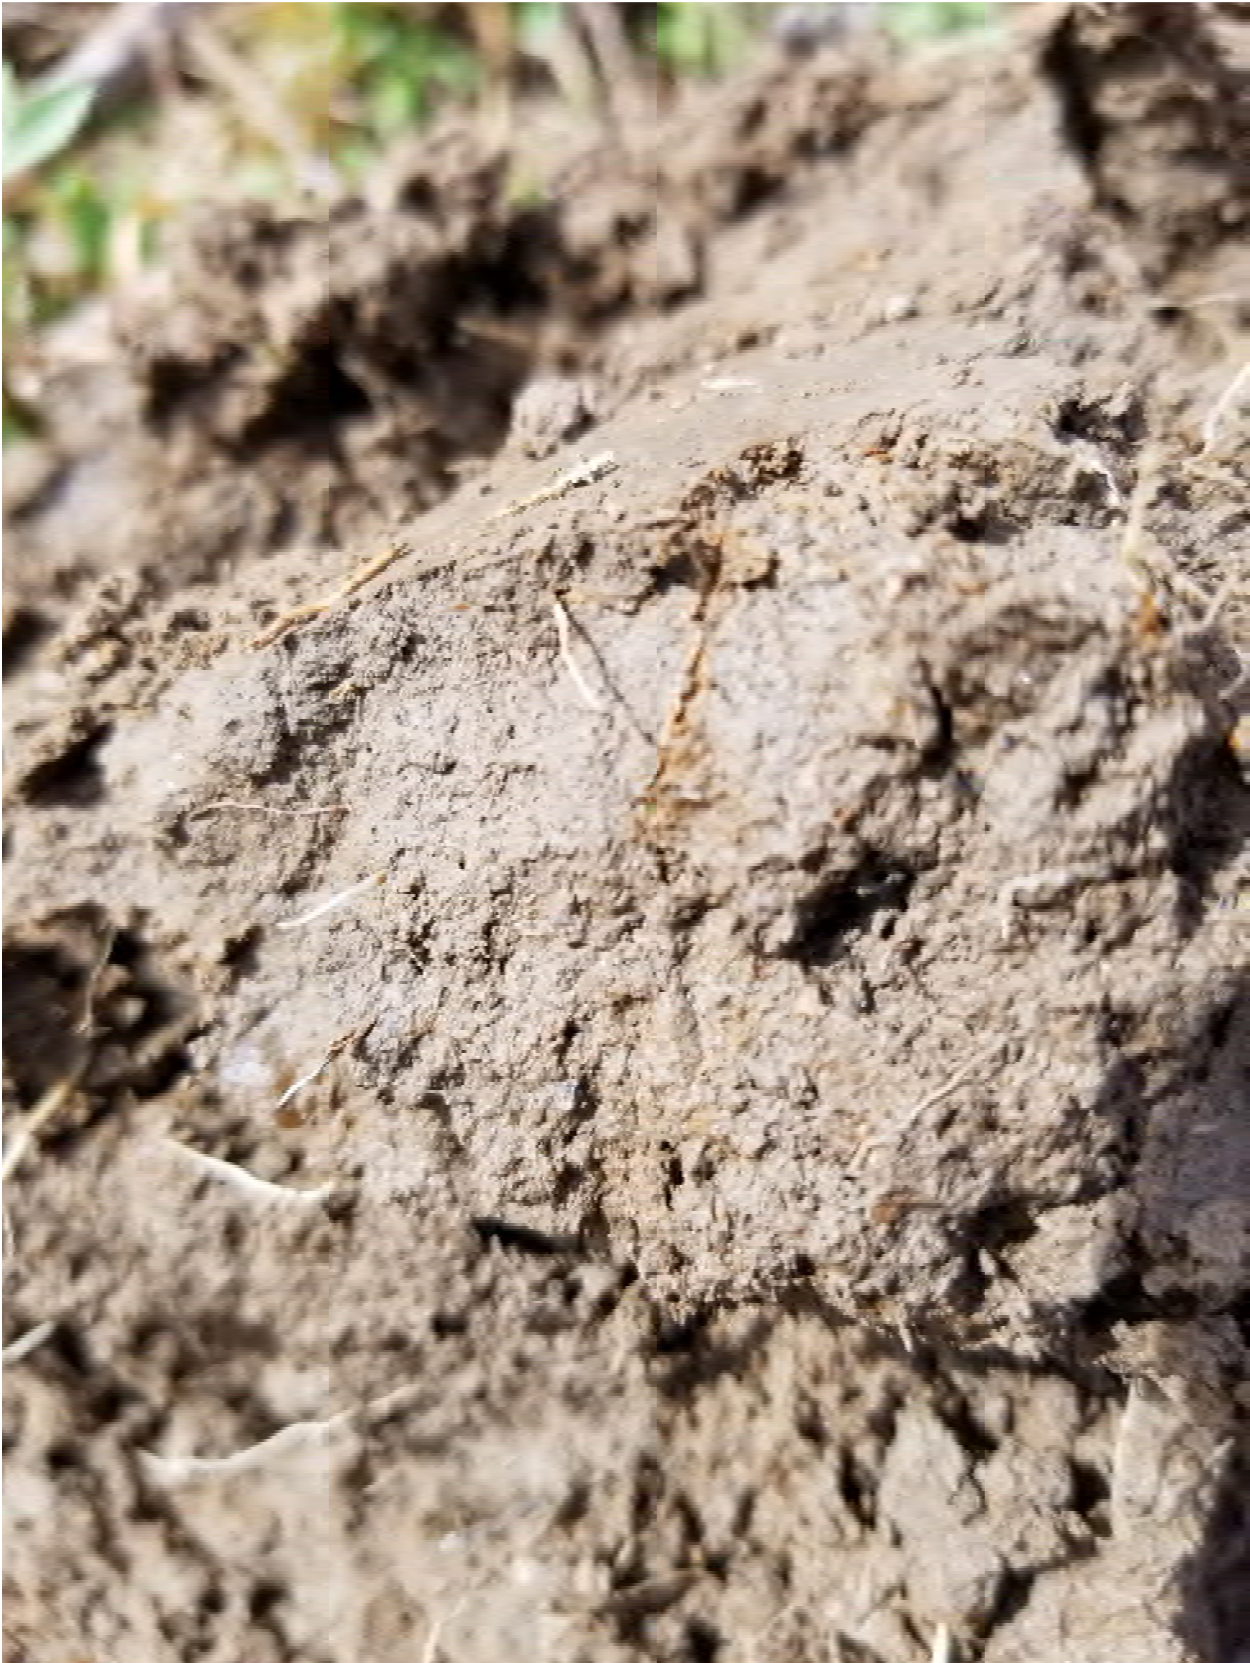
B3 Oxidized Rhizospheres & Pore Linings

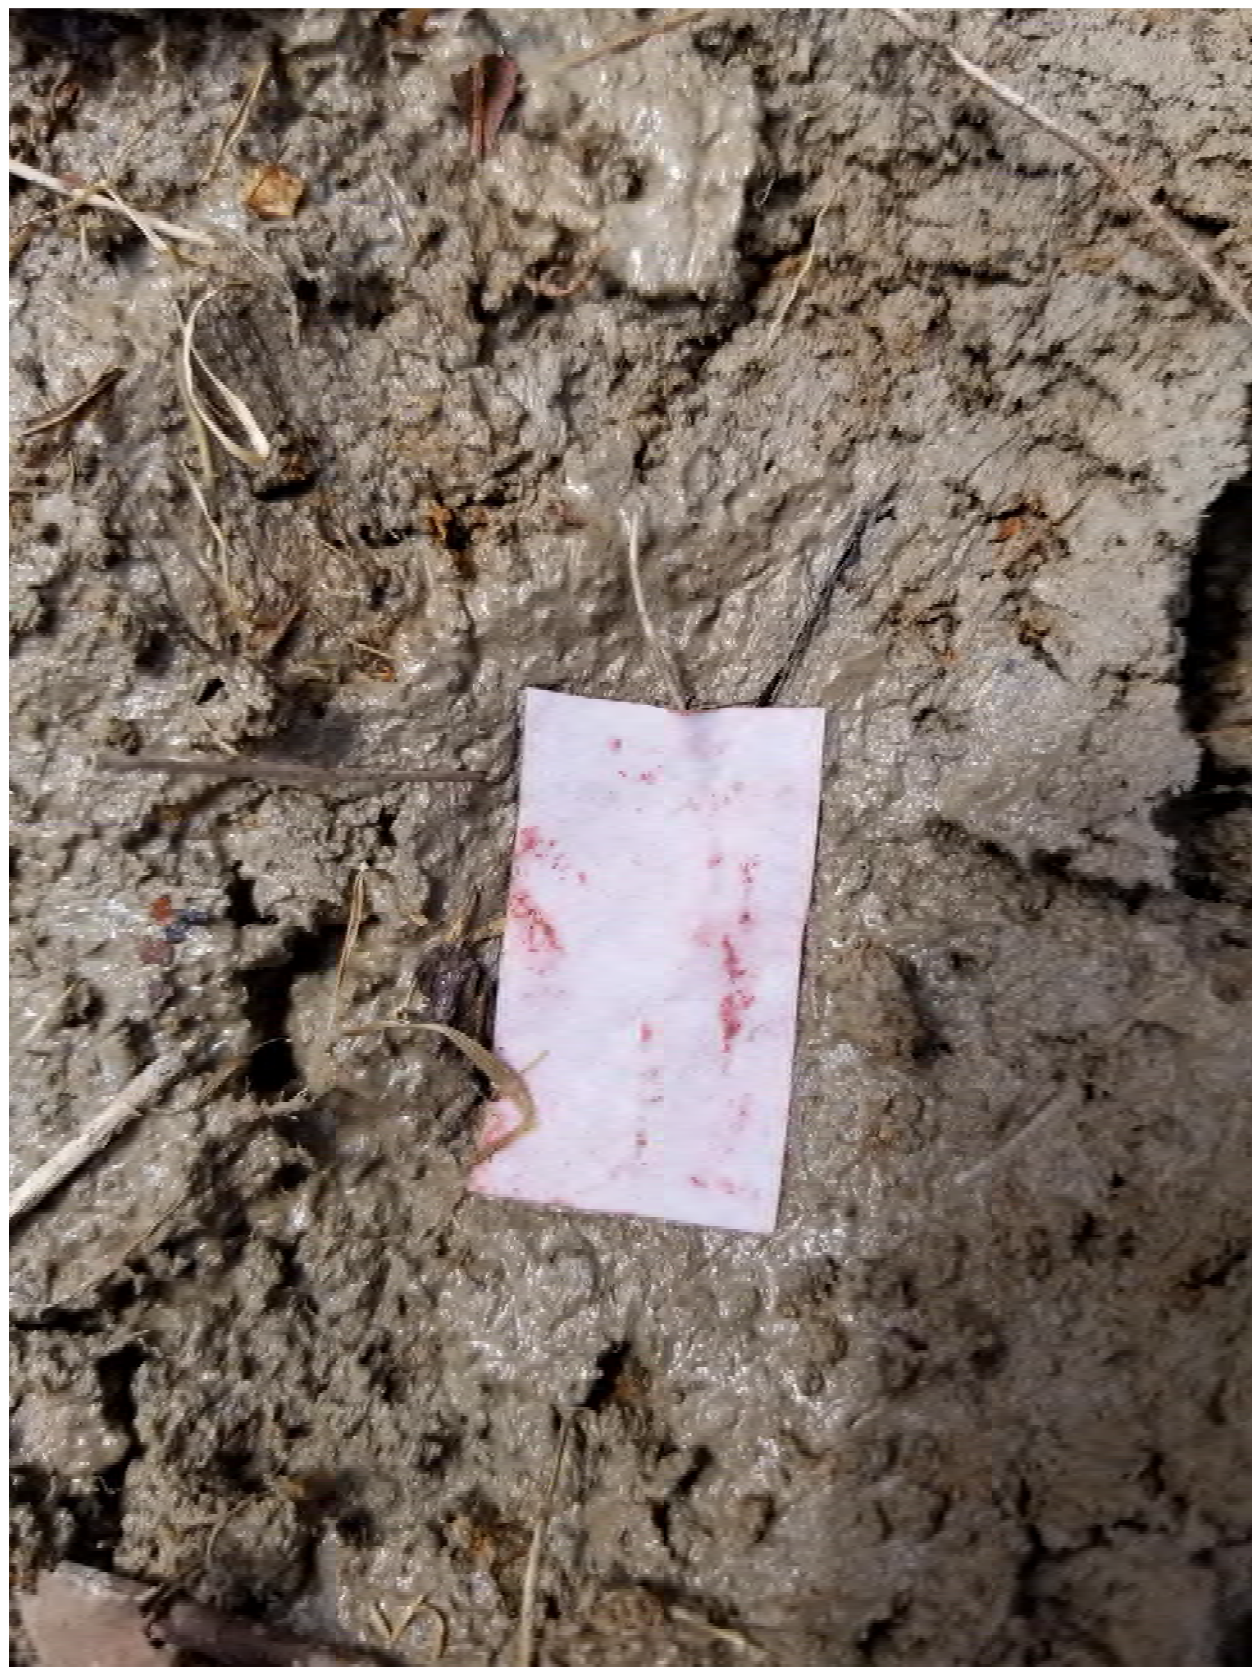
B4 Positive  $\alpha, \alpha'$ -dipyridyl

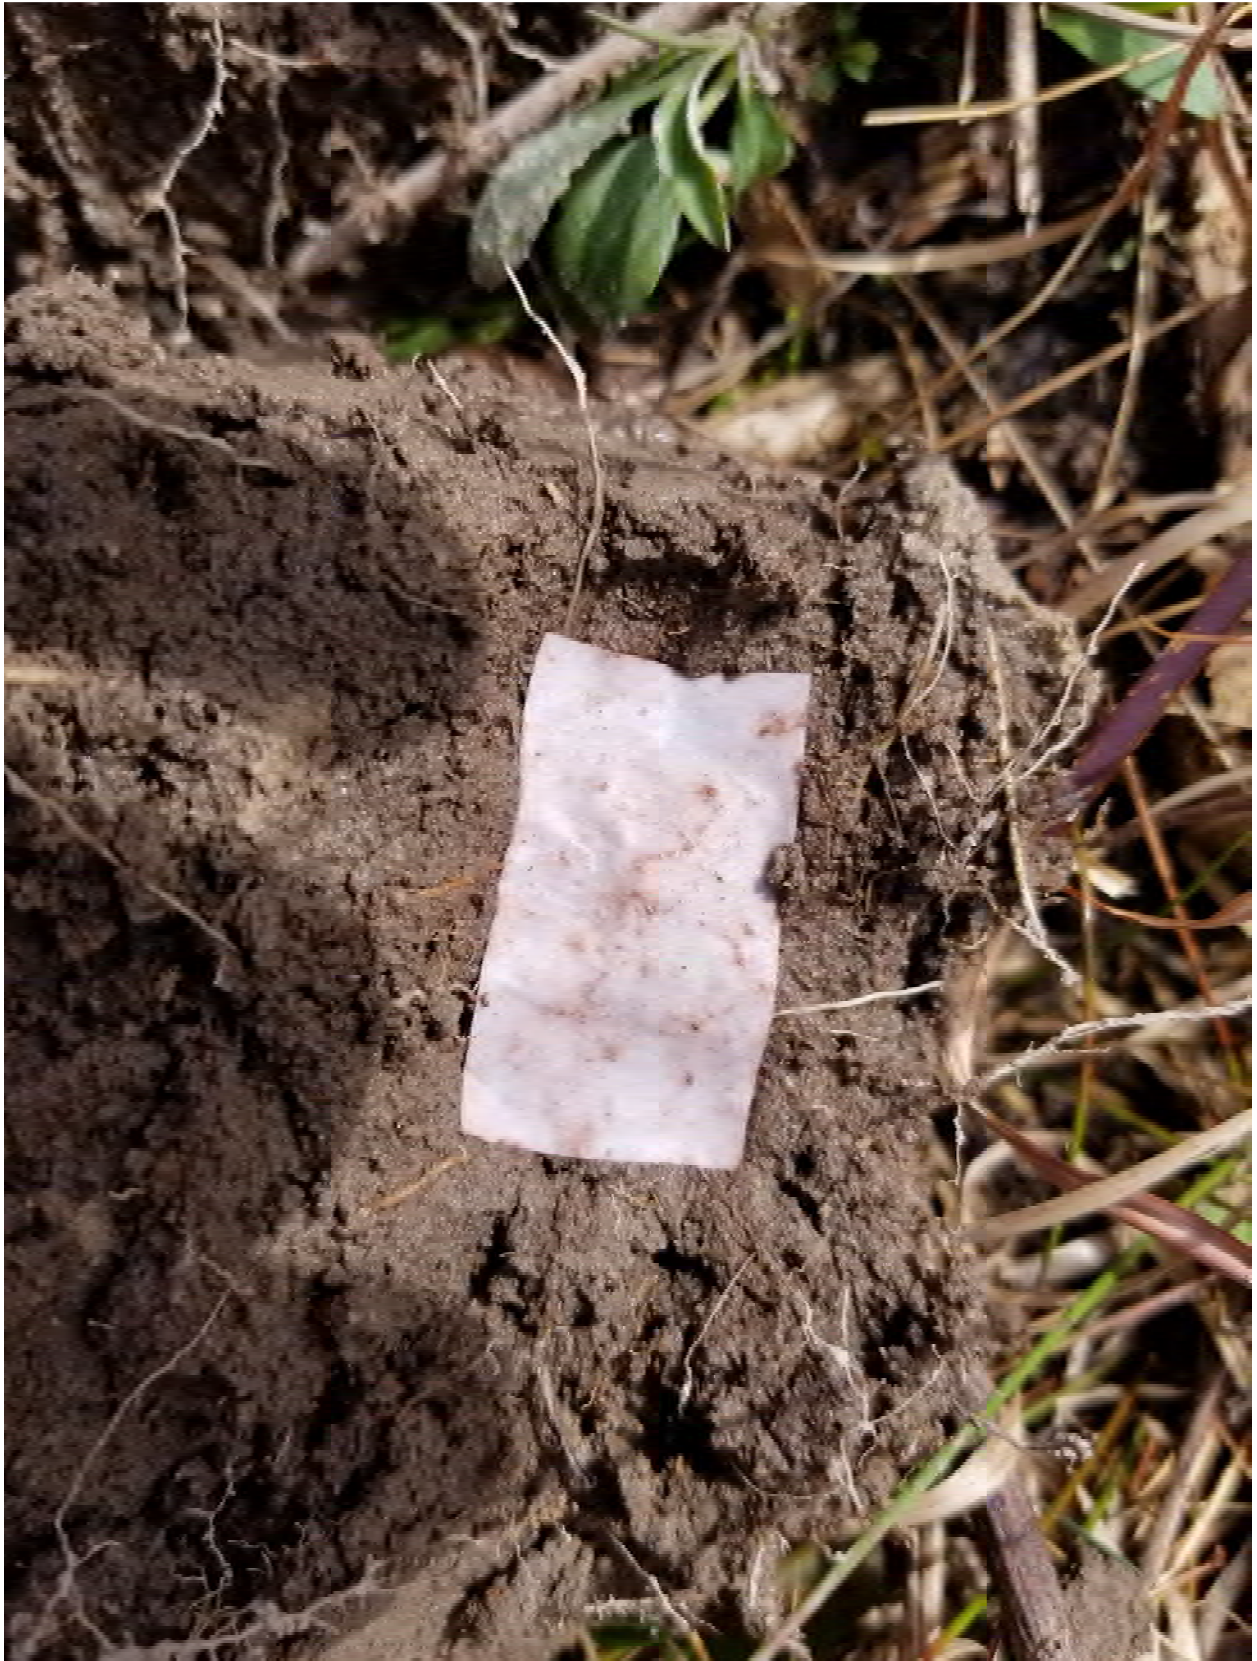
GW24 #2 Positive  $\alpha, \alpha'$ -dipyridyl

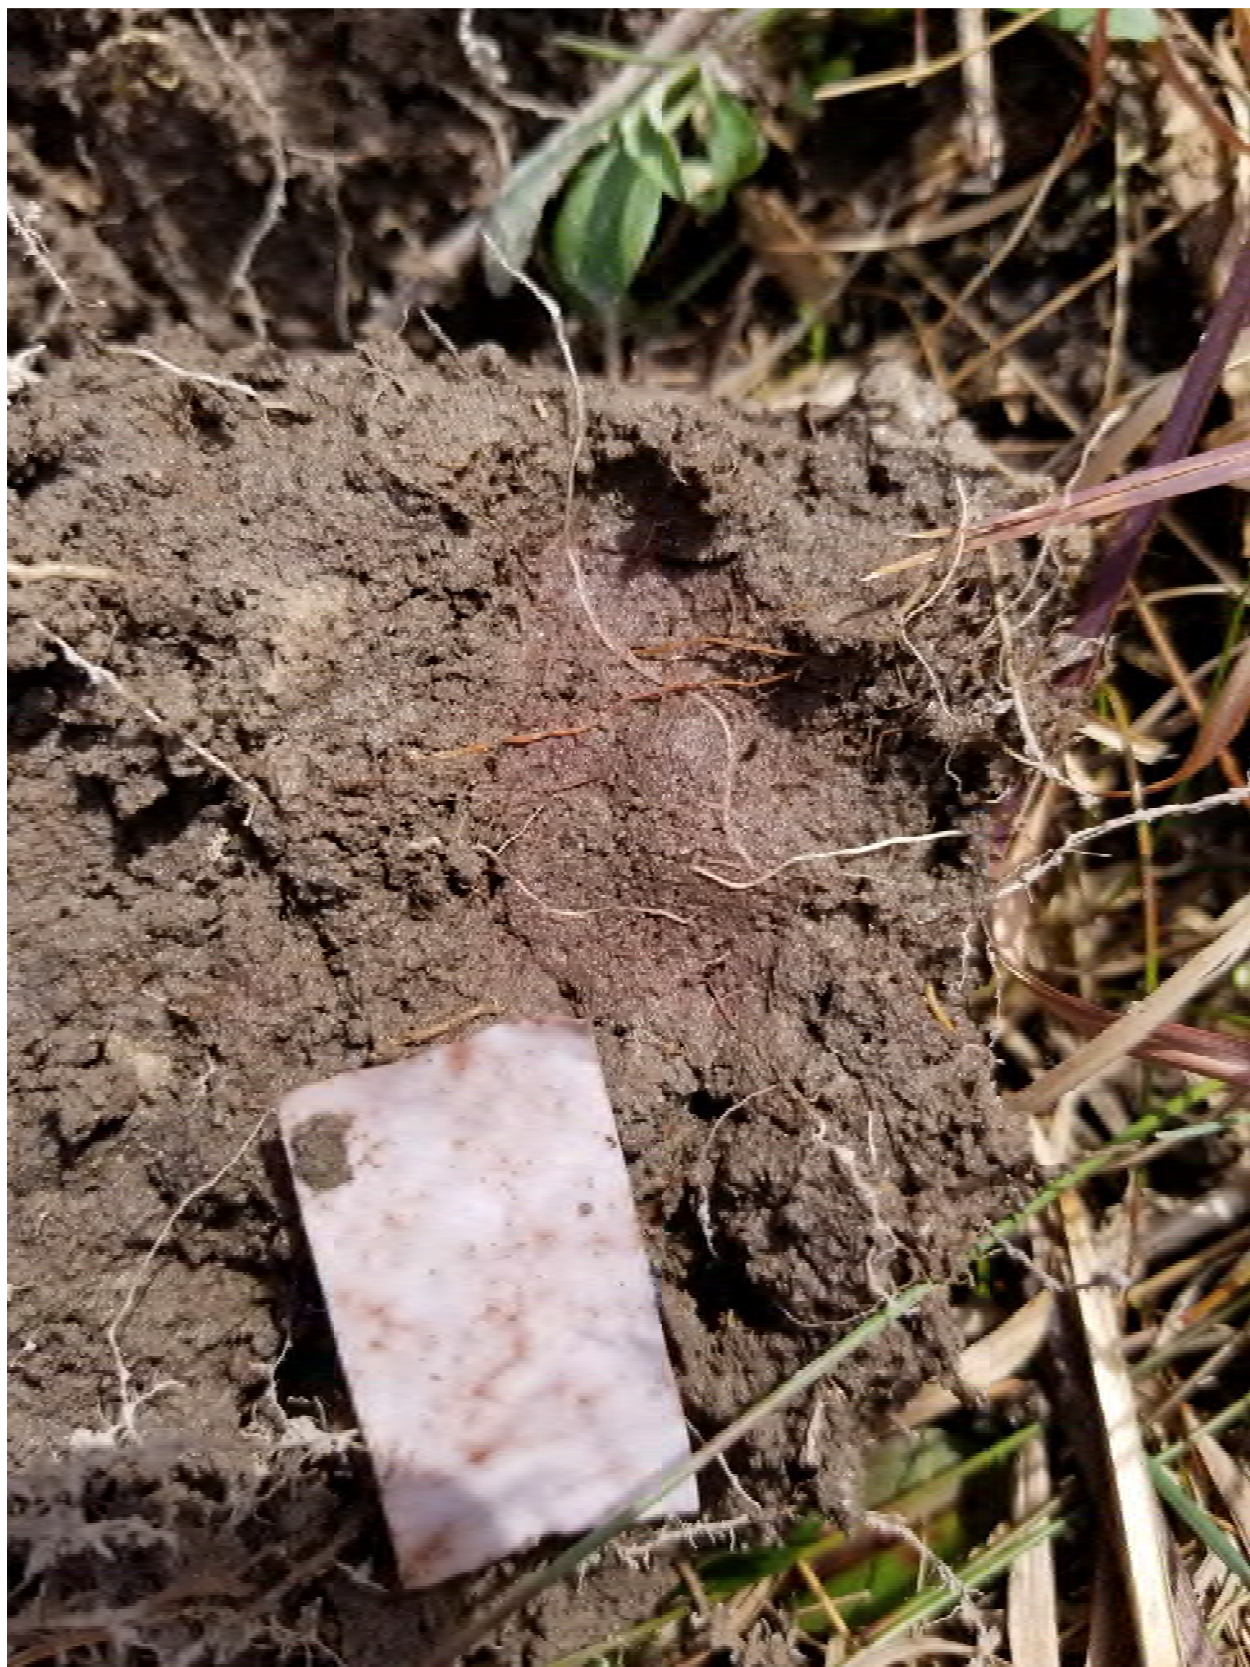
GW24 Positive  $\alpha, \alpha'$ -dipyridyl
