# **MONITORING YEAR 7 ANNUAL REPORT FINAL**

## **DEVIL'S RACETRACK MITIGATION SITE**

Johnston County, NC  
NCDEQ Contract 003989  
DMS Project Number 95021  
USACE Action ID Number 2012-00810  
NCDWR Project Number 12-0747

Data Collection Period: January - November 2020  
Draft Submission Date: December 21, 2020  
Final Submission Date: February 17, 2021

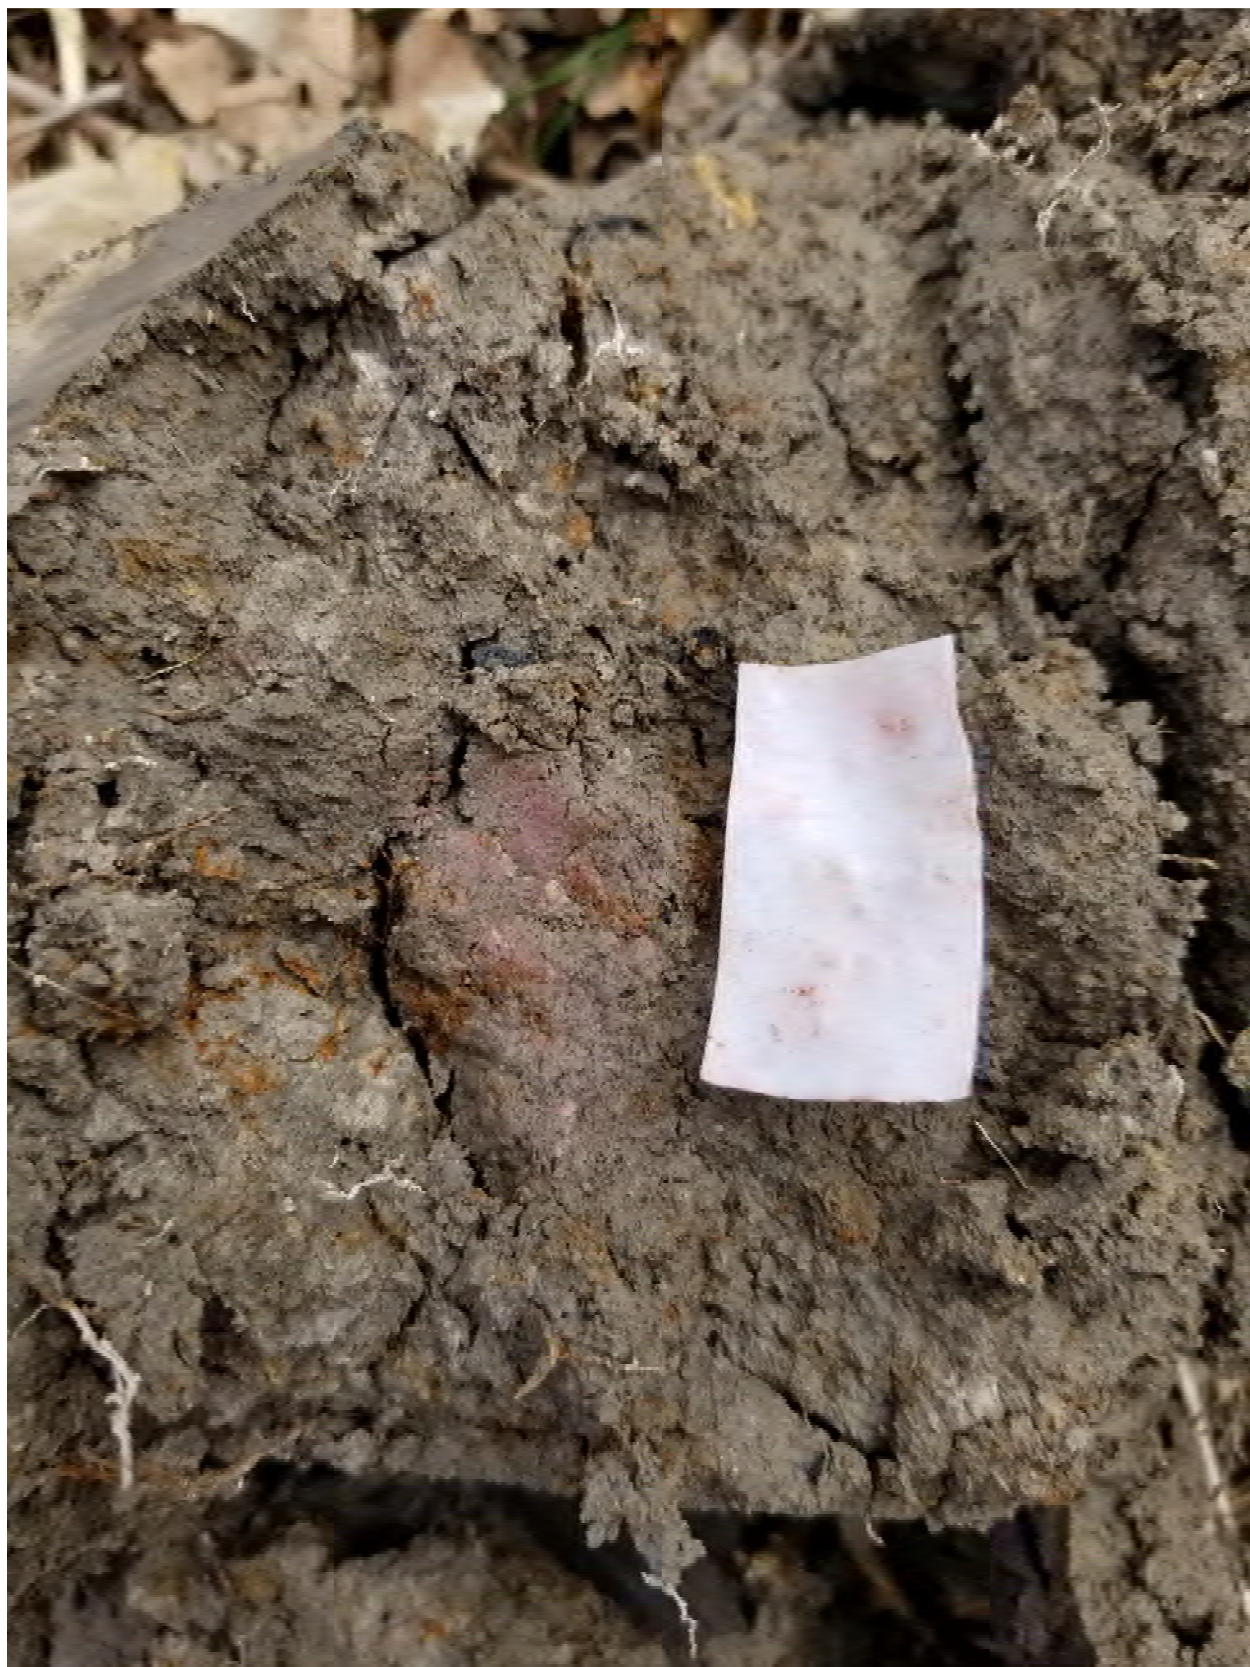
GW34 Positive  $\alpha, \alpha'$ -dipyridyl

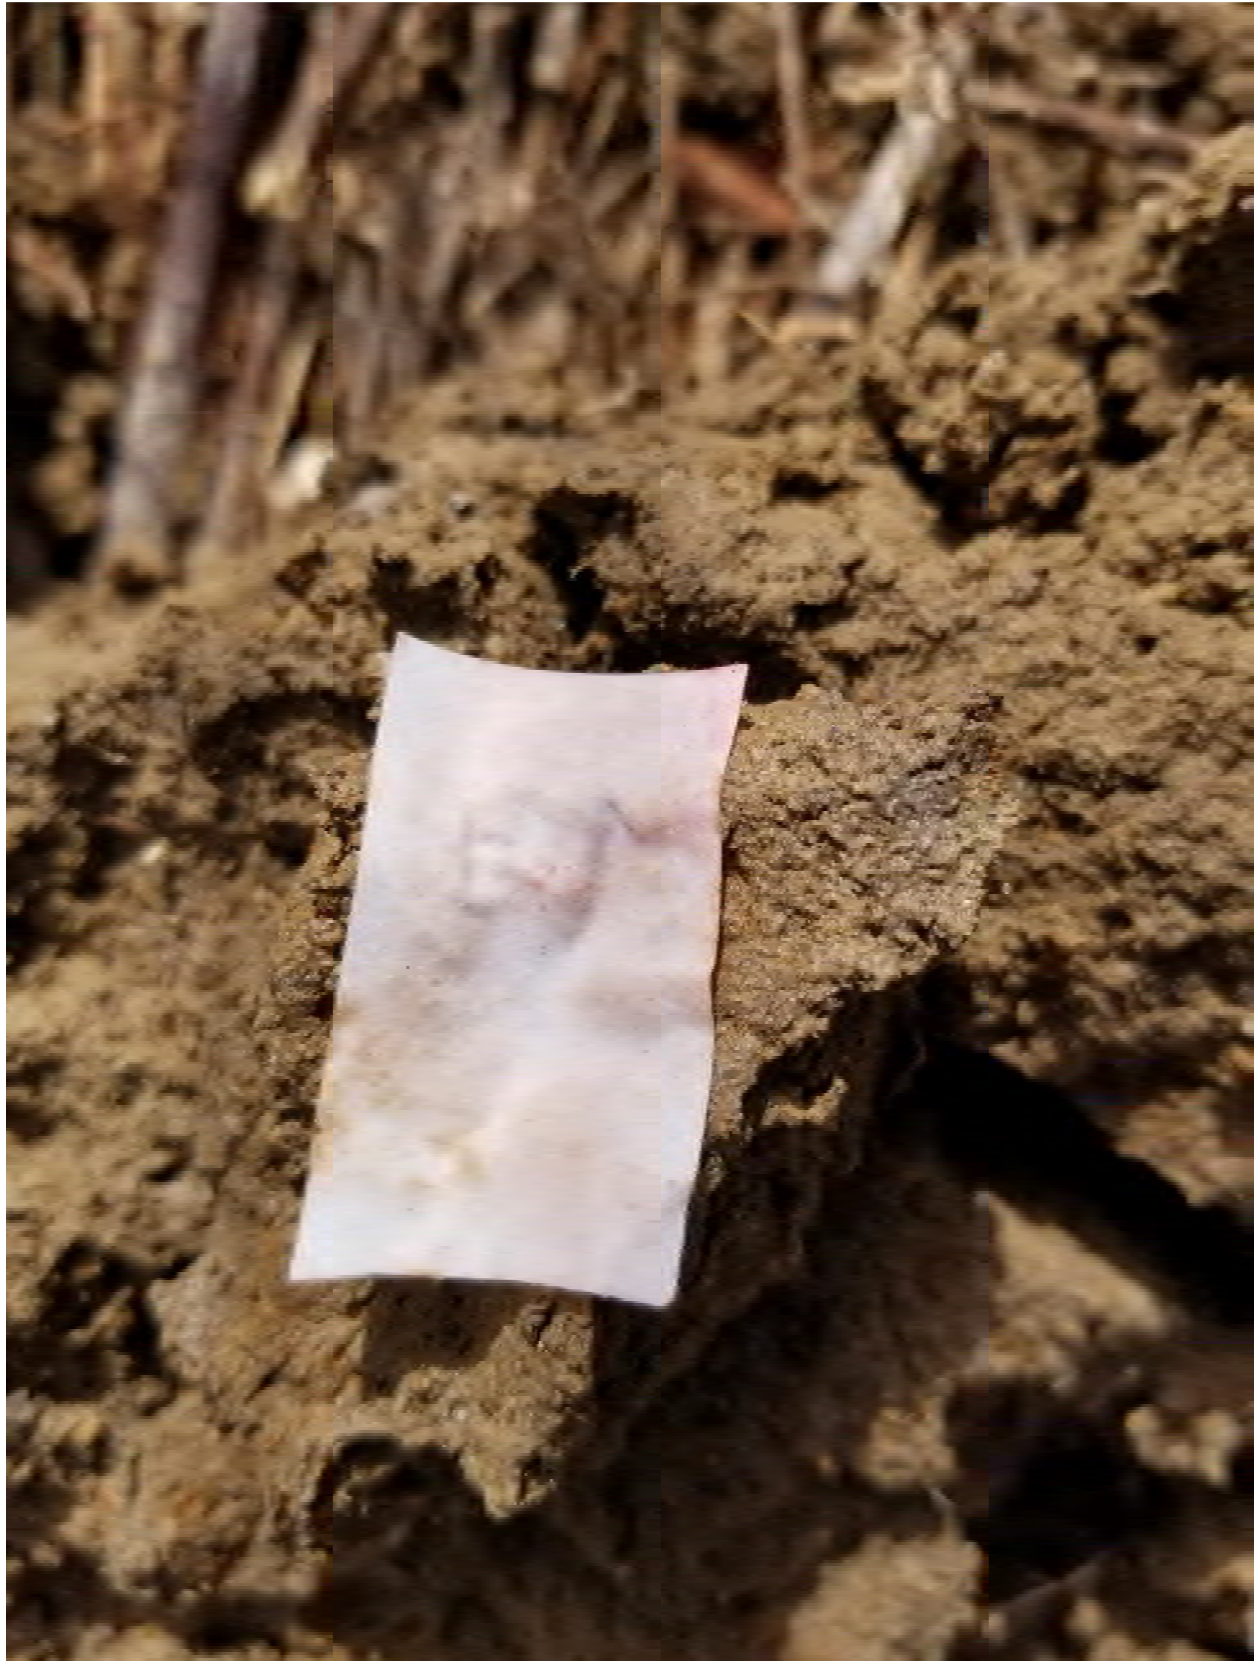
B5 0-6" Positive  $\alpha, \alpha'$ -dipyridyl

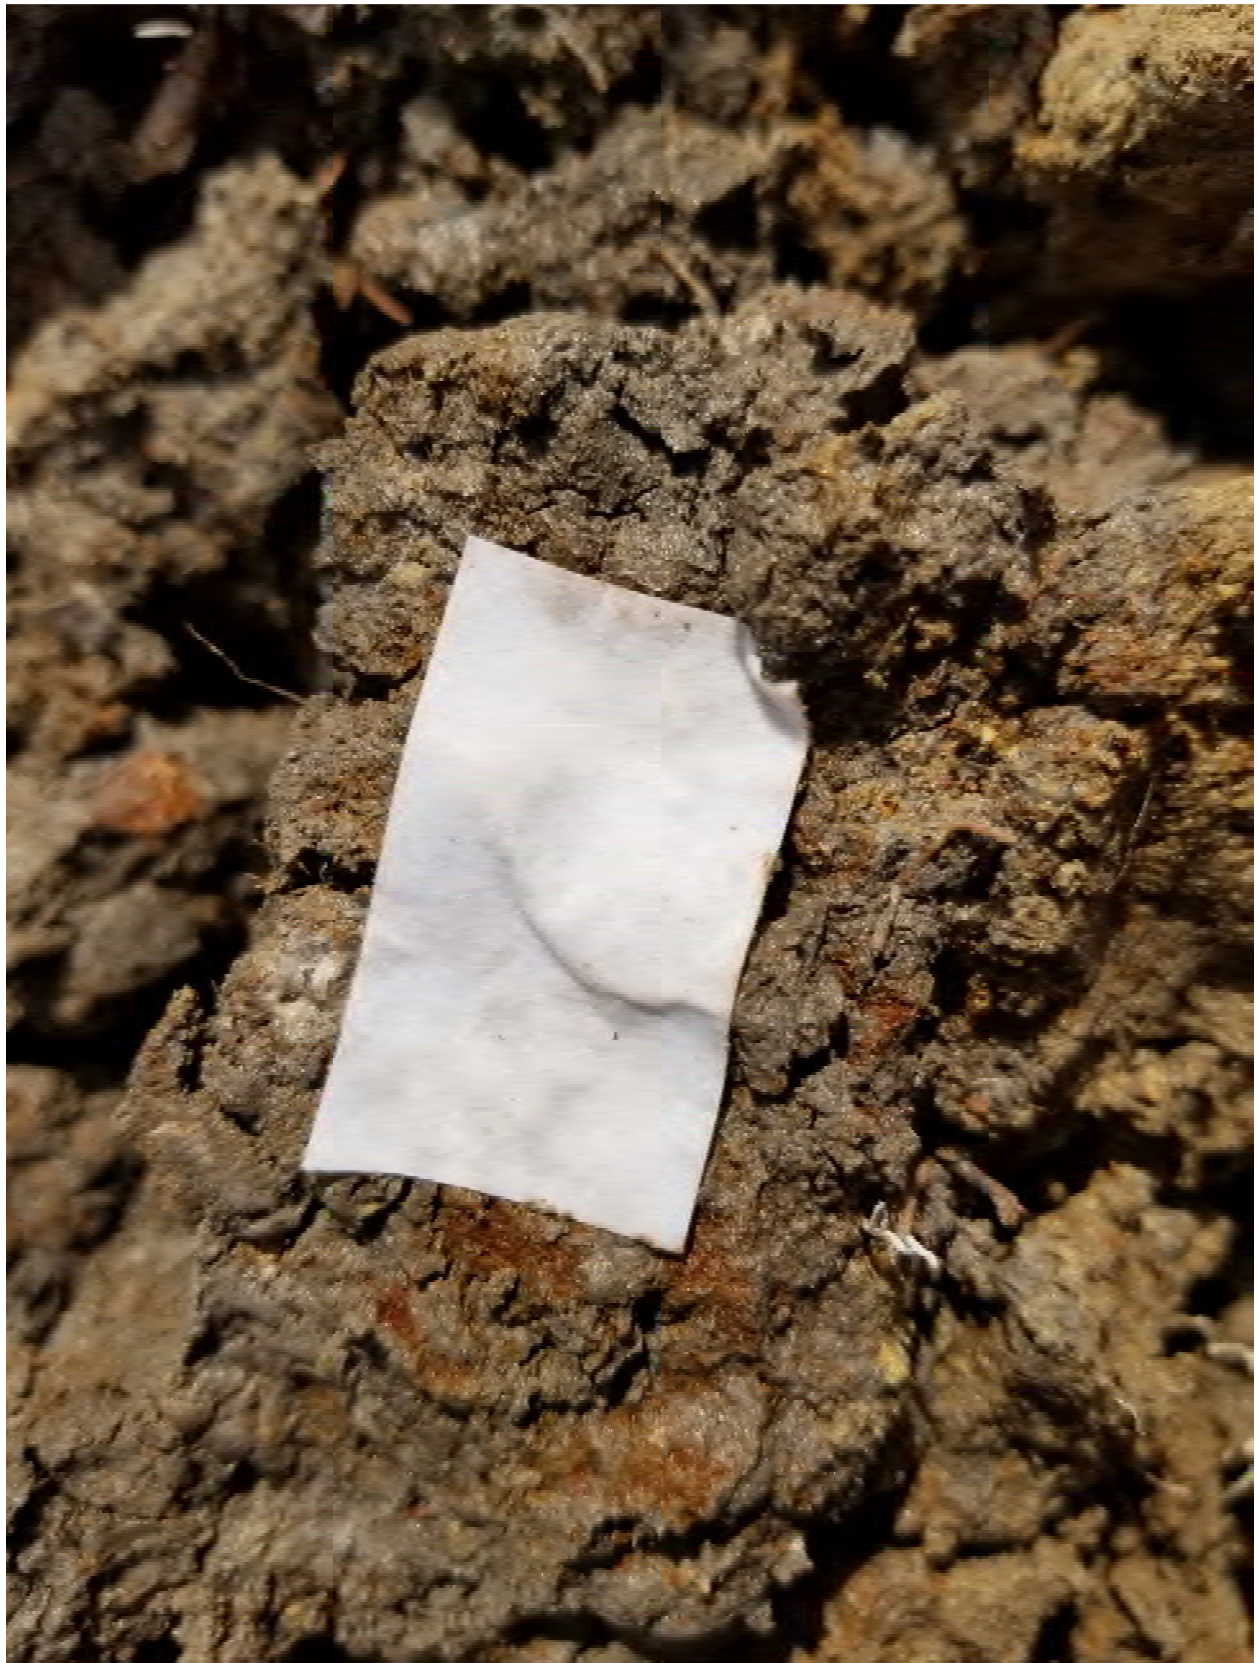
B5 6-12+” Positive  $\alpha$ ,  $\alpha'$ -dipyridyl

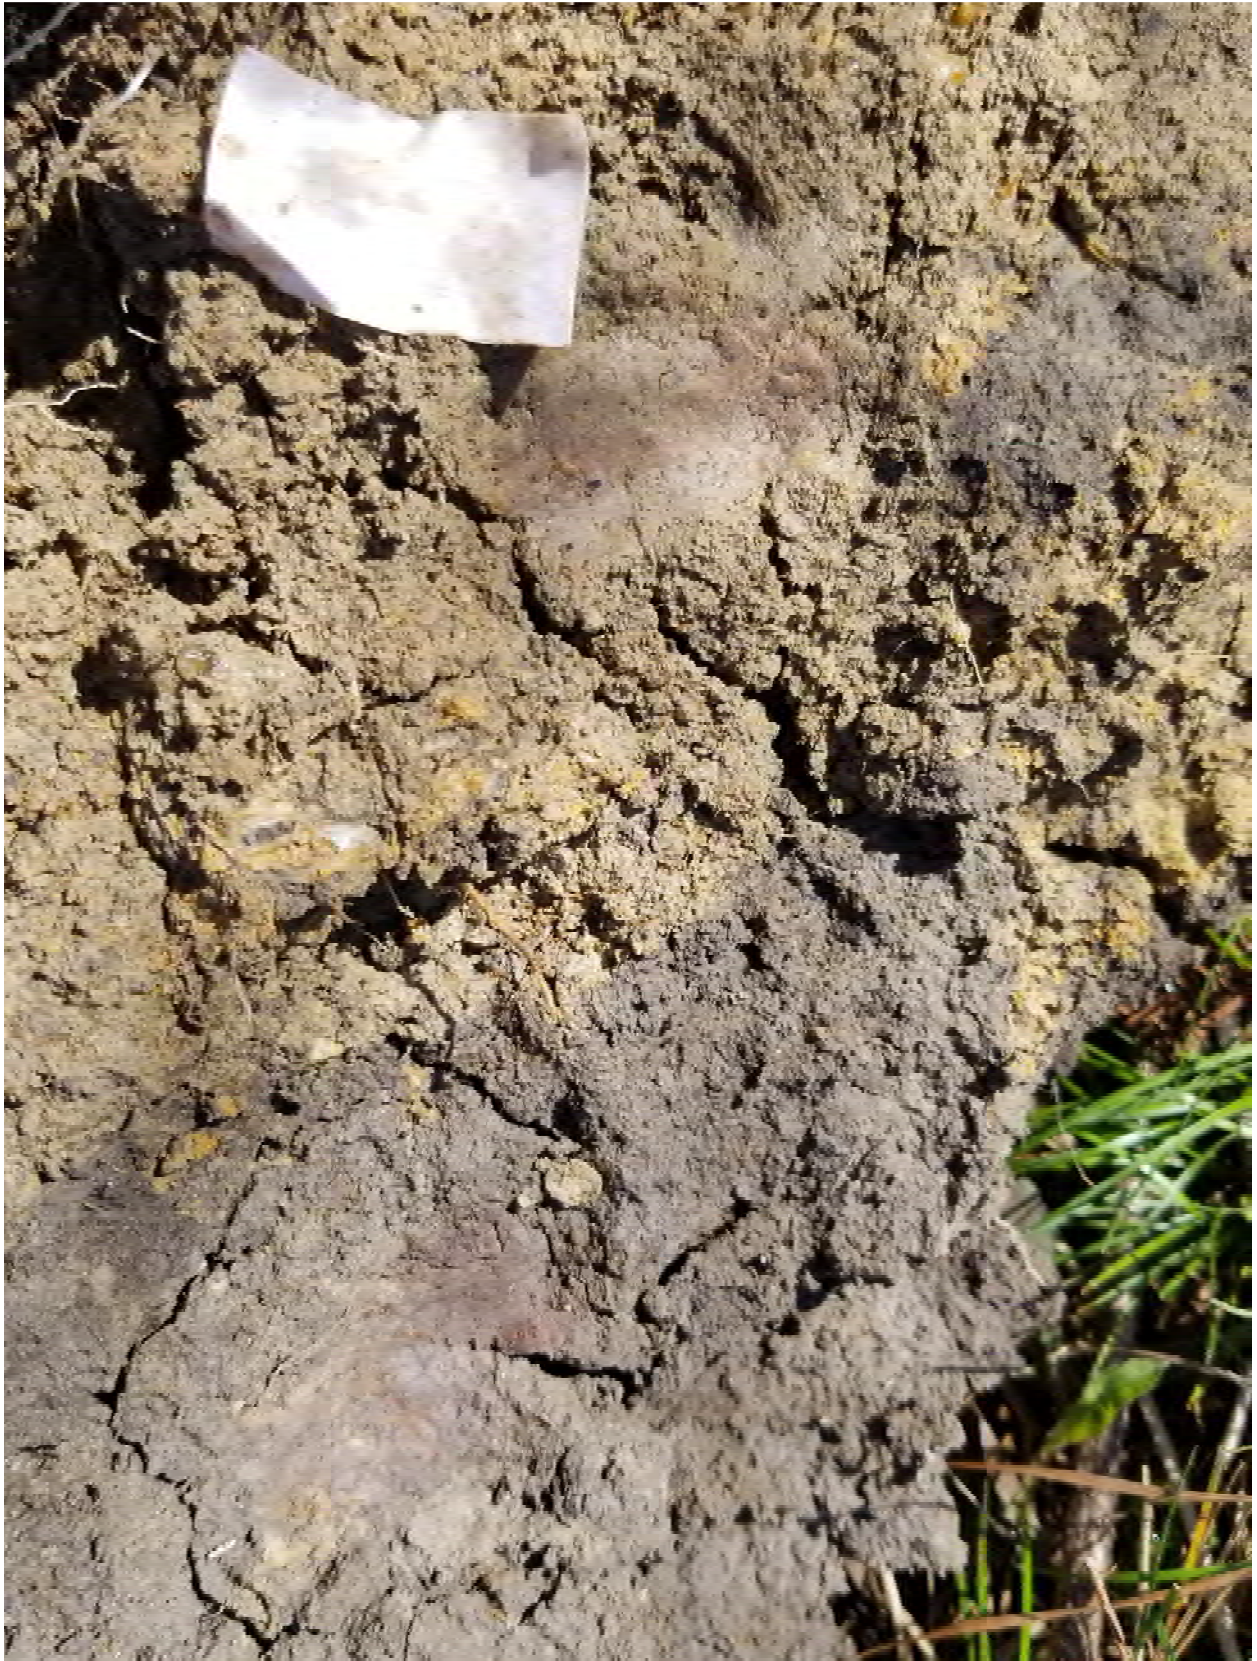
GW26 Positive  $\alpha, \alpha'$ -dipyridyl

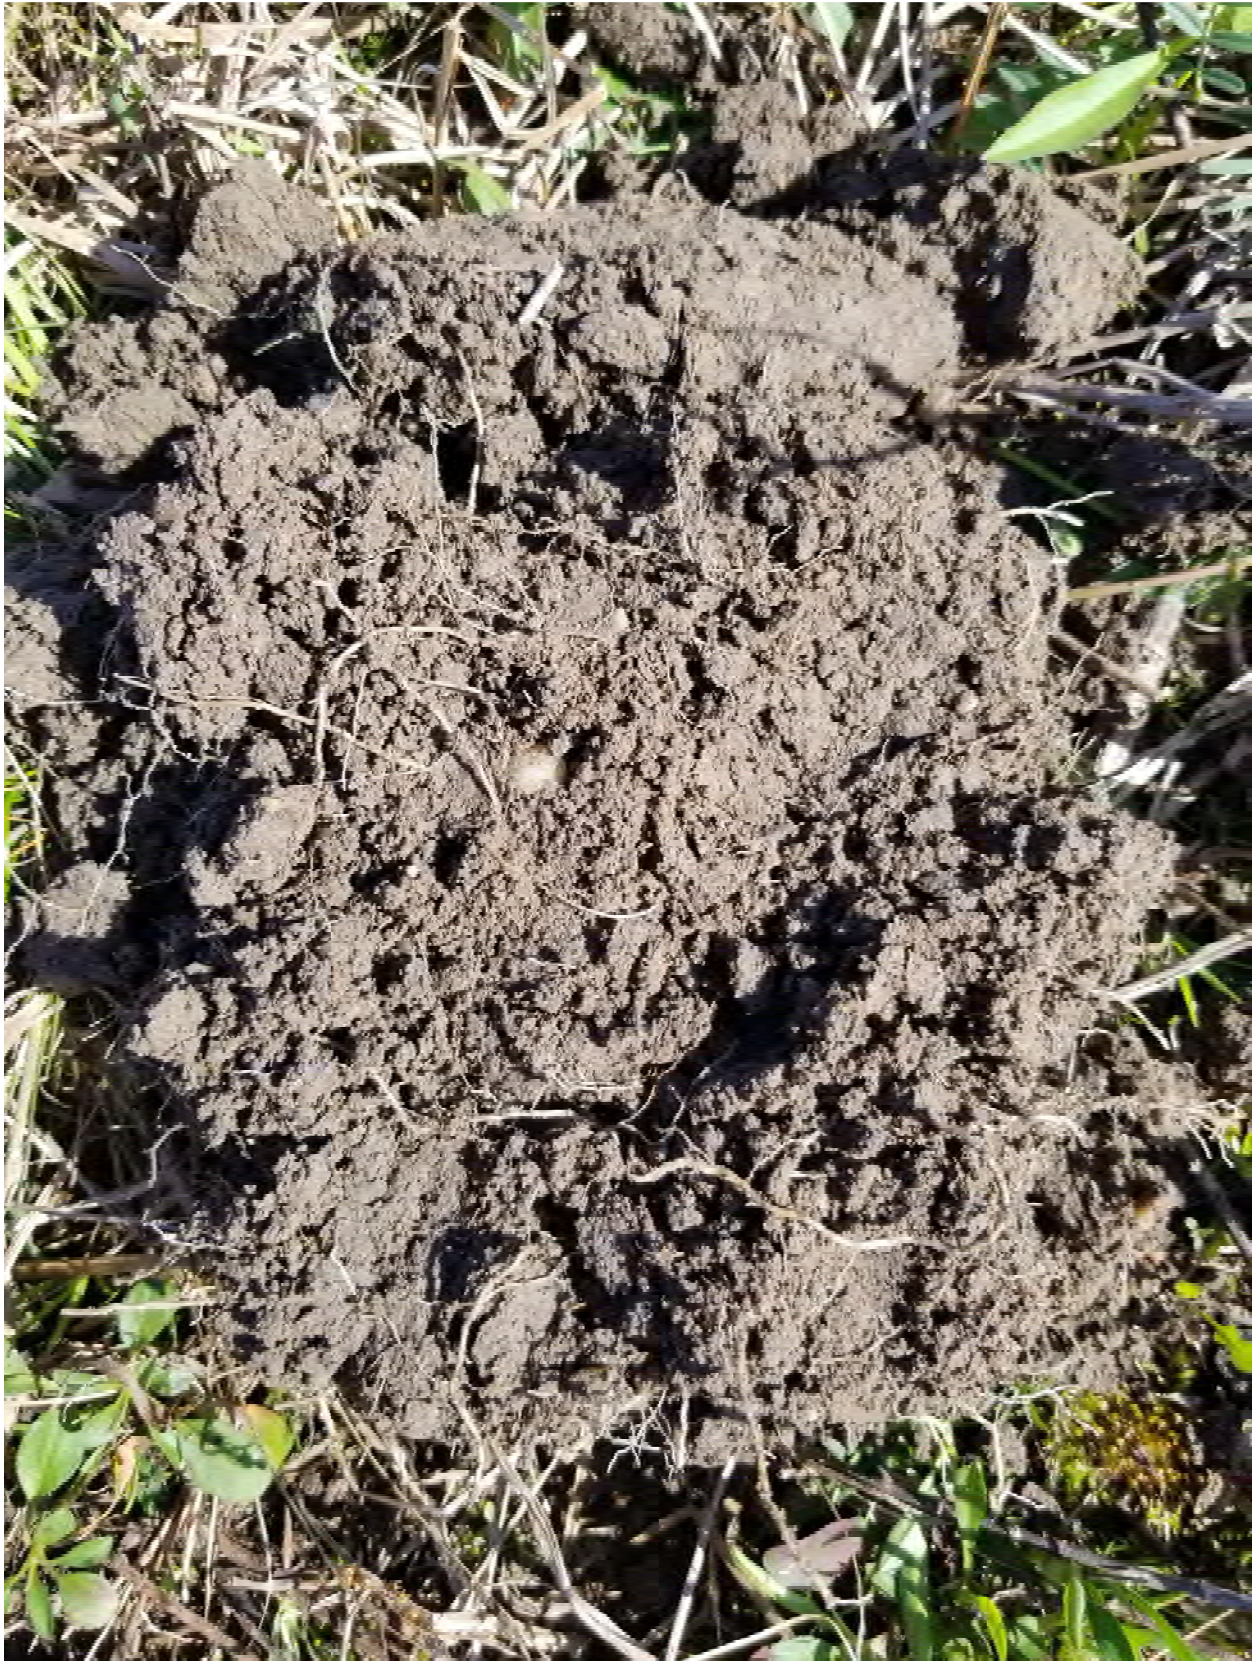
B8 no redox

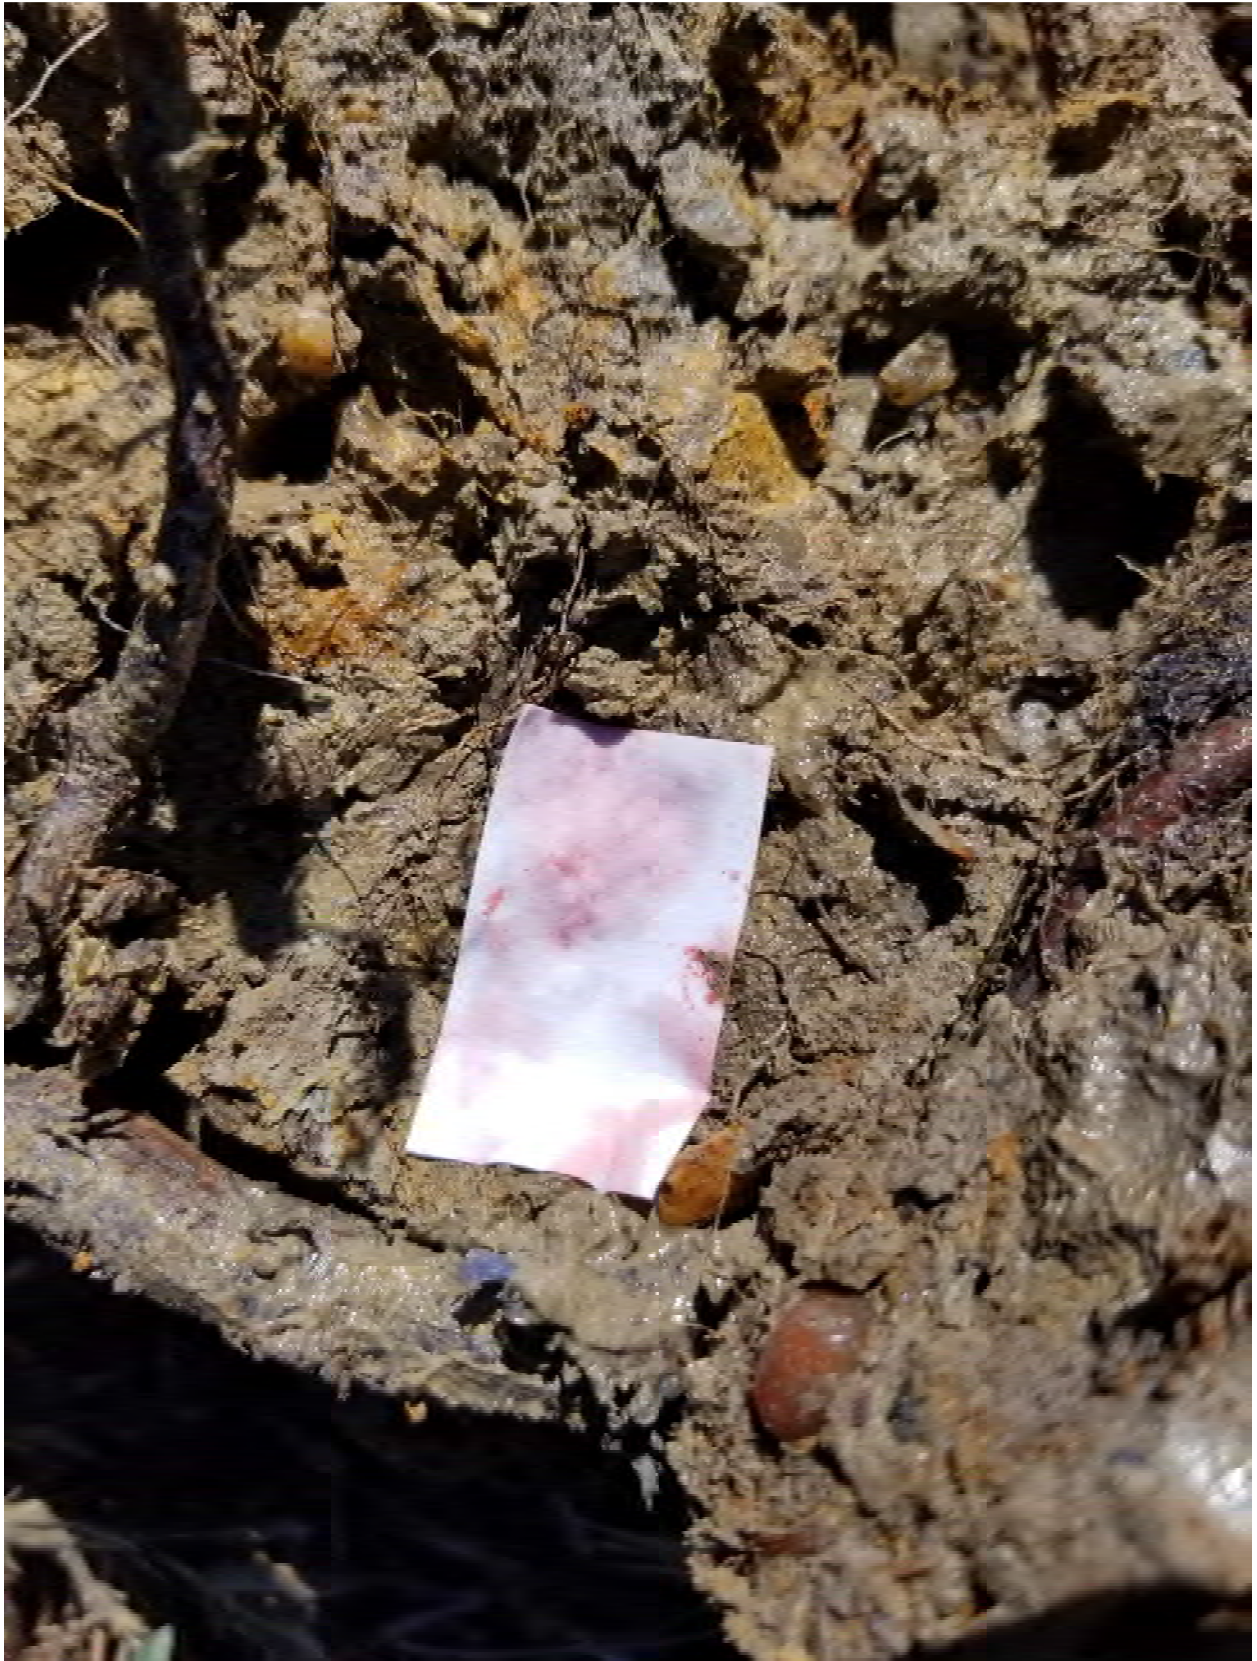
GW30 surface Positive  $\alpha$ ,  $\alpha'$ -dipyridyl

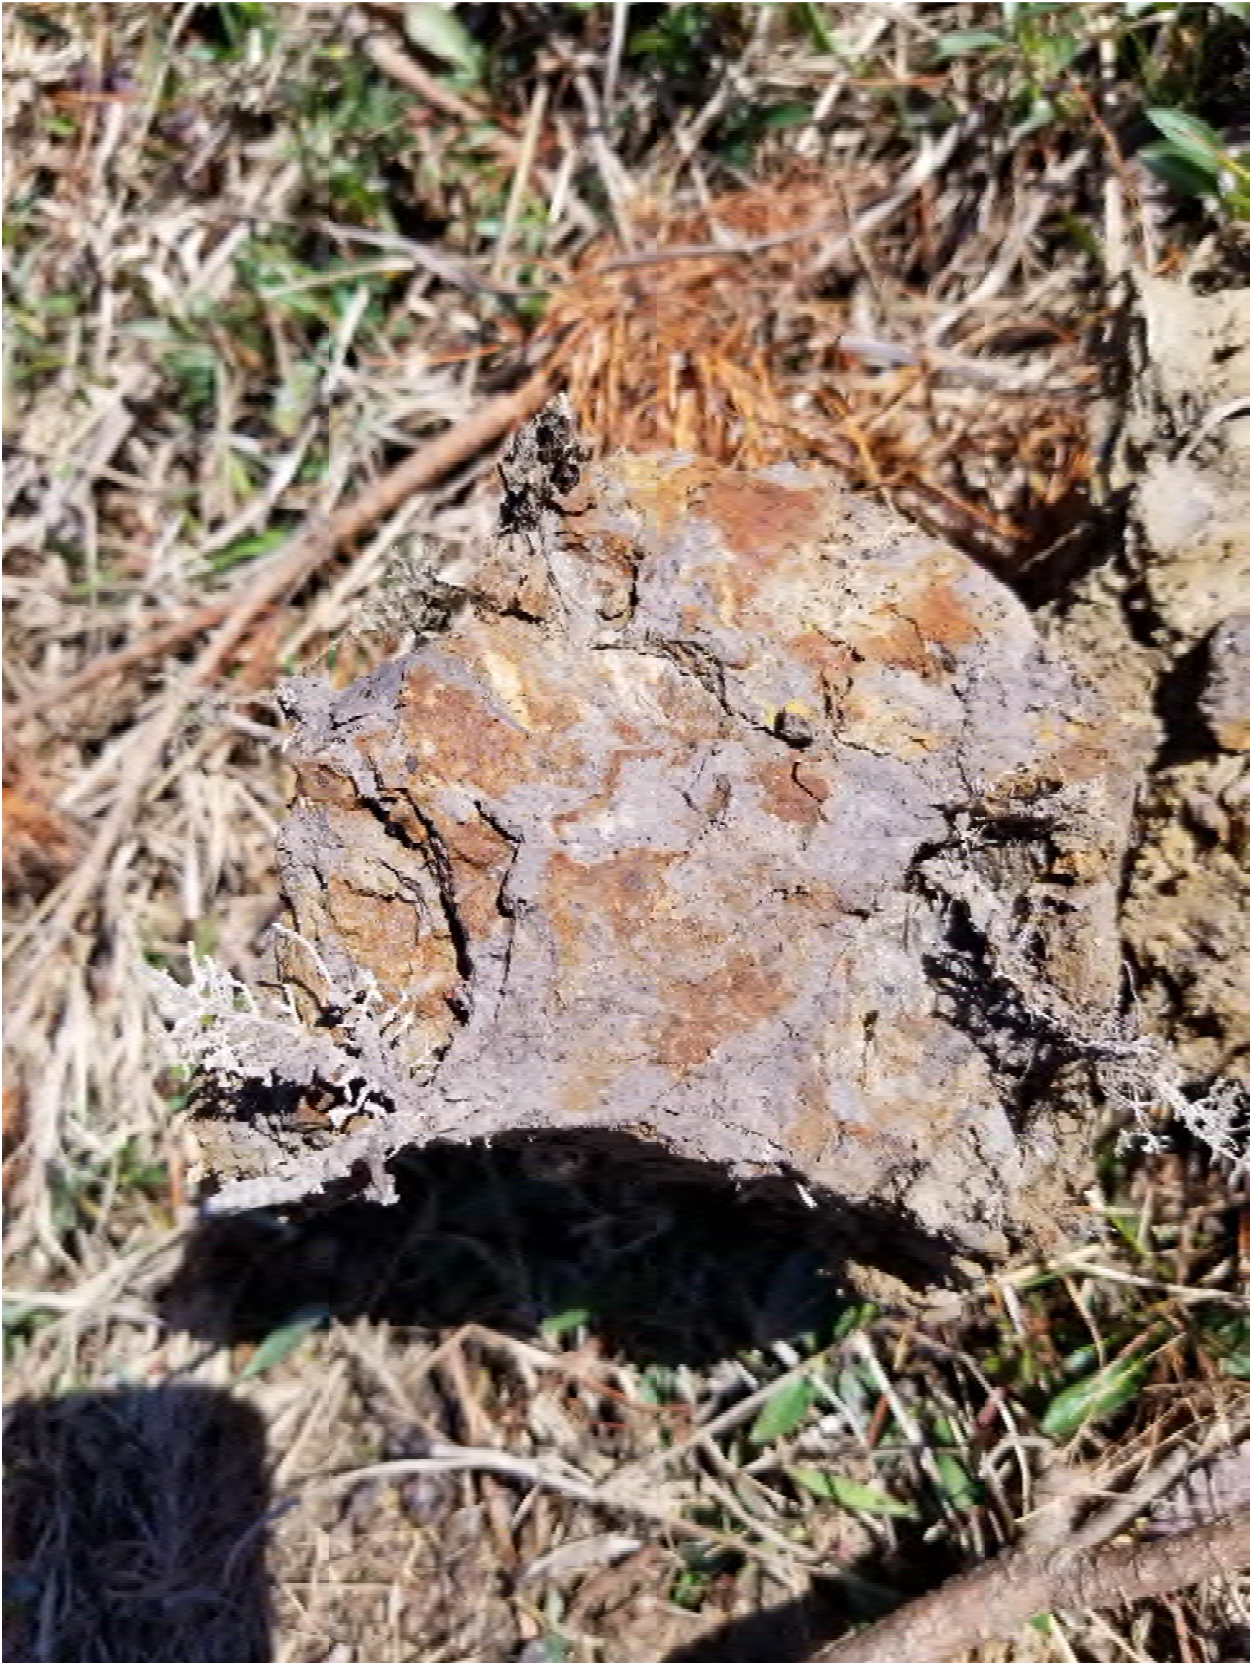
GW30 subsurface Masses on Ped Faces

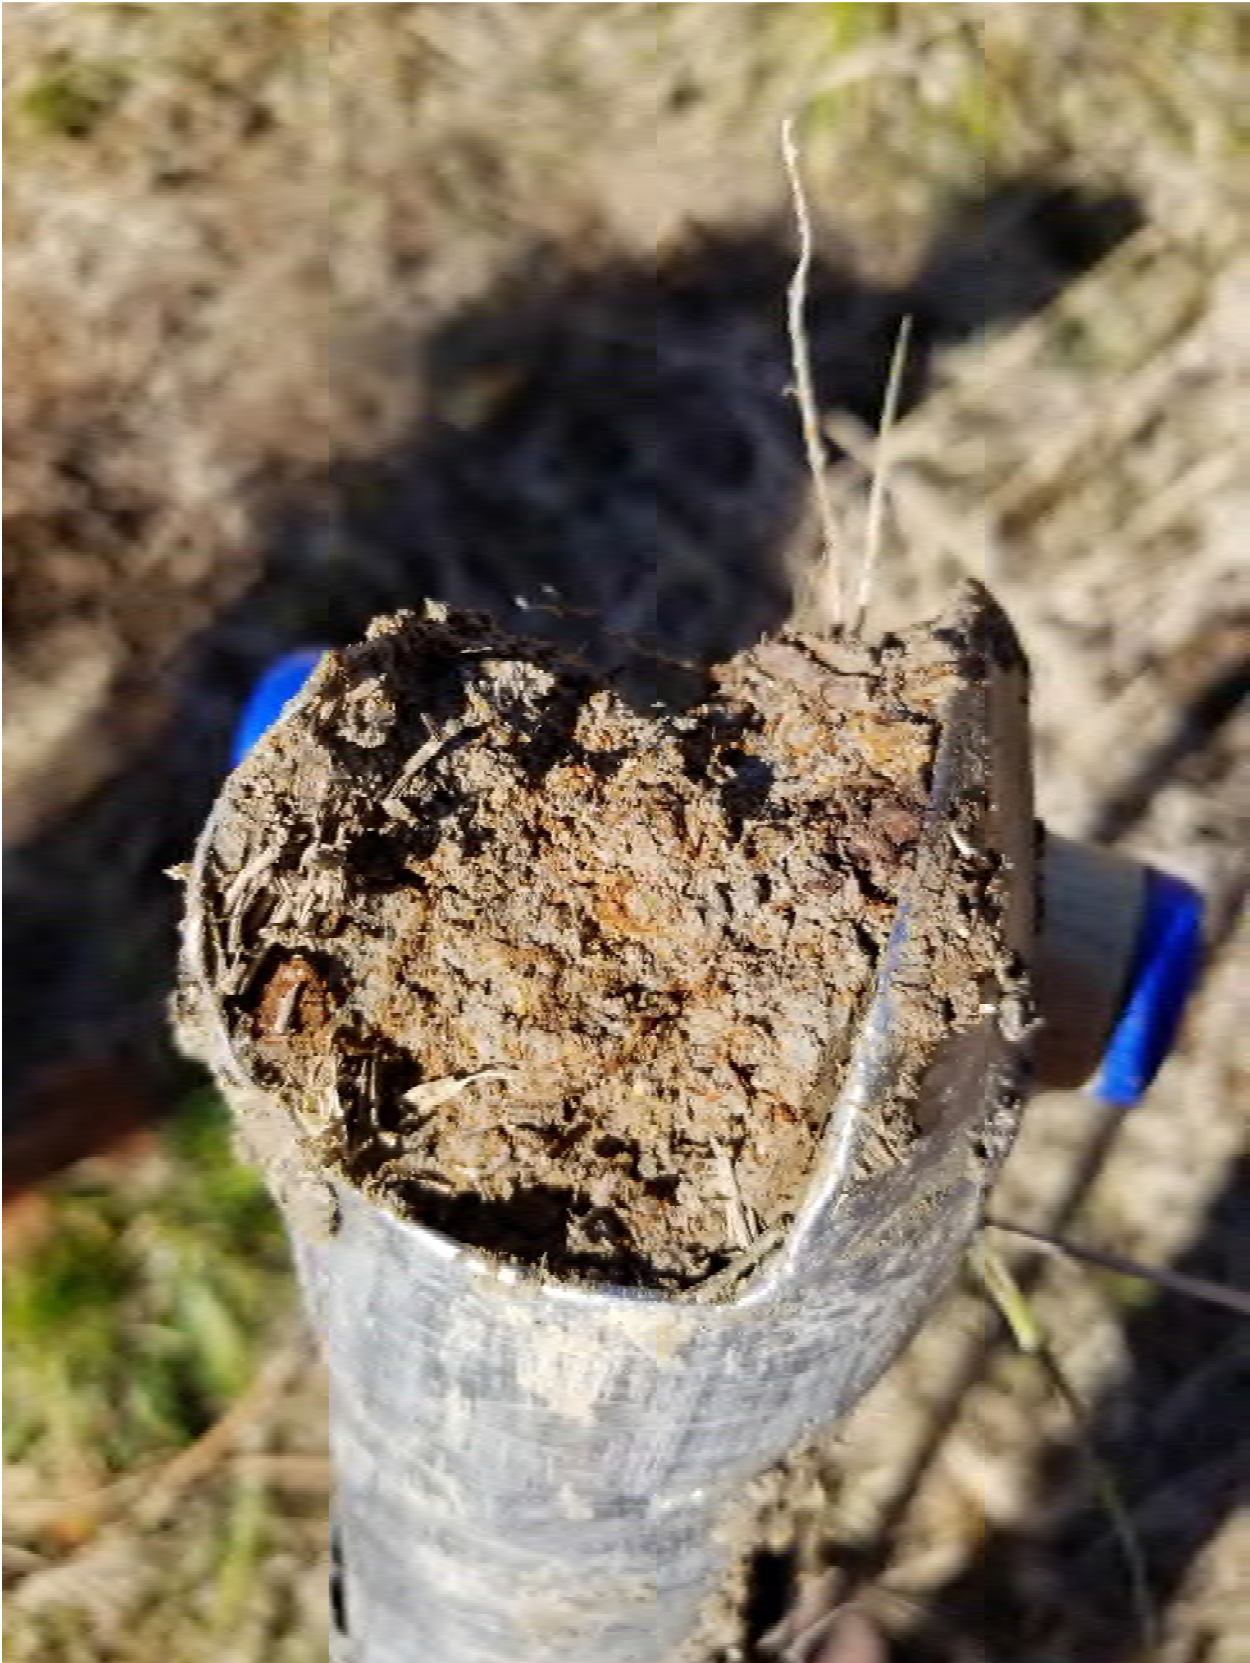
B9 surface #2 Pore Linings

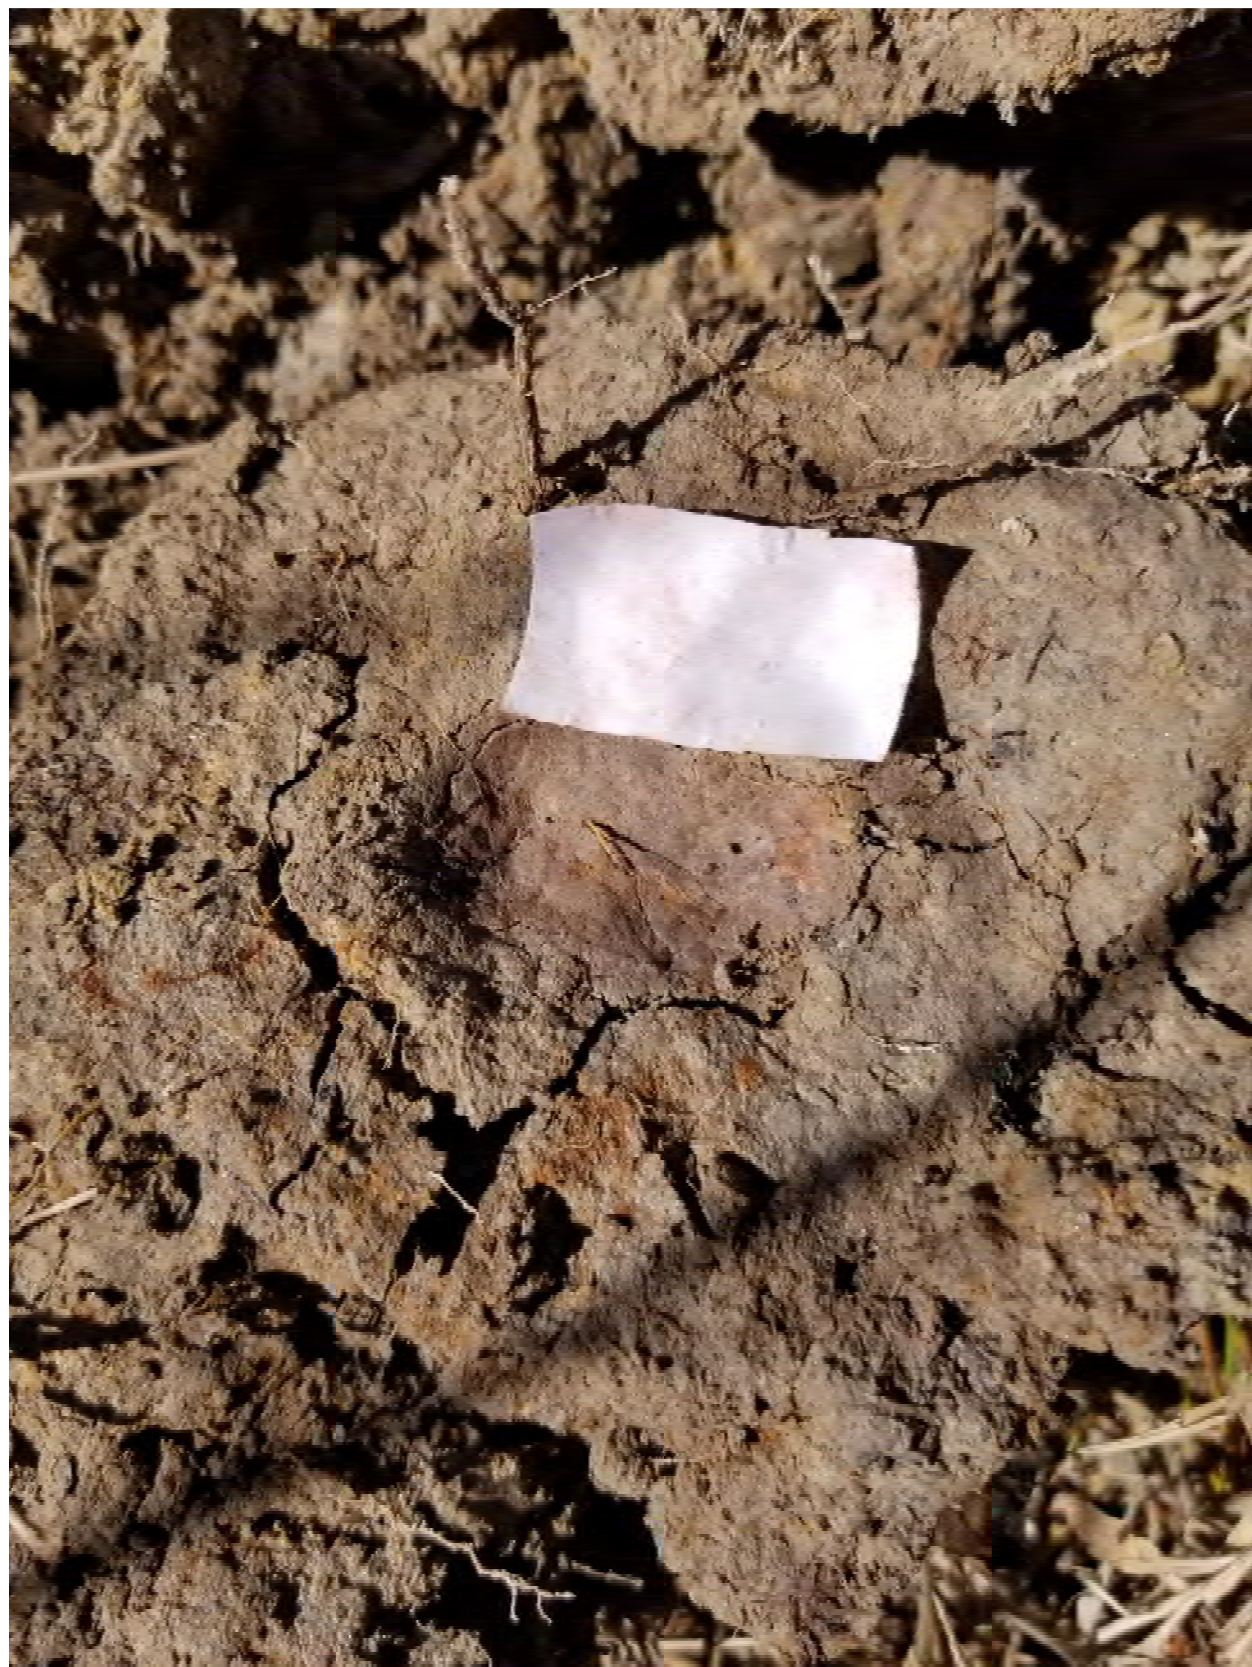
B9 surface Positive  $\alpha, \alpha'$ -dipyridyl

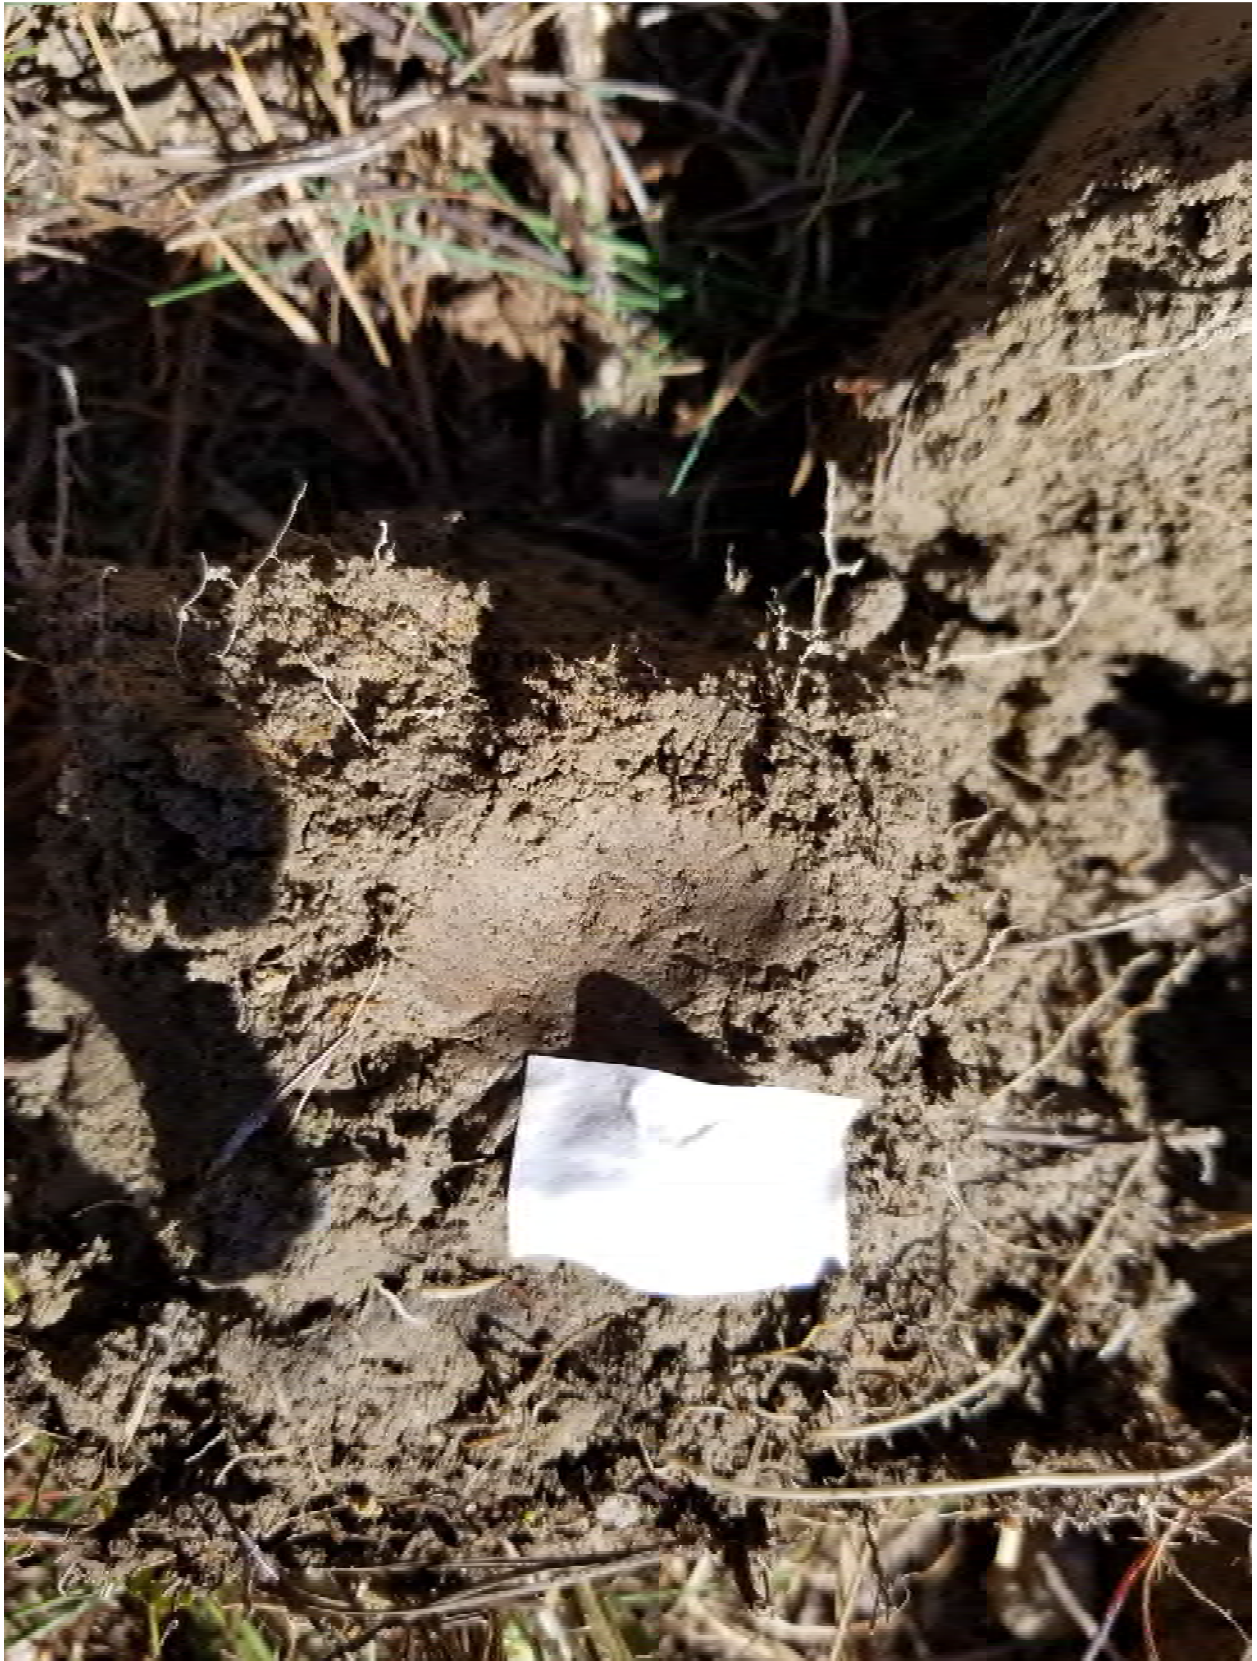
GW20 Negative  $\alpha$ ,  $\alpha'$ -dipyridyl surface

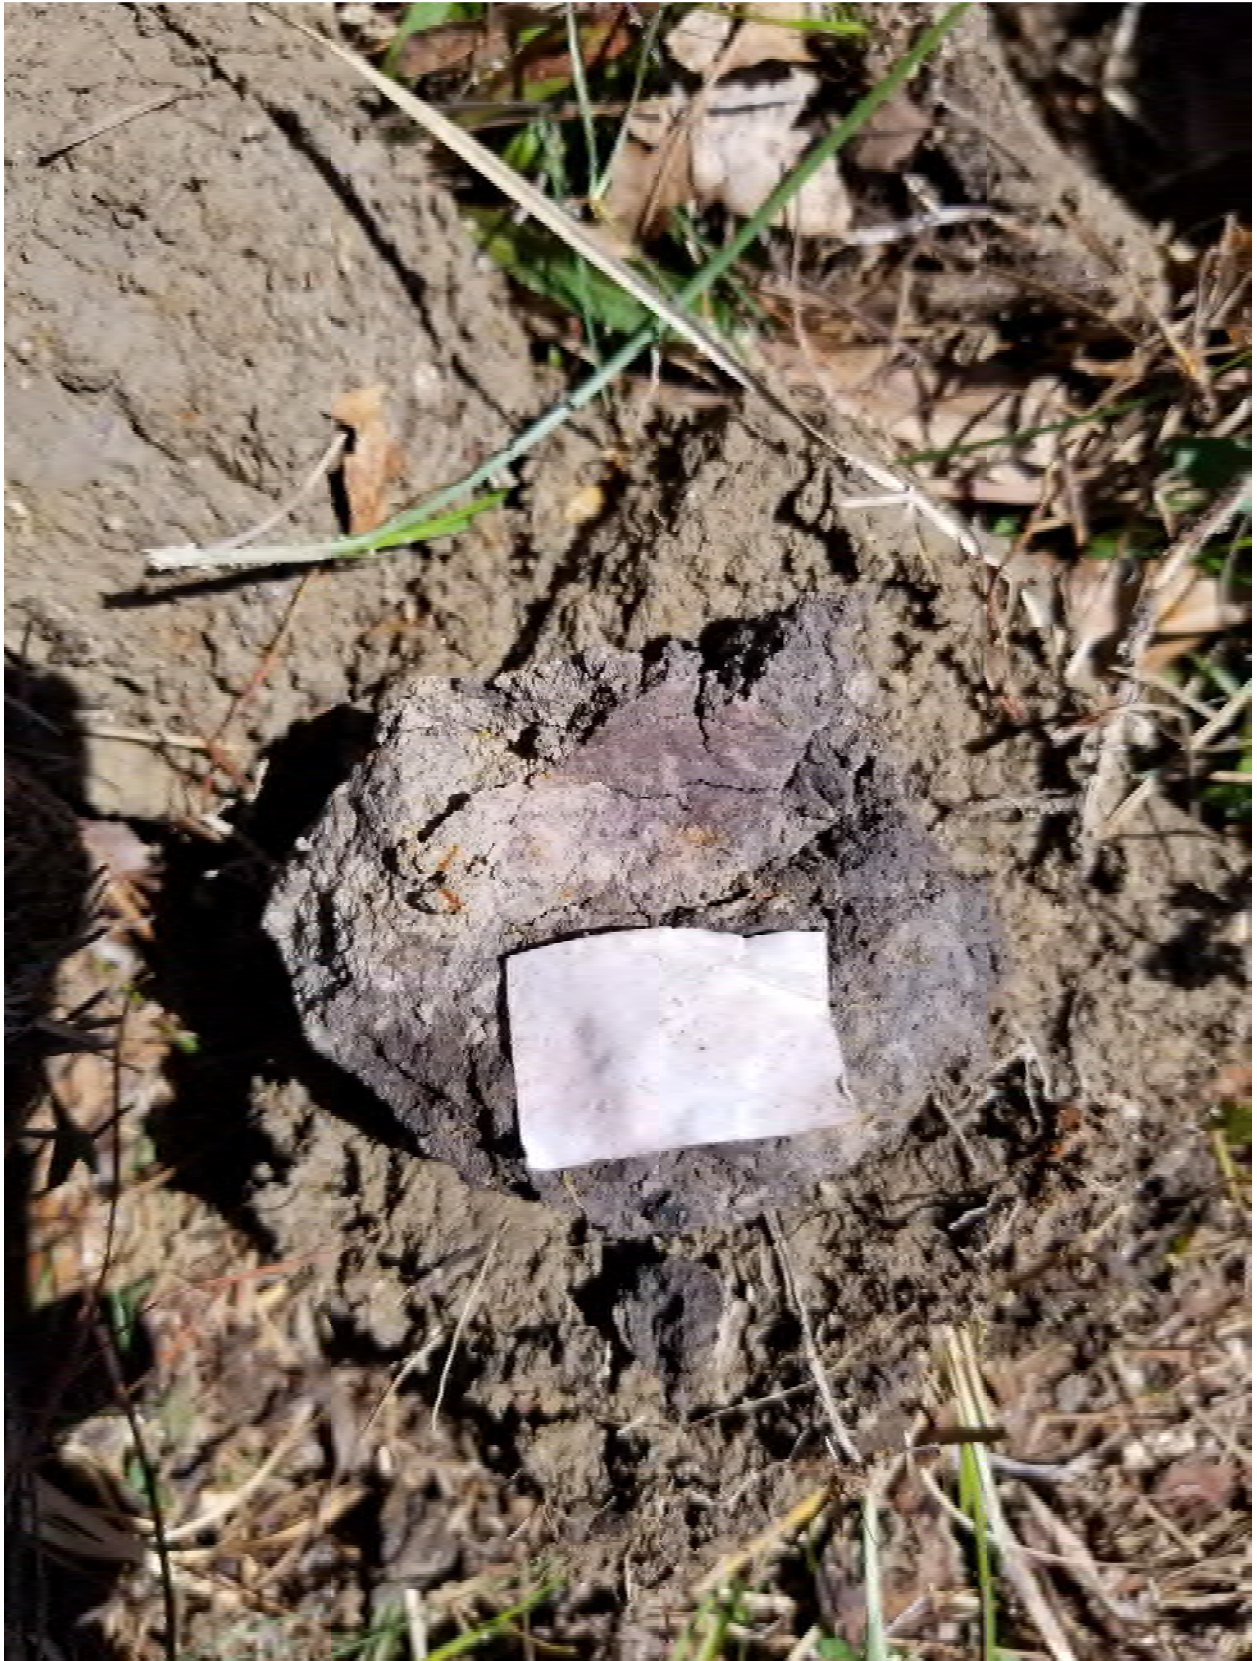
GW20 subsurface Positive  $\alpha$ ,  $\alpha'$ -dipyridyl
