# **MONITORING YEAR 7 ANNUAL REPORT FINAL**

## **DEVIL'S RACETRACK MITIGATION SITE**

Johnston County, NC  
NCDEQ Contract 003989  
DMS Project Number 95021  
USACE Action ID Number 2012-00810  
NCDWR Project Number 12-0747

Data Collection Period: January - November 2020  
Draft Submission Date: December 21, 2020  
Final Submission Date: February 17, 2021

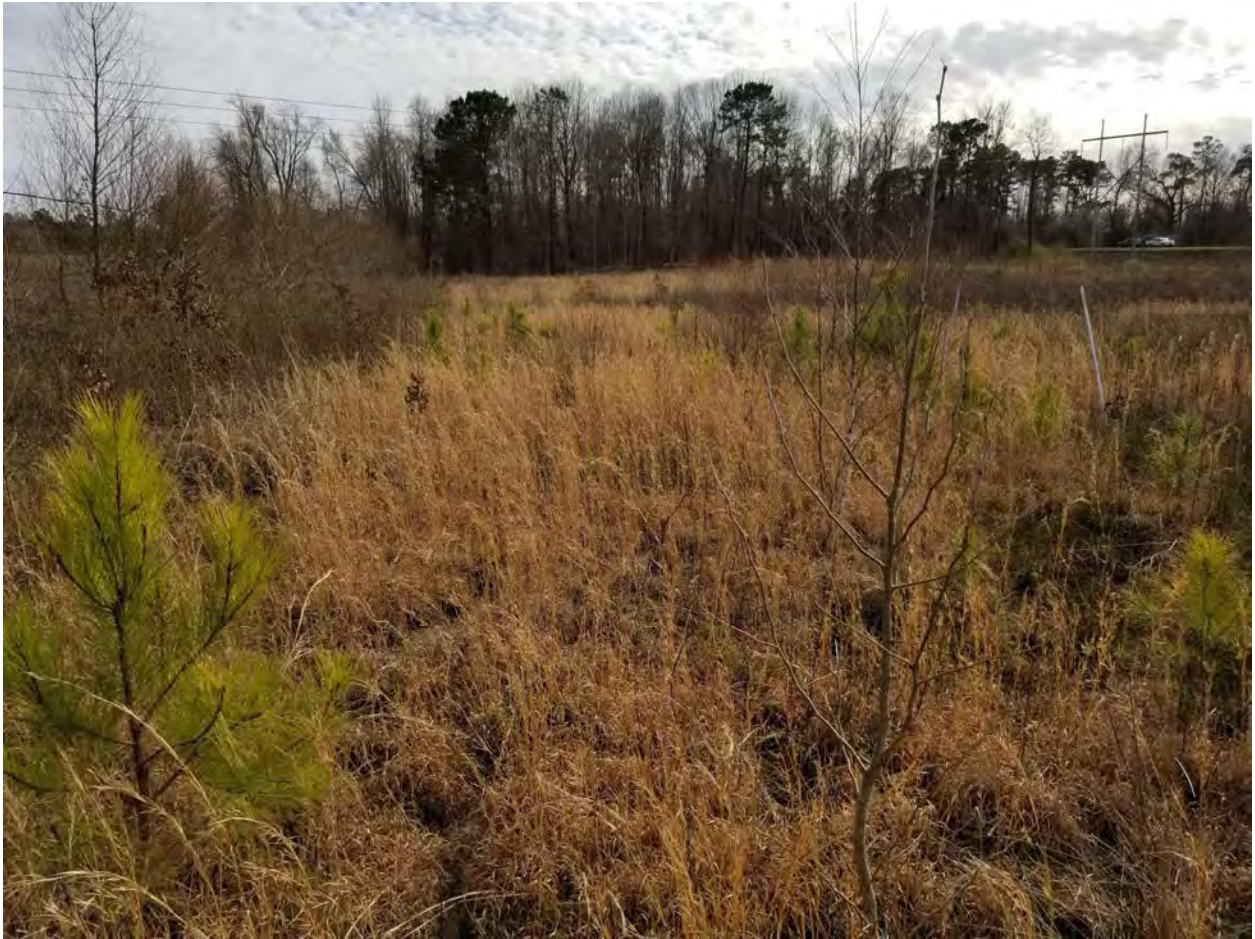
Near GW2 (Compacted area possibly due to old construction access, not meeting aquic conditions)

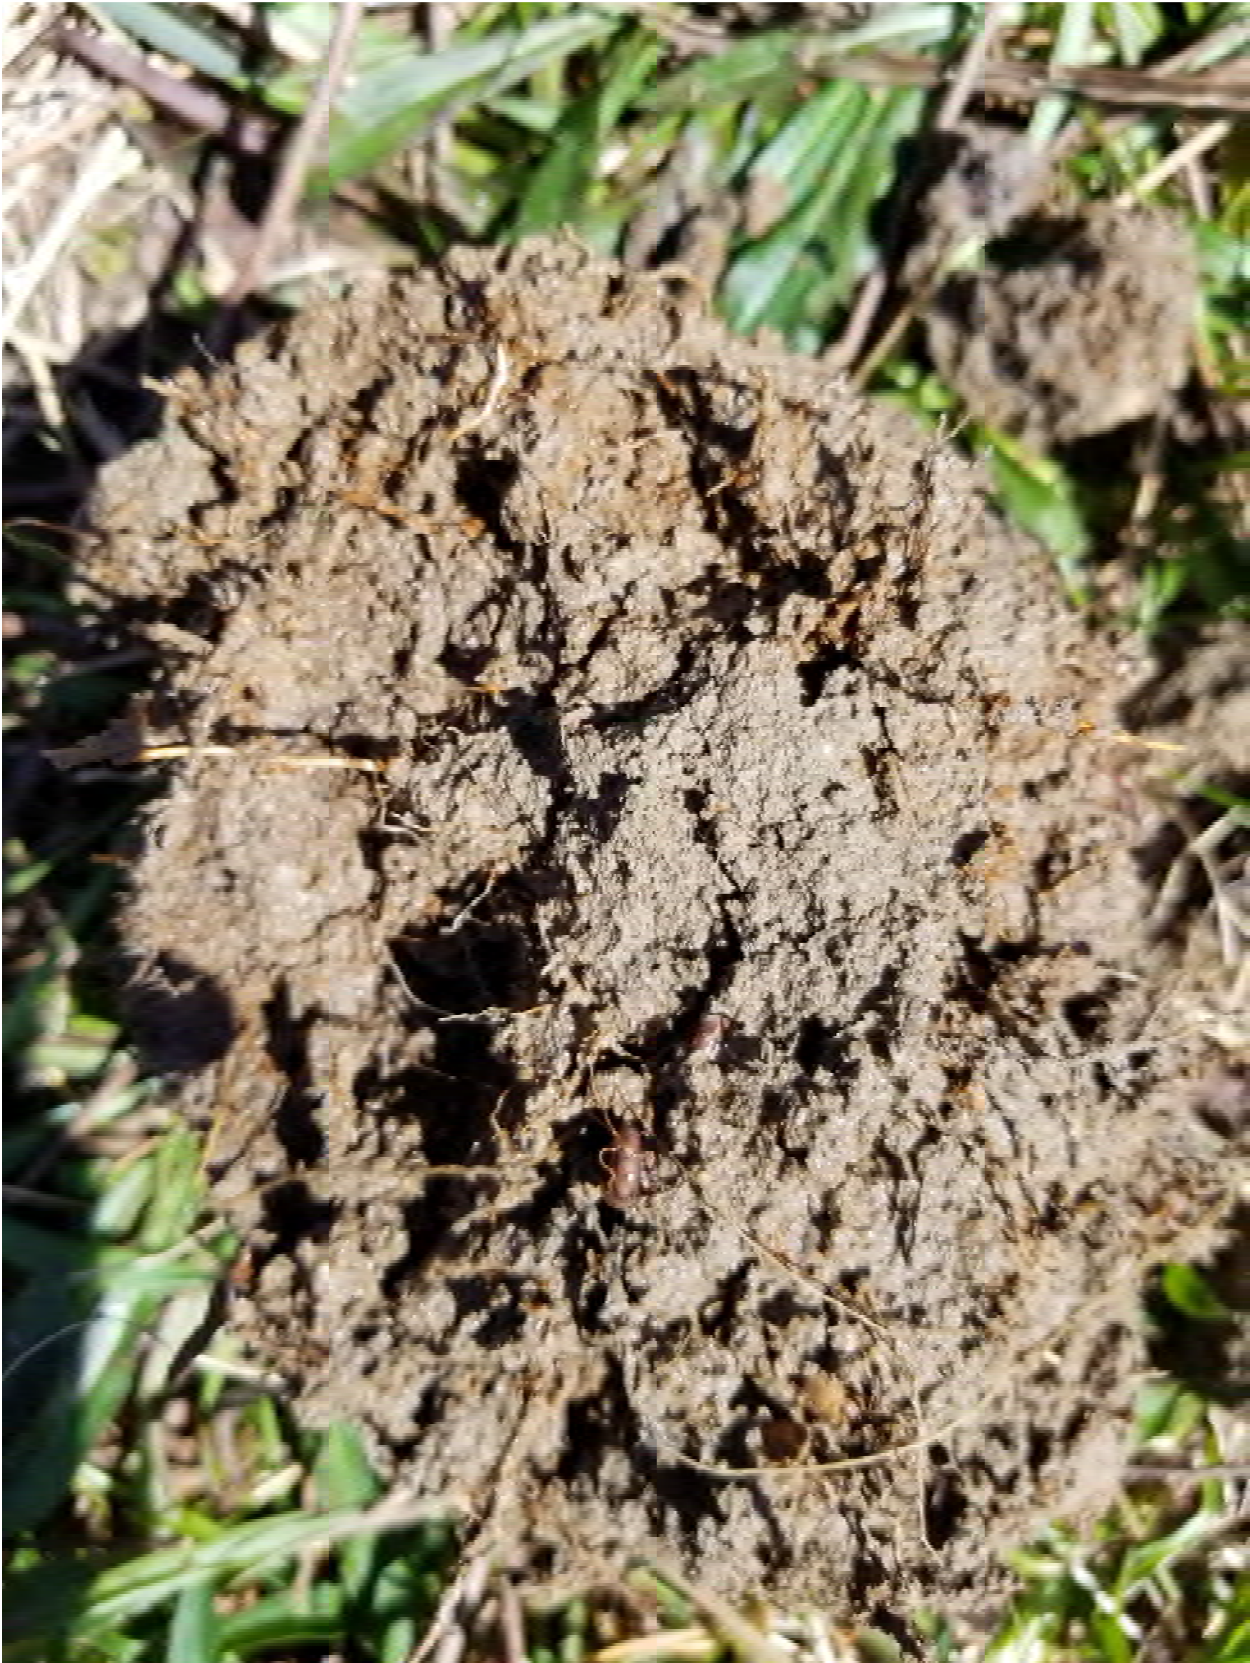
B10 surface #2 Pore Linings and Oxidized rhizospheres

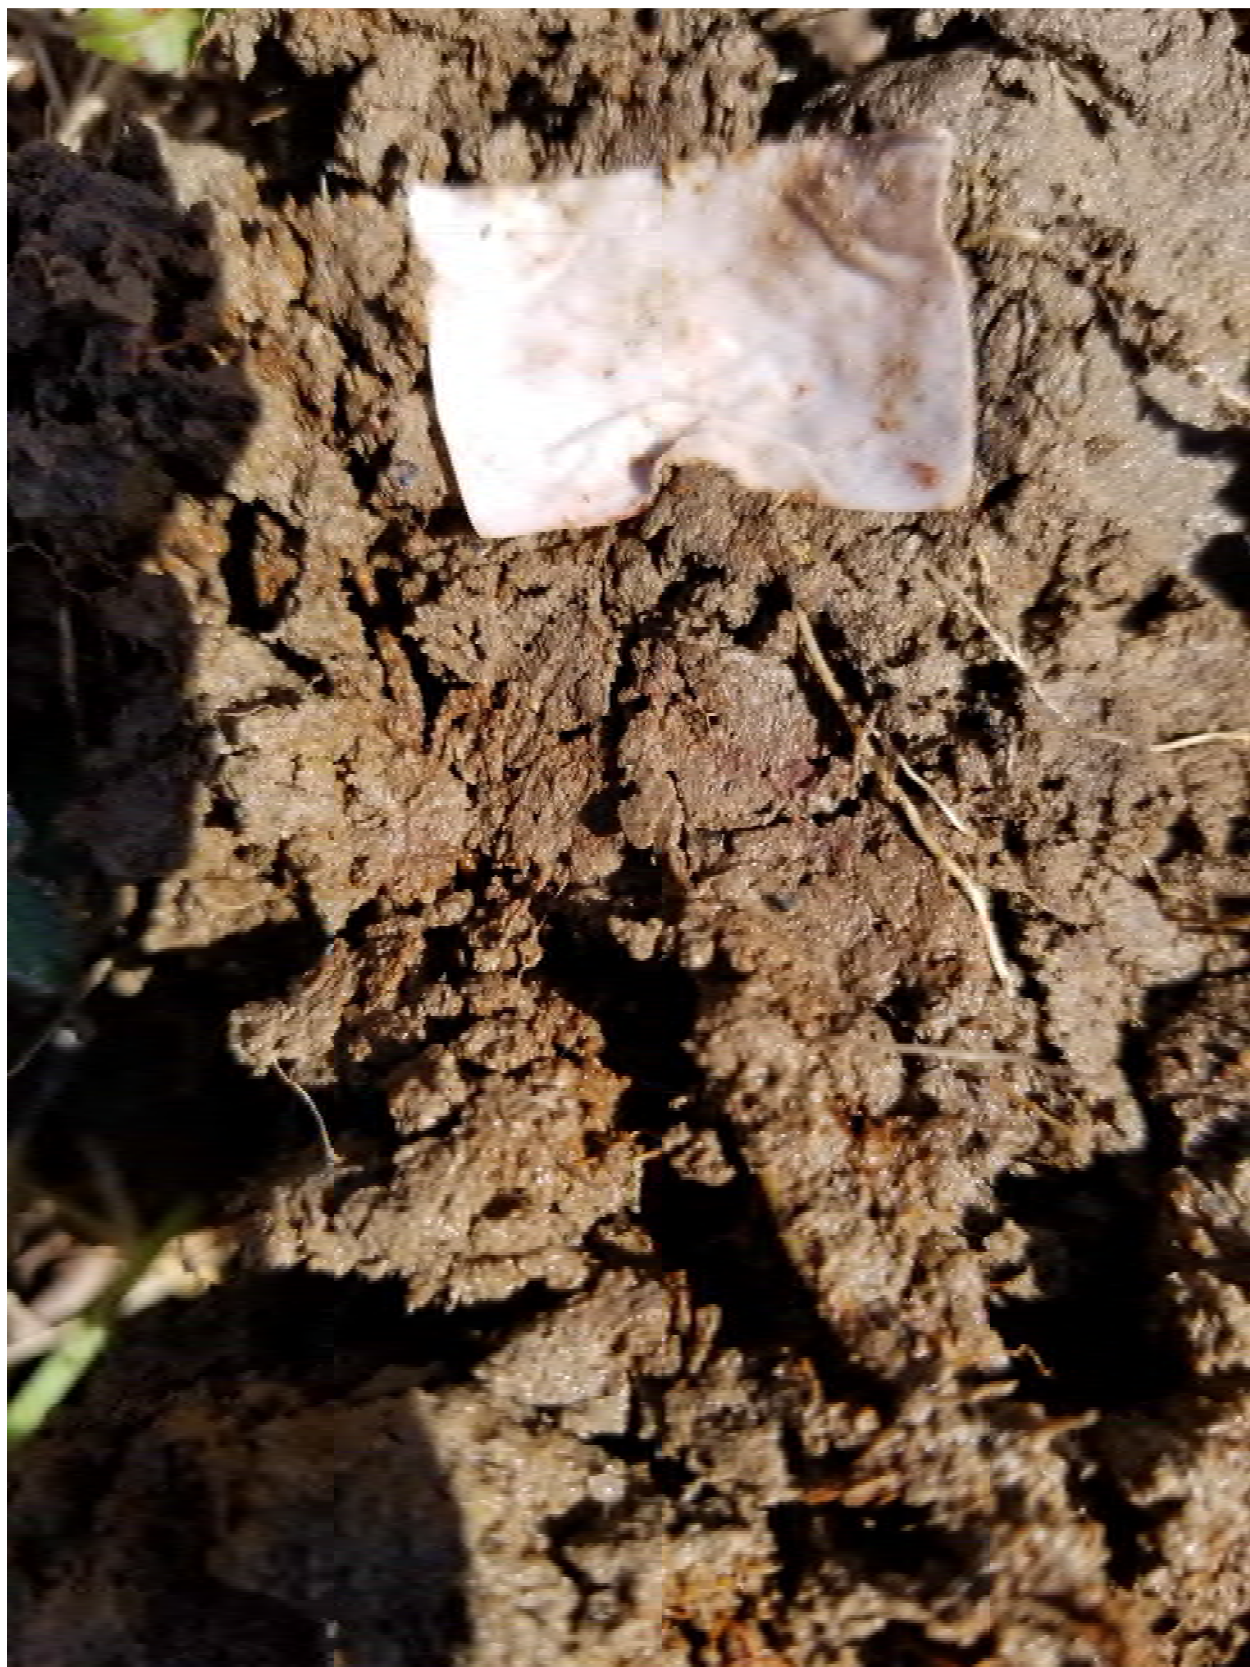
B10 surface Positive  $\alpha, \alpha'$ -dipyridyl

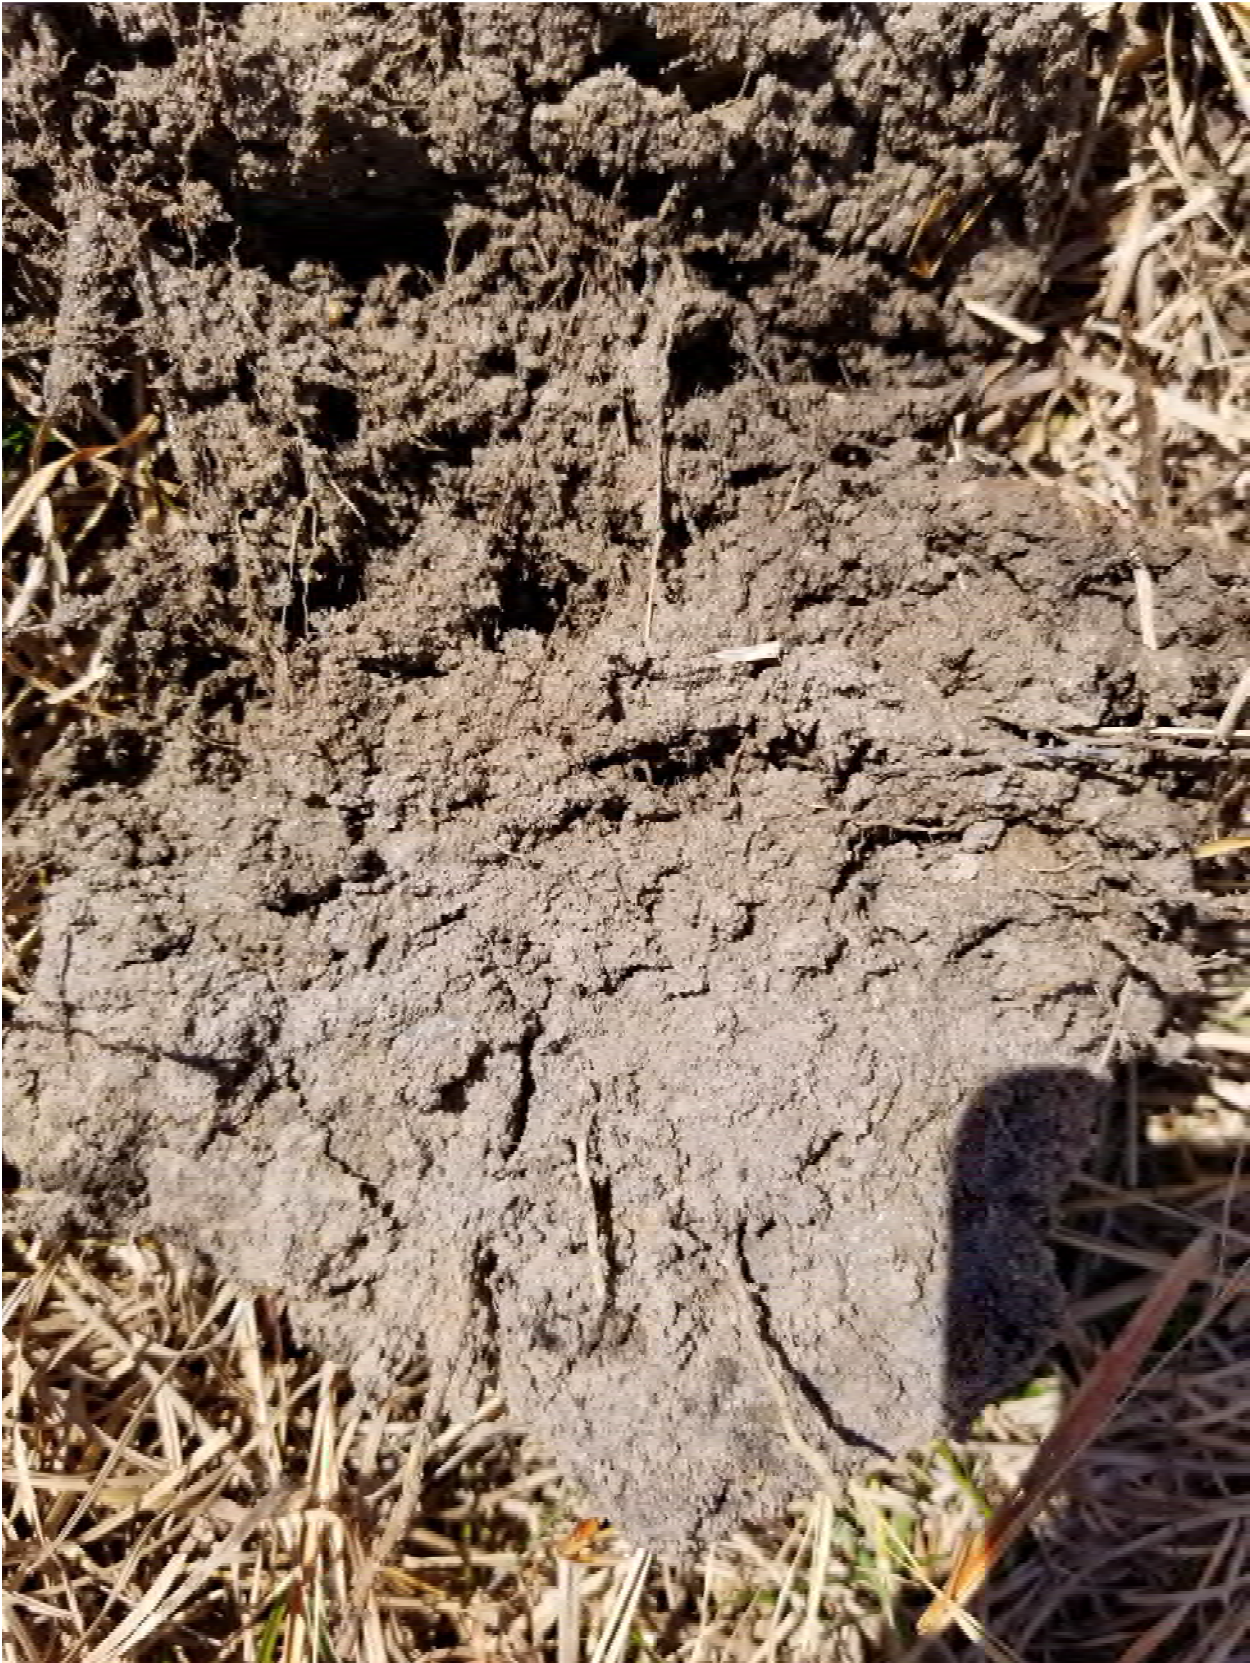
B11 no rhizosphers or Pore linings surface

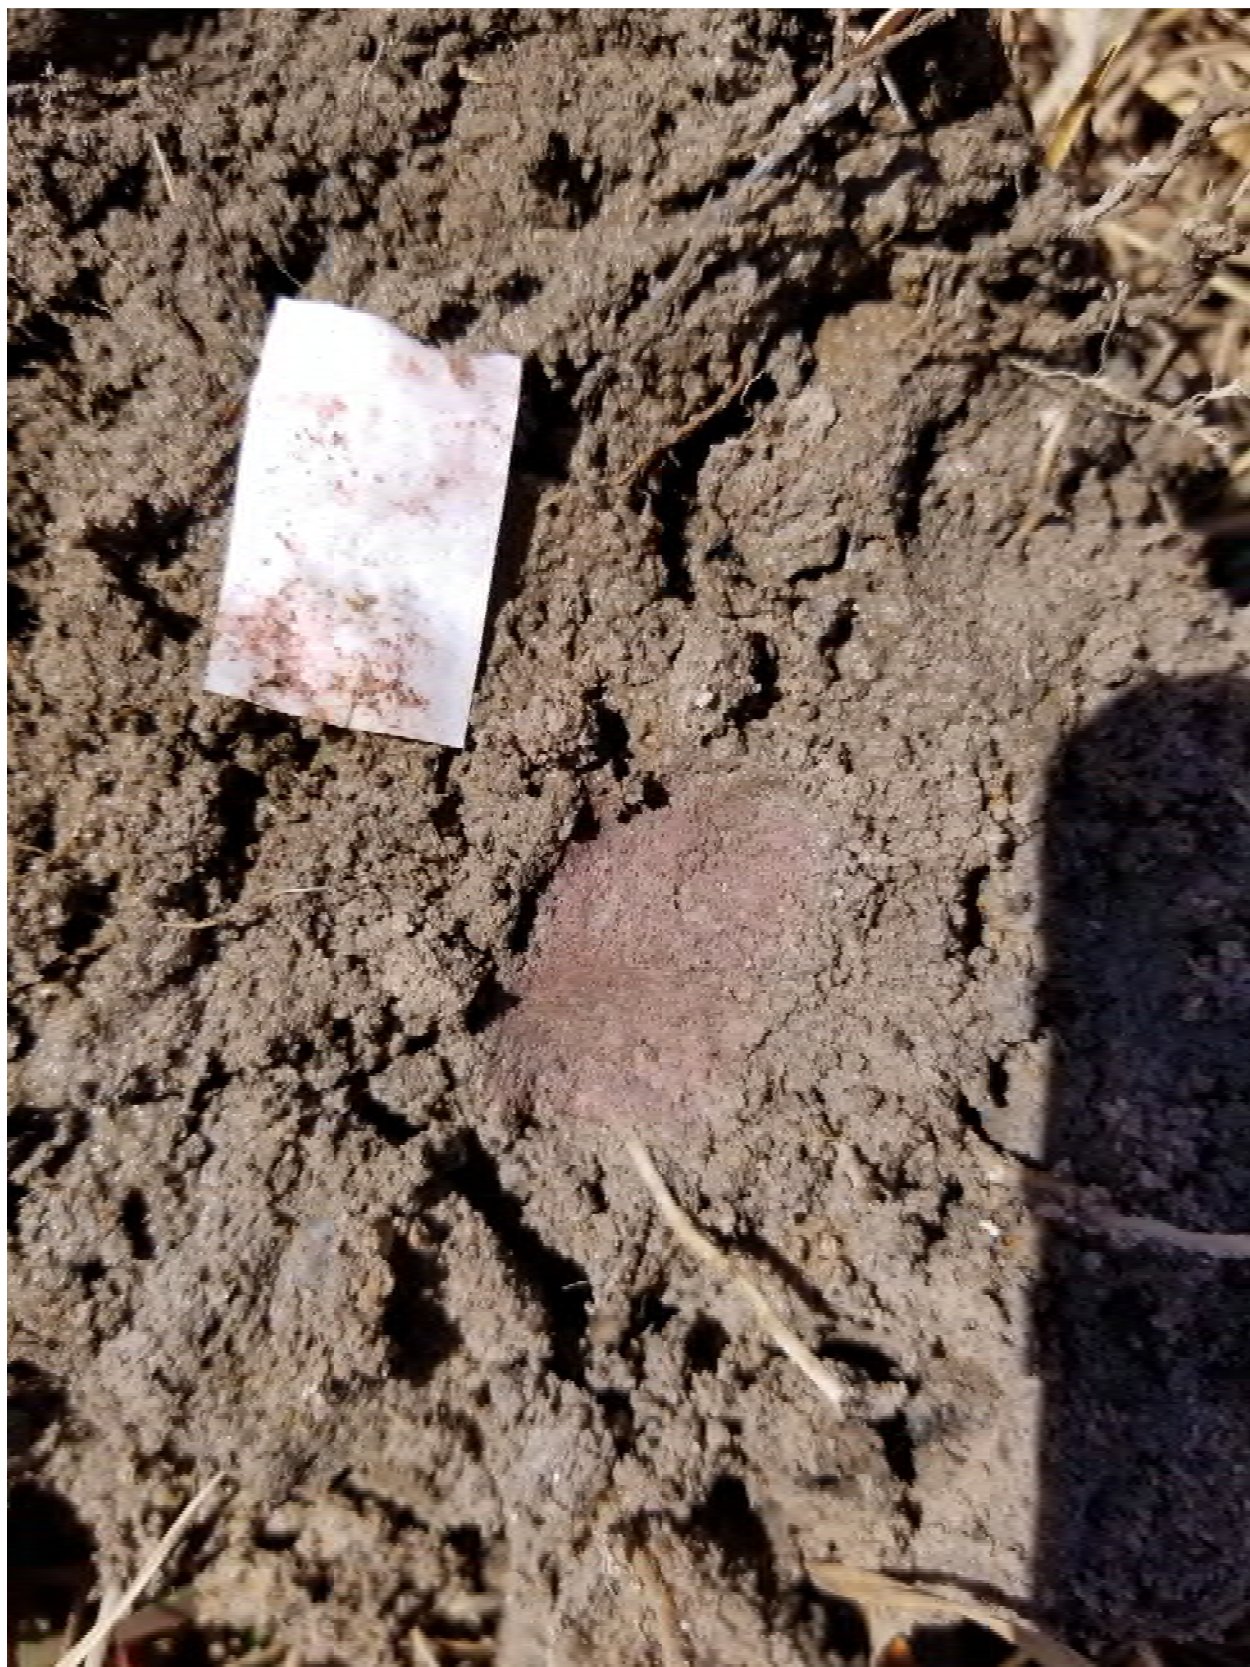
B11 surface Positive  $\alpha, \alpha'$ -dipyridyl
