**Dog Bite Stream Restoration Site
As-Built / Baseline Monitoring Report
Contract # D06056-A**

K C I
ASSOCIATES OF NC

April 2010

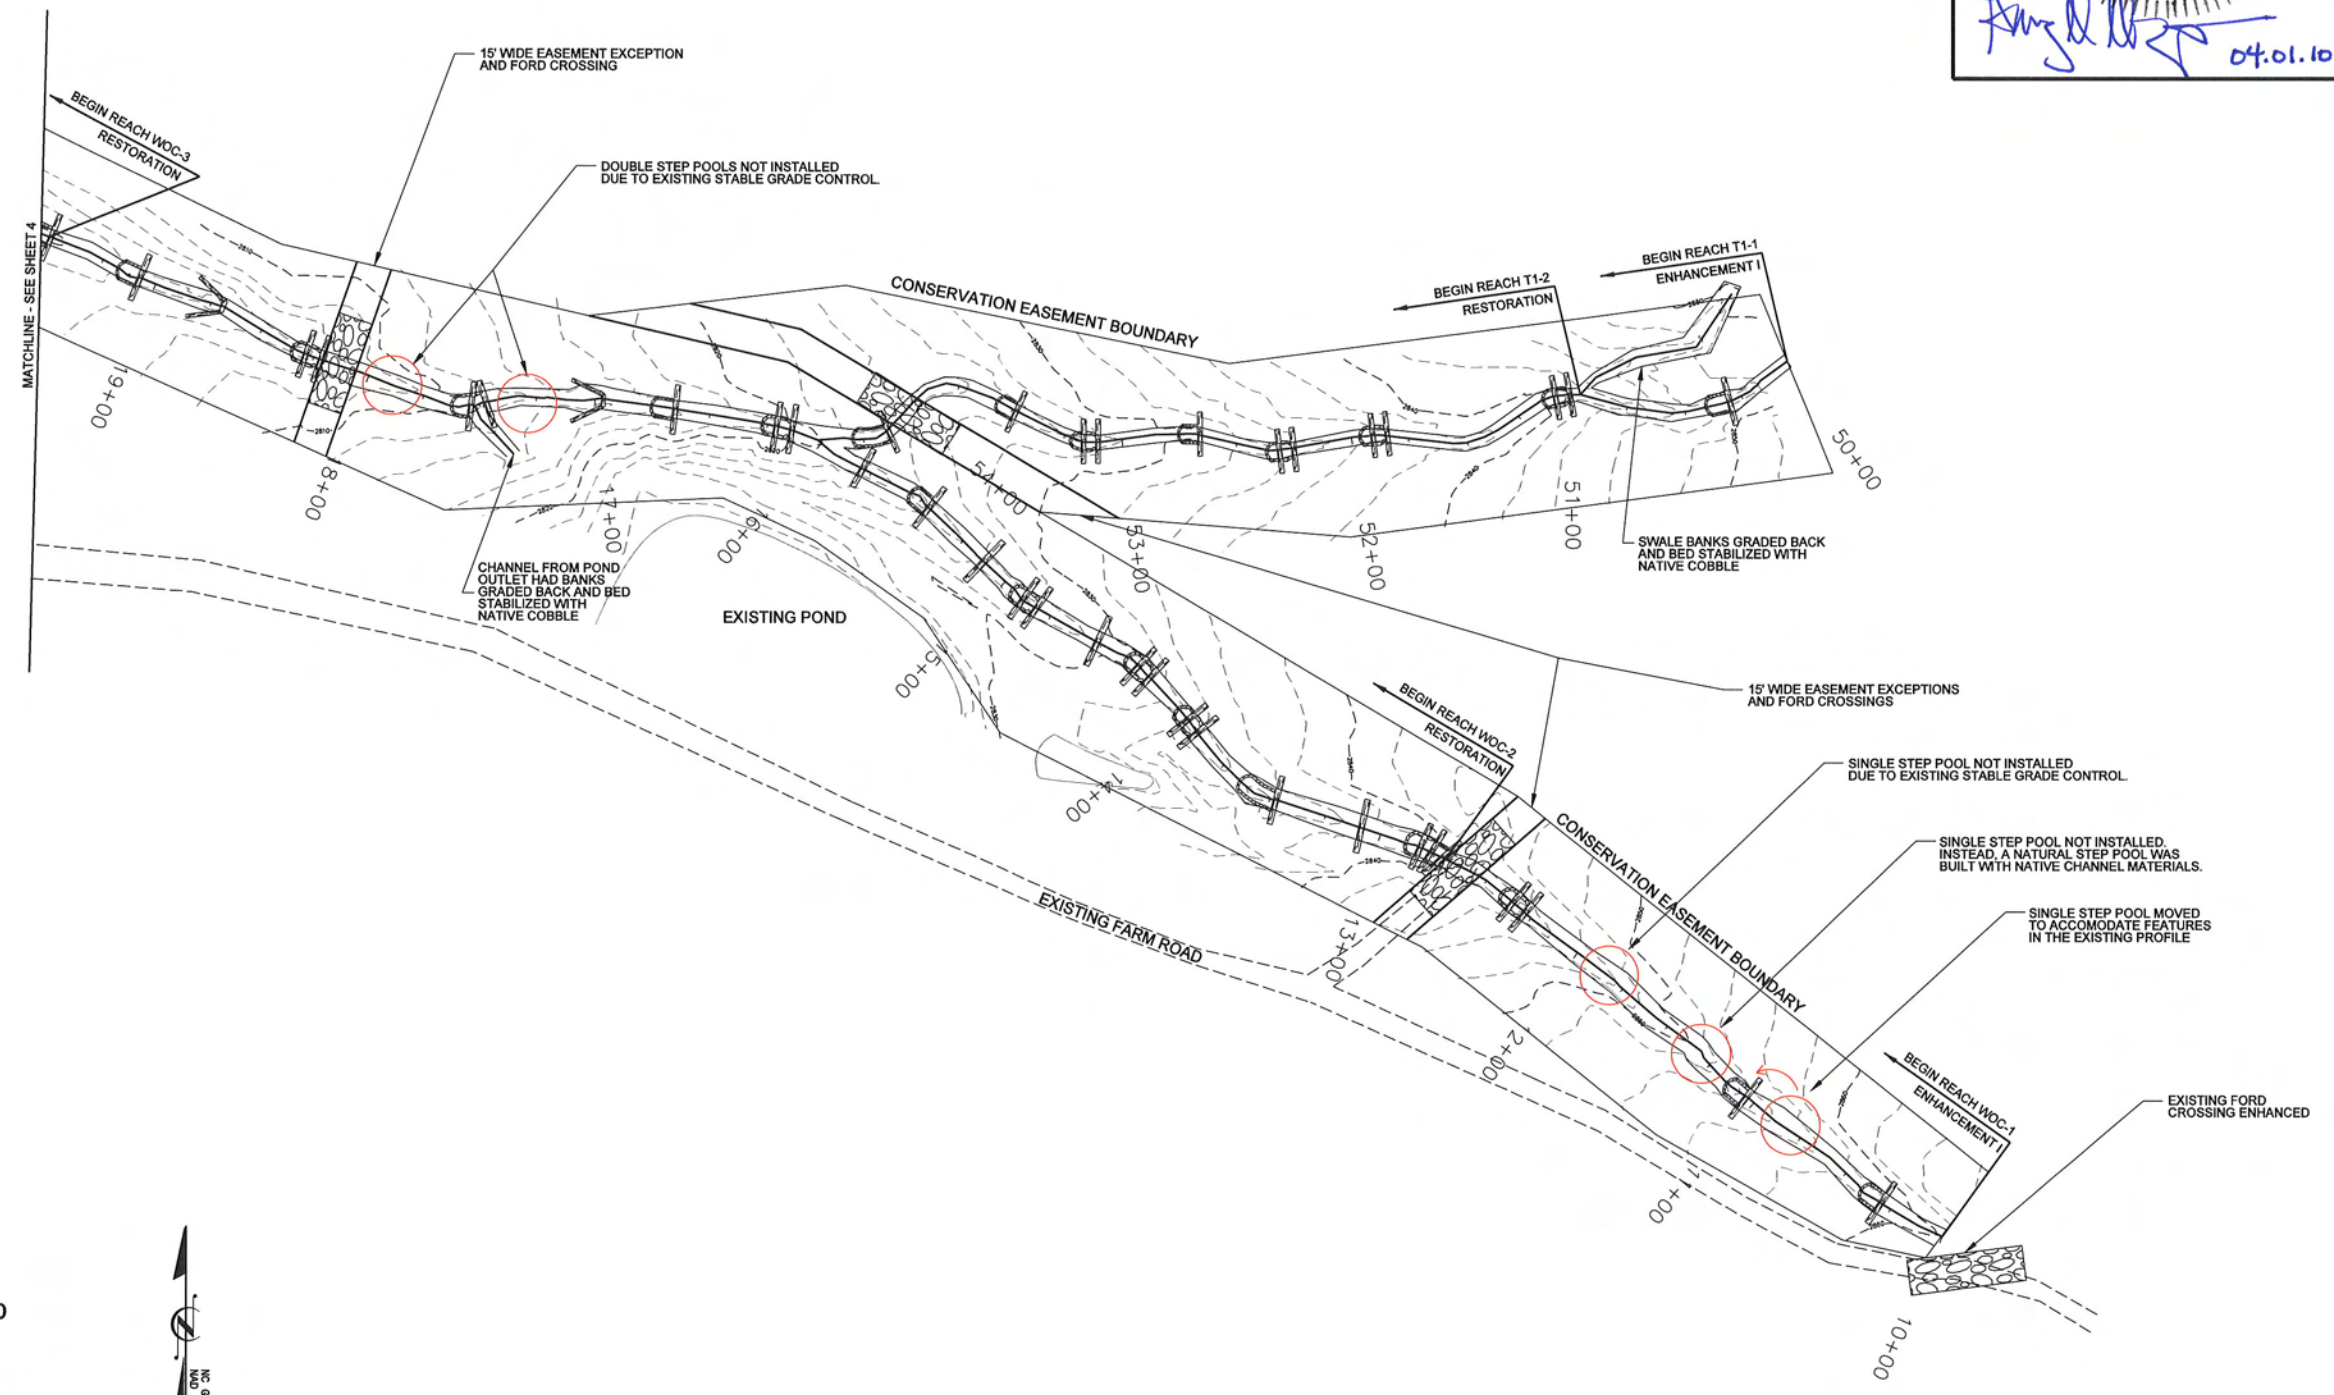
NOTE:
ALL RIFFLES WERE ENHANCED WITH NATIVE COBBLE. DESIGNED RIFFLE GRADE CONTROLS WERE NOT INSTALLED.

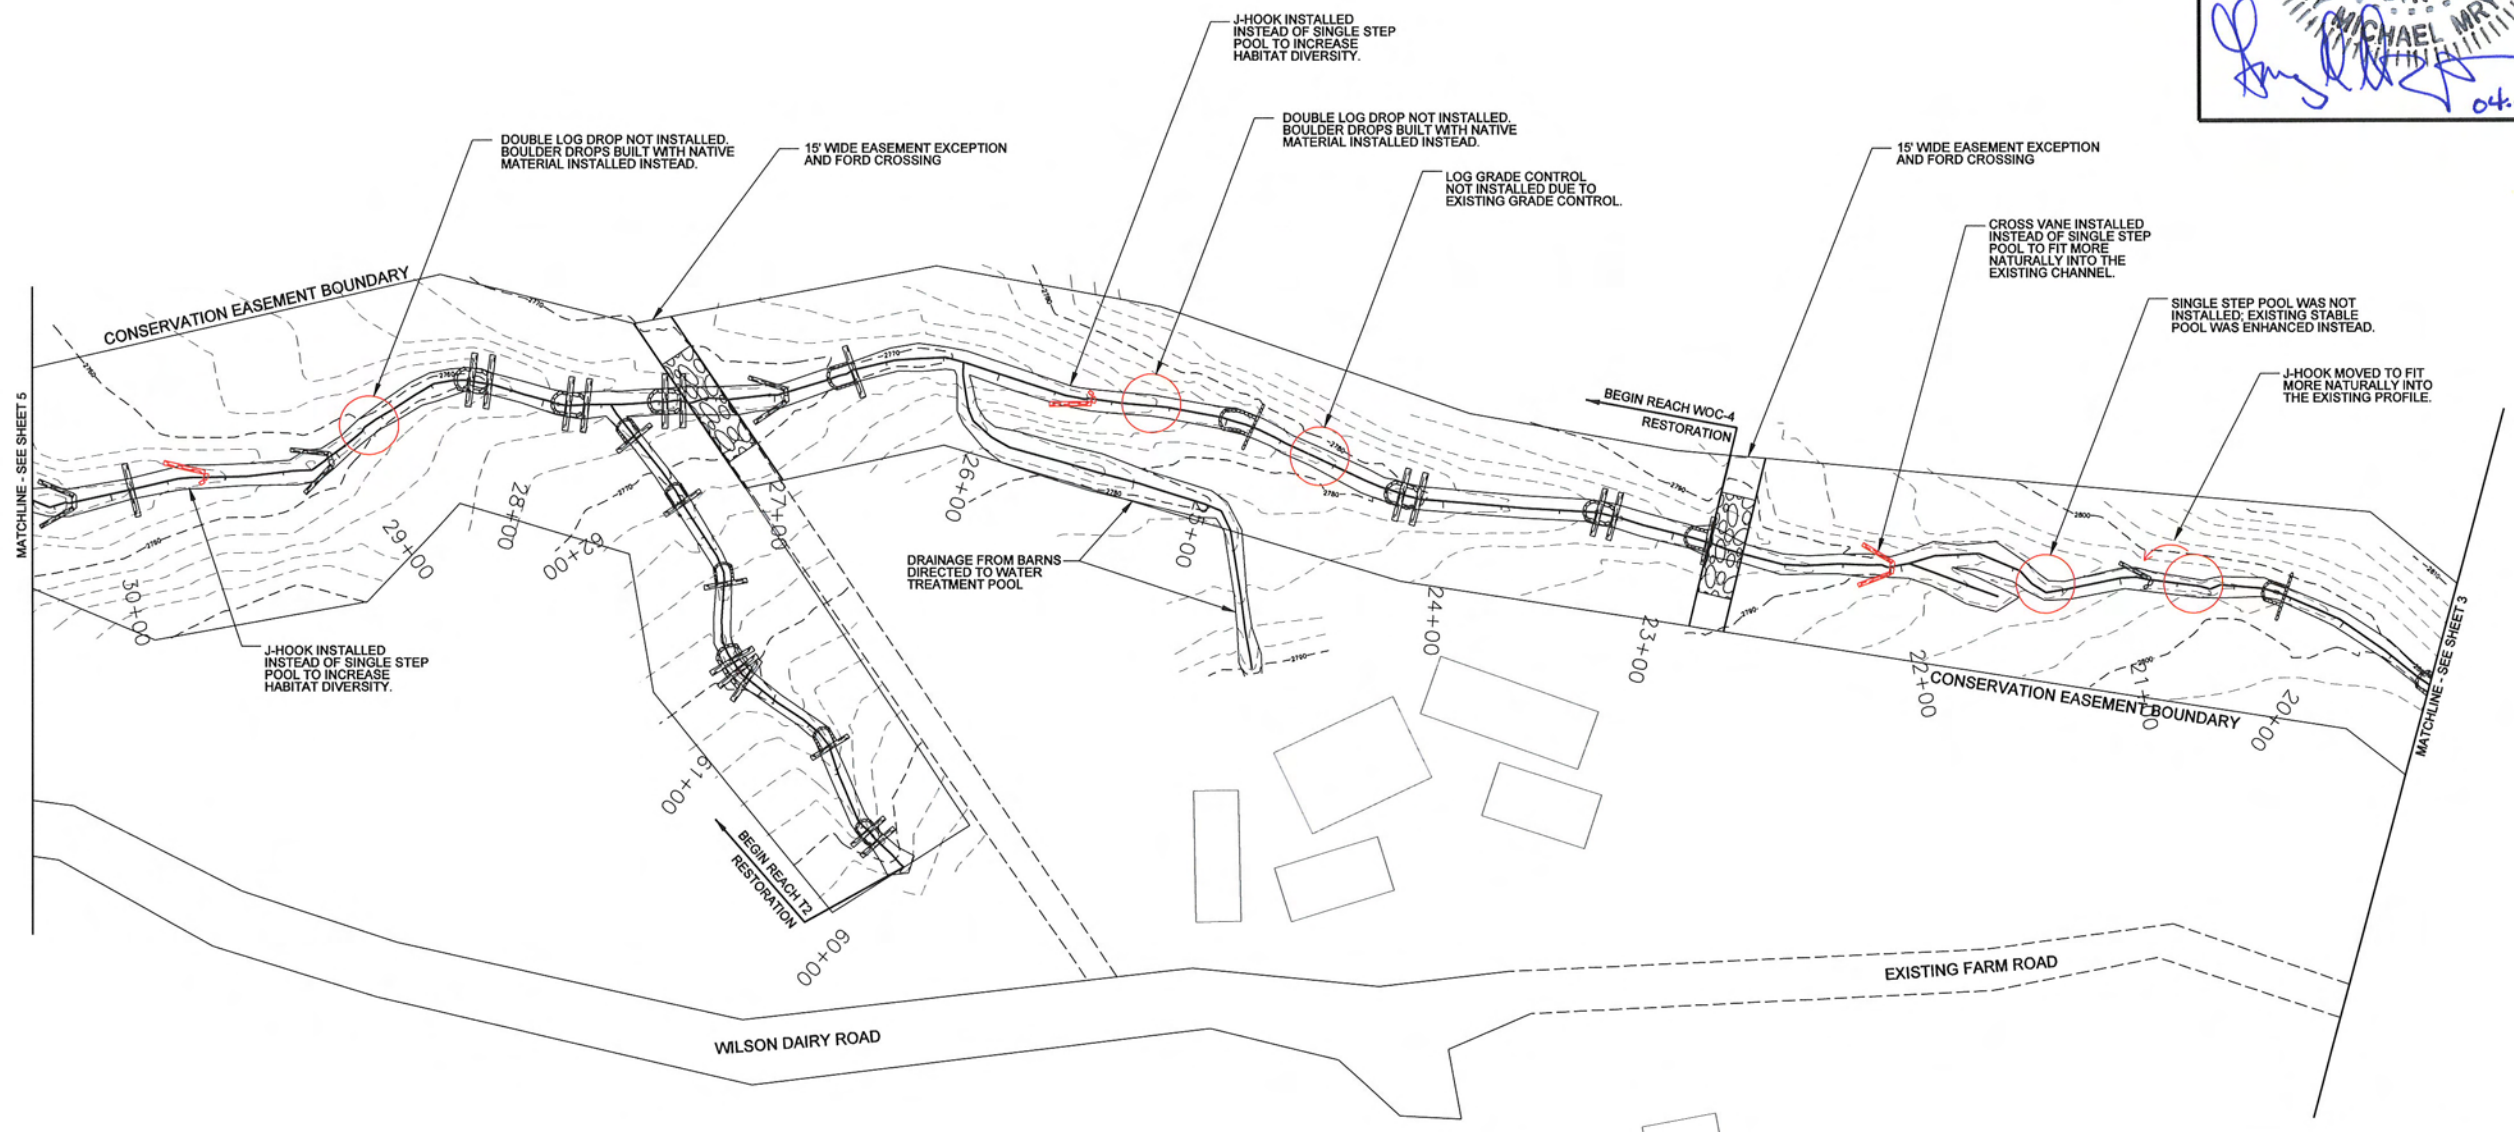
NOTE:
ALL RIFFLES WERE ENHANCED WITH NATIVE COBBLE. DESIGNED RIFFLE GRADE CONTROLS WERE NOT INSTALLED.

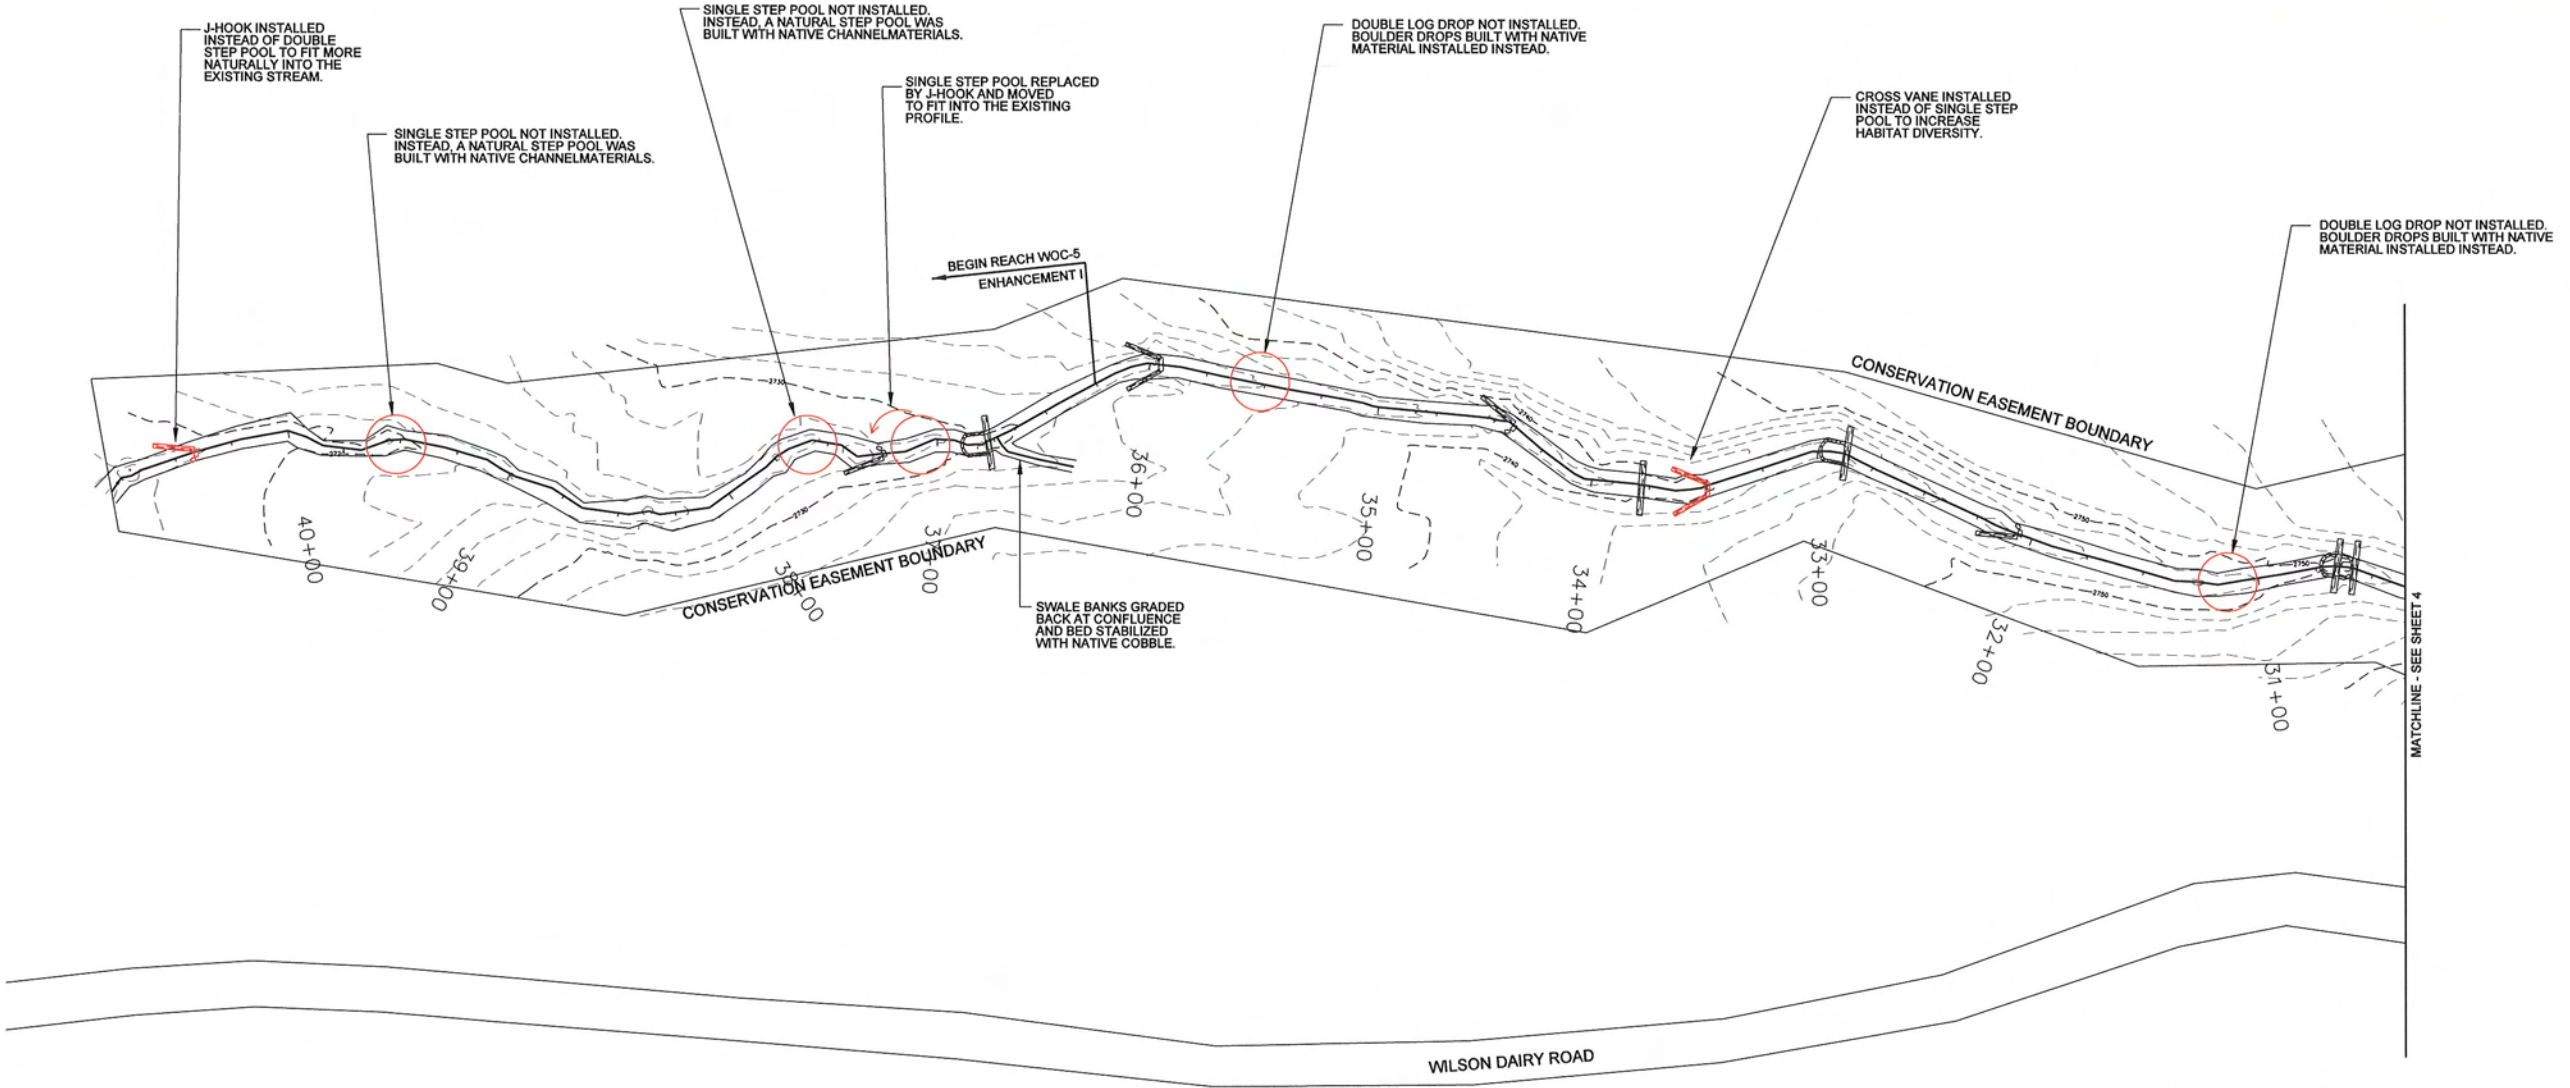
NOTE:
ALL RIFFLES WERE ENHANCED WITH NATIVE COBBLE. DESIGNED RIFFLE GRADE CONTROLS WERE NOT INSTALLED.

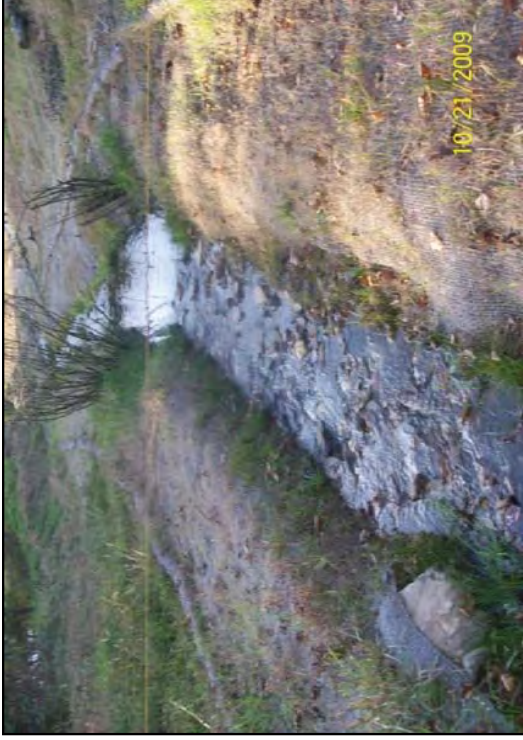
River Basin:	French Broad
Watershed:	Dog Bite
XS ID	XS-1, Riffle, WOC-2
Drainage Area (sq mi):	0.36
Date:	10/21/2009
Field Crew:	A. Spiller, K. Knight-Meng

SUMMARY DATA	
Bankfull Elevation:	2832.1
Bankfull Cross-Sectional Area:	4.8
Bankfull Width:	6.8
Flood Prone Area Elevation:	2833.1
Flood Prone Width:	26
Max Depth at Bankfull:	1.0
Mean Depth at Bankfull:	0.7
W / D Ratio:	9.6
Entrenchment Ratio:	3.8
Bank Height Ratio:	1.0

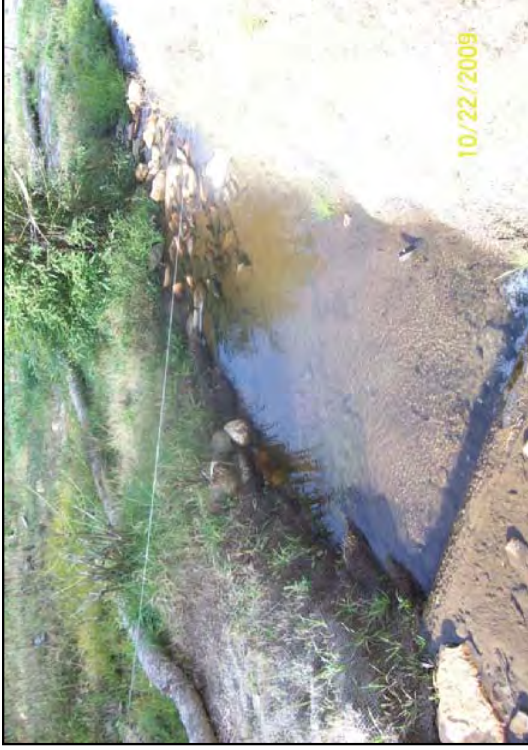
River Basin:	French Broad
Watershed:	Dog Bite
XS ID	XS-2, Pool, WOC-2
Drainage Area (sq mi):	0.36
Date:	10/22/2009
Field Crew:	A. Spiller, K. Knight-Meng

SUMMARY DATA	
Bankfull Elevation:	2810.5
Bankfull Cross-Sectional Area:	12.7
Bankfull Width:	9.1
Flood Prone Area Elevation:	-
Flood Prone Width:	-
Max Depth at Bankfull:	2.3
Mean Depth at Bankfull:	1.4
W / D Ratio:	-
Entrenchment Ratio:	-
Bank Height Ratio:	-

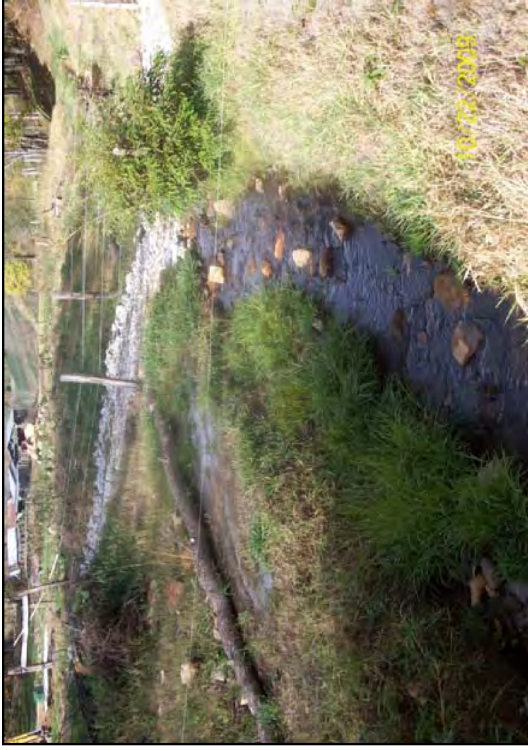
River Basin:	French Broad
Watershed:	Dog Bite
XS ID	XS-3, Riffle, WOC-2
Drainage Area (sq mi):	0.36
Date:	10/22/2009
Field Crew:	A. Spiller, K. Knight-Meng

SUMMARY DATA	
Bankfull Elevation:	2809.1
Bankfull Cross-Sectional Area:	5.5
Bankfull Width:	7.4
Flood Prone Area Elevation:	2810.3
Flood Prone Width:	21
Max Depth at Bankfull:	1.2
Mean Depth at Bankfull:	0.7
W / D Ratio:	10.0
Entrenchment Ratio:	2.8
Bank Height Ratio:	1.0

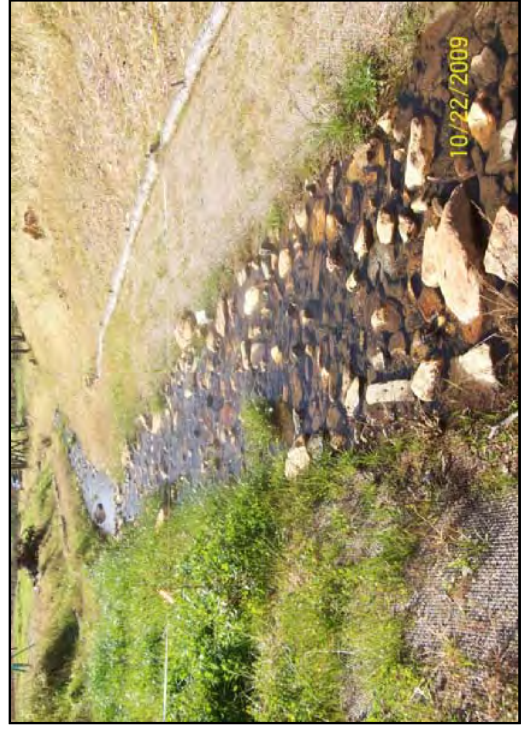
River Basin:	French Broad
Watershed:	Dog Bite
XS ID	XS-4, Riffle, WOC-4
Drainage Area (sq mi):	0.54
Date:	10/22/2009
Field Crew:	A. Spiller, K. Knight-Meng

SUMMARY DATA	
Bankfull Elevation:	2782.9
Bankfull Cross-Sectional Area:	6.2
Bankfull Width:	9.1
Flood Prone Area Elevation:	2784.1
Flood Prone Width:	26
Max Depth at Bankfull:	1.2
Mean Depth at Bankfull:	0.7
W / D Ratio:	13.4
Entrenchment Ratio:	2.8
Bank Height Ratio:	1.0

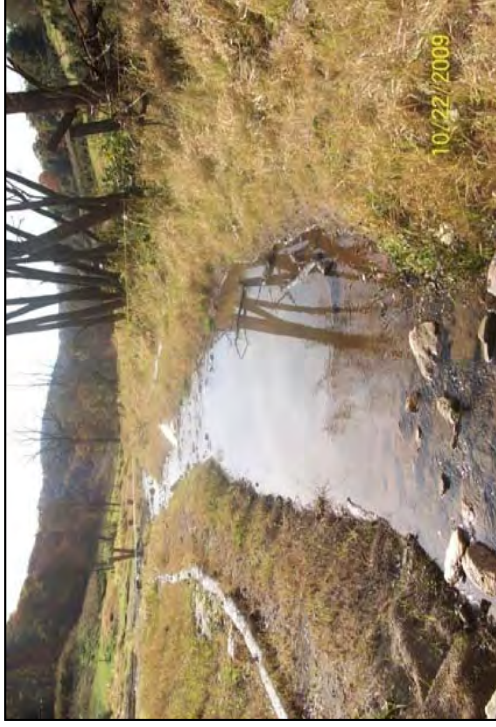
River Basin:	French Broad
Watershed:	Dog Bite
XS ID	XS-5, Pool, WOC-4
Drainage Area (sq mi):	0.54
Date:	10/22/2009
Field Crew:	A. Spiller, K. Knight-Meng

SUMMARY DATA	
Bankfull Elevation:	2771.0
Bankfull Cross-Sectional Area:	16.9
Bankfull Width:	11.6
Flood Prone Area Elevation:	-
Flood Prone Width:	-
Max Depth at Bankfull:	2.6
Mean Depth at Bankfull:	1.5
W / D Ratio:	-
Entrenchment Ratio:	-
Bank Height Ratio:	-

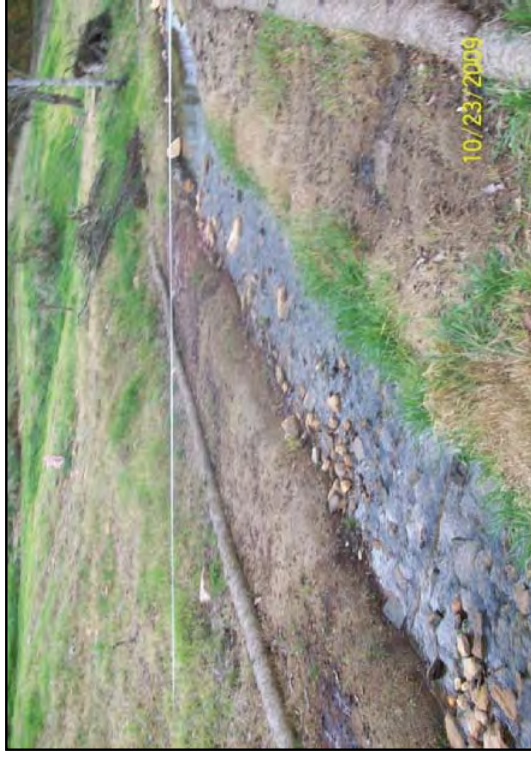
River Basin:	French Broad
Watershed:	Dog Bite
XS ID	XS-6, Riffle, WOC-4
Drainage Area (sq mi):	0.54
Date:	10/23/2009
Field Crew:	A. Spiller, K. Knight-Meng

SUMMARY DATA	
Bankfull Elevation:	2755.2
Bankfull Cross-Sectional Area:	7.6
Bankfull Width:	8.6
Flood Prone Area Elevation:	2756.5
Flood Prone Width:	28
Max Depth at Bankfull:	1.3
Mean Depth at Bankfull:	0.9
W / D Ratio:	9.7
Entrenchment Ratio:	3.3
Bank Height Ratio:	1.0

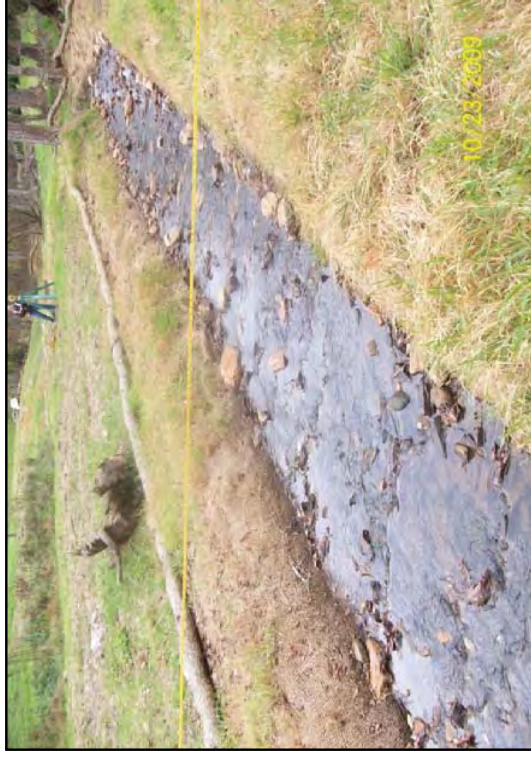
River Basin:	French Broad
Watershed:	Dog Bite
XS ID	XS-7, Riffle, WOC-4
Drainage Area (sq mi):	0.54
Date:	10/23/2009
Field Crew:	A. Spiller, K. Knight-Meng

SUMMARY DATA	
Bankfull Elevation:	2736.1
Bankfull Cross-Sectional Area:	8.1
Bankfull Width:	9.0
Flood Prone Area Elevation:	2737.4
Flood Prone Width:	26
Max Depth at Bankfull:	1.3
Mean Depth at Bankfull:	0.9
W / D Ratio:	10.0
Entrenchment Ratio:	2.9
Bank Height Ratio:	1.0

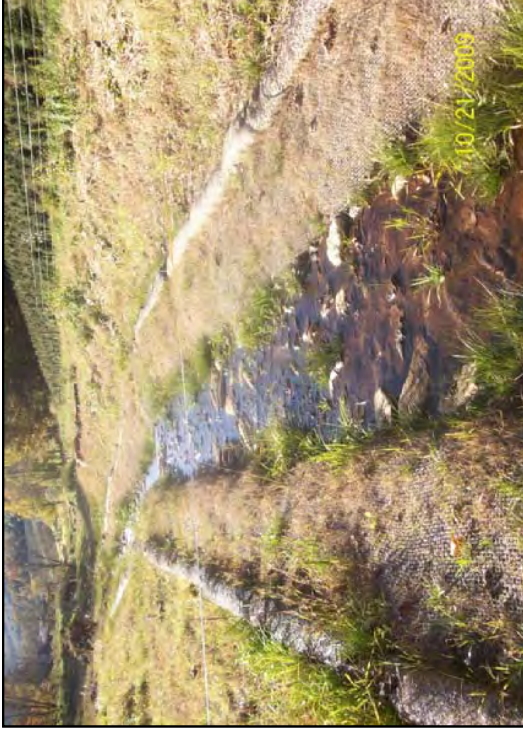
River Basin:	French Broad
Watershed:	Dog Bite
XS ID	XS-8, Riffle, T1-2
Drainage Area (sq mi):	0.08
Date:	10/21/2009
Field Crew:	A. Spiller, K. Knight-Meng

SUMMARY DATA	
Bankfull Elevation:	2838.0
Bankfull Cross-Sectional Area:	3.0
Bankfull Width:	5.5
Flood Prone Area Elevation:	2838.8
Flood Prone Width:	21
Max Depth at Bankfull:	0.7
Mean Depth at Bankfull:	0.5
W / D Ratio:	10.1
Entrenchment Ratio:	3.8
Bank Height Ratio:	1.0

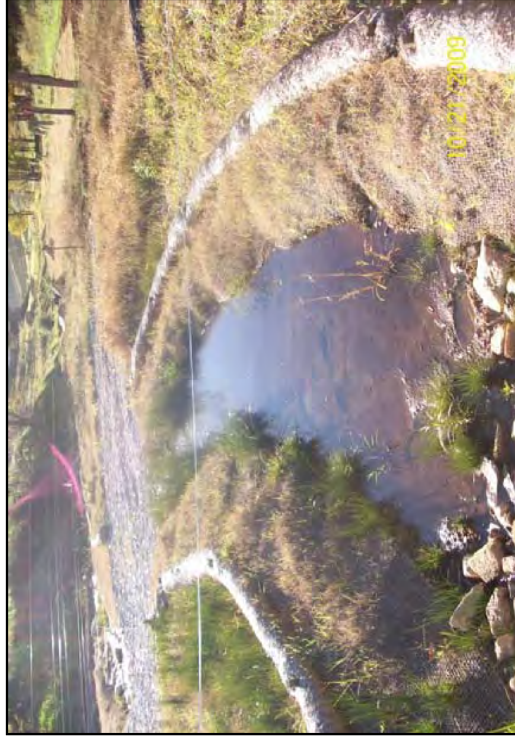
River Basin:	French Broad
Watershed:	Dog Bite
XS ID	XS-9, Pool, T1-2
Drainage Area (sq mi):	0.08
Date:	5/8/2009
Field Crew:	A. Spiller, K. Knight-Meng

SUMMARY DATA	
Bankfull Elevation:	2824.4
Bankfull Cross-Sectional Area:	6.8
Bankfull Width:	6.9
Flood Prone Area Elevation:	-
Flood Prone Width:	-
Max Depth at Bankfull:	1.6
Mean Depth at Bankfull:	1.0
W / D Ratio:	-
Entrenchment Ratio:	-
Bank Height Ratio:	-
