**Dog Bite Stream Restoration Site
Monitoring Report – MY04
Mitchell County, NC
Basin 06010108
EEP Project ID # 92533
Contract # D06056-A**

January 2014

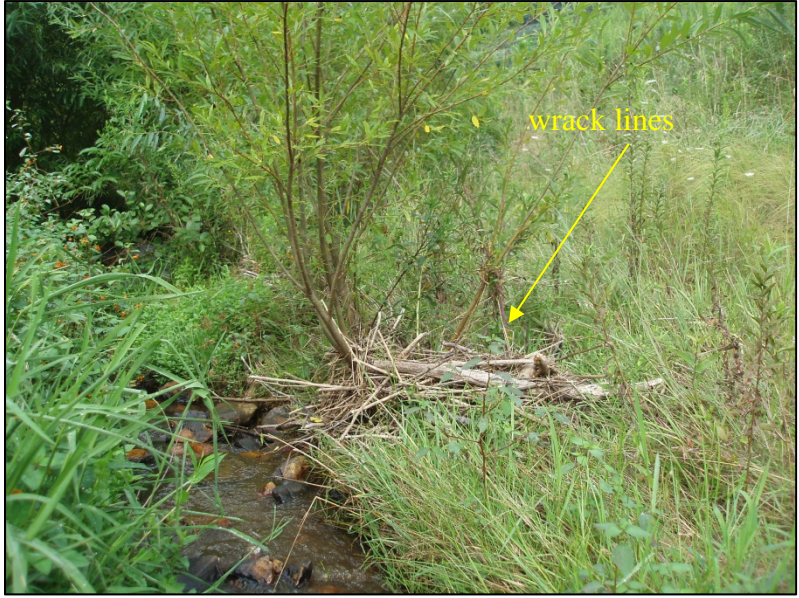
Photo #1 – Bankfull Evidence (wrack lines), 8/9/2012

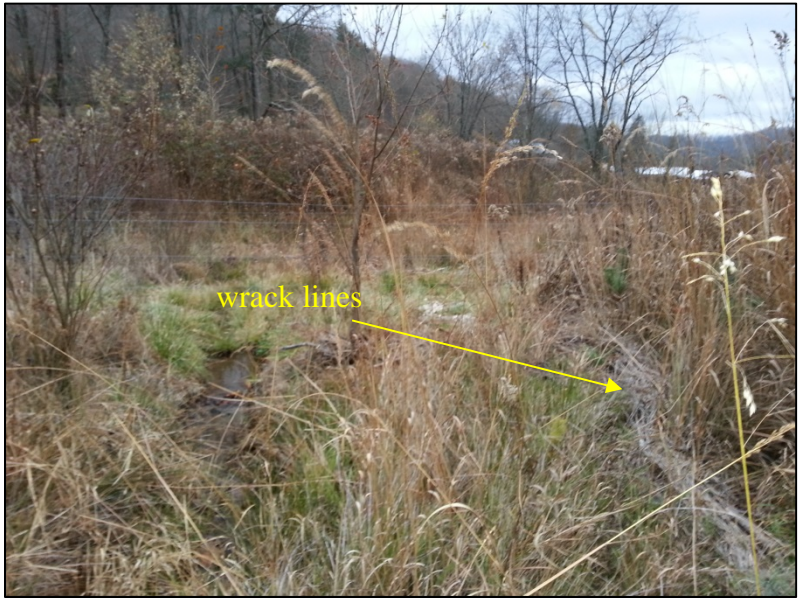
Photo #2 – Bankfull Evidence on (wrack lines), 11/11/2013

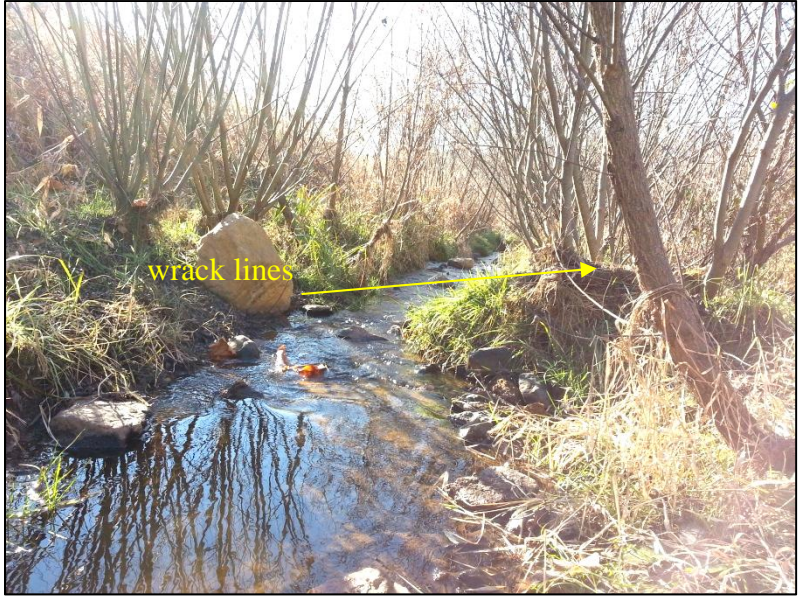
Photo #3 – Bankfull Evidence on (wreck lines), 11/11/2013
