MONITORING YEAR 1 ANNUAL REPORT

January 2023

DOUBLE H FARMS MITIGATION SITE

Alleghany County, NC
DEQ Contract No. 7608
DMS Project No. 100082

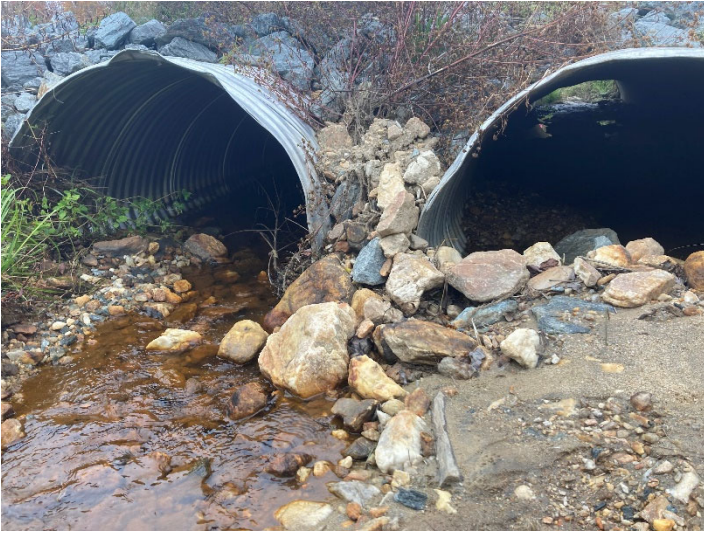
UT to Crab Creek R1 Crossing 2 (114+54) – Culvert Baseflow Adjustment for Aquatic Organism Passage (AOP) (10/12/2022)

6. Kim asked for a linear transect in the areas where a 30-foot buffer was planted adjacent to potential bog turtle habitat wetlands.
7. Andrea noted that the double barrel culvert is problematic for AOP because both culverts are set at the same elevation and noted that it needs adjustment. Christine asked if one culvert could be partially blocked to push all baseflow through one culvert, and Andrea said that was acceptable. Upstream single barrel culvert crossing noted as acceptable for AOP.
8. Andrea also noted one piping log sill upstream of the culvert crossing and a j-hook vane with a large drop that were barriers to aquatic passage. Wildlands will repair the piping log sill and notch the log to define a low point, and will build up the riffle head downstream of the j-hook vane and add an additional splash rock on the j-hook to minimize the drop.

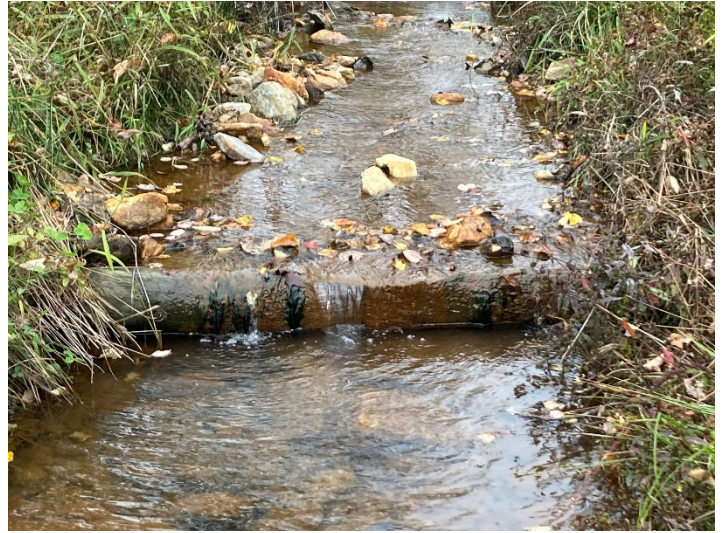
UT to Crab Creek R1 (113+46) – Piping Log Sill Repair (10/12/2022)

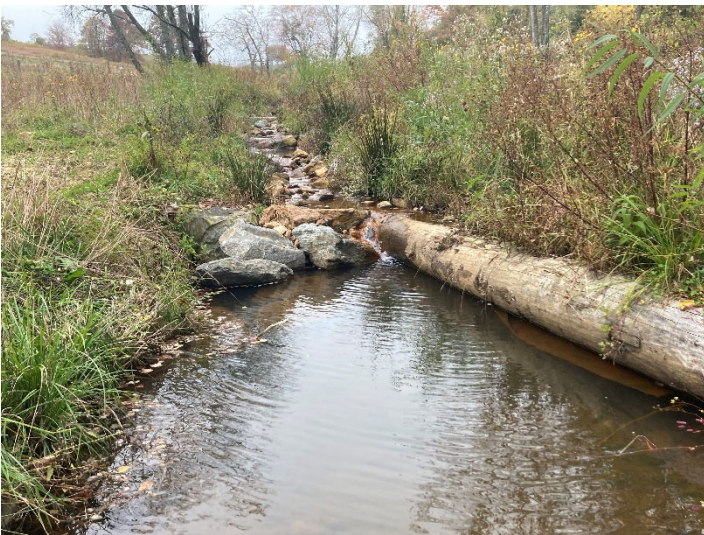
UT to Crab Creek R1 J-Hook (112+09) – Splash Rock Installation for AOP (10/12/2022)

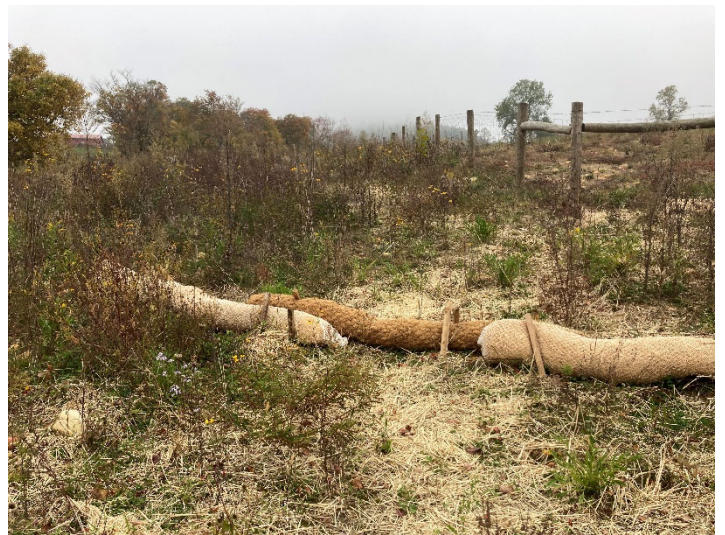
DMS' comment: There is a source of overland sediment coming from outside the easement at the corner of UT4 and UT to Crab Creek. Wildlands has installed coir logs; thank you for implementing that measure. Has WEI discussed this area with the landowner or considered a BMP or other longer-term improvement/stabilization measure in order to stop the sedimentation at its source?

UT to Crab Creek R2/ UT4 Confluence– Coir Log Install to Mitigate Overland Sediment Influx from Area Outside of the Conservation Easement (10/12/2022)

4. Both lower and upper UT4 culvert crossings were noted as acceptable for AOP.
5. There is a source of overland sediment coming from outside the easement at the corner of UT4 and UT to Crab Creek. Erin asked for treatment of this area. Wildlands will install a coir log check and reseed the area.

Wildlands' Response: The overland sediment is likely occurring due to the steep slope of the adjacent hillside. Wildlands will continue to monitor the repair and amount of sediment deposition occurring in the area and if needed will propose additional measures in MY2.

All action items discussed in the 8/17/22 MY0 Credit Release Site Walk meeting minutes located in the Appendix F have been addressed. A coir log check was added at the corner of UT4 and the UT to Crab Creek confluence. A partial baffle was added to right culvert inlet on the UT to Crab Creek Crossing 2 located at station 114+46 to direct baseflow to one culvert. The piping log sill on UT to Crab Creek R1 station 113+46 was notched to allow flow over the structure. The drop across the J-hook on UT to Crab Creek station 112+09 was repaired by adding splash rock and building up the downstream head of riffle to decrease the grade change over the structure. Treatment of multiflora rose (*Rosa multiflora*) took place in October 2022 within the existing forested areas of the easement along UT1A and UT6. Areas will continue to be monitored and treated as necessary in the remaining monitoring years. Documentation of the repairs listed above are located in the repair photographs in Appendix A. A separate planting map and vegetation transects have been added to the MY1 report as discussed in Section 2.1.

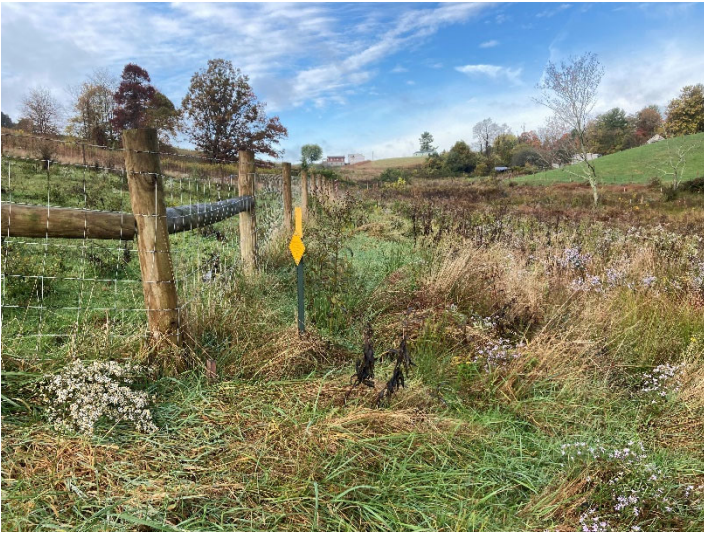
UT to Crab Creek R1 (Station 104+75 – 106+25) – Fence Relocated Outside of Conservation Easement (10/12/2022)

- Sta. 100+09 – 100+60: Fence line that was inadvertently installed from the easement corner in right floodplain to easement boundary along stream centerline was removed. Cattle do not have access on the adjacent parcels; therefore, the removal of the fence is not of concern.
- Sta. 104+50 – 106+11: A fence encroachment in right floodplain due to a missing post was moved outside of the easement boundary.

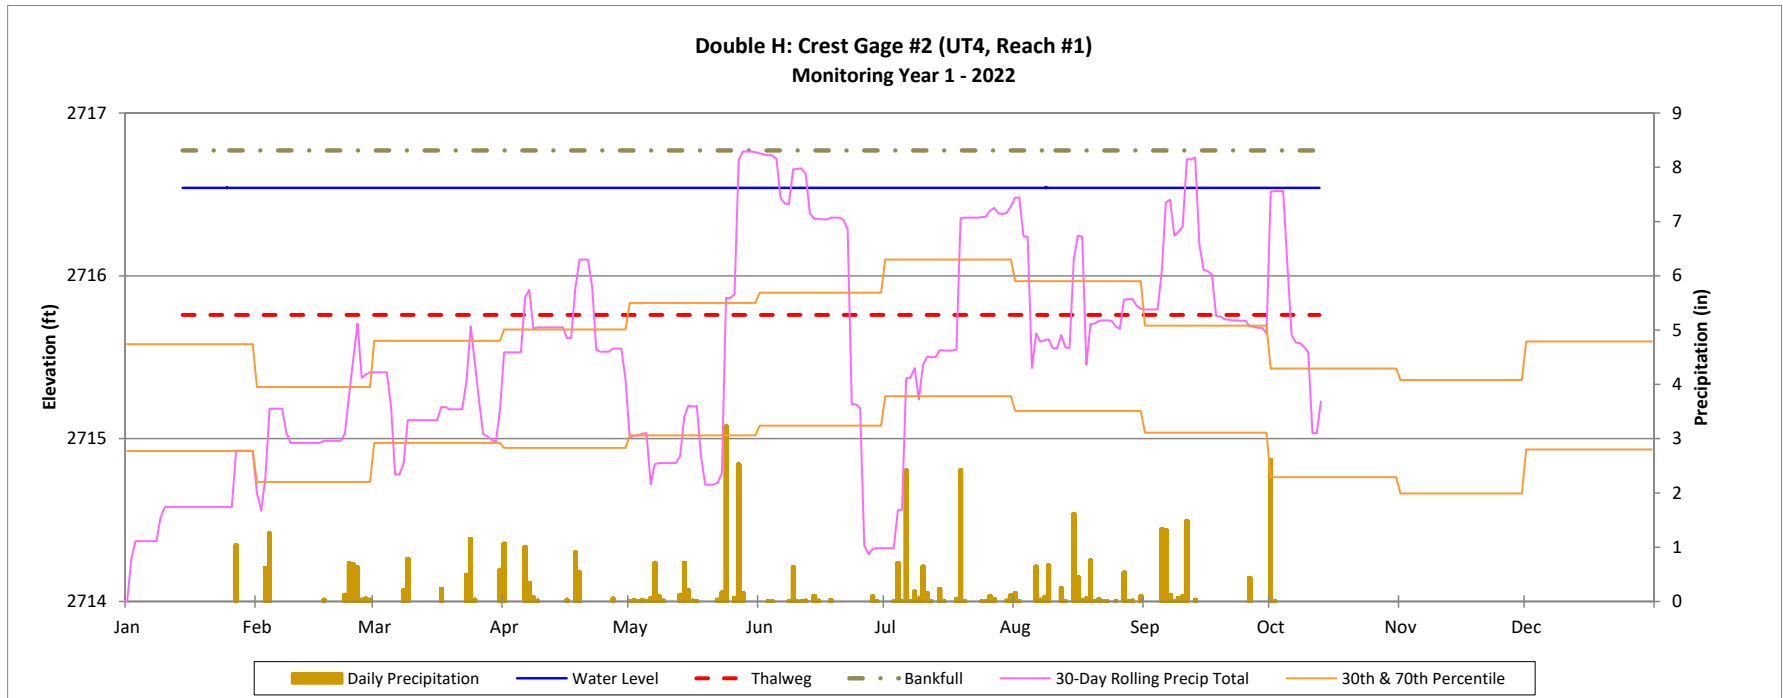
CG2 is located on a B-channel and was relocated on 10/12/22 in order to capture in-stream flow per the 8/17/2022 IRT meeting minutes. Plot data is included in MY1 report, but not being evaluated for bankfull criteria. The updated elevations will be reported in MY2.

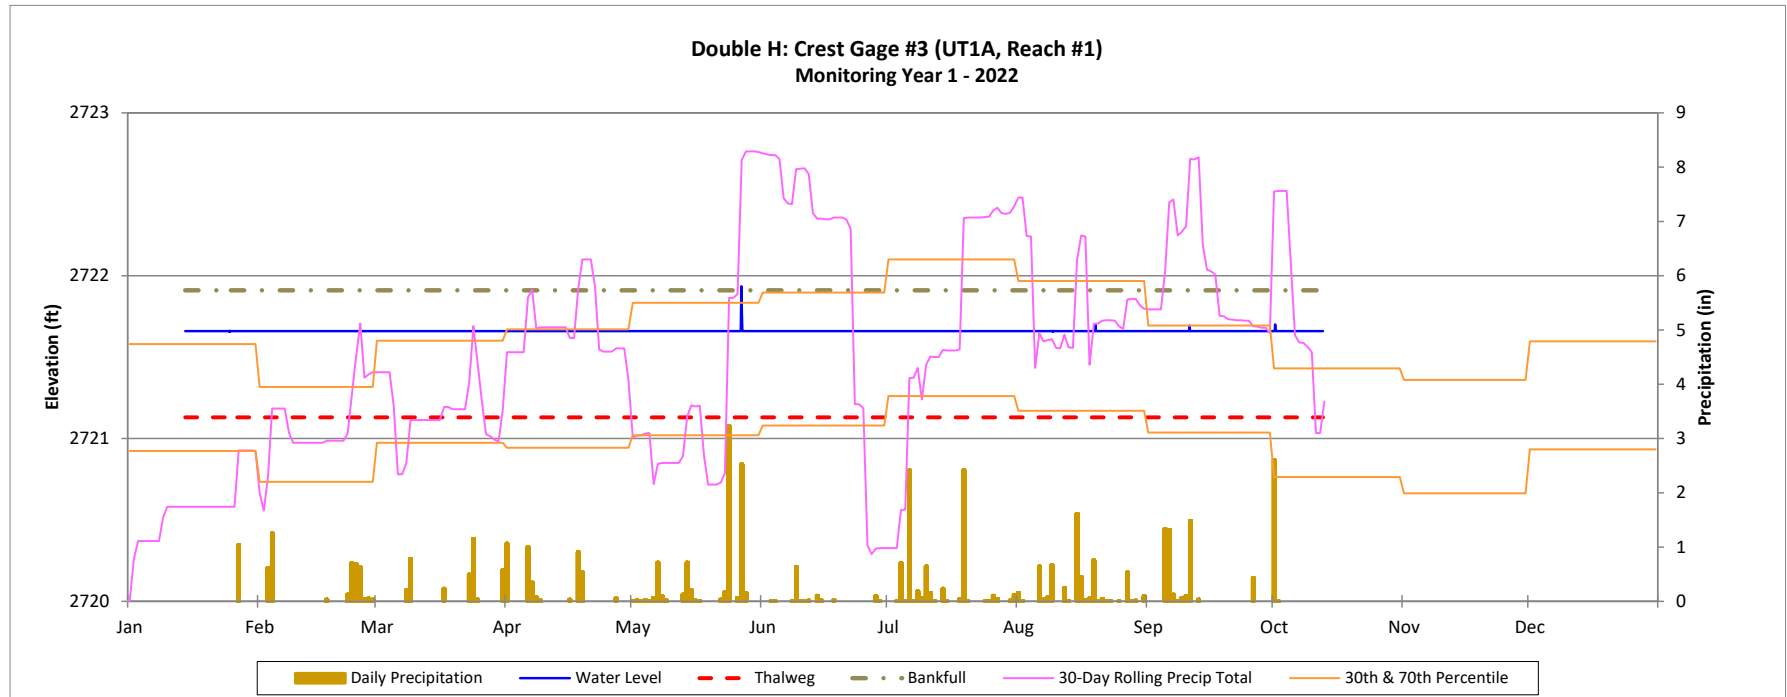
CG3 is located on a B-channel and was relocated on 10/12/22 in order to capture in-stream flow per the 8/17/2022 IRT meeting minutes. Plot data is included in MY1 report, but not being evaluated for bankfull criteria. The updated elevations will be reported in MY2.
