MONITORING YEAR 2 ANNUAL REPORT FINAL

DOUBLE H FARMS MITIGATION SITE

Alleghany County, NC
DEQ Contract No. 7608
DMS Project No. 100082

DOUBLE H FARMS MITIGATION SITE
Monitoring Year 2 Annual Report

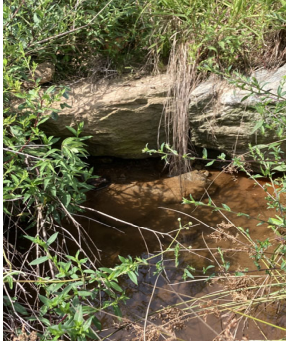
Reach/Location	Station	Problem	Repair	Pre-repair MY2 photo (s) taken 9/2023
UT to CC R1	101+91	Piping under and around rock sills into bank double drop structure.	Proposed repair is to re-build rock sills and decrease drop.

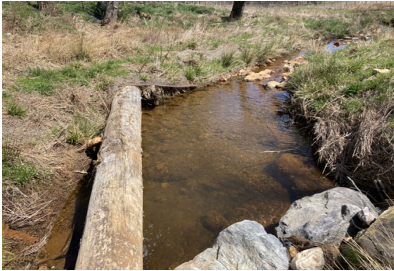
112+10	Downstream head of riffle raised in MY1 per IRT request to reduce drop over structure. Channel has adjusted by widening under log sill but has remained stable.	Stabilize bank behind logsill and repair structure.

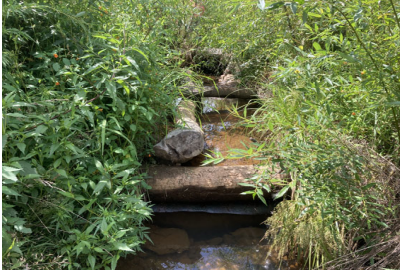
UT to CC R2	117+47	Piping around log sill and incision in riffle.	Re-build riffle and replace structure.

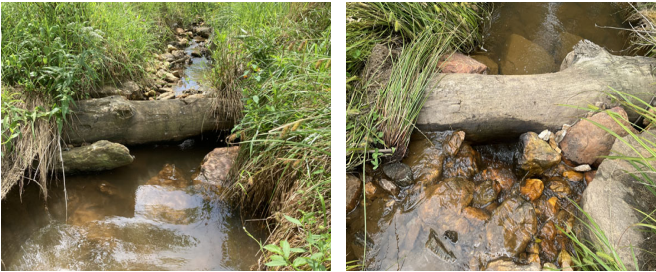
Reach/Location	Station	Problem	Repair	Pre-repair MY2 photo (s) taken 9/2023
UT to CC R2	118+67	Riffle piping under bottom log sill and actively inciisng.	Re-build riffle and replace structure.

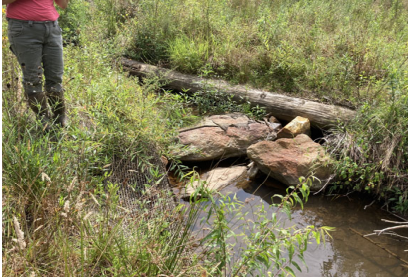
129+51	Riffle piping under bottom log J-hook sill.	Re-build j-hook, lay bank back, reduce drop, repair bank and re-build riffle.

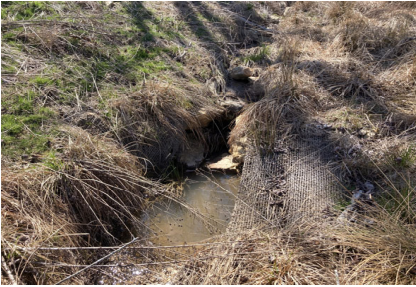
UT1A	154+10, approximatley 2-3 structures from 160+00 to 161+00	Piping around log sill and incision in riffle.	Re-build riffle and replace structure. Reduce drop over steps.

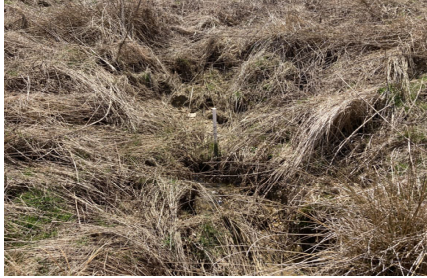
Wetland V	N/A	Heacut above stabilized wetland outlet to main channel.	Add a grade control structure.

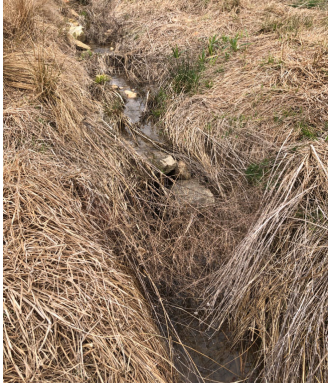
Reach/Location	Station	Problem	Repair	Pre-repair MY2 photo (s) taken 4/2023
UT4 R1	403+70	piping sill	reduce drop over structure, lay back bank, re-build riffle

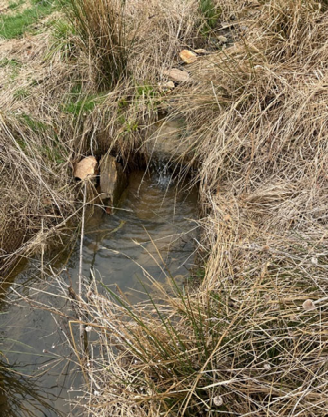
408+80	Too much drop over riffle and incision below.	reduce drop over structure, lay back bank, re-build downstream head of riffle

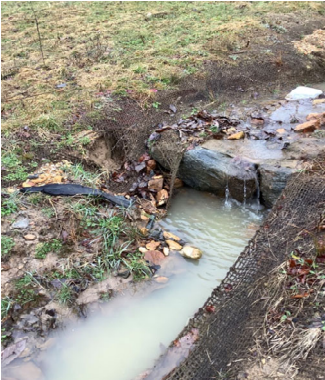
Reach/Location	Station	Problem	Repair	Pre-repair MY2 photo (s) taken 4/2023
UT4 R1	408+90	right bank collapsing around rock sill.	re-build bank

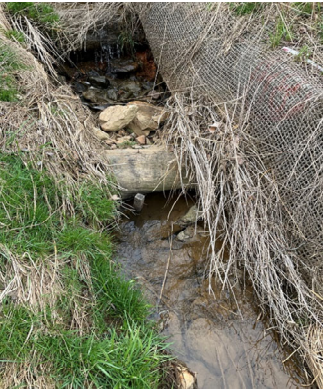
409+80	piping sill	reduce drop over structure, lay back bank, re-build riffle

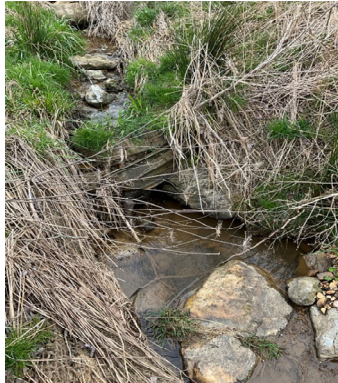
Reach/Location	Station	Problem	Repair	Pre-repair MY2 photo (s) taken 4/2023
UT4 R2	410+00	piping sill	reduce drop over structure, lay back bank, re-build riffle
