# MONITORING YEAR 2 ANNUAL REPORT

## DRY CREEK MITIGATION SITE

Durham County, NC

DMS Project No. 97082

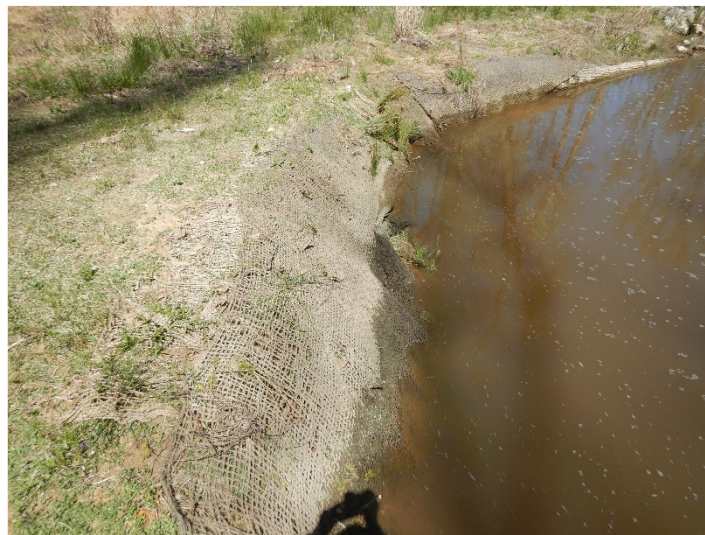
Localized bank erosion on the outside bend of a pool directly downstream of the culvert crossing along Dry Creek Reach 4, was identified during MY1. This area was repaired in March 2021. The stream bank repair included reshaping the stream bank and installing sod mats and live stakes. After more than six months and several storm events, the repair is stable, and vegetation is establishing. See before and after photos of the area in Appendix 2. This area will continue to be monitored to determine the success of the repair work.

**Before – Localized Erosion (11/4/2020)**

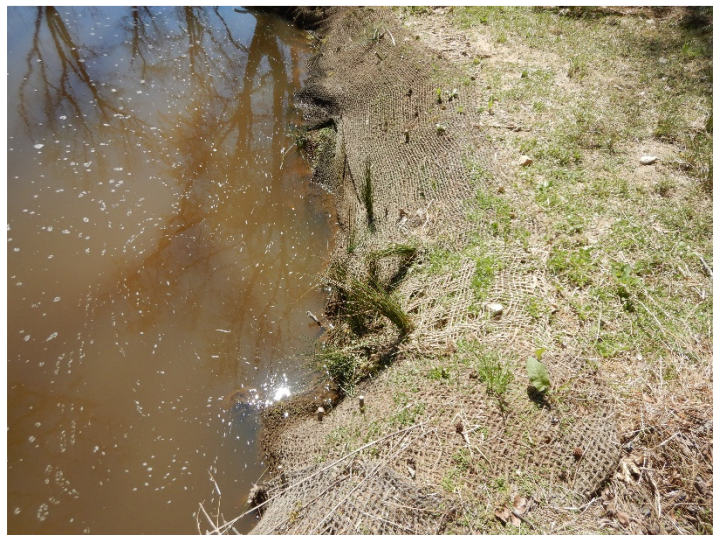
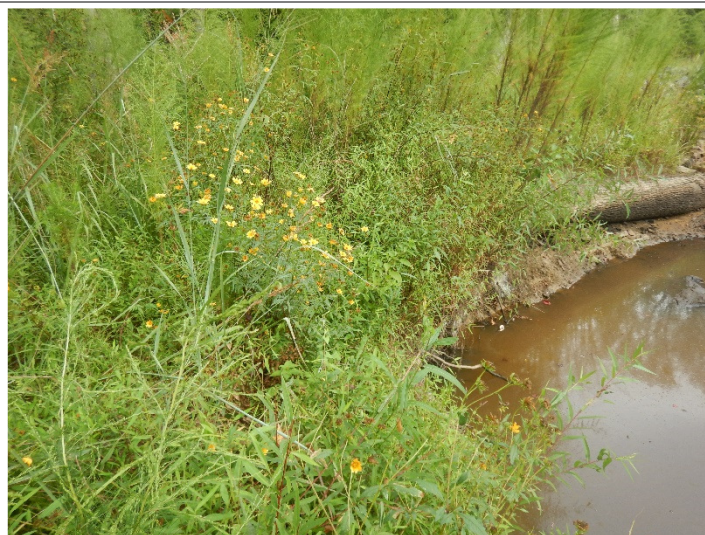
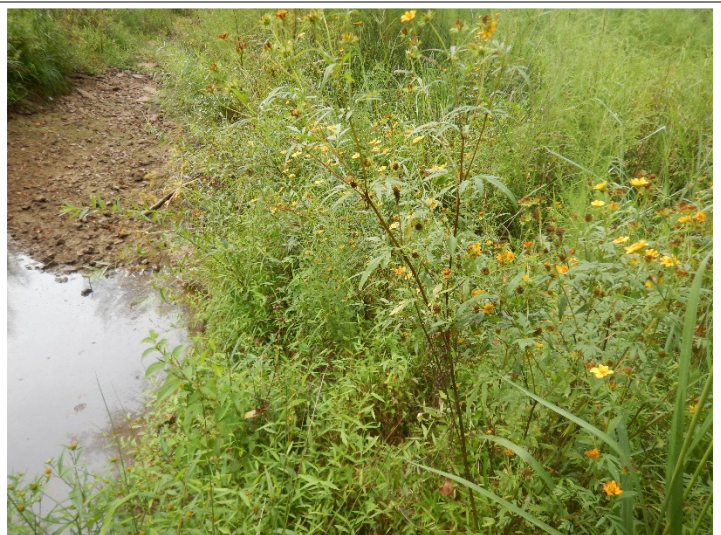
**After – Repaired Localized Erosion (04/2/2021)**

**After – Repaired Localized Erosion (09/16/2021)**
