**MONITORING YEAR 3
ANNUAL REPORT
Final**

DRY CREEK MITIGATION SITE

Durham County, NC
Neuse River Basin
HUC 03020201010050

DMS Project No. 97082
NCDEQ Contract No. 6827
USACE Action ID No. SAW-2016-00880
DWR Project No. 2016-0369

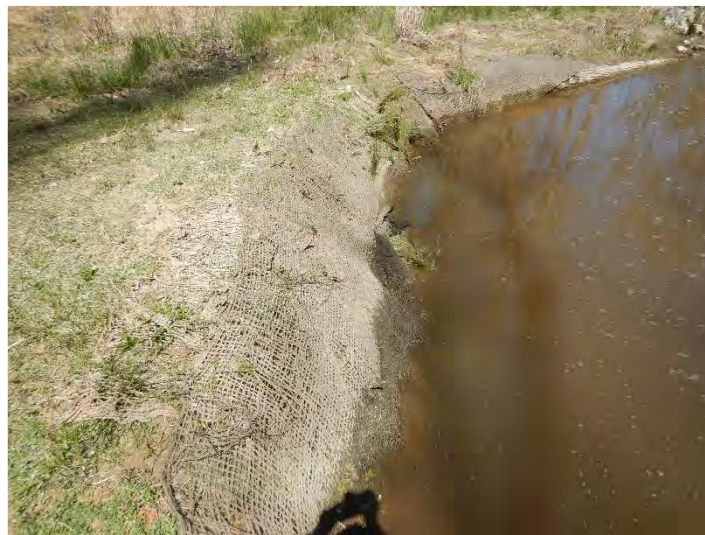
Localized bank erosion on the outside bend of a pool directly downstream of the culvert crossing along Dry Creek Reach 4, was identified during MY1. This area was repaired in March of MY2. After more than a year and several storm events, the repair is stable, and vegetation is establishing. See a timeline of before and after photos of the area in Appendix 2. This area will continue to be monitored to determine the success of the repair work.

Before – Localized Erosion (11/4/2020)

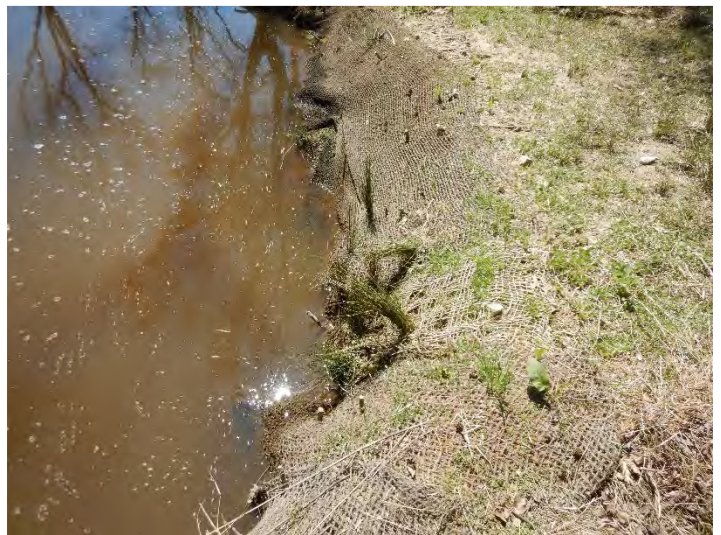
After – Repaired Localized Erosion (04/2/2021)

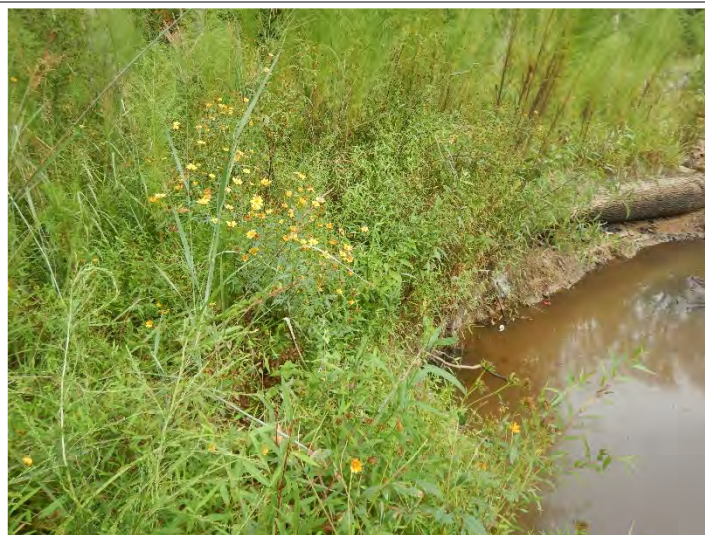
After – Repaired Localized Erosion (04/2/2021)

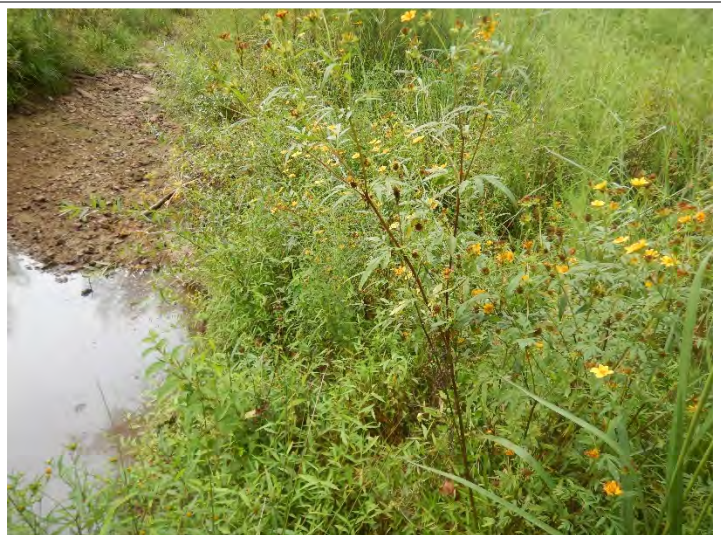
After – Repaired Localized Erosion (09/16/2021)

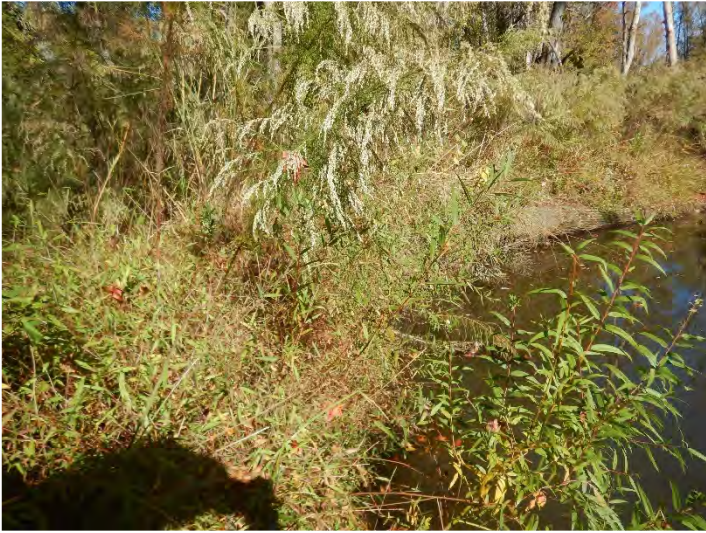
After – Repaired Localized Erosion (09/16/2021)

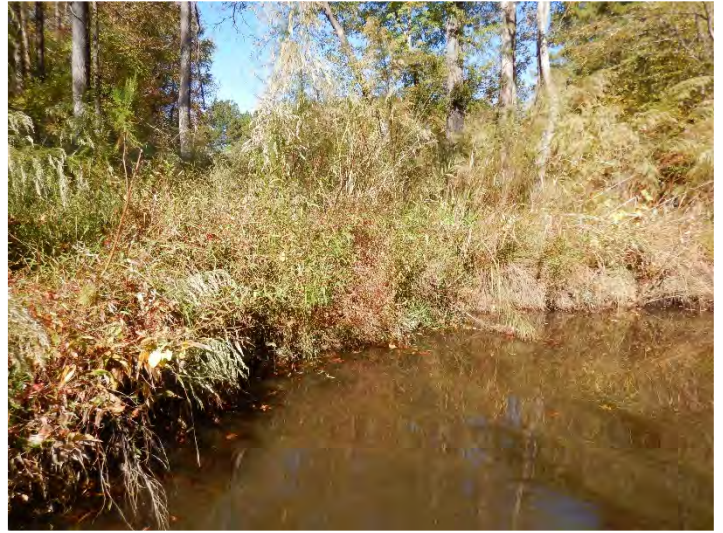
After – Repaired Localized Erosion (10/18/2022)
