# **MONITORING YEAR 4 ANNUAL REPORT Final**

January 2024

## **DRY CREEK MITIGATION SITE**

Durham County, NC  
Neuse River Basin  
HUC 03020201010050  
DMS Project No. 97082  
NCDEQ Contract No. 6827  
USACE Action ID No. SAW-2016-00880  
DWR Project No. 2016-0369

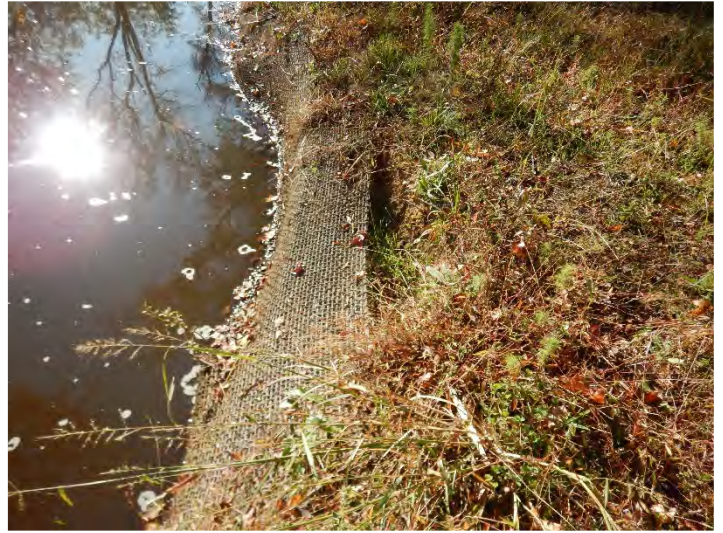
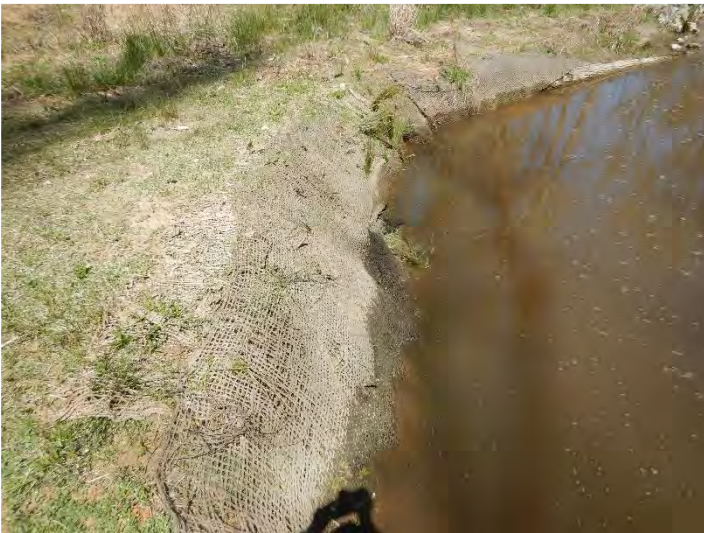
Localized bank erosion on the outside bend of a pool directly downstream of the culvert crossing along Dry Creek Reach 4, was identified during MY1. This area was repaired in March of MY1. The repair has continued to be stable, and vegetation is establishing. See a timeline of before and after photos of the area in Appendix 2. This area will continue to be monitored to assess the continued stability of the repaired area.

**Before – Localized Erosion (11/4/2020)**

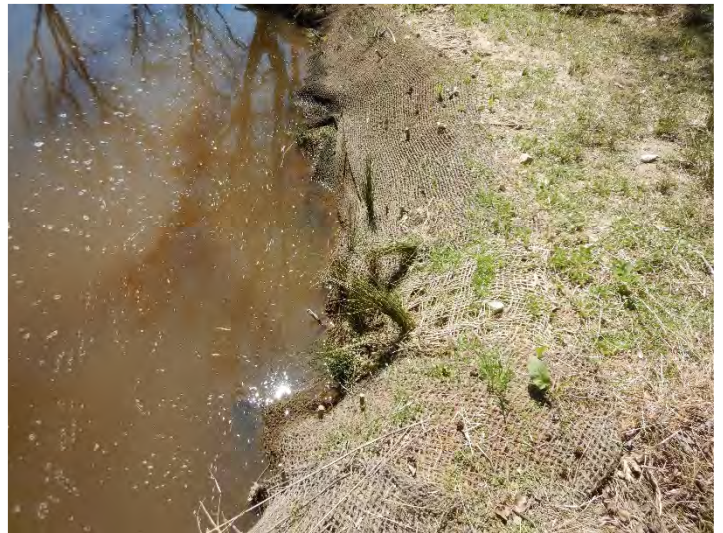
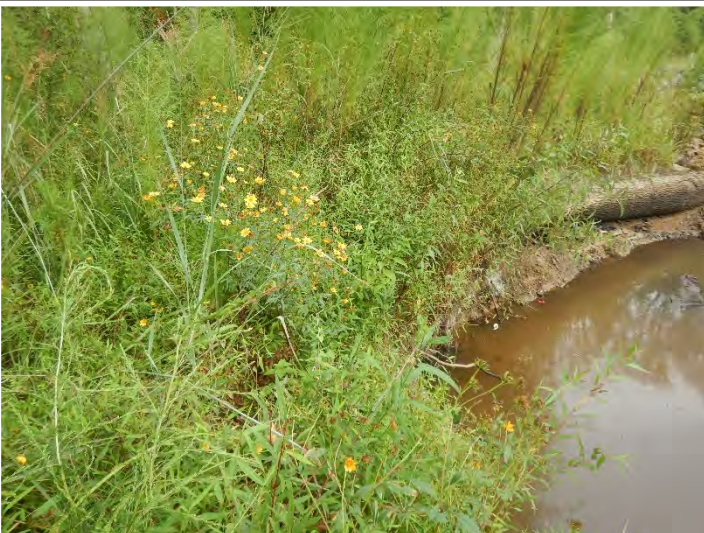
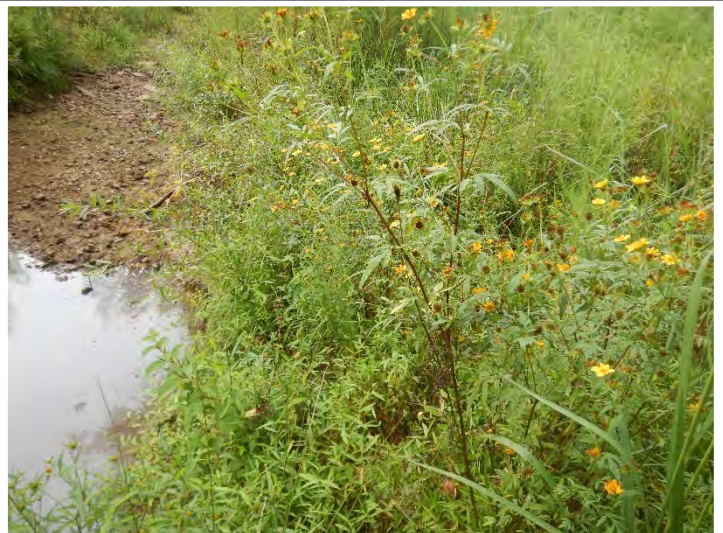
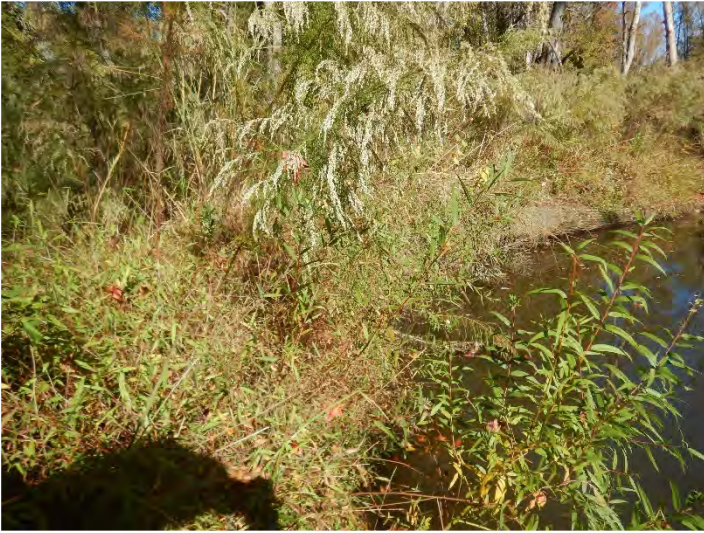
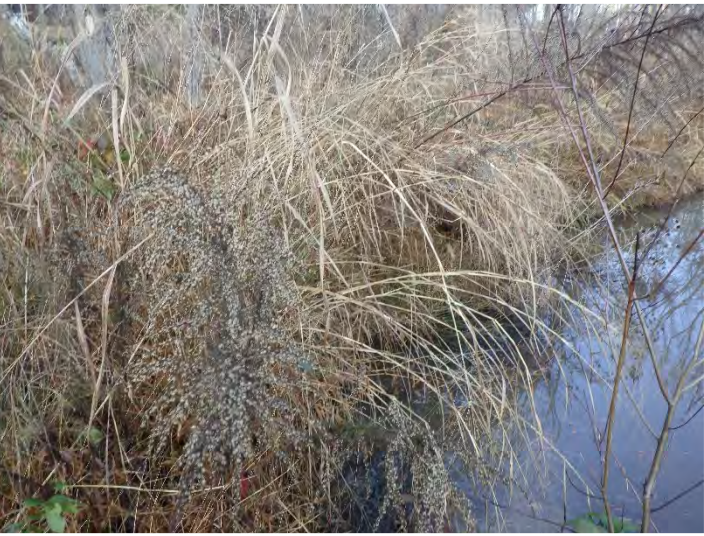
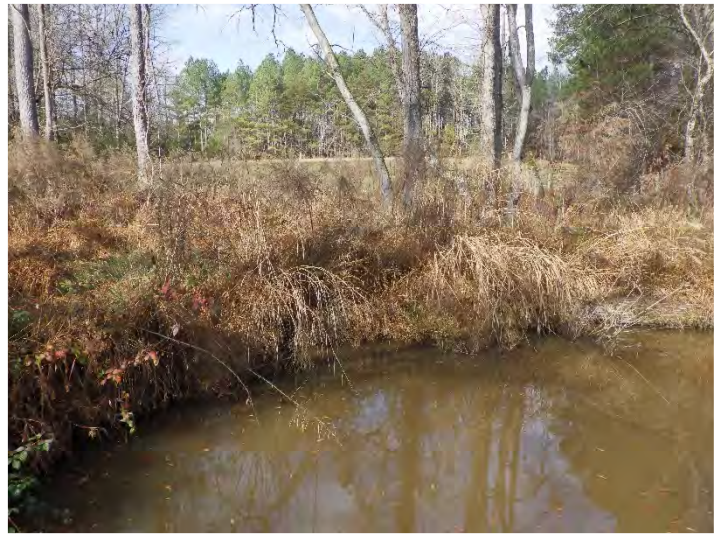
**After – Repaired Localized Erosion (04/2/2021)**

**After – Repaired Localized Erosion (09/16/2021)**

**After – Repaired Localized Erosion (10/18/2022)**

**After – Repaired Localized Erosion (11/8/2023)**
