# Duke Swamp Wetland and Stream Restoration Mitigation Report – Monitoring Year 0 of 5 Gates County, North Carolina

Date Submitted: March 2008

Project Number: D06065-A

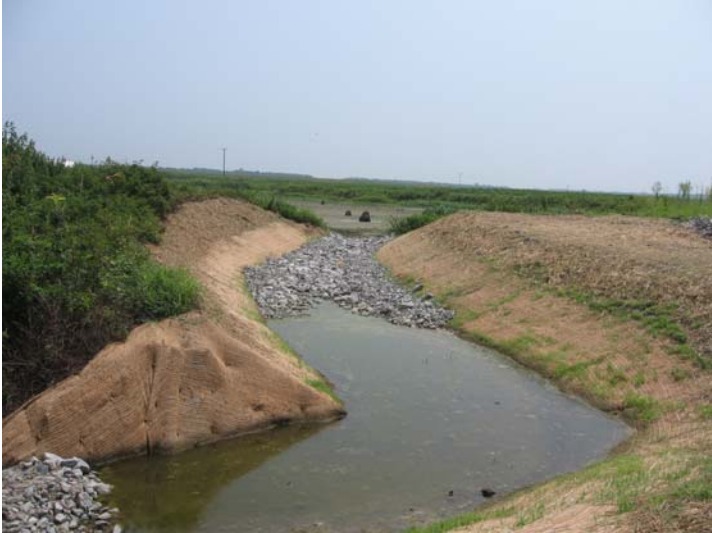
PP2 Pond 1 tie in UT1A.jpg

The de-watering of Pond 1 was not necessary due to extreme drought conditions. The dam was breached to lower the design water elevation and tied into the new design channel per the drainage berm detail and specifications. The channel was constructed from station 17+00 moving upstream, eventually tying into the culvert at Kellogg Fork Road. Once the upper section of UT1a was complete, construction resumed at station 41+00 tying into the existing ditch as the new channel was formed downstream of the farm crossing and ultimately connecting with reach UT1b immediately within the existing woodline. A constructed riffle was installed near station 49+00 towards the downstream section of UT1a. UT1b was then routed into the remnant channel and the old ditch canal was plugged and filled to the end of the project.

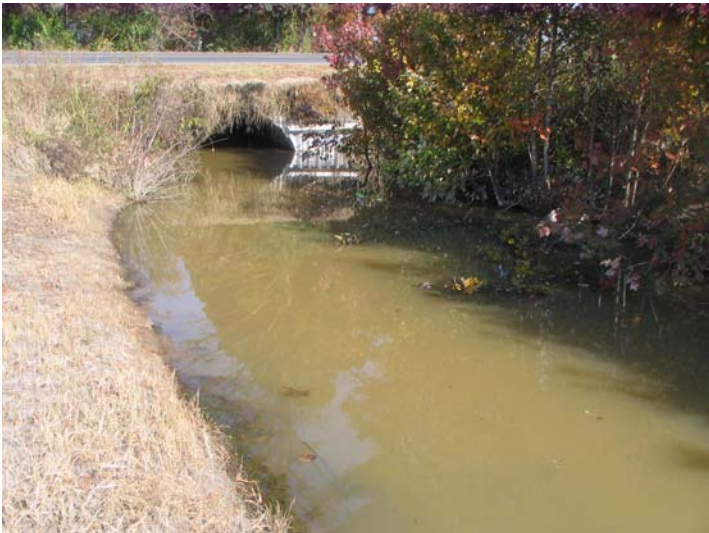
Upstream culvert crossing under Kellogg Fork Rd Station 10+00.JPG

The existing pipe culvert crossing was stabilized by removing the failed head walls, fill cover material was added to the road crossing, and rip rap was added to the side slopes. The excess stockpile material was spread evenly throughout upland areas within the limits of disturbance boundaries. Lastly, all disturbed areas were covered with temporary and permanent seed and straw before demobilizing from the site. Planting of bare roots and live stakes was completed in December 2007 and detailed in sections 2.4 and 2.6.3 of this report.

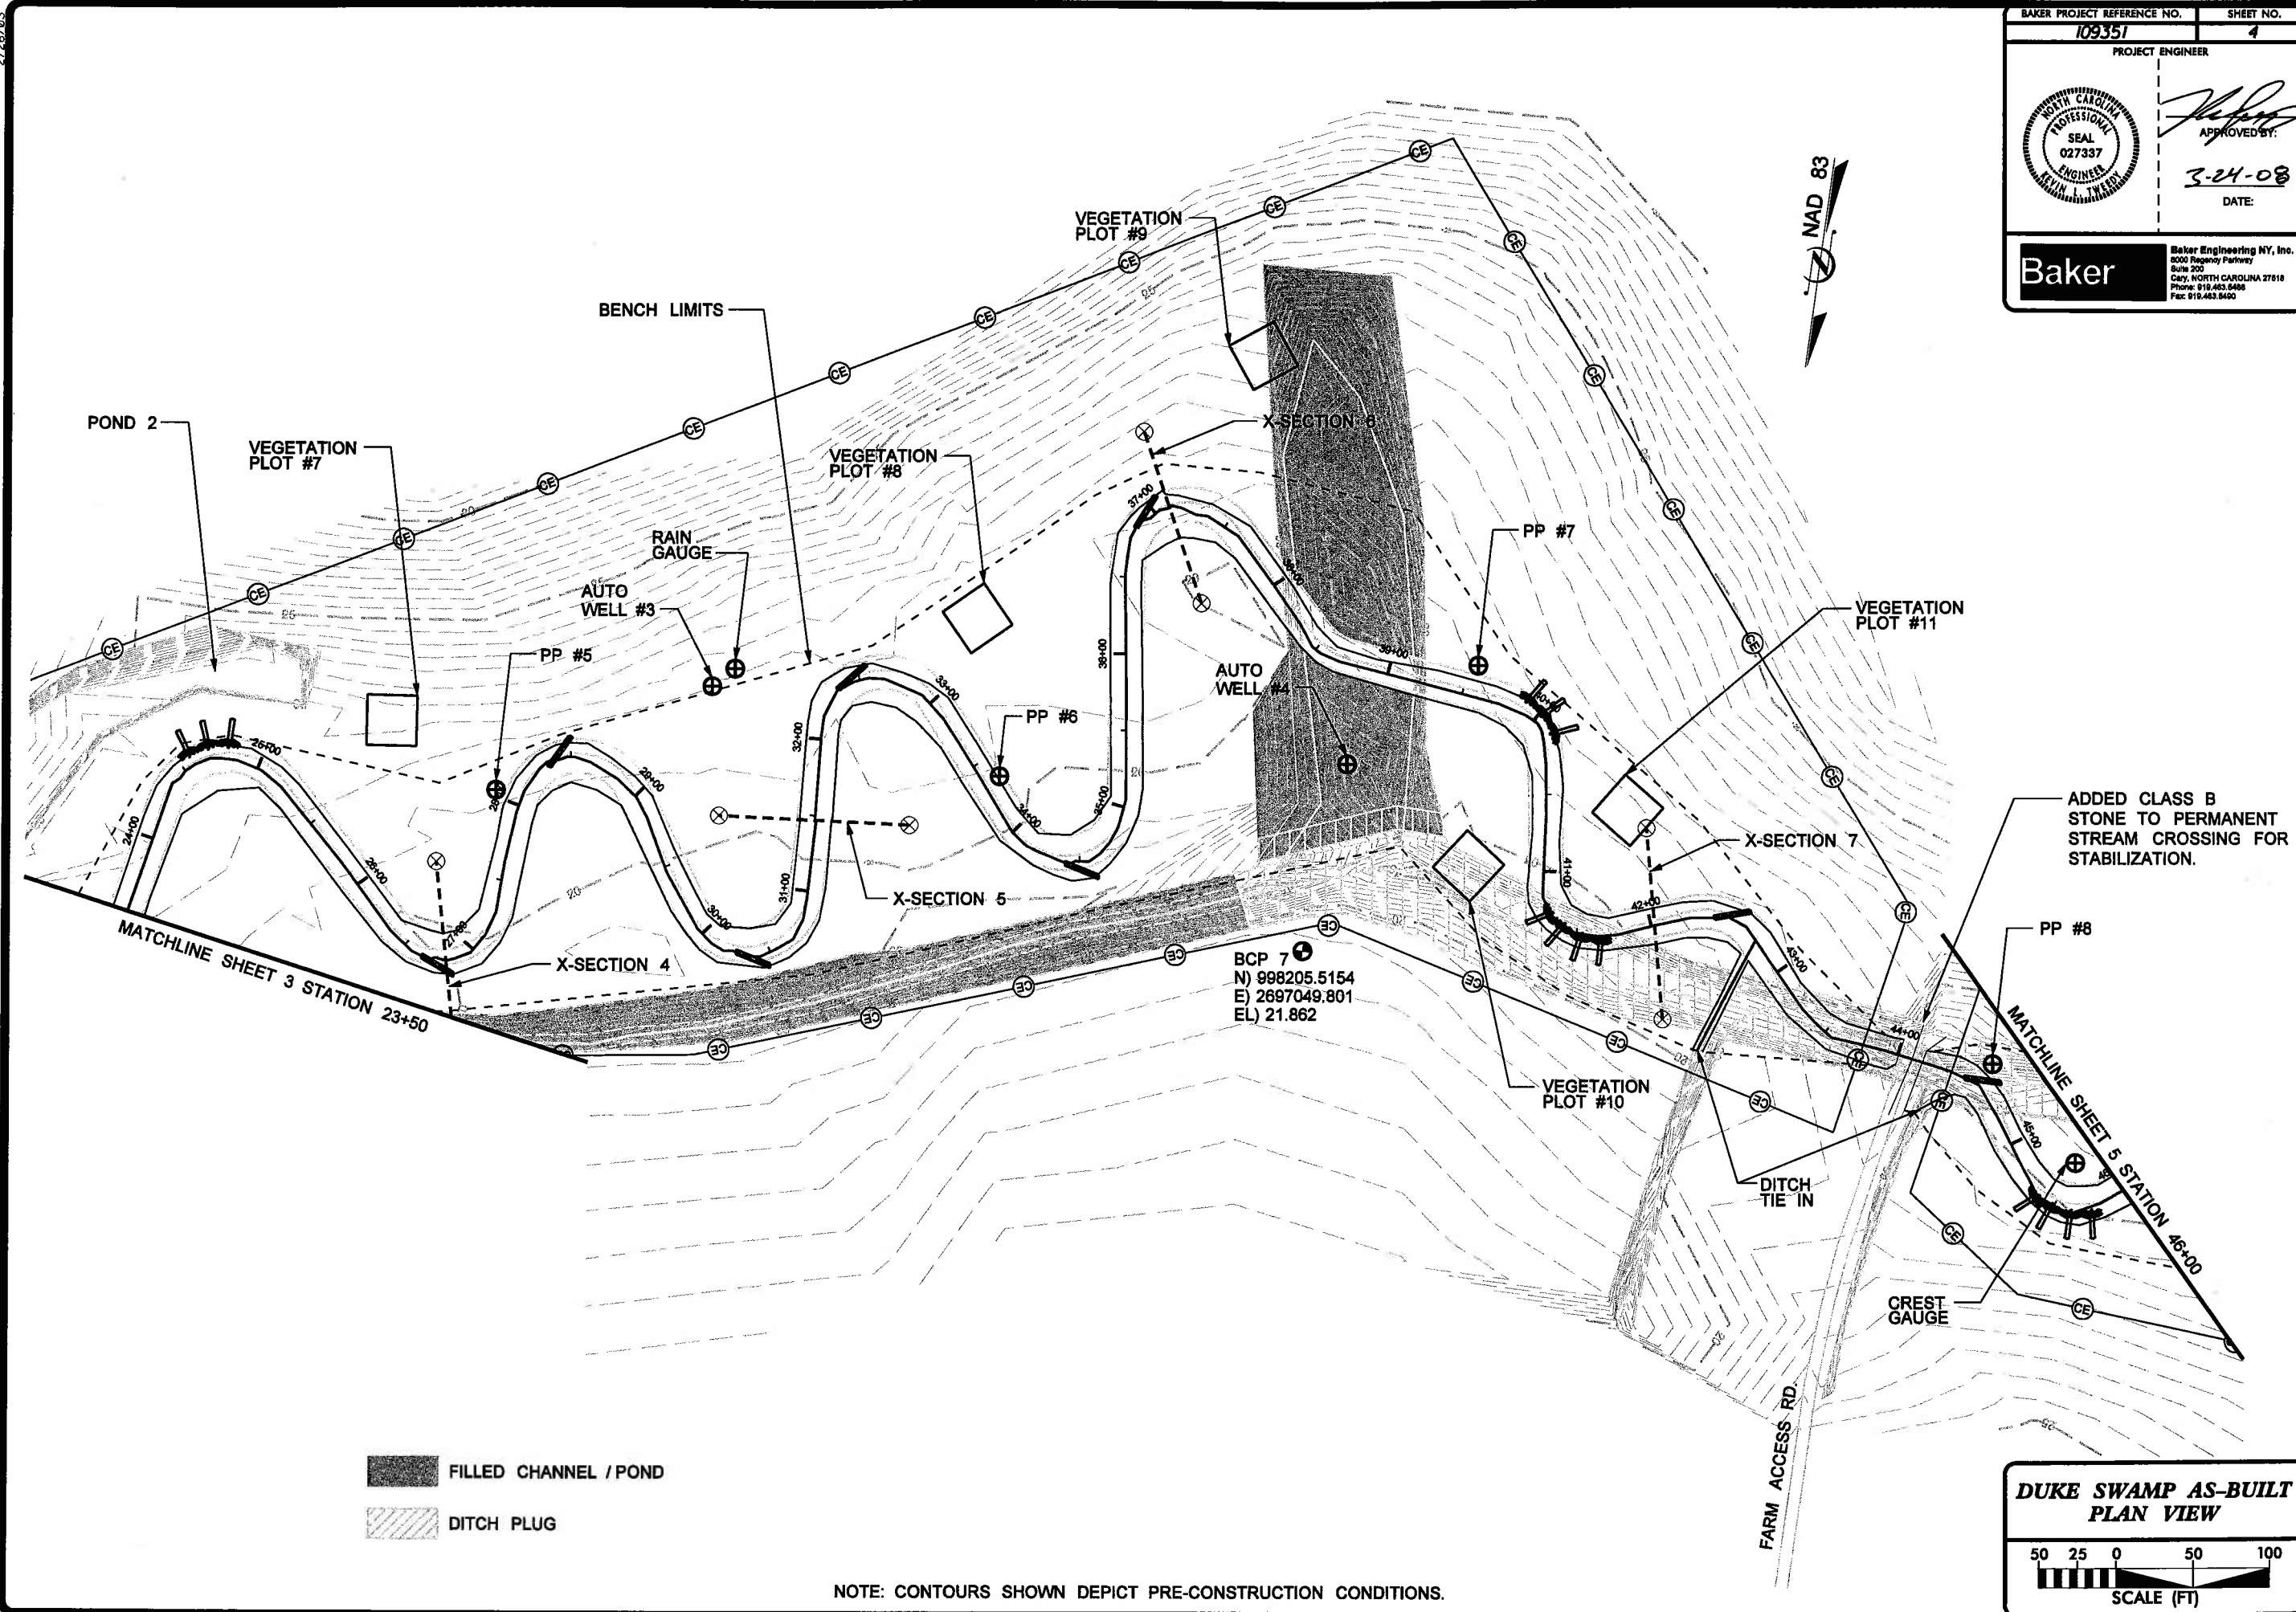
ADDED CLASS B STONE TO PERMANENT STREAM CROSSING FOR STABILIZATION.
