DUKE SWAMP STREAM RESTORATION PROJECT ANNUAL MONITORING REPORT FOR 2008 (YEAR 1)

Contract Number D06065-A

Prepared by: Michael Baker Engineering, Inc.

December 2008

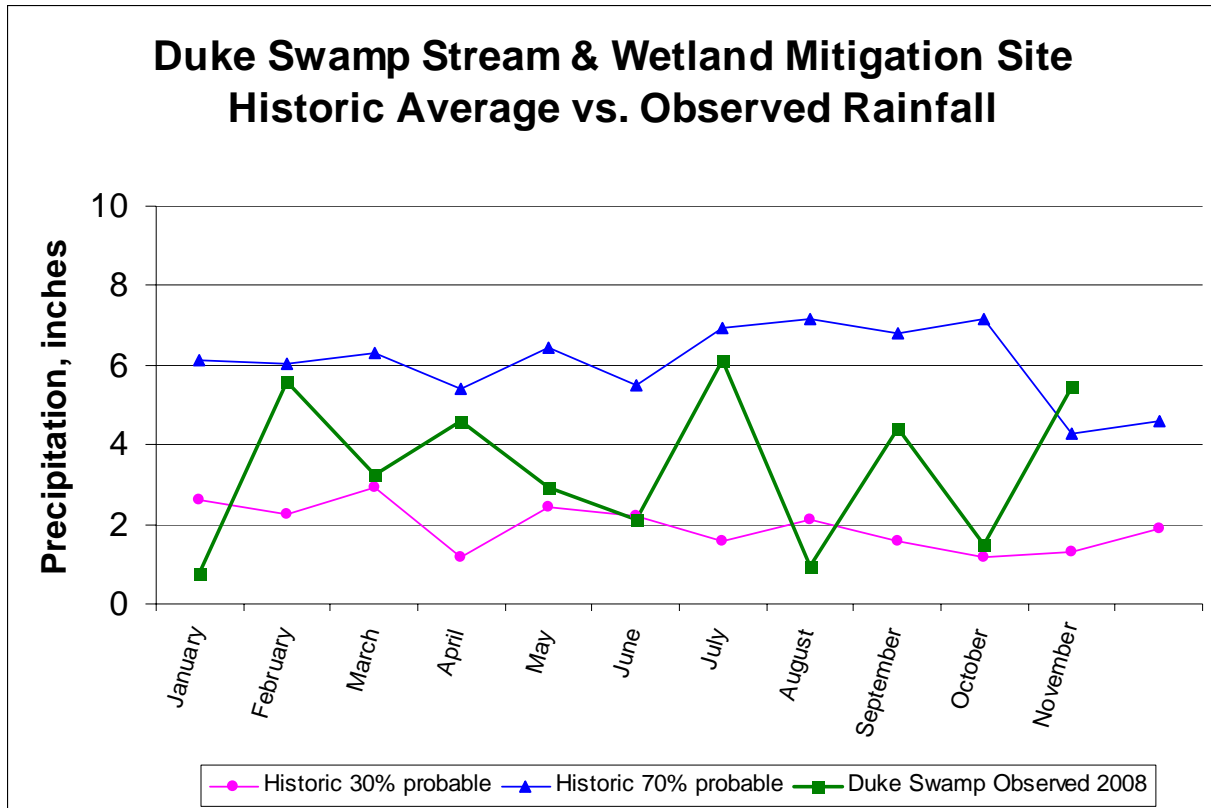
Figure 3. Historic Average vs. Observed Rainfall

Weather station data from the Buckland Elementary Weather Station (Buckland, BUCK - ECONET) were used in conjunction with a manual rain gauge located on the Site to document precipitation amounts. The manual rainfall gauge was initially installed in February 2008 and is used to validate observations made at the Buckland station. Total observed rainfall at the on-site rain gauge for the period March 2008 through October 2008 was 25.14 inches, compared to the Buckland gauge of 25.86 inches for the same period. For 2008, total rainfall during the monitoring period was below the normal average (from January 2008 through November 2008 rainfall was 12.73 inches below average). Much of the rain that fell during the 2008 growing season fell in July and September, when evapotranspiration losses were highest (Table 7 and Figure 3).

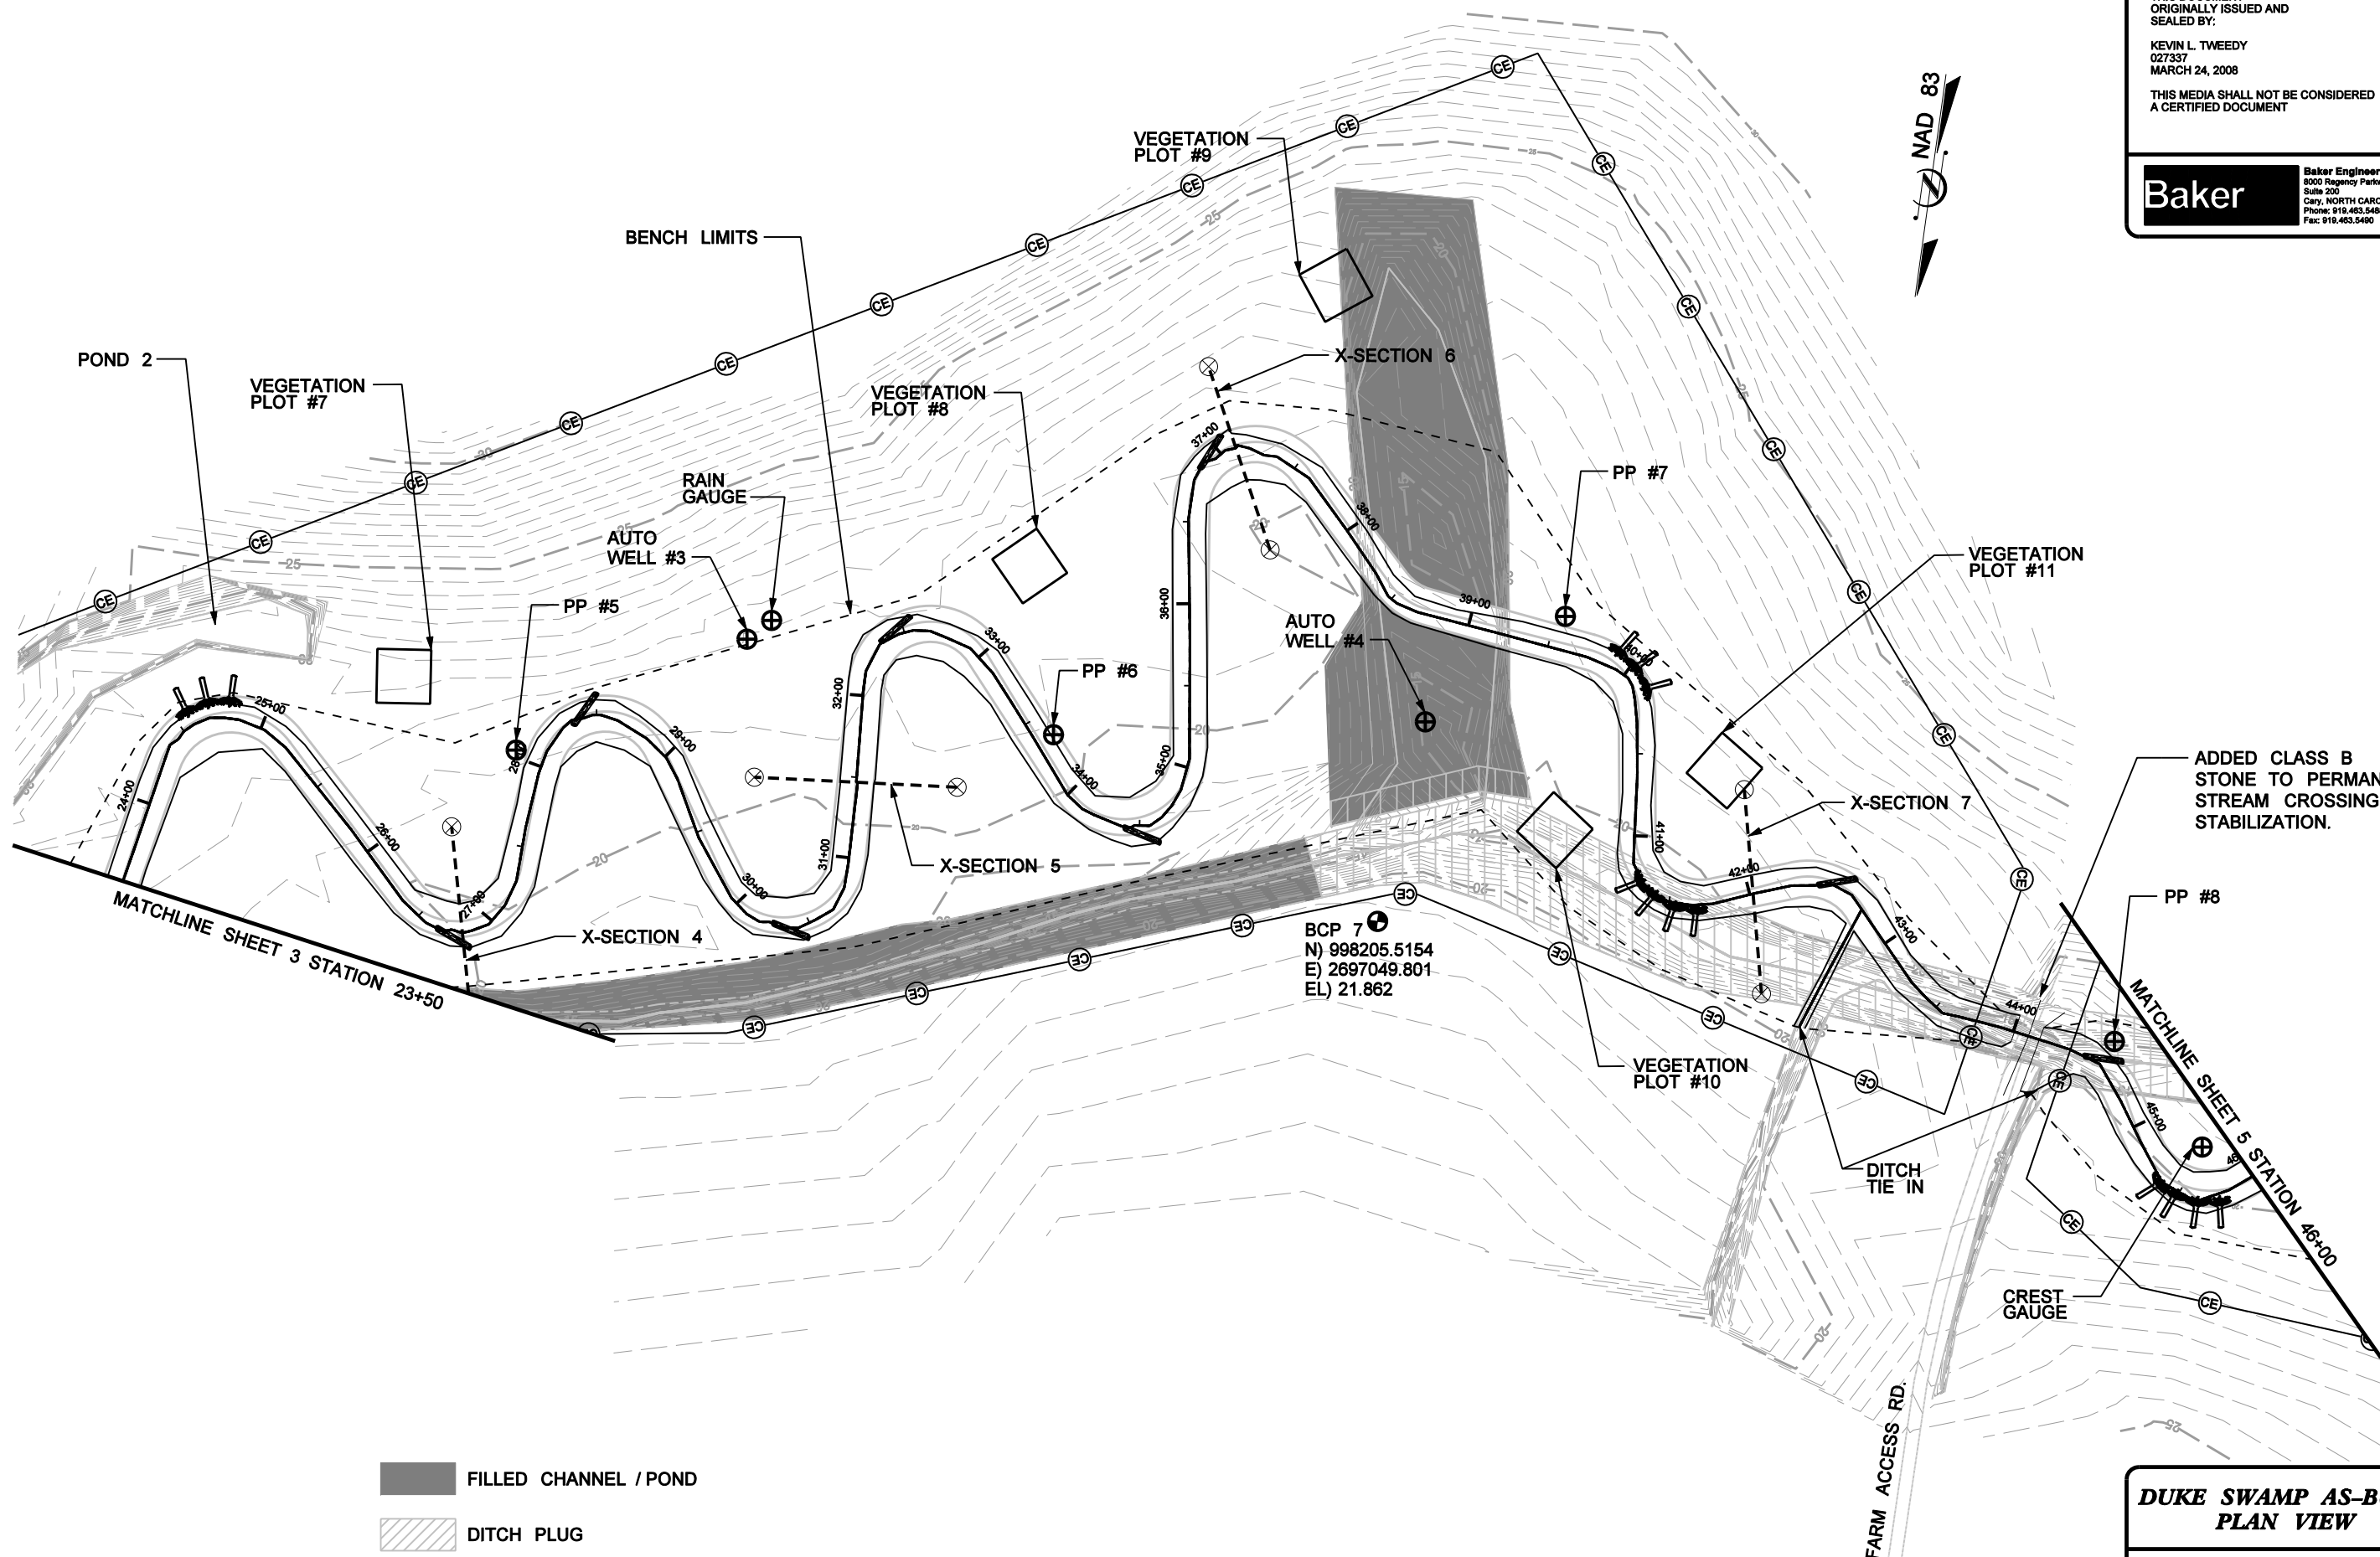
ADDED CLASS B
STONE TO PERMANENT
STREAM CROSSING FOR
STABILIZATION.

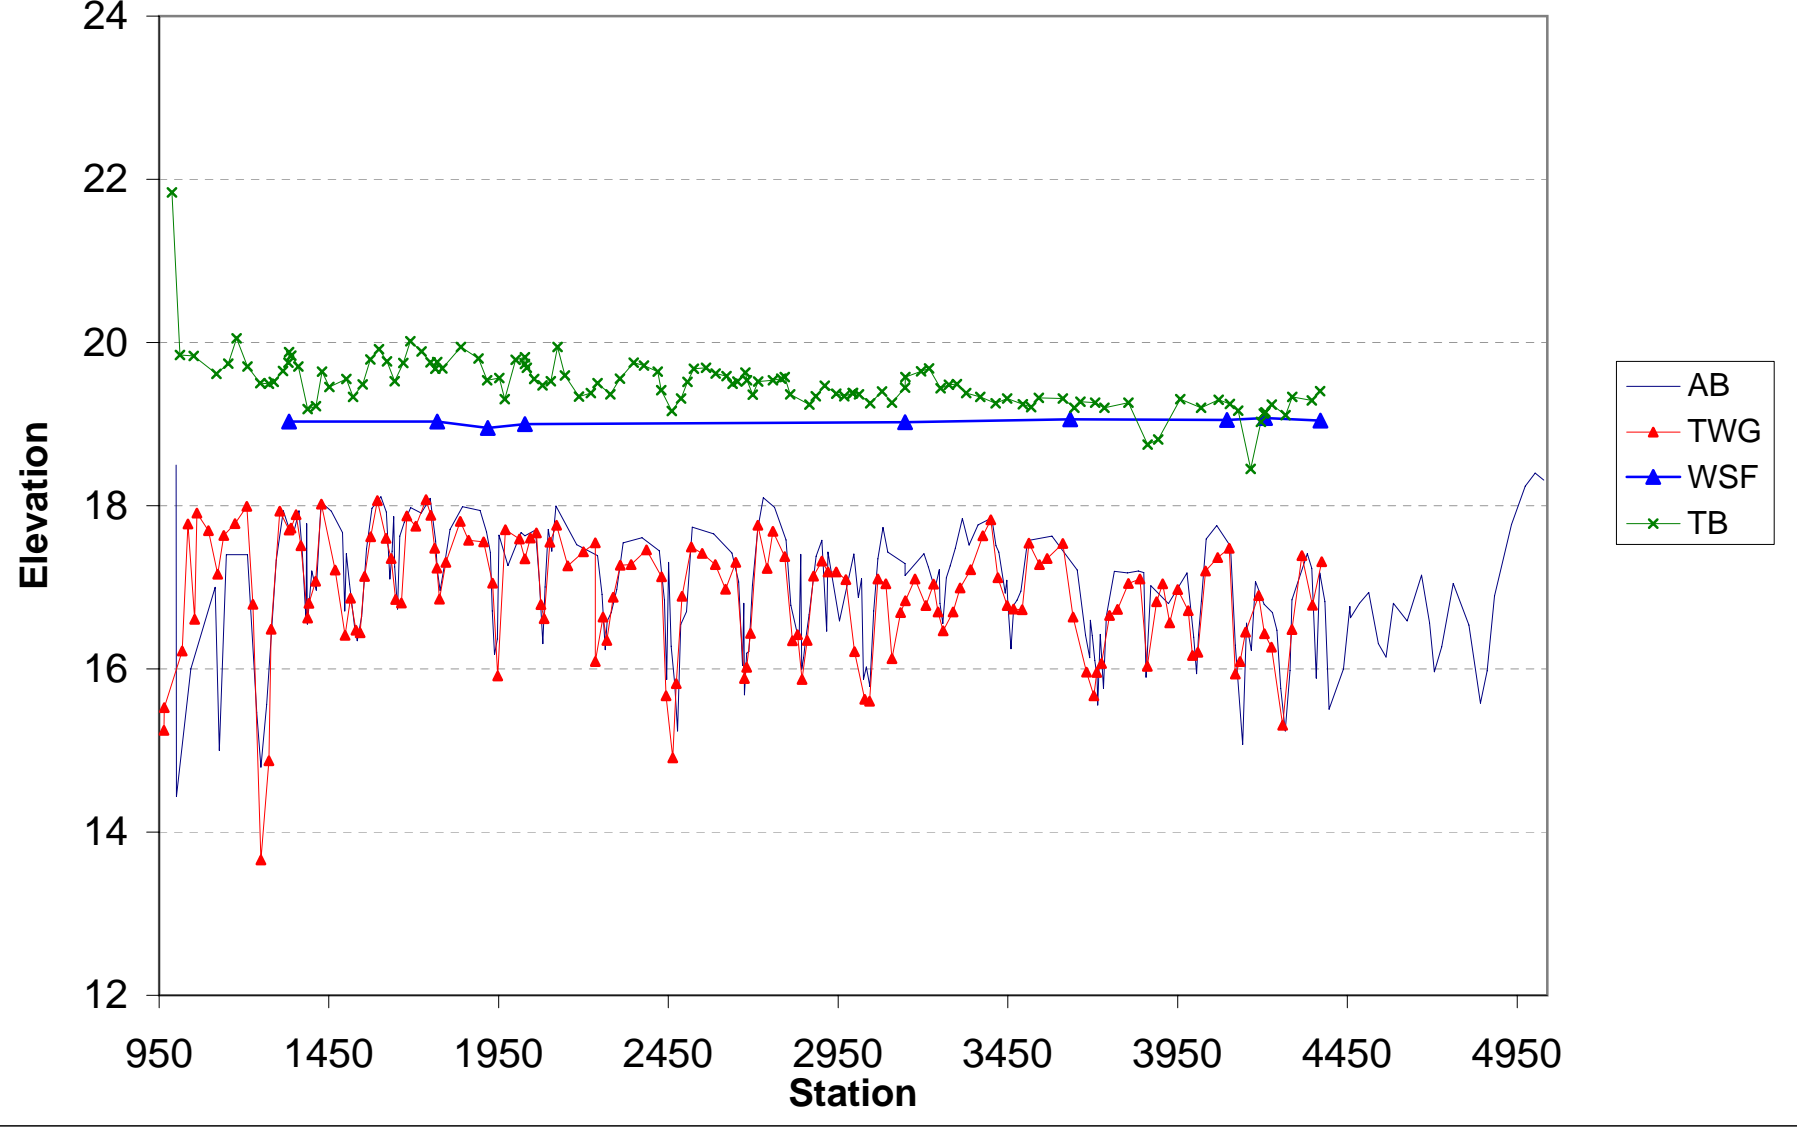
Duke Swamp Longitudinal Profile Station 10+00 to 43+75

The longitudinal profile for Year 1 was surveyed in August 2008 and was compared to the data collected during the as-built condition survey. The longitudinal profile is presented in Appendix B. The results of longitudinal profile show that the pools in UT1a have maintained elevations and depths similar to those documented during the as-built survey. The longitudinal profile shows that some of the riffles, most of which are located in the middle portion of the Site, are at an elevation slightly lower than that found during as-built conditions. The water surface slopes across the pools have remained flat during Year 1 monitoring.

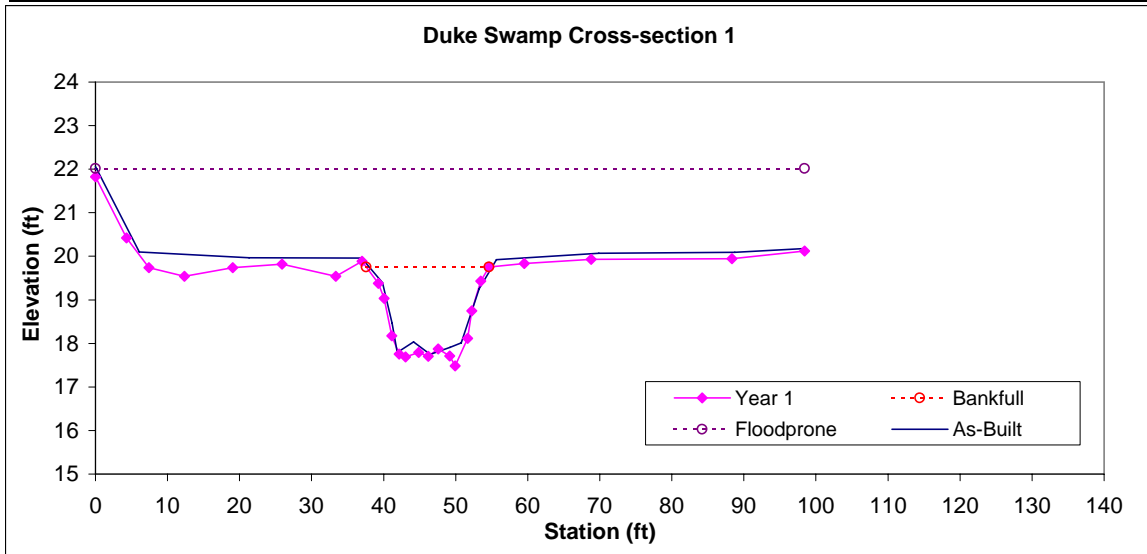
Permanent Cross-section 1, Station 13+30
(Year 1 Data - Collected August 2008)

Cross-sections 1, 3, 5, and 7 are located across riffles, which are found between meander bends. Based on the Year 1 survey data, all of the riffle cross-sections exhibited a lower streambed elevation than was present during baseline conditions. All cross-sections are stable and do not show signs of channel instability. However, the right bank at cross-section 7 has subsided and has allowed below bankfull flows to flood the right floodplain. The submersion of the meander bend is due to settling of sediment used to fill the old stream channel in this area. There is a similar area downstream from cross-section 7 at the crest gauge. These areas are not considered a threat to stream stability, but are providing increased diversity of wetland habitats along the restored floodplain.

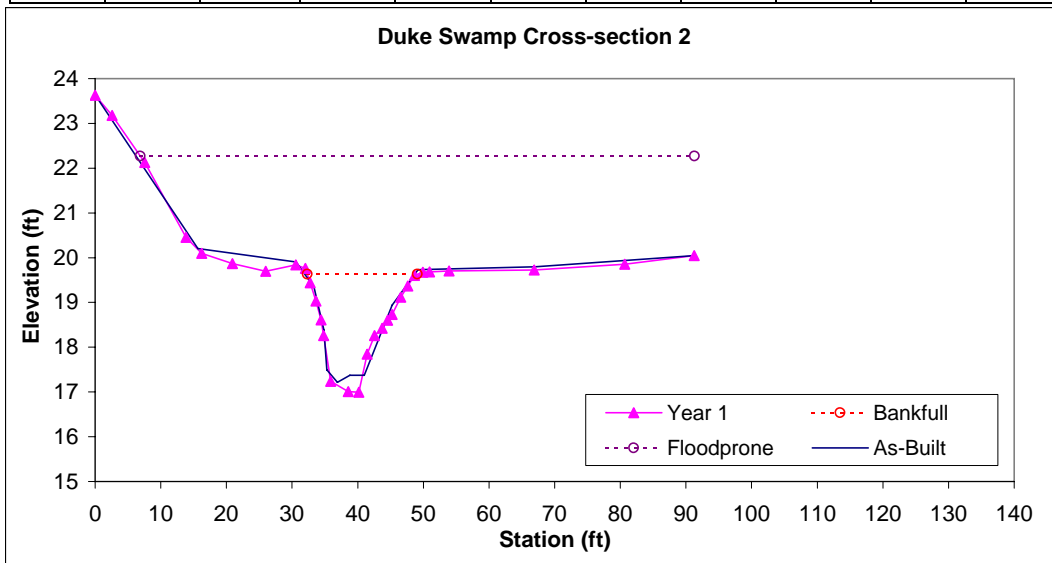
Permanent Cross-section 2, Station 17+69
(Year 1 Data - Collected August 2008)

Cross-sections 2, 4 and 6 are located across pools which are found at meander bends. Based on the cross-section data and visual observations, none of these cross-sections have shown strong development of point bar features on the inside bank of the meander bend, due to low sediment delivery from the watershed. The pool cross-sections did not experience significant change during Year 1.
