**DUKE SWAMP WETLAND AND STREAM
RESTORATION PROJECT**
ANNUAL MONITORING REPORT FOR 2009 (YEAR 2)

Contract Number D06065-A

Prepared by: Michael Baker Engineering, Inc.

December 2009

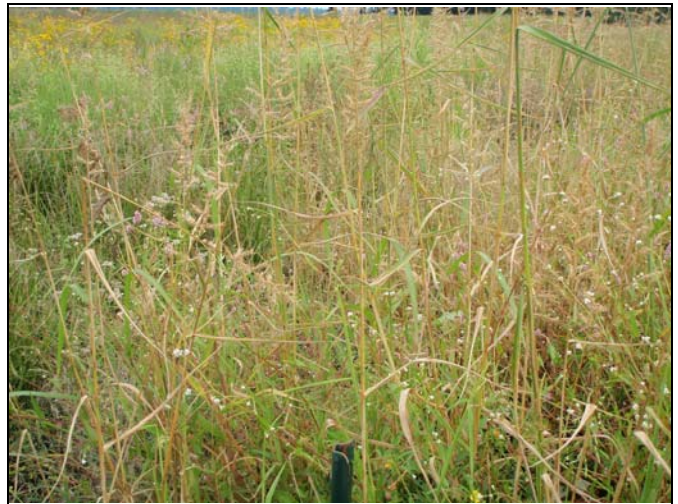
Vegetation Plot 2

Vegetation plot 2 showed density of 320 stems per acre and is most likely experiencing problems due to the presence of a thick herbaceous cover within the plot boundaries. It is also noted that vegetation plot 2 is located on top of the remnant channel on the upstream portion of the Site and fill soil conditions in within this plot are saturated most of the year.

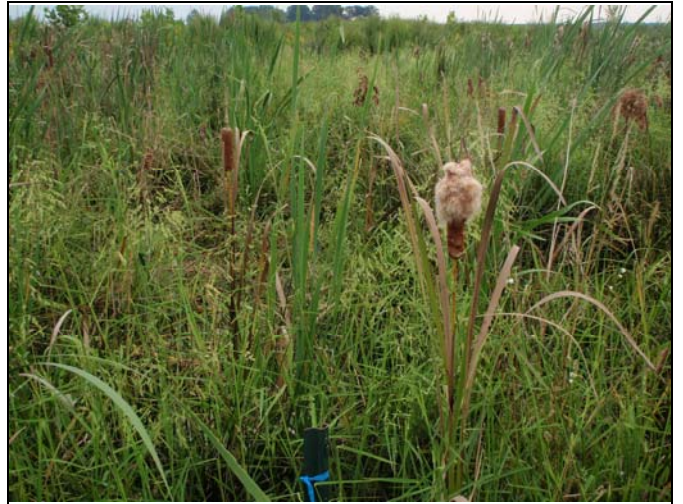
Vegetation Plot 10

Vegetation plots 10, 11 and 12 are located on the downstream portion of the Site where conditions are wet for most of the year. The downstream portion of the site ties into the existing Duke Swamp system and thus experiences swamp like conditions during wet periods. Vegetation plot 10 displayed a density of 0 stems per acre during Year 2 and is submerged for most of the year. Plot 10 is in an area on top of the remnant channel and the remnant pond 3 where fill soils have subsided since construction. Due to the subsidence of the soils in vegetation plot 10, overbank flooding of at least 6 inches has remained present in this area year round and has proved difficult for sapling survival. Plot 11 displayed a density of 200 stems per acre during Year 2 and is also experiencing heavy competition with a very thick herbaceous layer and saturated soils. Plot 12 displayed a density of 120 stems per acre during Year 2 and is the most downstream vegetation plot. This plot is experiencing saturated soils for most of the year due to backwater conditions at the UT1a/UT1b tie-in. The

These problem areas will be observed closely during Year 3 of monitoring, but it is likely that these monitored locations will not support the typical woody density of drier locations. This is considered to be a natural effect of the saturated, swamp conditions that these areas are experiencing after restoration. Under natural conditions, swamp systems exhibit slow establishment of young trees, with sapling establishment typically occurring in abnormally dry years.

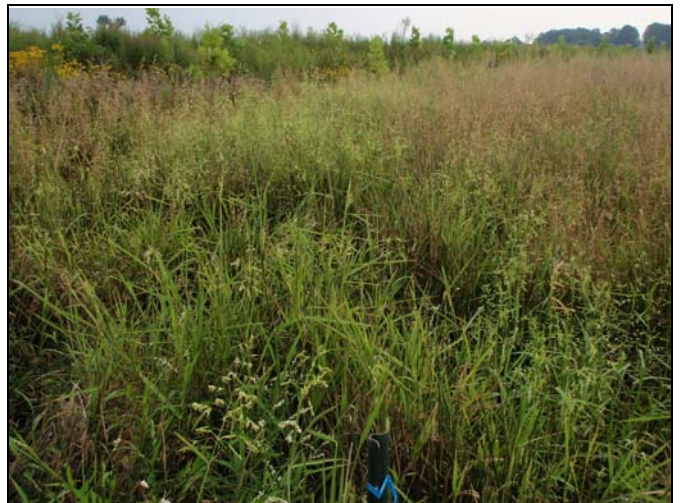
Vegetation Plot 12

saplings in vegetation plot 12 are experiencing difficulties in surviving the extremely wet conditions.

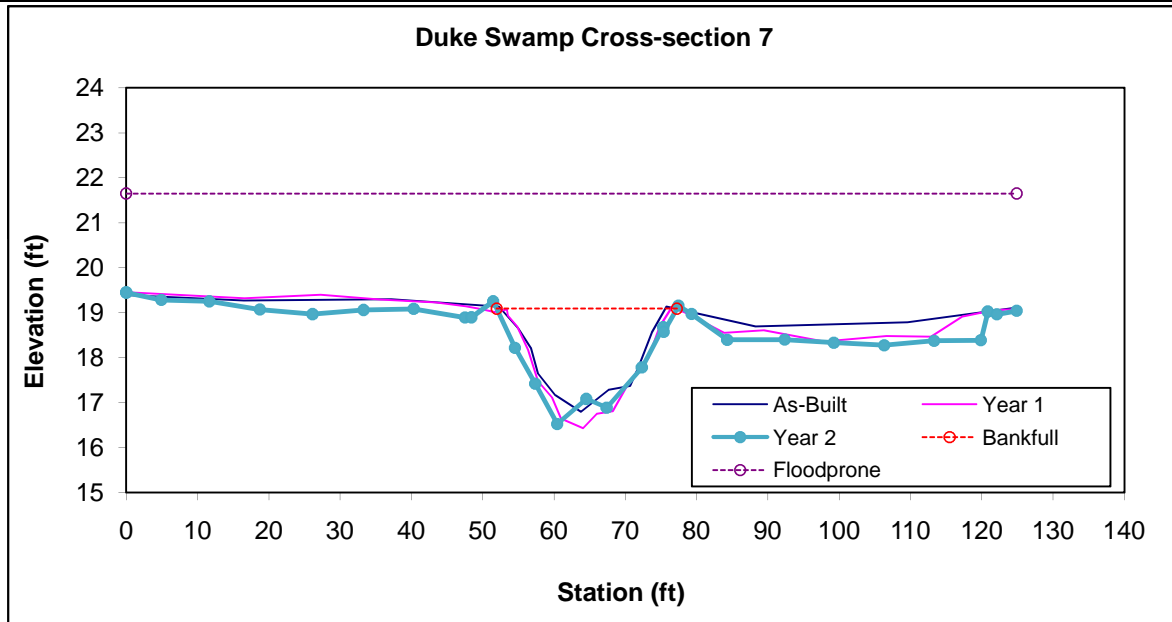
Permanent Cross-section 7, Station 42+05
 (Year 2 Data - Collected September 2009)

Cross-sections 1, 3, 5, and 7 are located across riffles, which are found between meander bends. Based on the Year 2 survey data, all of the riffle cross-sections exhibited a slightly lower streambed elevation than was present during baseline conditions. However, the elevations of the riffle cross-sections have remained stable since Year 1 cross-section monitoring. All riffle cross-sections are stable and do not show signs of channel instability.

As mentioned in Section 3.2.3, the area between stations 38+00 and 40+00 near cross-section 7, AW4 and vegetation 10 has undergone subsidence on the right floodplain. This area was first noted to have subsided during Year 1 monitoring. The settling has allowed below bankfull flows to permanently flood the right floodplain of cross-section 7. The floodplain elevation of cross-section 7 has decreased since as-built conditions, but it has remained stable since Year 1 data collection. This subsided area has also remained stable since Year 1 and no significant changes have been noted. This area will continue to be observed closely during future site visits and any significant changes will be reported in subsequent reports.
