**DUKE SWAMP WETLAND AND STREAM  
RESTORATION PROJECT**  
ANNUAL MONITORING REPORT FOR 2010 (YEAR 3)

**Contract Number D06065-A**

**Prepared by:** Michael Baker Engineering, Inc.

**December 2010**

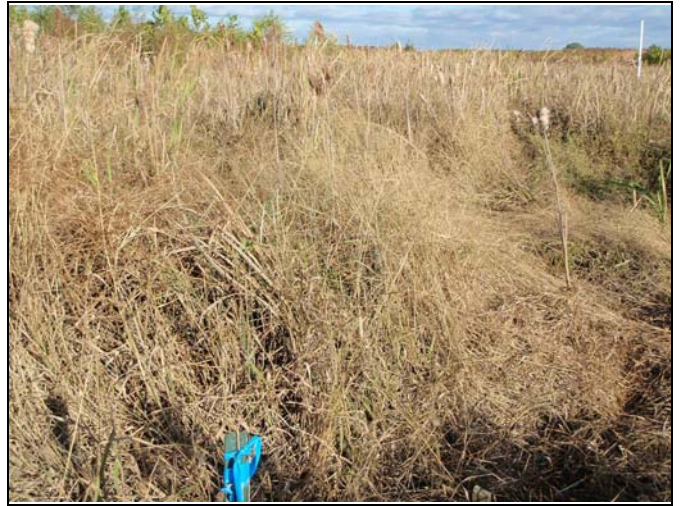
Vegetation Plot 10

Vegetation plots 10, 11 and 12 are located on the downstream portion of the Site where conditions are wet for most of the year. The downstream portion of the Site ties into the existing Duke Swamp system and thus experiences swamp like conditions during wet periods. Vegetation plot 10 once again displayed a density of 0 stems per acre during Year 3 and is submerged for most of the year. Plot 10 is in an area on top of the remnant channel and the remnant pond 3 where fill soils have subsided since construction. Due to the subsidence of the soils in vegetation plot 10, overbank flooding of at least 6 inches has remained present in this area year round and has proved detrimental to sapling survival. Plot 11 displayed a density of 200 stems per acre during Year 3 and is also experiencing heavy competition with a very thick herbaceous layer and saturated soils. Plot 12 displayed a density of 80 stems per acre during Year 3 and is the most downstream vegetation plot. This plot is experiencing saturated soils for most of the year due to backwater conditions at the UT1a/UT1b tie-in. The saplings in vegetation plot 12 are experiencing difficulties in surviving the extremely wet conditions.

These problem areas will be observed closely during Year 4 of monitoring, but it is likely that these monitored locations will not support the typical woody density of drier locations. This is also observed in mature swamps, where constant saturation can lead to clear areas where it is hard for volunteer recruitment to occur. Under natural conditions, swamp systems exhibit slow establishment of young trees, with sapling establishment typically occurring in abnormally dry years.

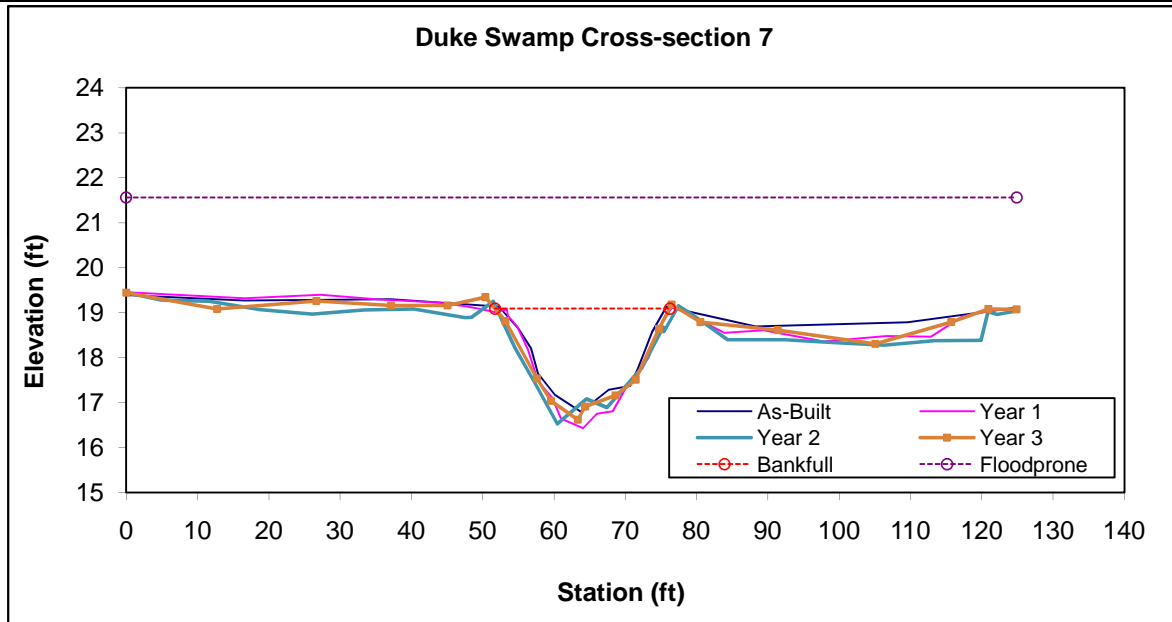
As mentioned in Section 3.2.3, the area between stations 38+00 and 40+00 near cross-section 7, AW4 and vegetation 10 has undergone subsidence on the right floodplain. This area was first noted to have subsided during Year 1 monitoring. The settling has allowed below bankfull flows to permanently flood the right floodplain of cross-section 7. The floodplain elevation of cross-section 7 has decreased since as-built conditions, but it has remained stable since Year 1 data collection. According to Year 3 cross-section data, this subsided area has remained stable since Year 1 monitoring. No significant changes were noted during Year 3

**Permanent Cross-section 7, Station 42+05**  
 (Year 3 Data - Collected November 2010)

Feature	Stream Type	BKF Area	BKF Width	BKF Depth	Max BKF Depth	W/D	BH Ratio	ER	BKF Elev	TOB Elev
Riffle	Cc	36.1	24.49	1.47	2.47	16.61	1	5.1	19.09	19.18

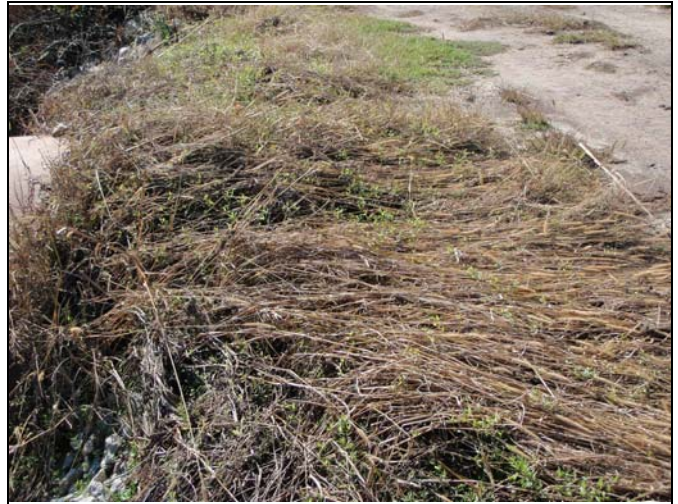
Bankfull evidence observed at farm culvert  
(Storm event occurred on October 1, 2010)

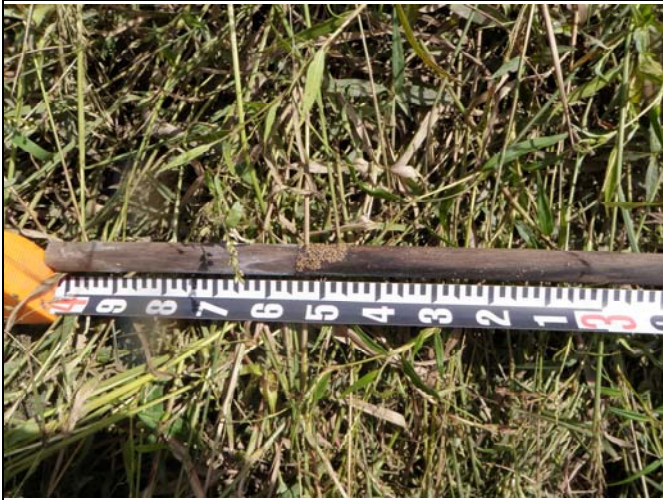
Dimension, pattern, profile and in-stream structures remained stable during Year 3. The on-site crest gauge documented the occurrence of at least three bankfull flow events during Year 3 of the post-construction monitoring period. Inspection of conditions during site visits revealed visual evidence of out-of-bank flow, confirming the highest crest gauge reading of 3.54 feet (42.48 inches) above the bankfull stage.

Crest Gauge – 3.54 feet  
(Storm event occurred on October 1, 2010)

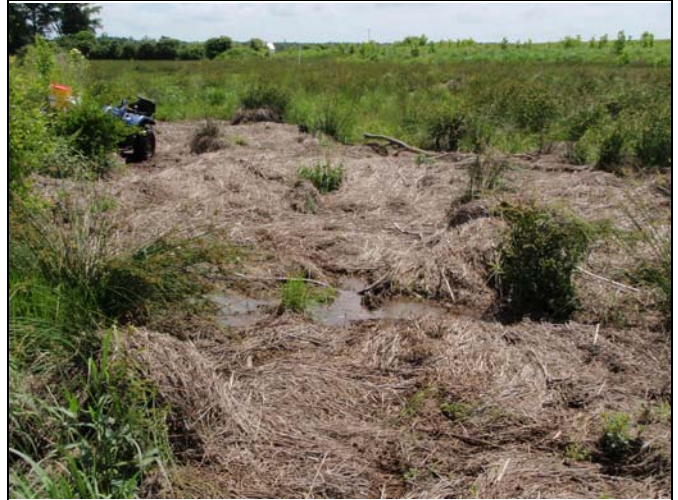
Strong bankfull evidence observed at station 19+00  
(Storm event occurred in March, 2010)
