**DUKE SWAMP WETLAND AND STREAM
RESTORATION PROJECT**
ANNUAL MONITORING REPORT FOR 2011 (YEAR 4)

Contract Number D06065-A

Prepared by: Michael Baker Engineering, Inc.

December 2011

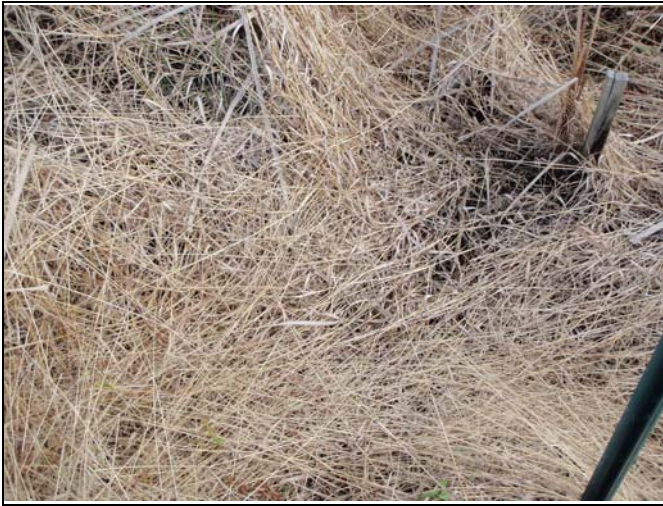
Vegetation Plot 10-Herbacious

These problem vegetation plots (10, 11 and 12) are located on the downstream portion of the Site where conditions are wet for most of the year. The downstream portion of the Site ties into the existing Duke Swamp system and has characteristics of a Non-Tidal Freshwater Marsh during wet periods. Vegetation plot 10 demonstrated a density of 40 stems per acre following Year 4 and continues to be wet for most years. Plot 10 is in an area on top of the remnant channel and the remnant pond 3 where fill soils have subsided since construction. Due to the subsidence of the soils in Vegetation Plot 10, overbank flooding of at least 6 inches has remained present in this area year round and has proved detrimental to sapling survival. Plot 11 displayed a density of 160 stems per acre during Year 4 and is also experiencing heavy competition with a very thick herbaceous vegetative layer and saturated soils. Plot 12 displayed a density of 120 stems per acre during Year 4 and is the most downstream vegetation plot. This plot is experiencing saturated soils for most of the year at the UT1a/UT1b tie-in. The saplings in vegetation plot 12 are experiencing difficulties in surviving the extremely wet conditions.

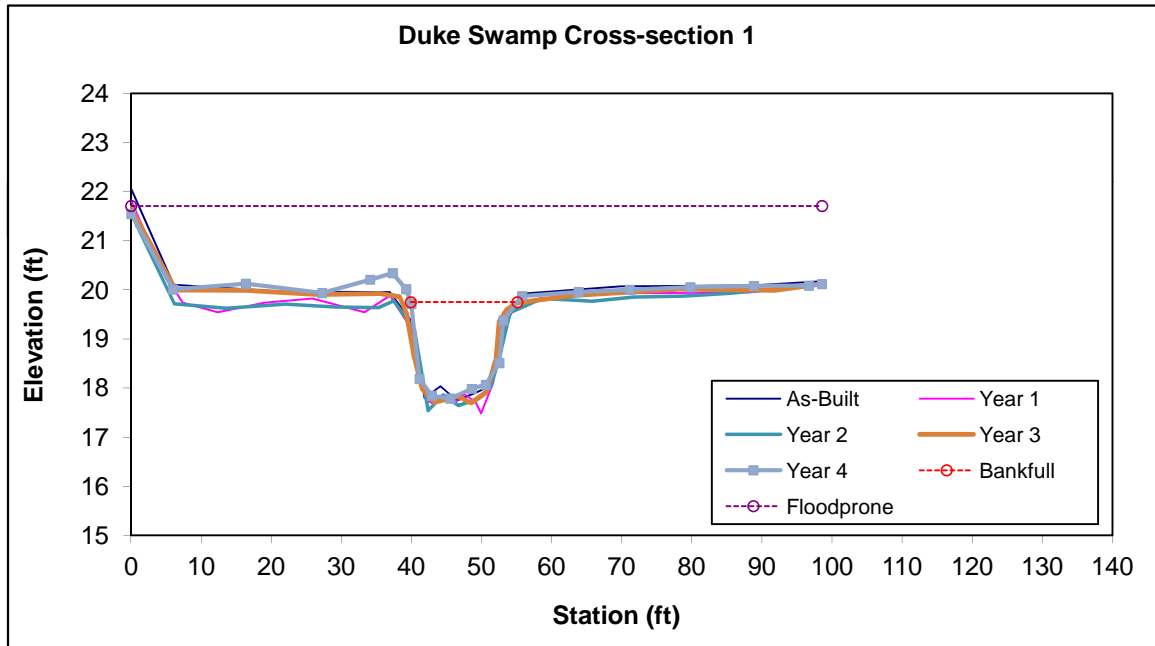
Permanent Cross-section 1, Station 13+30
 (Year 4 Data - Collected November 2011)

Cross-sections 1, 3, 5, and 7 are located across riffles, which are found between meander bends. Based on the Year 4 survey data, all riffle cross-sections exhibited a relatively similar streambed elevation compared to baseline conditions. The elevations of the riffle cross-sections have remained stable since Year 1 cross-section monitoring. All riffle cross-sections are currently stable and do not show signs of channel instability.

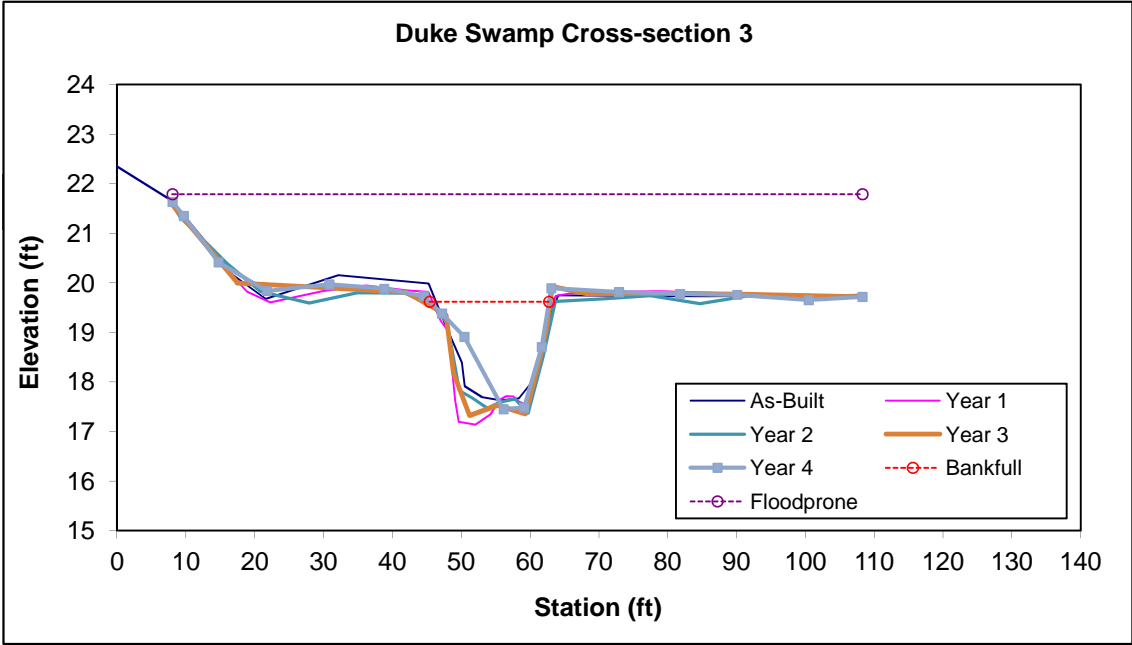
Permanent Cross-section 3, Station 20+27
 (Year 4 Data - Collected November 2011)

However, according to the Year 4 survey data, channel dimension within riffle cross-section 3 has demonstrated a decrease in bankfull cross-sectional area. The thalweg elevation has remained stable since as-built conditions and it has been determined that a thick layer of aquatic vegetation has filled the left channel in cross-section 3. Therefore, the survey data displays a shift in the thalweg to the right portion of the channel following Year 4 monitoring. This area does not demonstrate signs of instability and appears to be very stable.

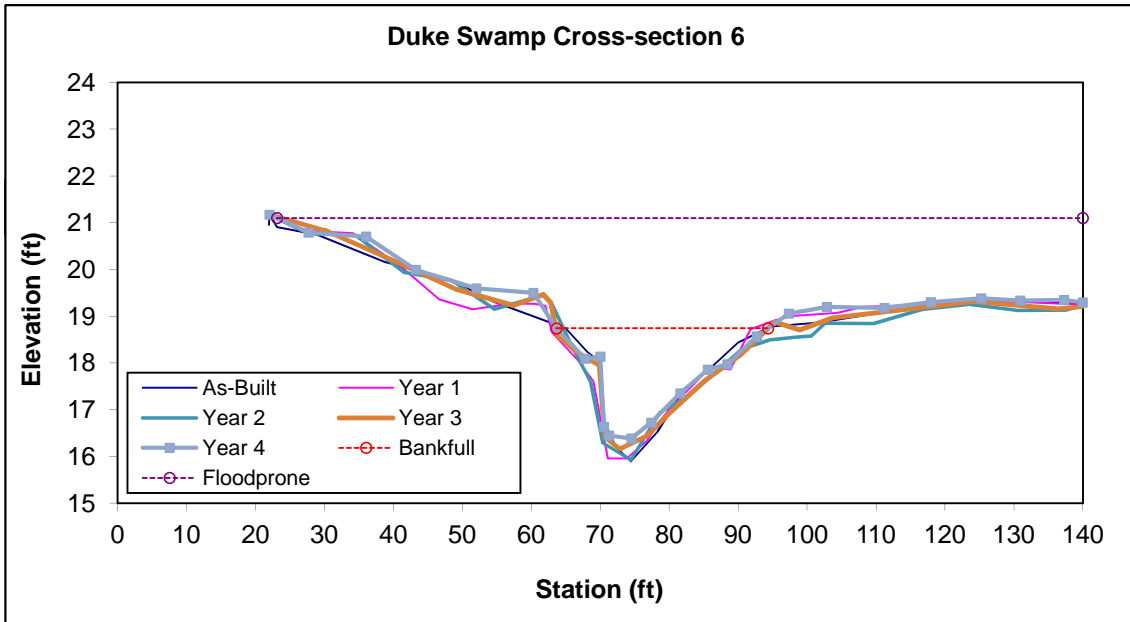
Permanent Cross-section 6, Station 37+13
 (Year 4 Data - Collected November 2011)

Cross-sections 2, 4 and 6 are located across pools which are found at the apex of meander bends. The Year 4 data show that the pool cross-sections exhibit a relatively similar streambed elevation compared to baseline conditions. Based on the Year 4 pool cross-section data and visual observations, the pools have not shown strong development of point bar features on the inside bank of the meander bends. It is concluded that point bar features have continued to show little development due to low sediment delivery from the watershed or low hydrologic energy within the channel.

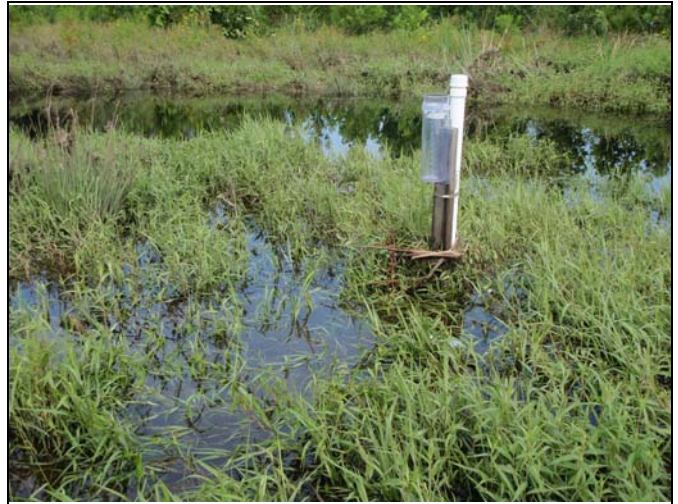
Hurricane Irene flood waters at crest gauge
(Storm event occurred on August 27, 2011)

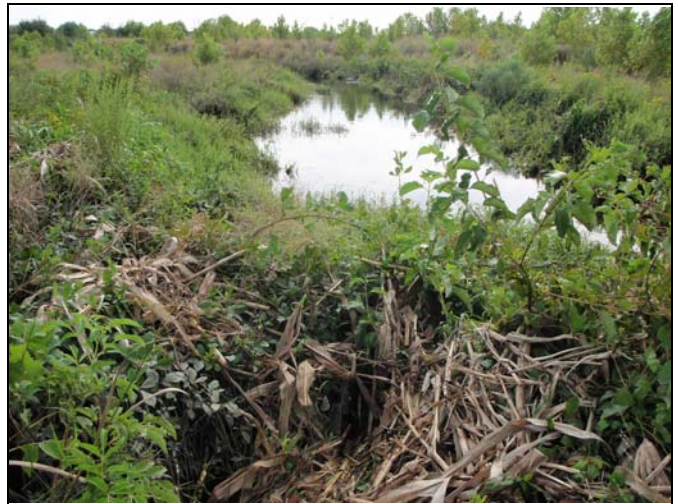
Strong upstream bankfull evidence at station 22+50
(Storm event occurred in August 27, 2011)

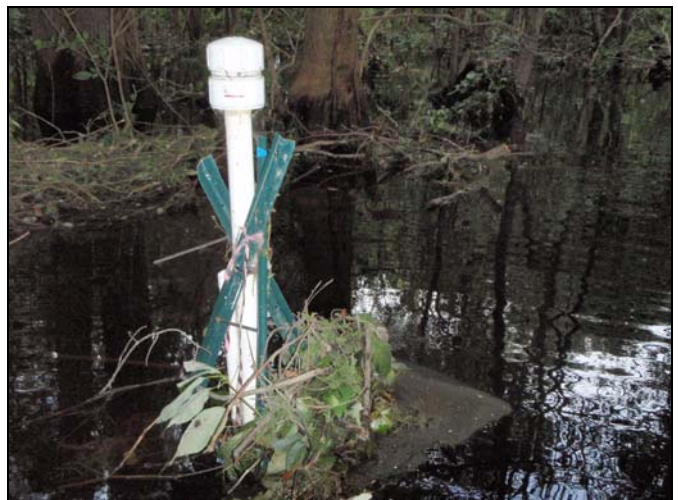
Flood gauge 1 with wrack from Hurricane Irene
(Storm event occurred in August 27, 2011)
