Dula Thoroughfare Stream and Wetland Restoration Project No. 65 2008 Monitoring Report (Final): Year 2 of 5

March 2009

Prepared for: NCDENR-EEP
1652 Mail Service Center
Raleigh, NC 27699-1652

Prepared by: Jordan, Jones, & Goulding
9101 Southern Pine Blvd., Suite 160
Charlotte, NC 28273

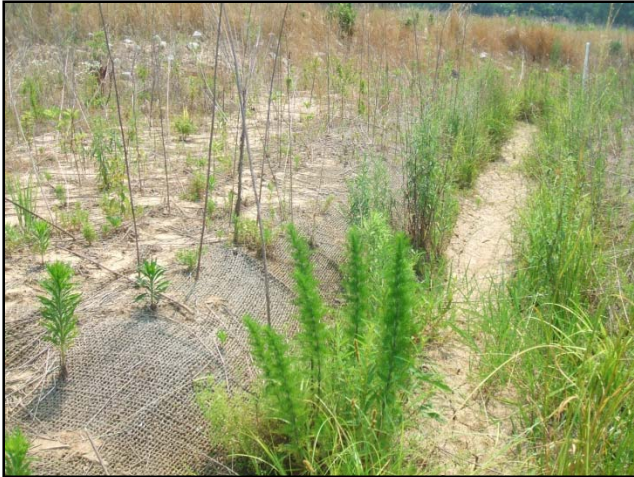
1. Poor Vegetation Cover-Main Channel
Dula Thoroughfare (5/2008)

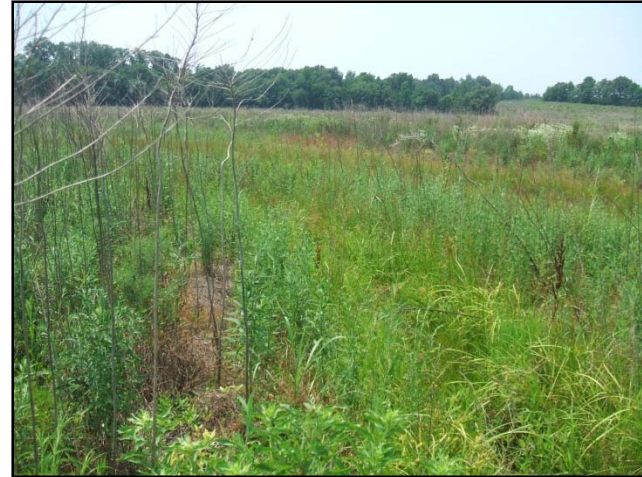
2. In-Stream Vegetation-Main Channel
Dula Thoroughfare (5/2008)

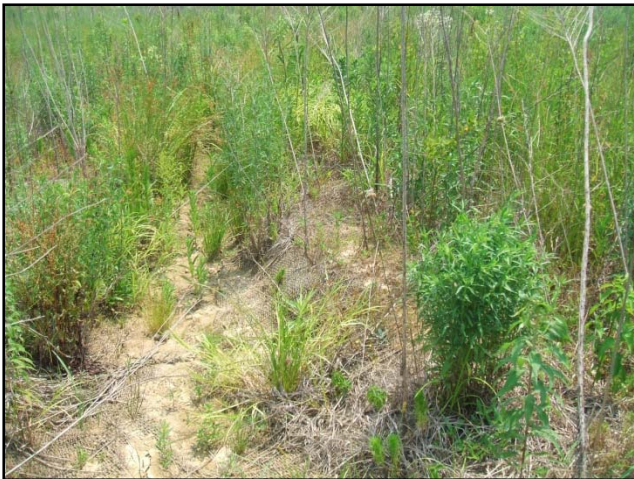
3. Poor Vegetation Cover-Tributary
Dula Thoroughfare (5/2008)

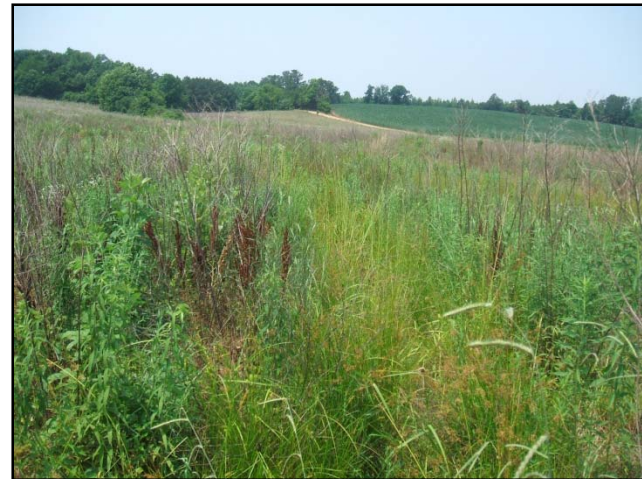
4. In-Stream Vegetation-Tributary
Dula Thoroughfare (5/2008)

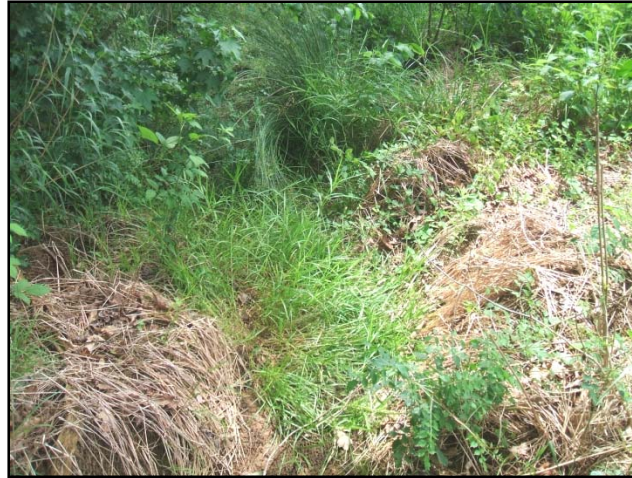
5. In-Stream Vegetation
UT Dula Thoroughfare (5/2008)

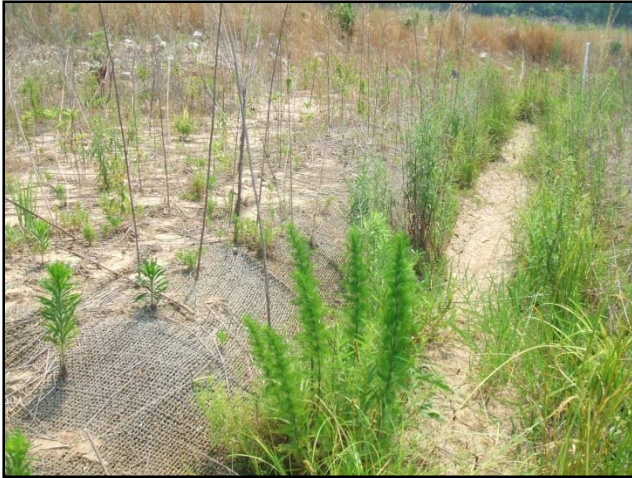
1. Poor Vegetation Cover-Main Channel
Dula Thoroughfare (5/2008)

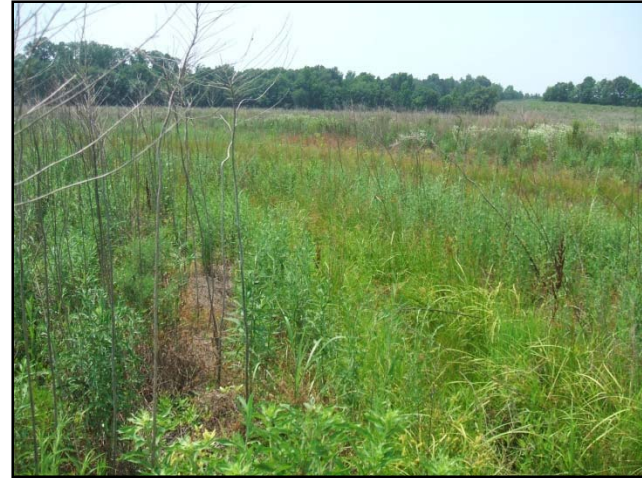
2. In-Stream Vegetation-Main Channel
Dula Thoroughfare (5/2008)

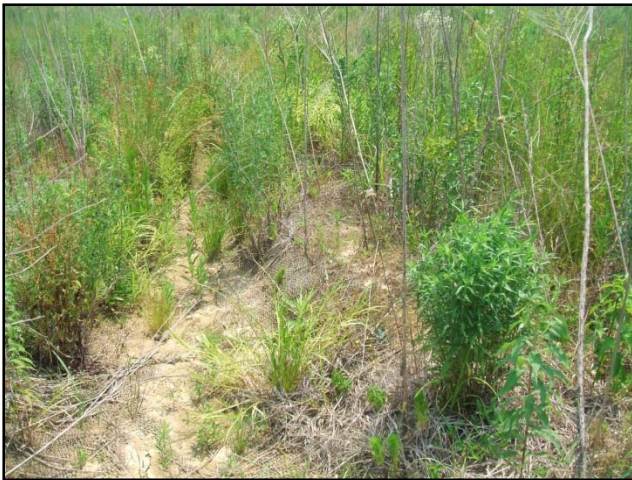
3. Poor Vegetation Cover-Tributary
Dula Thoroughfare (5/2008)

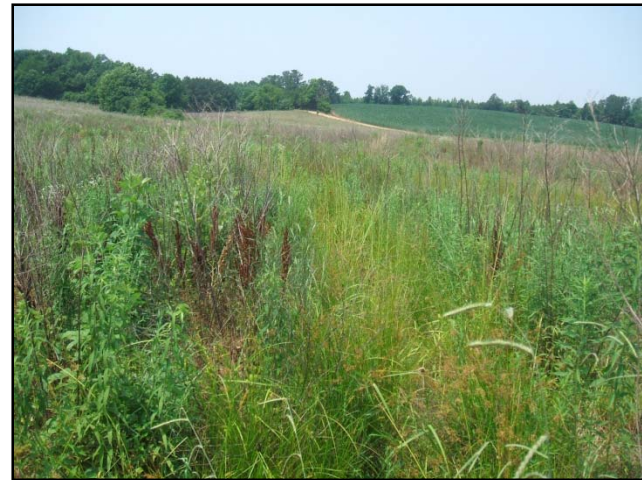
4. In-Stream Vegetation-Tributary
Dula Thoroughfare (5/2008)

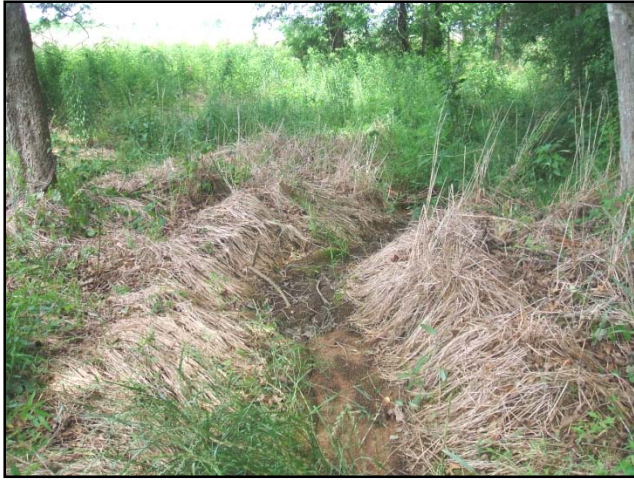
| Feature Issue | Station Numbers | Suspected Cause | Photo ID # |
|---|---|--|---|
| Channel Dry | N/A | Abnormal flow conditions along a few riffles | 5 |

5. Dry Channel
UT Dula Thoroughfare (5/2008)

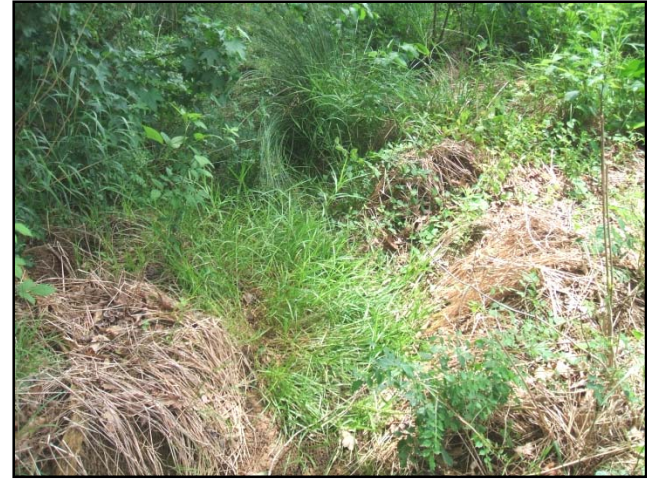
| Feature Issue | Station Numbers | Suspected Cause | Photo ID # |
|---|---|--|---|
| In-Stream Vegetation | N/A | Vegetation growing in middle of channel | 6 |

6. In-Stream Vegetation
UT Dula Thoroughfare (5/2008)
