**Dula Thoroughfare Stream and Wetland Restoration
Project No. 65
2009 Monitoring Report: Year 3 of 5**

February 2010 (Revised April 2010)

Prepared for: NCDENR-EEP
1652 Mail Service Center
Raleigh, NC 27699-1652

Prepared by: Jordan, Jones & Goulding
9101 Southern Pine Blvd., Suite 160
Charlotte, NC 28273

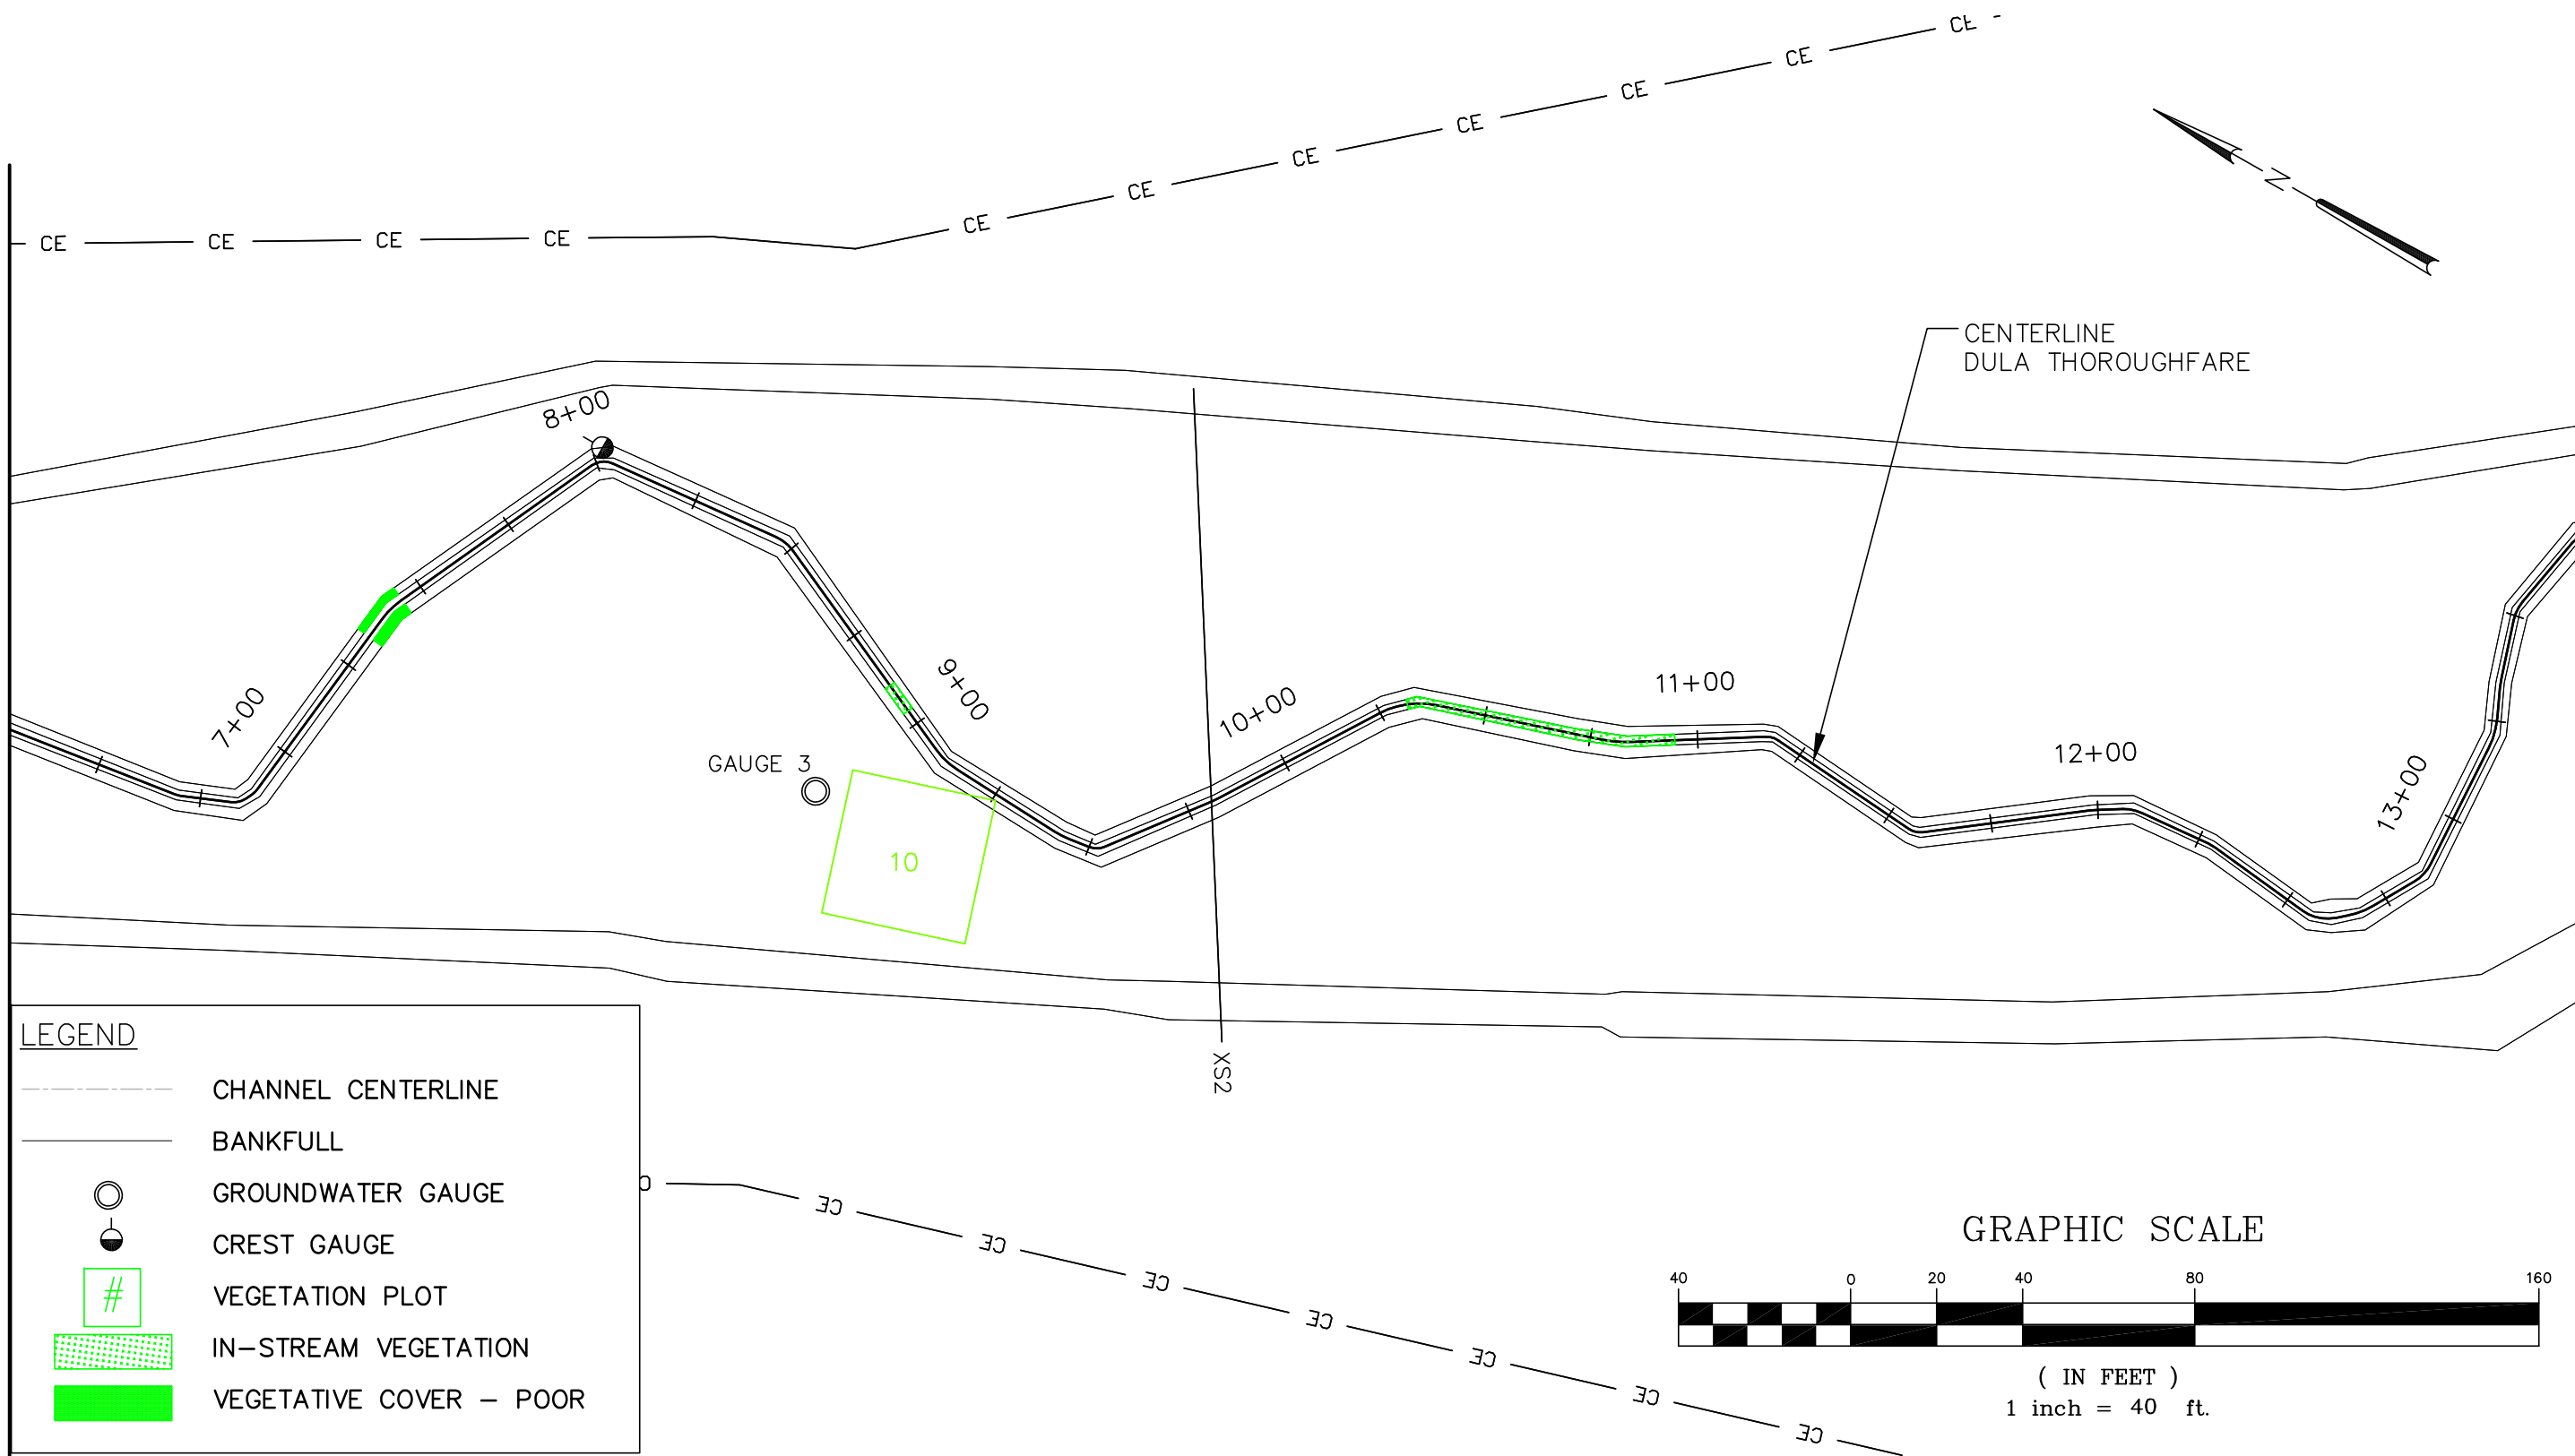
FIGURE 1.2a
 CURRENT CONDITION PLAN VIEW

Based on current monitoring data and the visual inspection, the channel appears to be functioning properly and maintaining stability. No erosion failure was observed along this reach. In-stream vegetation and poor streambank vegetation cover were observed and noted in the Current Condition Plan View (CCPV, Appendix 1.2). The substrate along the entire reach was dominated by silt deposition.

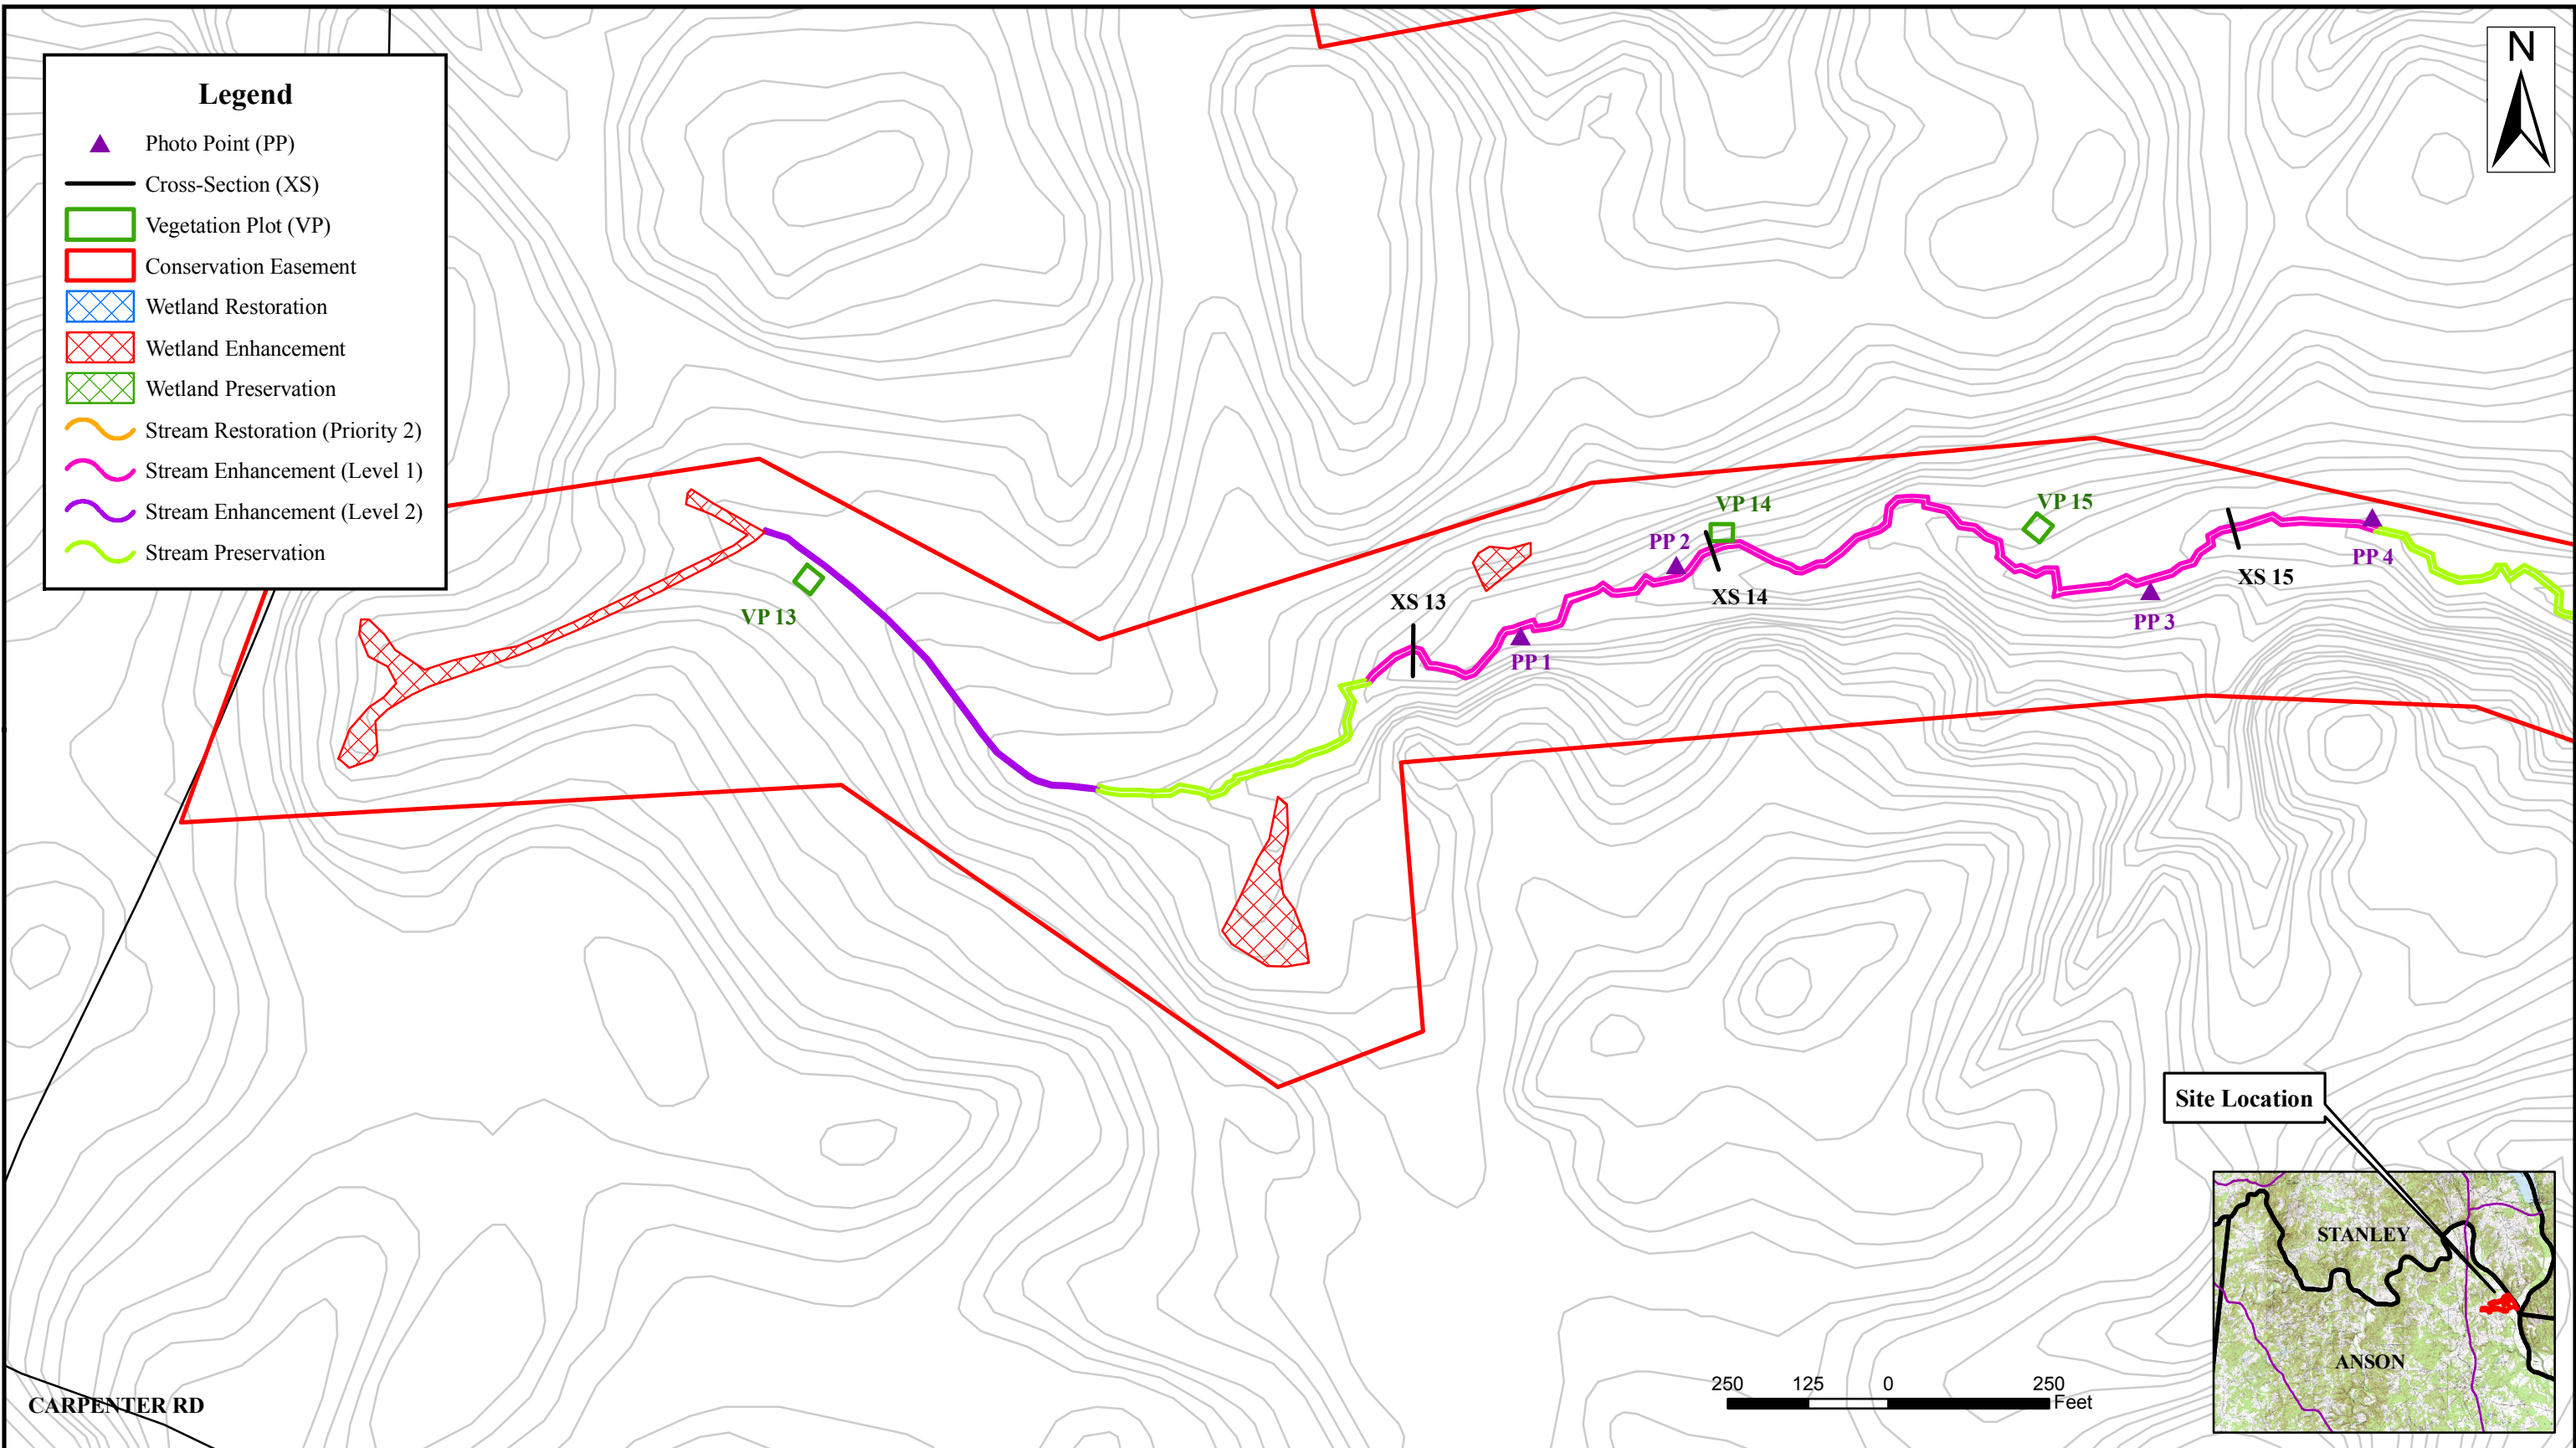
Appendix 1. General Figures and Plan Views
Figure 1.2b. Current Condition Plan View Map
UT to Dula Thoroughfare Stream Restoration
Anson County, NC
Year 3 of 5

During JJG's assessment, the channel had normal flow conditions with riffles, runs, and pools present. Approximately midway down the project reach (between the first and second cross-vane triplets), the water in the channel disappears and then reappears 50 ft downstream. All cross-vanes triplets appear to be stable and are not showing any signs of erosion or piping.

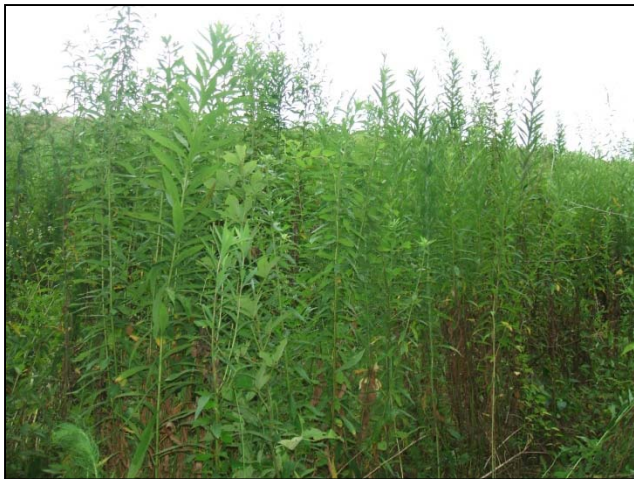
Monitoring Plot 14 (7/2009)
UT Dula Thoroughfare

Vegetation Plot ID	Vegetation Survival Threshold Met (Y/N)
Plot 8	Y
Plot 9	Y
Plot 10	Y
Plot 11	Y
Plot 12	Y
Plot 13	Y
Plot 14	N
Plot 15	N
