Dula Thoroughfare Stream and Wetland Restoration Project No. 65 2010 Monitoring Report: Year 4 of 5

June 2011

Prepared for: NCDENR-EEP
1652 Mail Service Center
Raleigh, NC 27699-1652

Prepared by: Jordan, Jones & Goulding
309 E. Morehead St., Suite 110
Charlotte, NC 28202

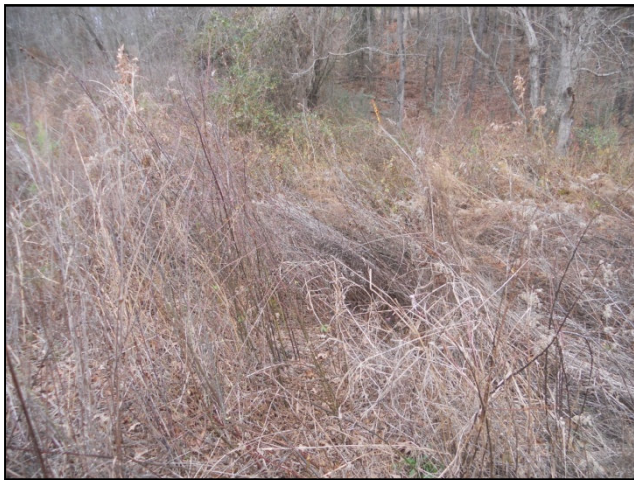
Vegetation Plot 14
(1/2011)

The 2010 vegetation monitoring results indicated that the main reach of DT appears to be meeting vegetation success criteria. However, the UT to DT results indicate the Site did not meet the 2010 vegetation success criteria. The DT and the UT to DT site density are approximately 810 and 243 planted stems per acre, respectively. The DT exceeds the year 4 goal of 288 planted stems per acre. The UT to DT did not exceed the year 4 goal for 288 planted stems per acre, but with natural recruitment and re-planting of woody vegetation, the planted riparian area could improve and exceed the vegetation success criteria by year five. Natural recruitment in Plot 13 and Plot 15 of the UT to DT vegetation sites increased dramatically from MY 2009.

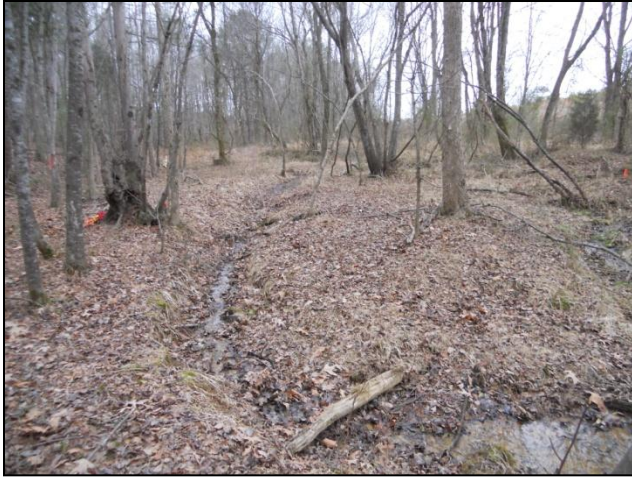
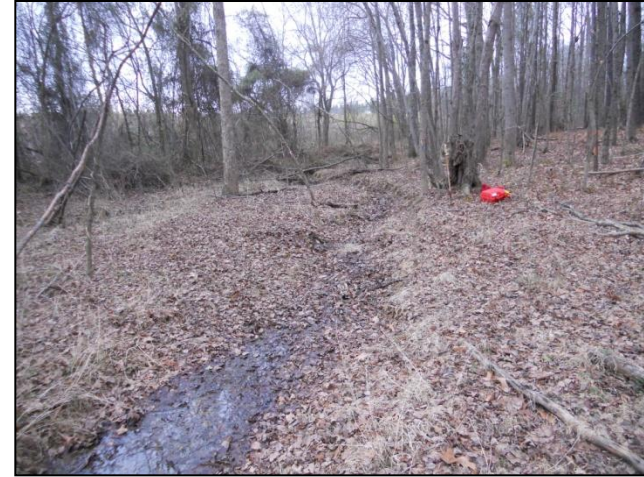
During JJG's assessment, the channel was generally dry until approximately 200 feet upstream of cross-section 7. Beyond cross-section 7, the channel had normal flow conditions with riffles, runs, and pools present. Approximately midway down the project reach (between the first and second cross-vane triplets), the water in the channel disappears and then reappears 50 ft downstream. All cross-vanes triplets appear to be stable and are not showing any signs of erosion or piping. The surveyed cross-sections have remained stable over the last year.

Cross-Section 7-Upstream
UT Dula Thoroughfare (2/2011)

Cross-Section 7-Downstream
UT Dula Thoroughfare (2/2011)

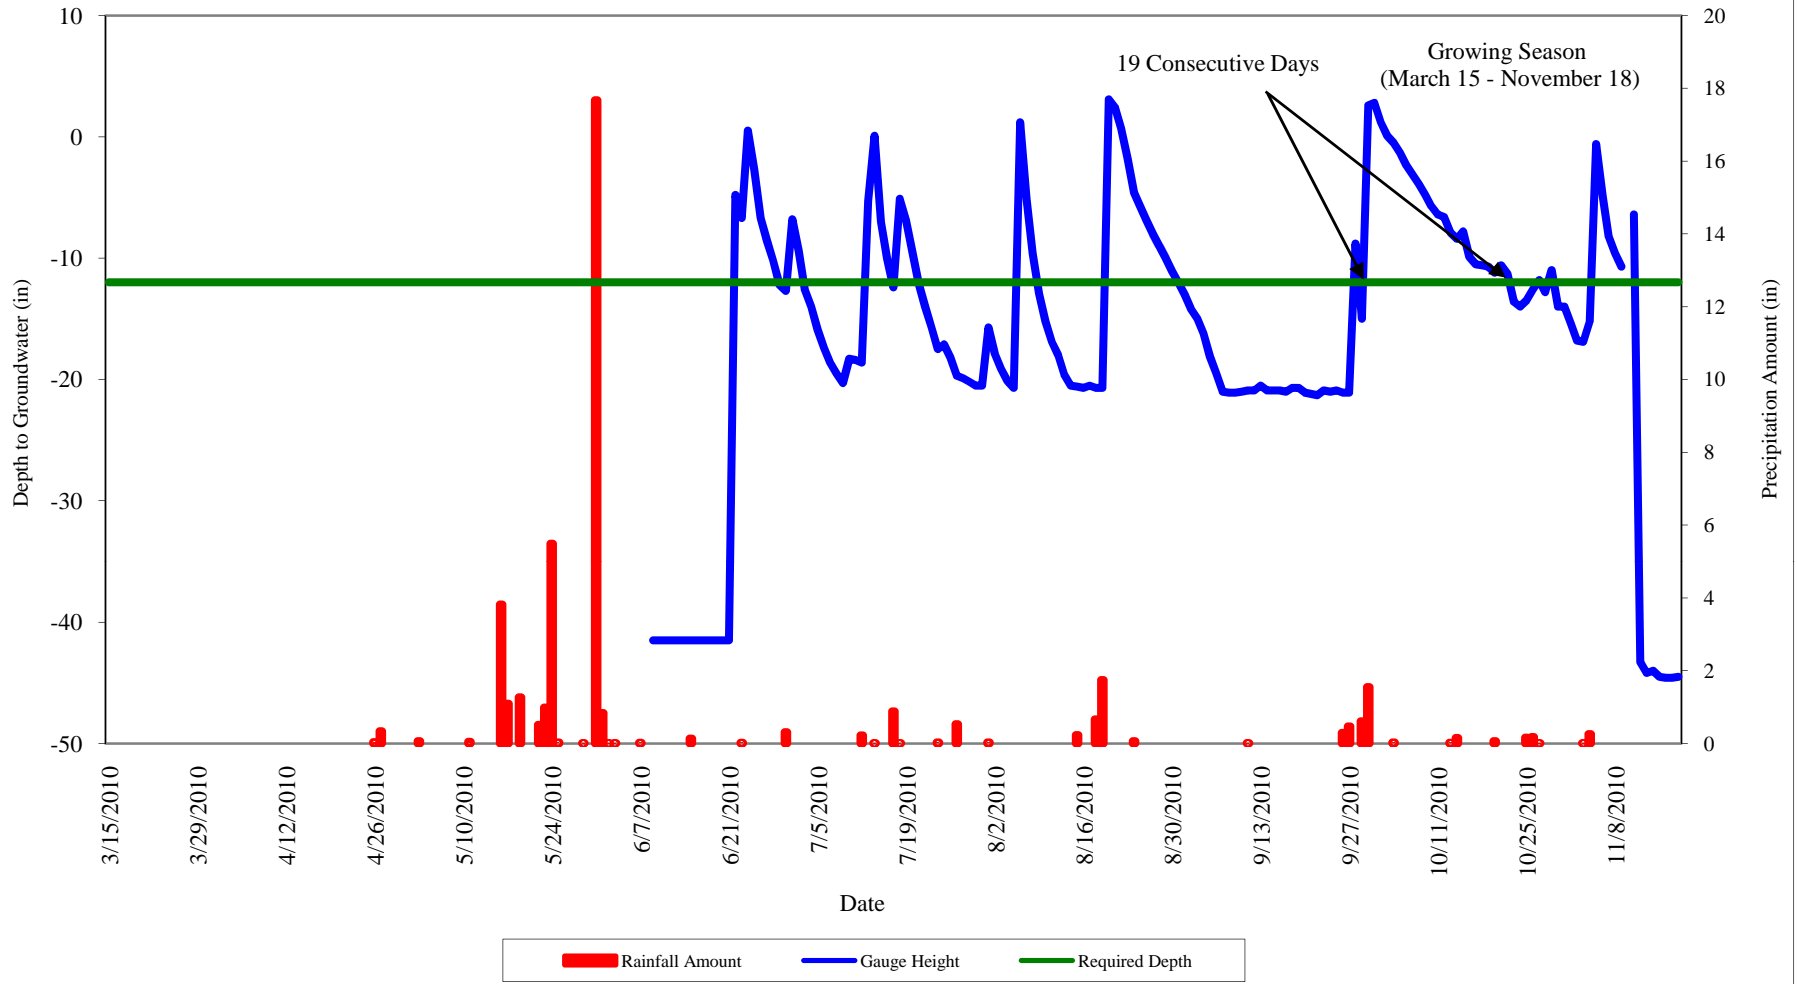
Appendix 5.1 Precipitation - Water Level Plots for Gauges
Dula Thoroughfare Stream and Wetland Restoration/EEP Project No. 65
Groundwater Gauge 1
Monitoring Year 4 of 5

could not be accessed from September 1 through December 31 due to the landowner's hunting moratorium. Data was collected again in January 2011. Data from Groundwater gauge 1, which was replaced June 9, 2010, was processed from June 22 through the end of the growing season (data from June 9 – June 21 was not included due to an apparent malfunction). Groundwater gauge 2 was found to be malfunctioning at the January 2011 field survey and was replaced. Therefore, data from Groundwater gauge 2 was processed from the beginning of the growing season through July 27, 2010. Data from Groundwater gauge 3 was processed for the entire growing season.
