# Dula Thoroughfare Stream and Wetland Restoration

**EEP Project No. 65**  
**2011 Monitoring Report: Year 5 of 5**

**Construction Completed: February 2007**  
**Submission Date: April 2012**

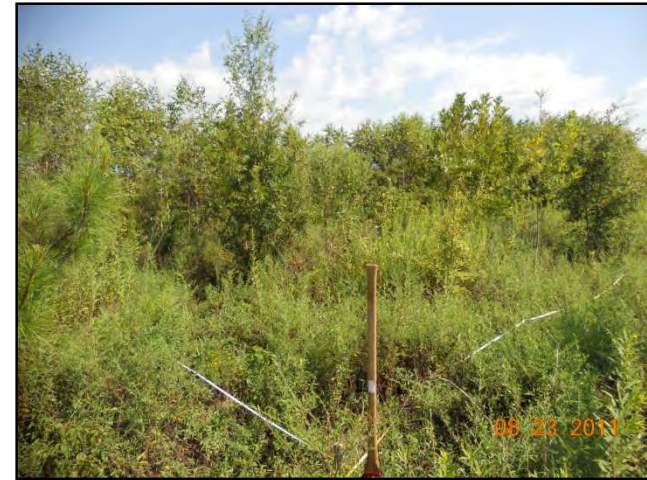
Vegetation Plot 8  
(MY 5 - 8/2011)

The 2011 vegetation monitoring results indicated that the main reach of DT has met the vegetation success criteria in four (Plots 8, 9, 10, and 11) of the five plots. Results for the UT to DT indicate that two (Plots 14 and 15) out of three did not meet the 2011 vegetation success criteria. Potential causes of unsuccessful establishment in Plot 12 were likely due to excessive inundation and flooding associated with the downstream beaver dam along DT. Woody vegetation growth observed in Plots 14 and 15 was limited due to competition with blackberry and other invasive species along UT to DT.

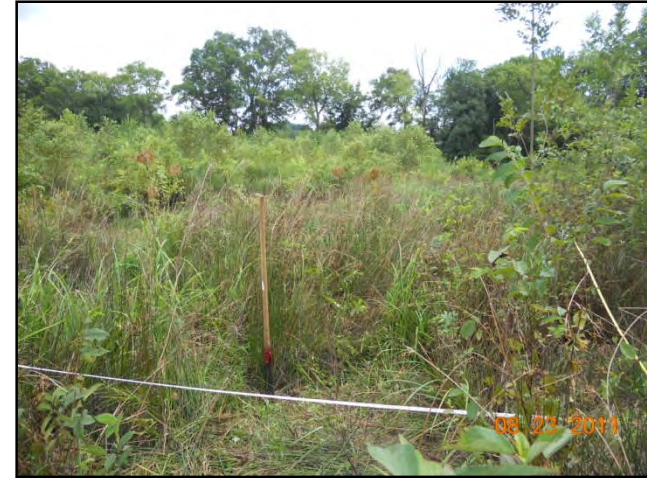
Vegetation Plot 12  
(MY 5 - 8/2011)

Although five of eight plots met the vegetation success threshold, the results from plots 12, 14 and 15 did not substantially decrease the overall site's average survivability estimate, having an average of 592 living woody stems per acre per plot. Monitoring data averaged from both sites recorded an average of 15 planted live stems per plot. Plots in DT and UT to DT that have met the success criteria had stem densities of approximately 802 and 364 planted stems per acre, respectively.

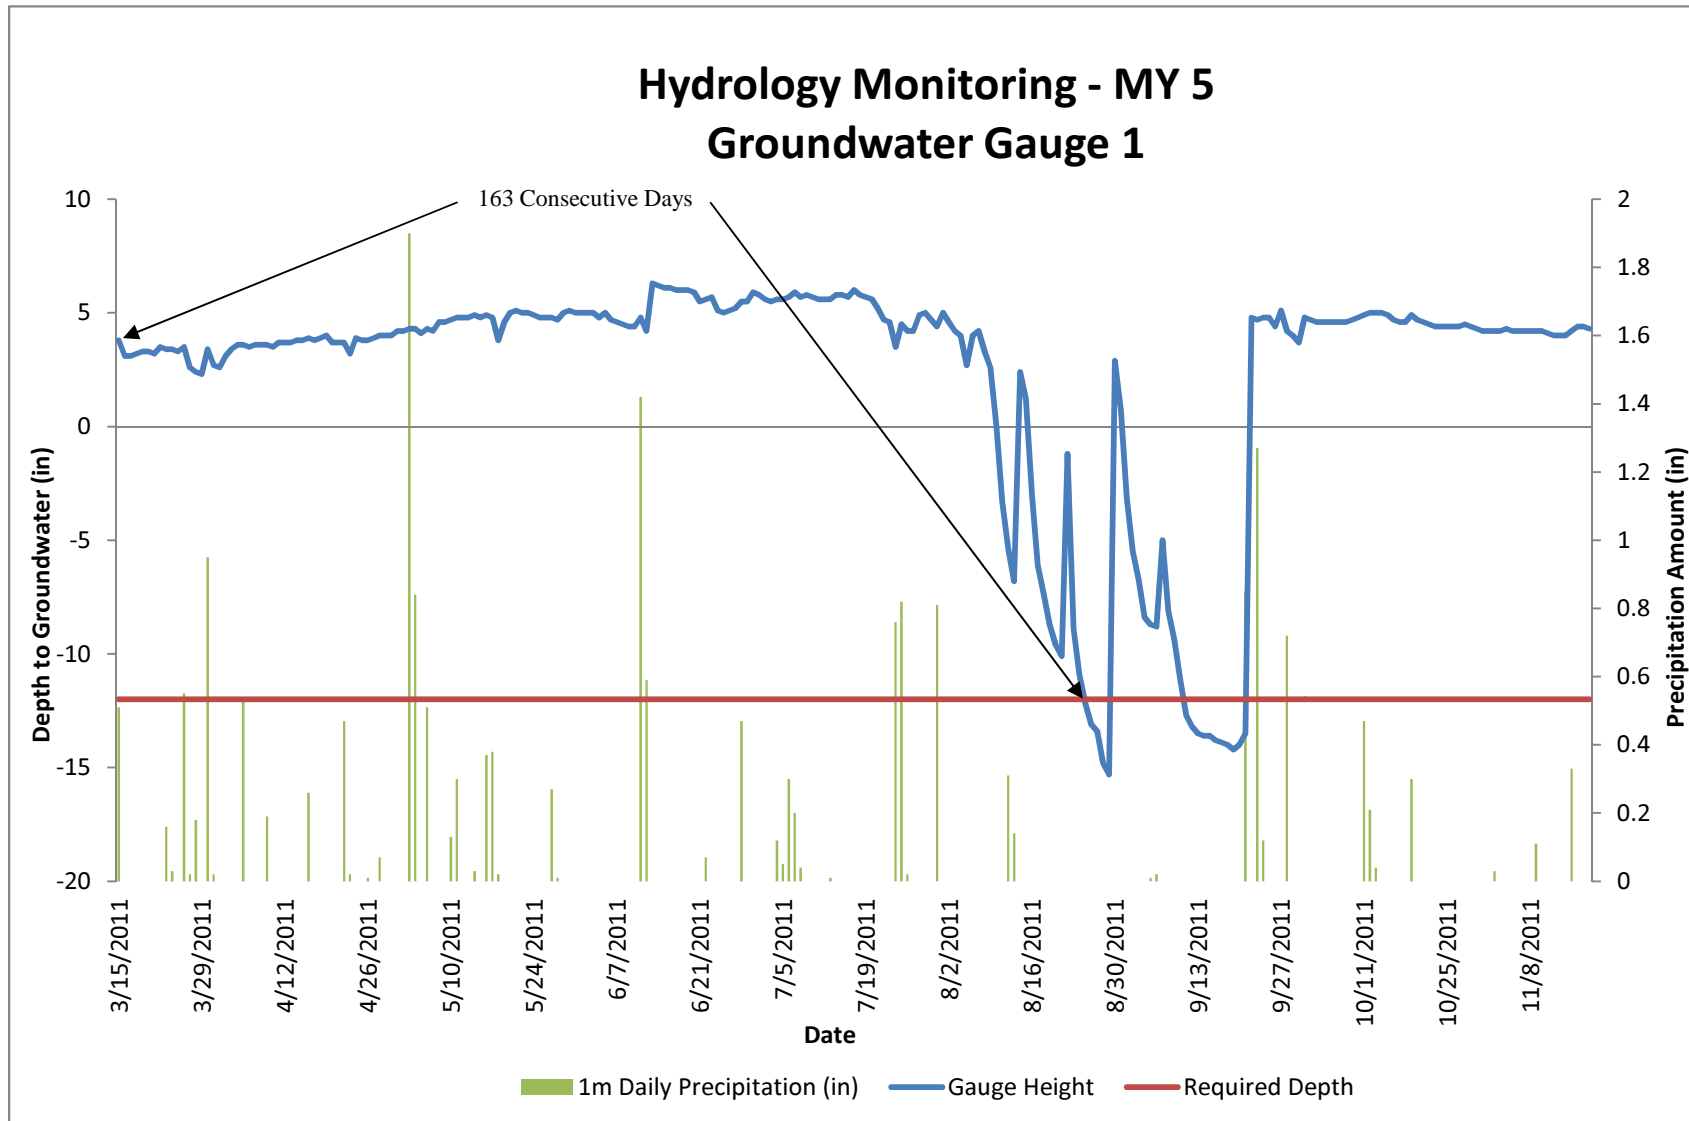
**Figure 7a: Precipitation and Water Level Plots for Gauges**  
 Dula Thoroughfare Stream and Wetland Restoration/EEP Project No. 65  
 Monitoring Year 5 of 5

All gauges on Site achieved the wetland success criterion of soil saturation within the upper 12 inches for the required minimum of 31 consecutive days, which is 12.5 percent of the growing season. There were no problem areas observed within the wetland restoration zones for the DT Site. Within the wetland zones, hydrophytic vegetation and hydrology indicators have developed. The planted woody stem species throughout the wetland areas are meeting the required success criteria; however, minimal woody stems were observed within plot 14. It is suspected that the planted stem rates may have been too low in this area to achieve success criteria. With the natural recruitment of woody vegetation, the planted riparian area could improve and exceed the vegetation success criteria by year five. Please refer to Appendix E for the wetland plots and a summary of wetland criteria attainment.
