# **Camp Branch Stream Restoration**

## **Project No. 92350**

### **2009 Monitoring Report: Year 3 of 5**

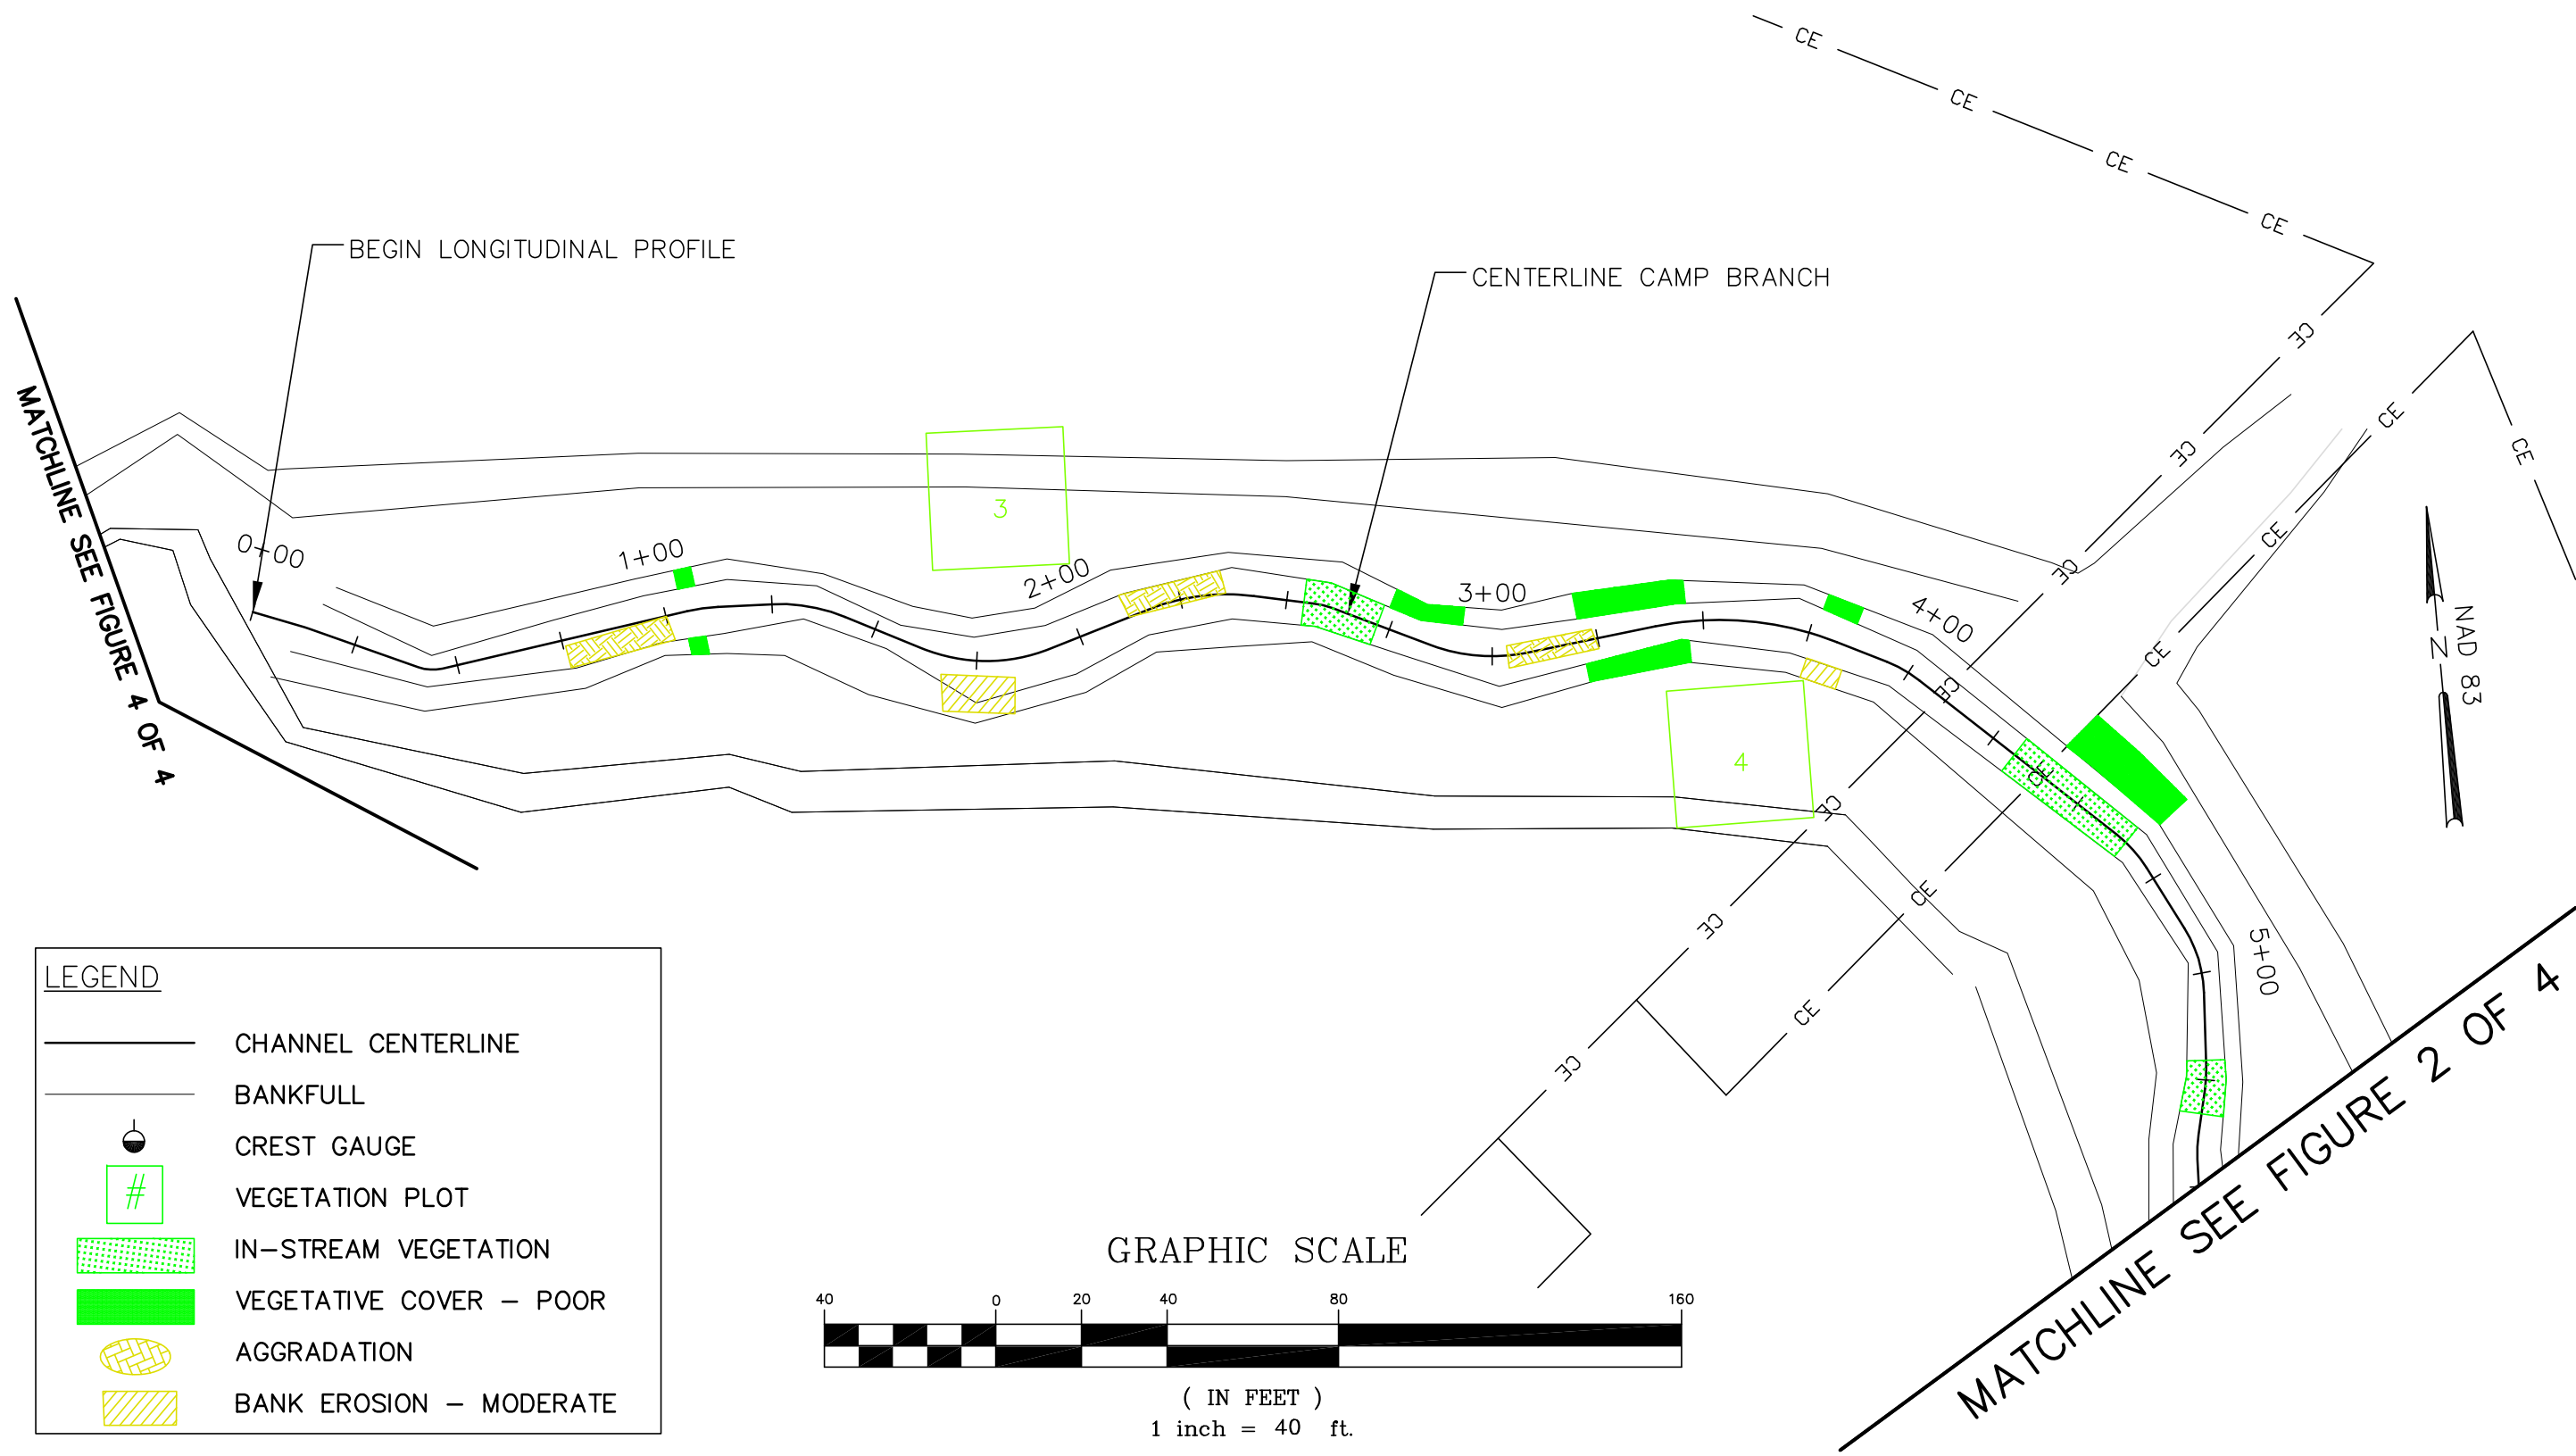
FIGURE 1.2  
 CURRENT CONDITION PLAN VIEW

LEGEND	
	CHANNEL CENTERLINE
	BANKFULL
	CREST GAUGE
	VEGETATION PLOT
	IN-STREAM VEGETATION
	VEGETATIVE COVER - POOR
	AGGRADATION
	BANK EROSION - MODERATE

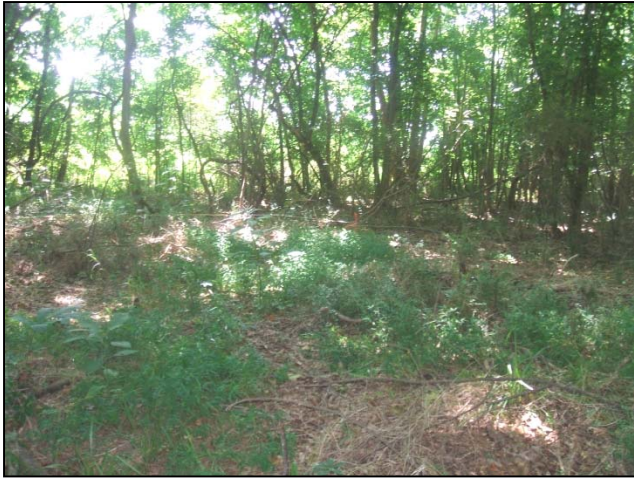
Monitoring Plot 1 (7/2009)

<b>Vegetation Plot ID</b>	<b>Vegetation Survival Threshold Met (Y/N)</b>
Plot 1	N
Plot 2	Y
Plot 3	Y
Plot 4	Y
Plot 5	Y
Plot 6	Y
Plot 7	Y

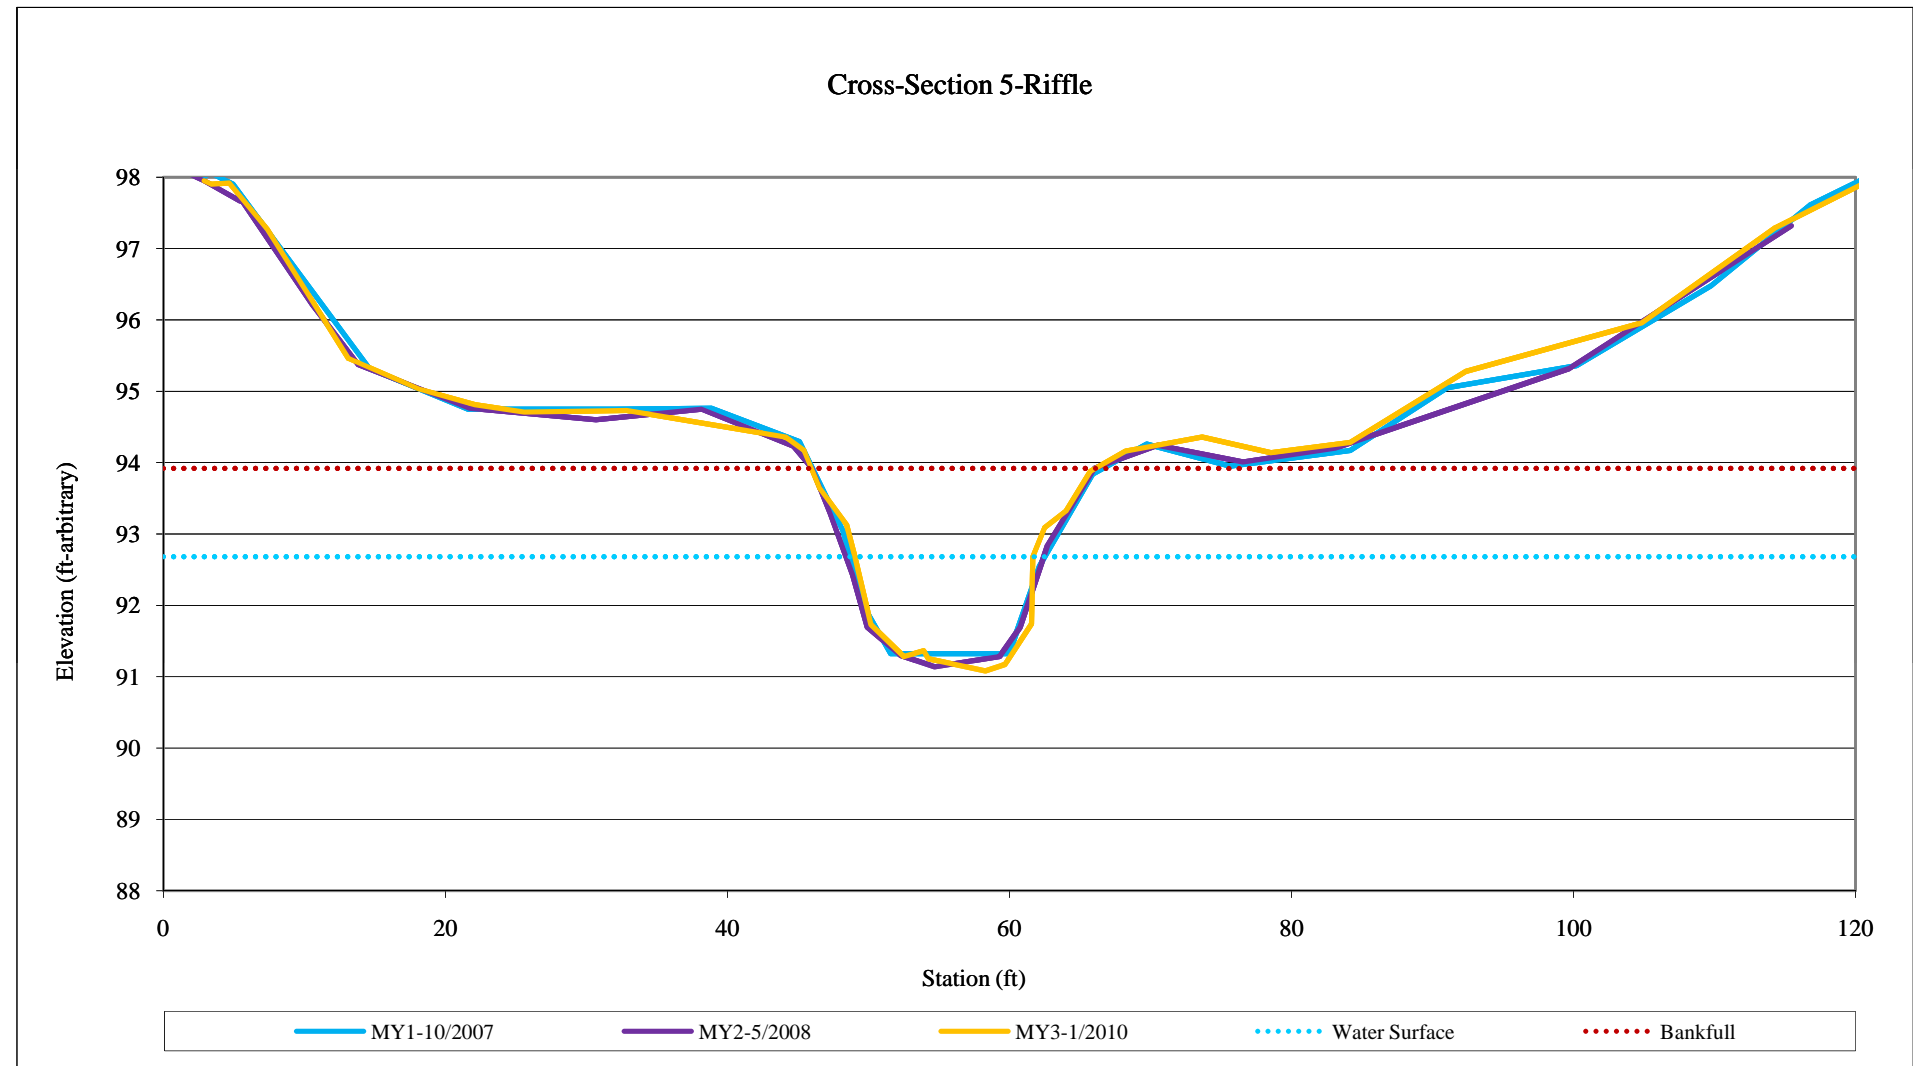
**Figure 4.1e. Cross-Sections with Annual Overlays**

Summary Data	
Bankfull Cross-sectional Area (ft <sup>2</sup> )	36.18
Bankfull Width (ft)	20.43
Bankfull Mean Depth (ft)	1.77
Bankfull Max Depth (ft)	2.84
Width/Depth Ratio	11.54
Entrenchment Ratio	4.97

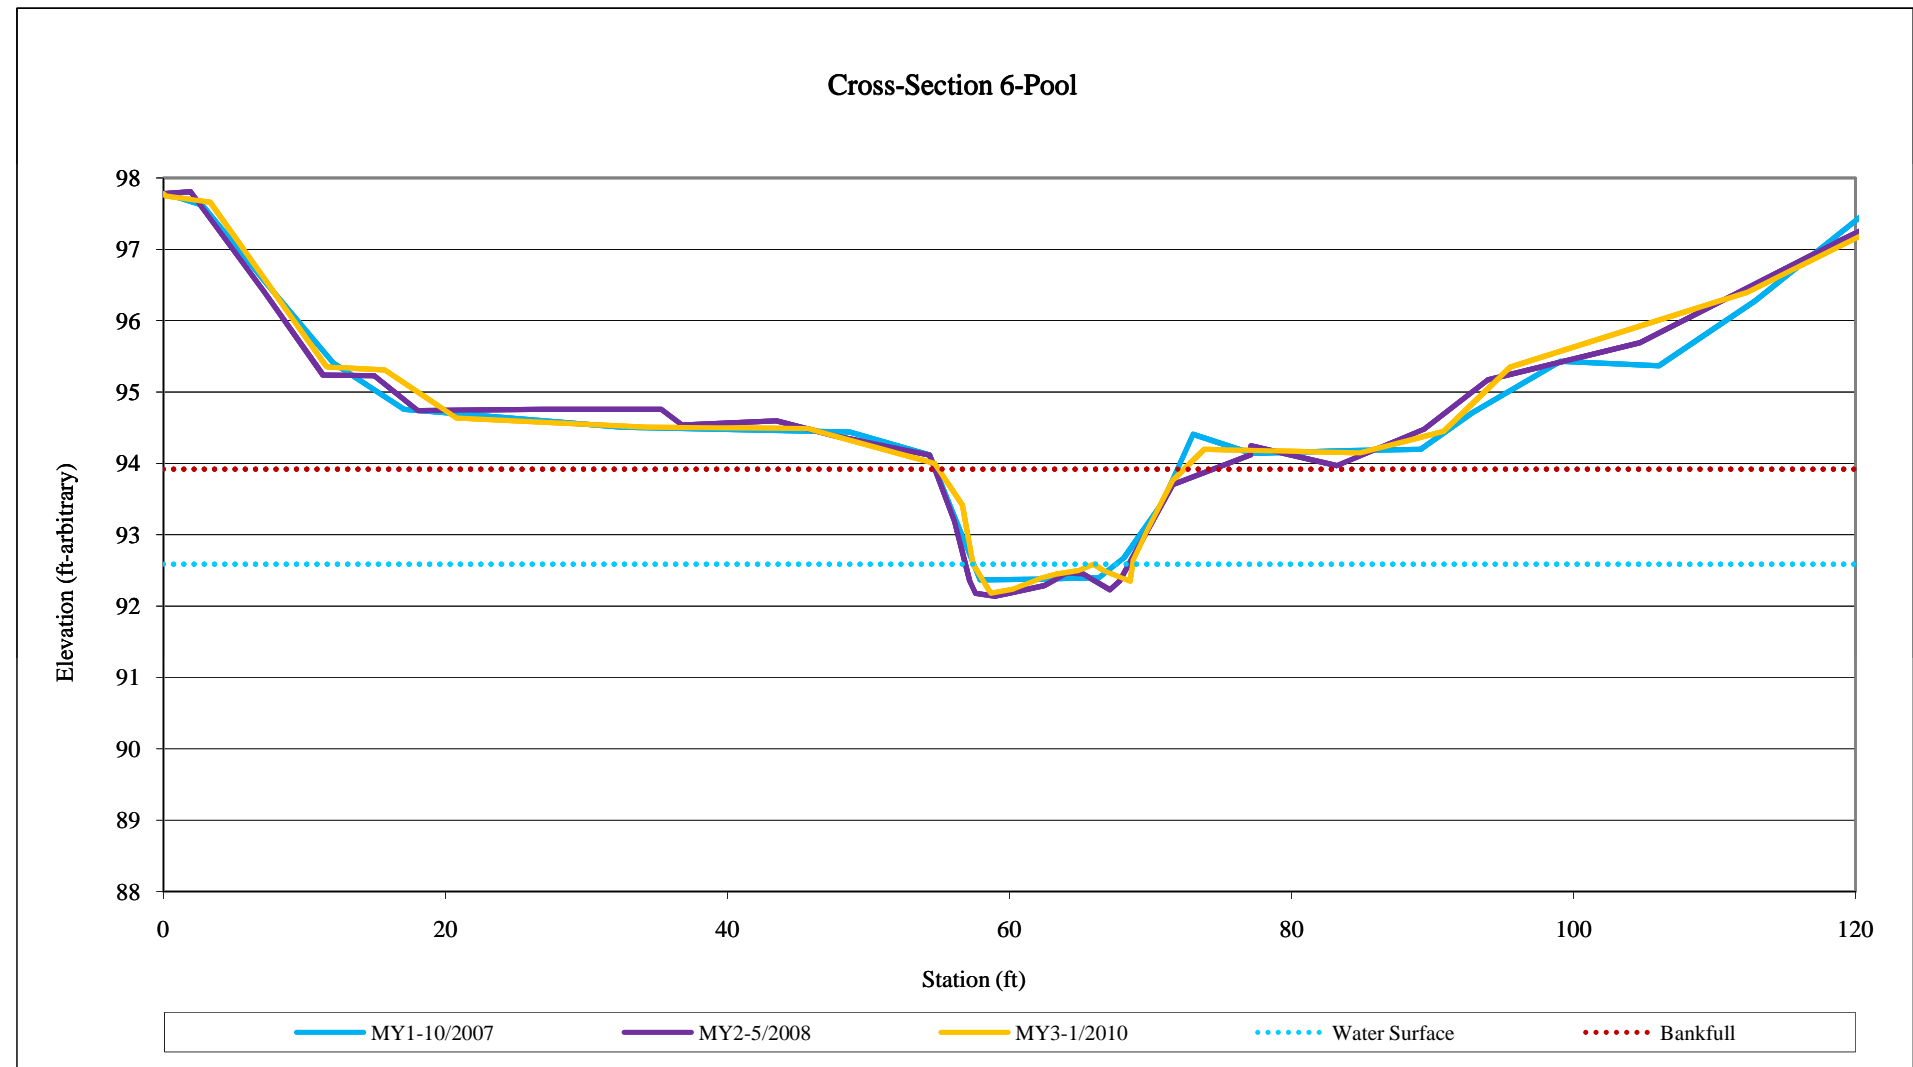
**Figure 4.1f. Cross-Sections with Annual Overlays**

Summary Data	
Bankfull Cross-sectional Area (ft <sup>2</sup> )	24.20
Bankfull Width (ft)	20.95
Bankfull Mean Depth (ft)	1.16
Bankfull Max Depth (ft)	1.94
Width/Depth Ratio	18.06
Entrenchment Ratio	4.67

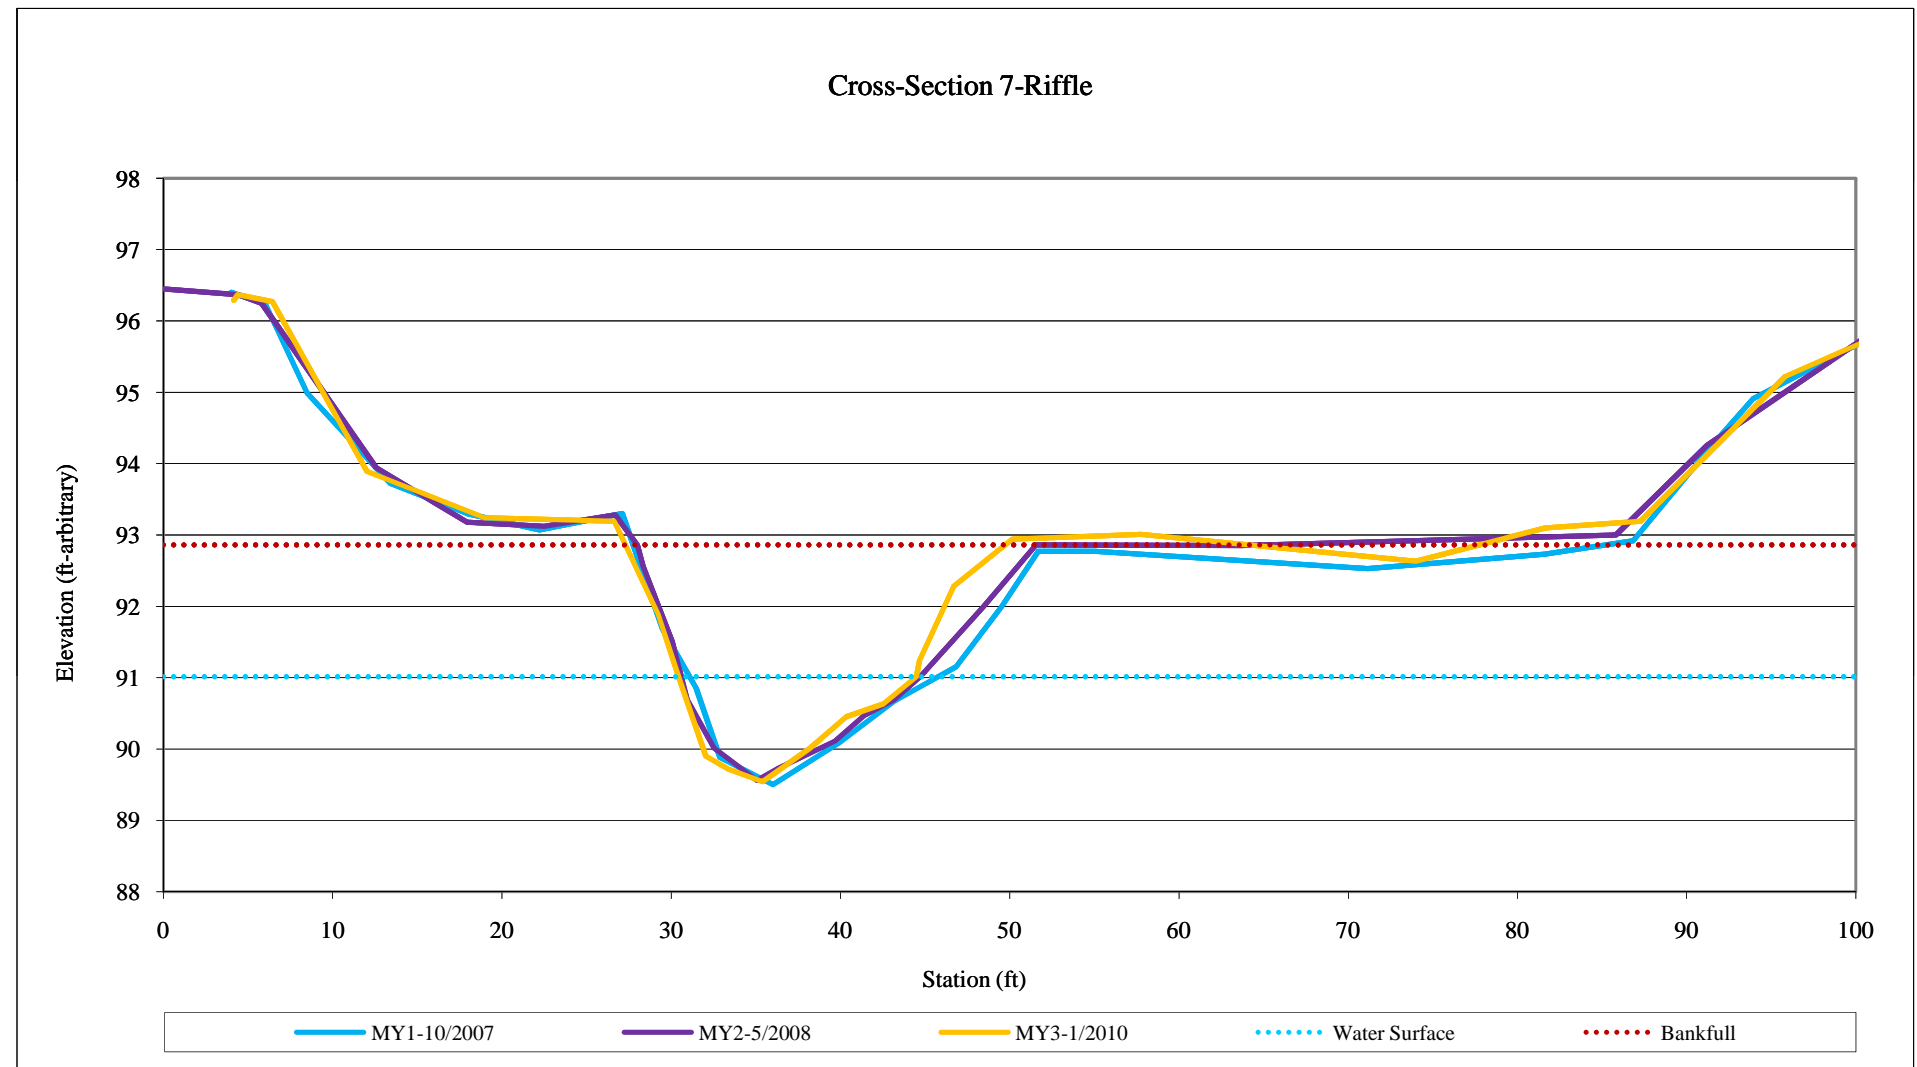
**Figure 4.1g. Cross-Sections with Annual Overlays**

Summary Data	
Bankfull Cross-sectional Area (ft <sup>2</sup> )	43.91
Bankfull Width (ft)	22.53
Bankfull Mean Depth (ft)	1.95
Bankfull Max Depth (ft)	3.32
Width/Depth Ratio	11.55
Entrenchment Ratio	4.33

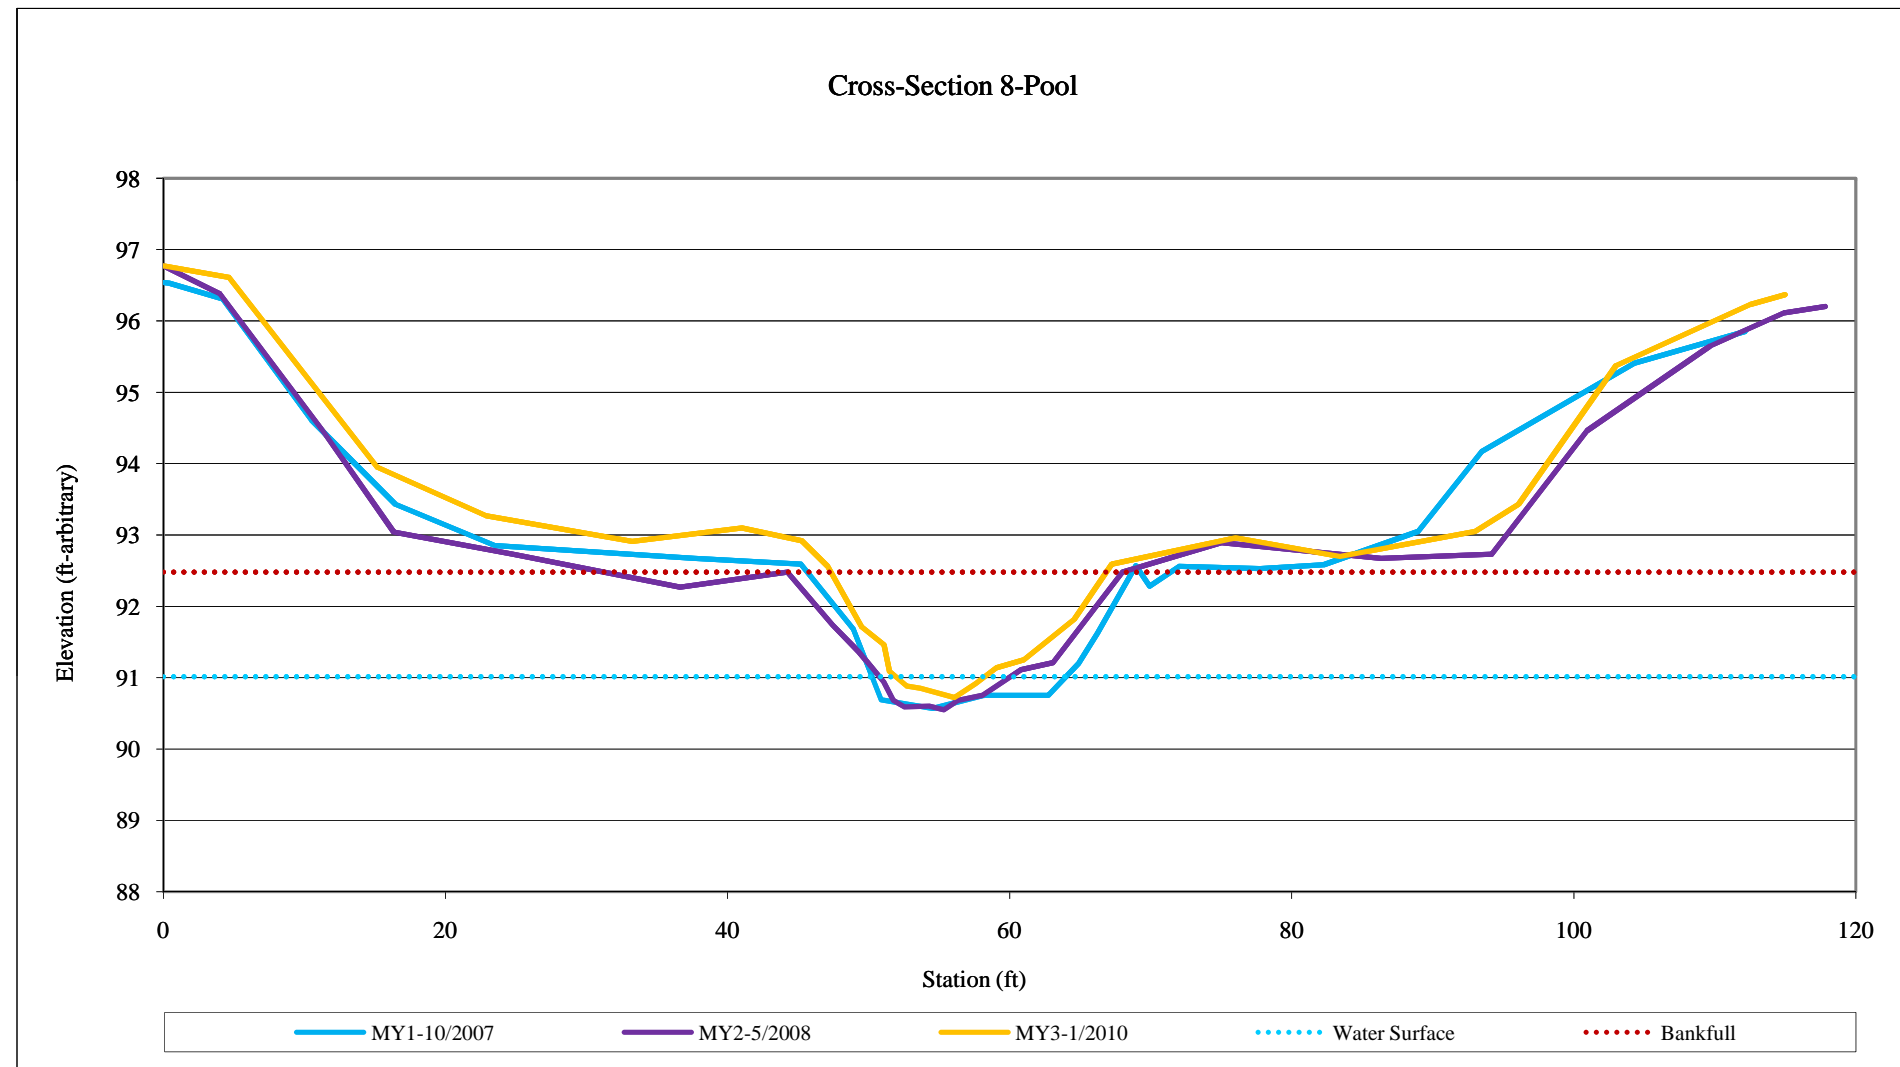
**Figure 4.1h. Cross-Sections with Annual Overlays**

Summary Data	
Bankfull Cross-sectional Area (ft <sup>2</sup> )	21.48
Bankfull Width (ft)	19.50
Bankfull Mean Depth (ft)	1.10
Bankfull Max Depth (ft)	1.76
Width/Depth Ratio	17.73
Entrenchment Ratio	4.36

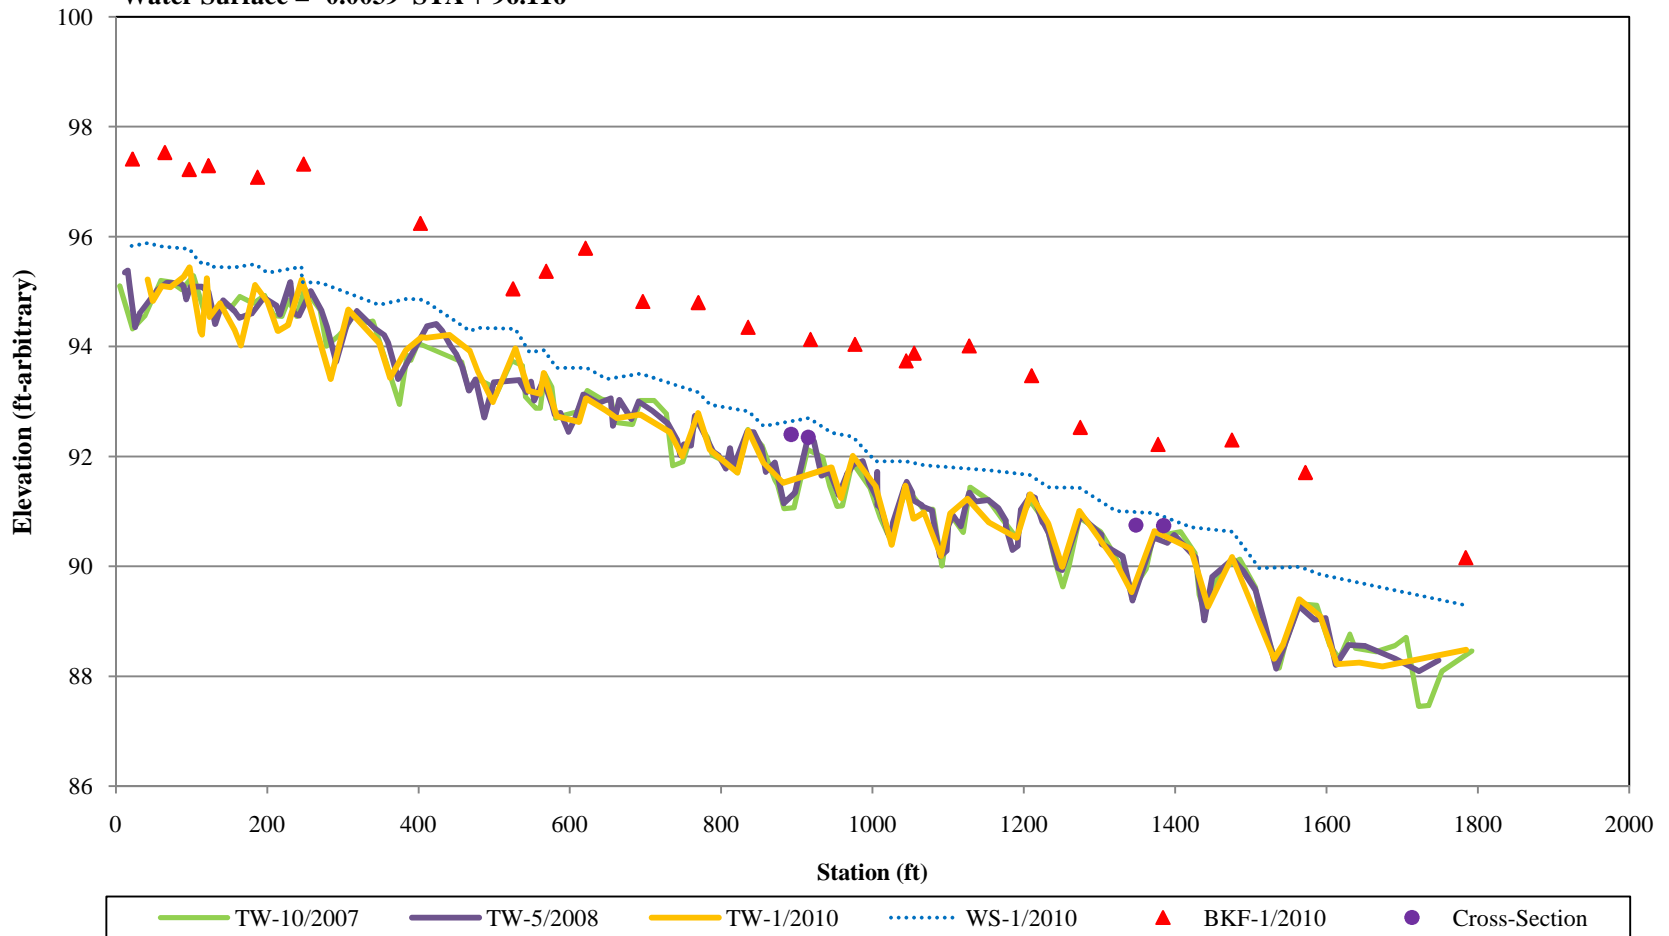
**Figure 4.2a. Longitudinal Profiles with Annual Overlays**  
**Camp Branch-Main Channel**  
**Longitudinal Profile**  
**2009 Monitoring Year**

Overall, the main channel is maintaining both lateral and vertical stability. The average bankfull width (20.9 ft) of the surveyed cross-sections falls within the proposed range of 16-22 ft. The thalweg profile appears to be stable, and is characterized by well-defined riffle and pool features. The average water surface slope and the average bankfull slope were the same for the surveyed reach, 0.0039 ft/ft. High sedimentation rates are evident at the lower end of the main channel, immediately upstream of the transition point from the restoration reach to the preservation reach. The shift in bankfull elevation and dimension from the restoration reach to the preservation reach could have resulted in high sediment deposition upstream of the convergence point. These areas will continue to be monitored closely for significant adjustments in the bed features and the channel thalweg.

**Bankfull/Top of Bank =  $-0.0039 \cdot \text{STA} + 97.77$**   
**Water Surface =  $-0.0039 \cdot \text{STA} + 96.116$**

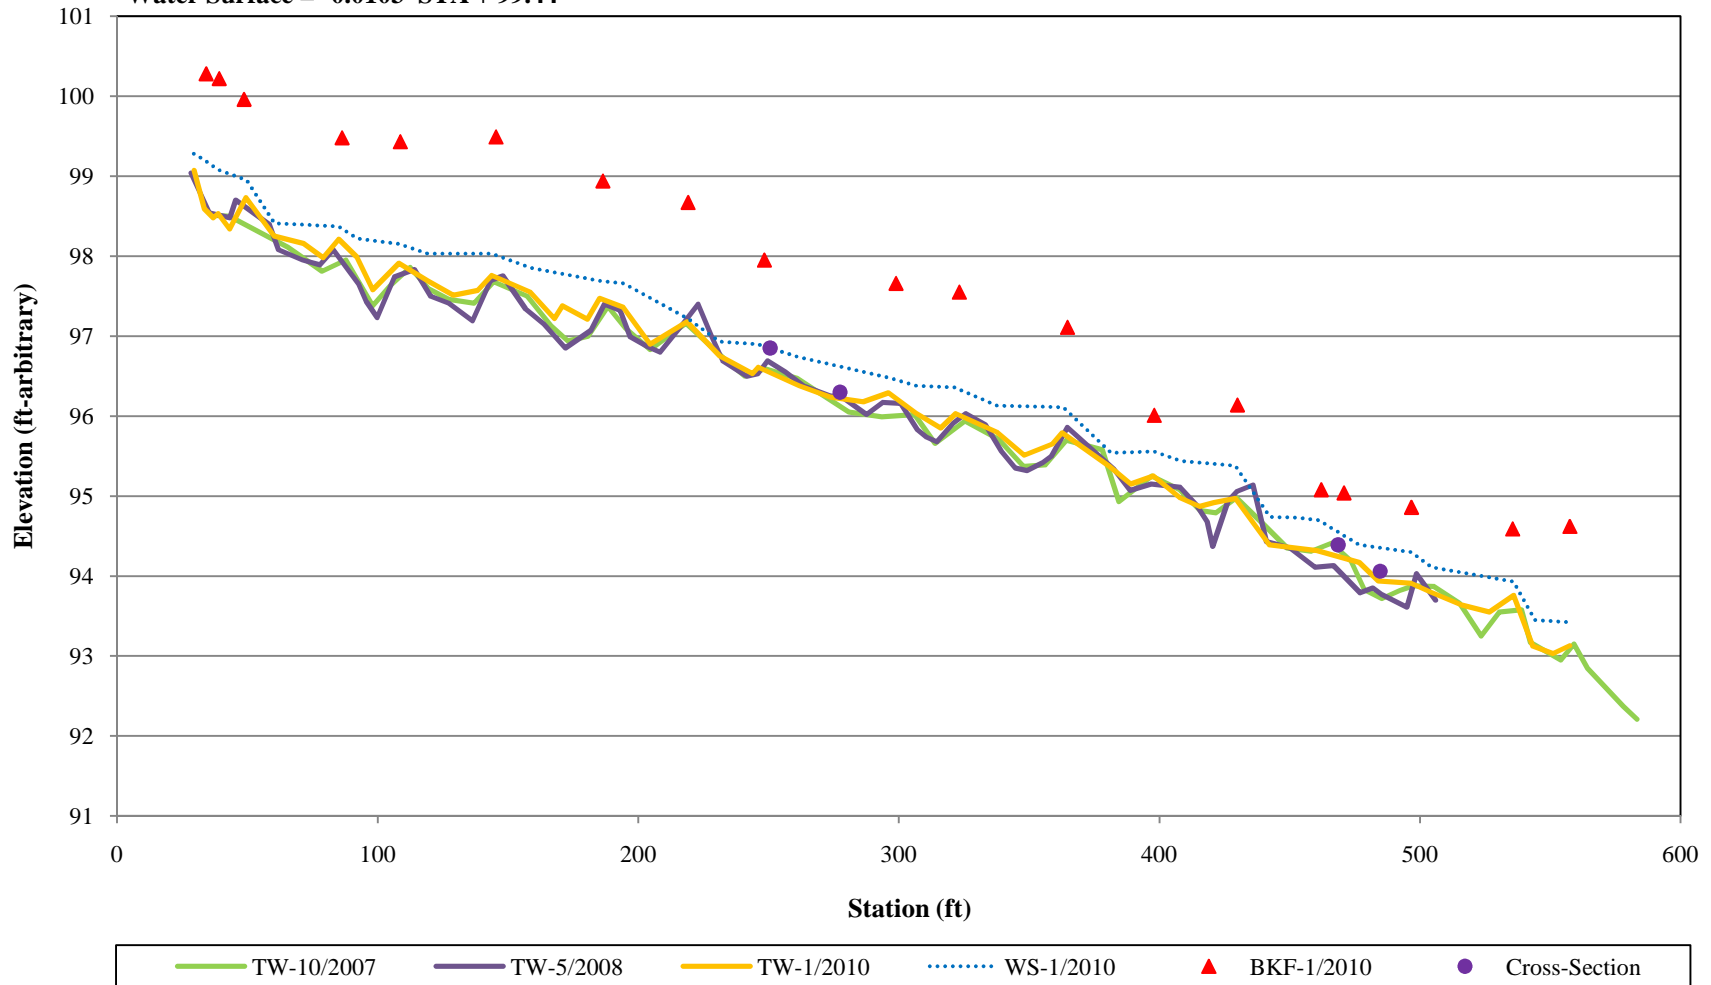
**Figure 4.2b. Longitudinal Profiles with Annual Overlays**  
**Camp Branch-Tributary**  
**Longitudinal Profile**  
**2009 Monitoring Year**

Based on current monitoring data and the visual inspection, the channel appears to be functioning properly and maintaining stability. No erosional failure was observed along this reach. The average bankfull width (6.8 ft) of the surveyed cross-sections is similar to the proposed width of 6.4 ft. The thalweg profile appears to be stable, and is characterized by well-defined riffle and pool features. The average water surface slope and the average bankfull slope were very similar for the surveyed reach, 0.0114 ft/ft and 0.0103 ft/ft, respectively.

**Bankfull/Top of Bank =  $-0.0114*STA + 100.8$**   
**Water Surface =  $-0.0103*STA + 99.44$**
