Camp Branch Stream Restoration

Project No. 92350

2010 Monitoring Report: Year 4 of 5

July 2011

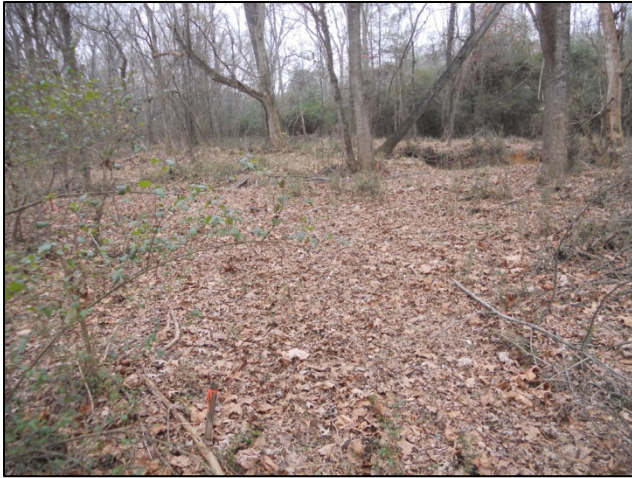
Vegetation Plot 1 (2/2011)

The monitoring data recorded an average of 34 planted live stems per plot. The site density is approximately 931 planted stems per acre, which exceeds the year 4 goal of 288 planted stems per acre. Although all plots met the vegetation success threshold with the exception of plot 1, the results from plot 1 did not affect the site's average survivability to be considered unsuccessful. Plot 1 is located in the preservation reach, which has an existing hardwood forest within the floodplain. The vigor of the live planted stems within the plots also appears to have been affected by wildlife activity and drought over the monitoring years. Planted stems that were struggling in previous years have continued to improve in vigor, with the exception of those in plot 1 as discussed above.
