Camp Branch Stream Restoration

EEP Project No. 92350
2011 Final Monitoring Report: Year 5 of 5

Construction Completed: February 2007
Submission Date: March 2012

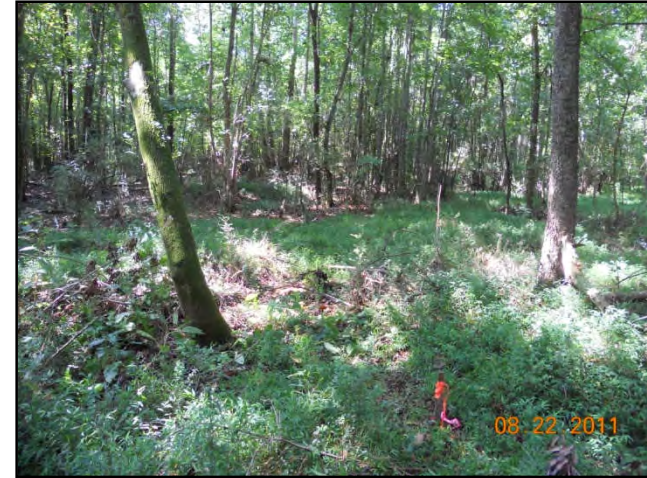
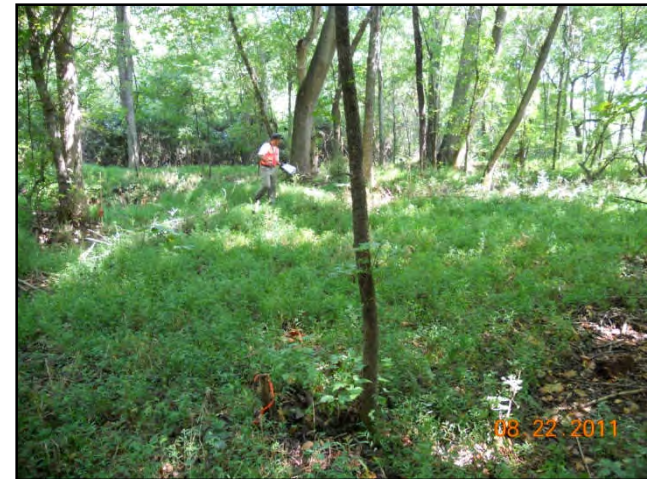
Vegetation Plot 1
(MY 5 - 8/2011)

Individually, all plots met the success criteria excluding Plot 1 (162 stems/acre). Plot 1 is located along the enhancement reach, within an existing hardwood forest riparian area. Limited survivability of planted species within Plot 1 is likely due to shading and competition from adjacent mature trees. Site-wide, the vigor of the live planted stems appears to have been affected by wildlife activity and drought conditions over the

previous monitoring years. Planted stems exhibiting poor growth in previous years have continued to improve in vigor, with the exception of those in Plot 1 as discussed above.
