**Monitoring Baseline Report  
Final  
Dye Branch II  
Stream Restoration Site**

**NCEEP Project Number: 92255  
Iredell County, North Carolina**

**Submitted to  
Ecosystem Enhancement Program  
North Carolina Department of Environment and Natural Resources  
October 2011**

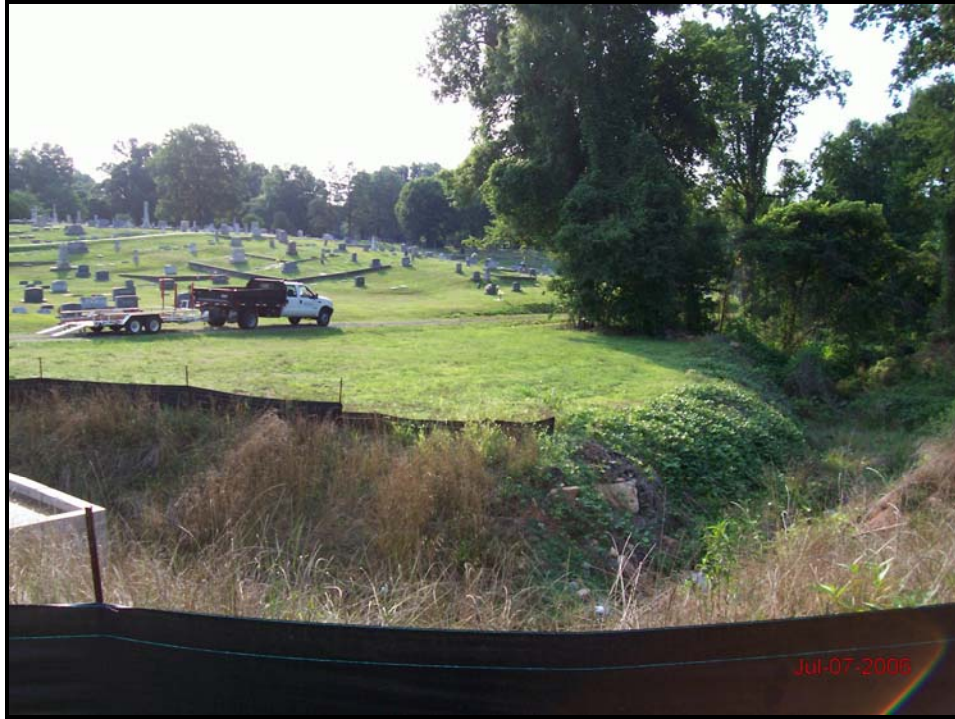
Cemetery Branch  
Pre-construction conditions in proximity to Photo Station 1

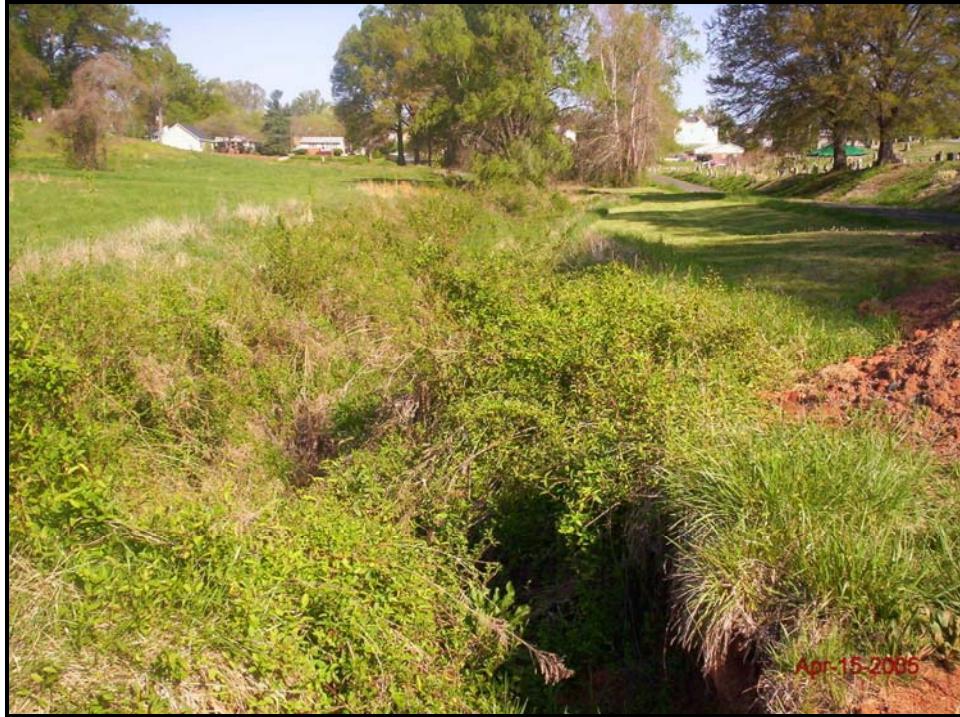
Cemetery Branch  
Pre-construction conditions in proximity to Photo Station 2

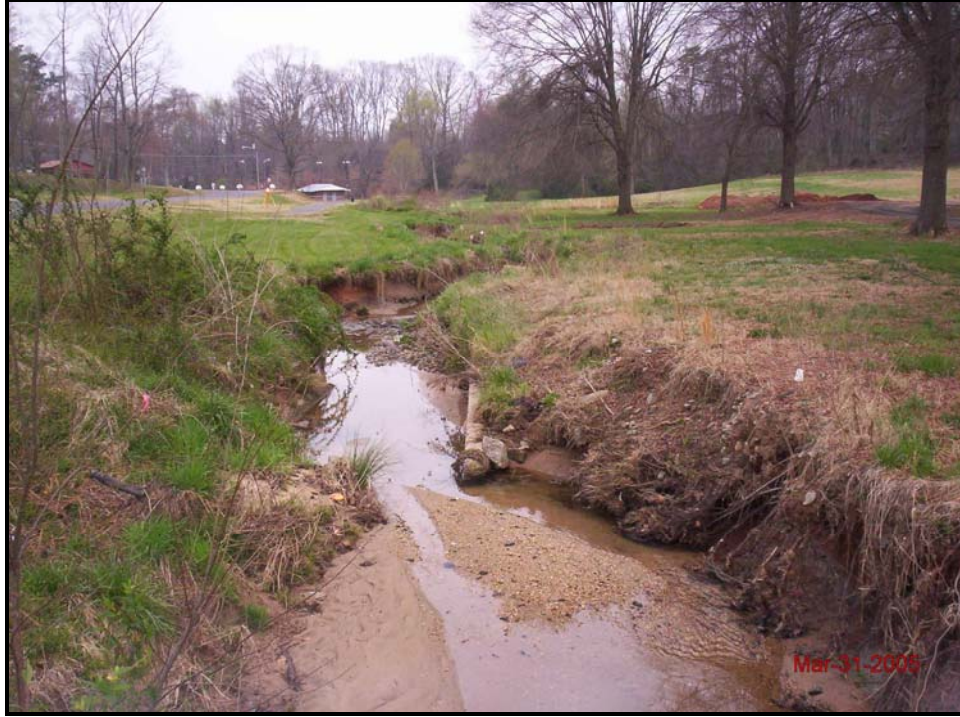
Dye Branch  
Pre-construction conditions in proximity to Photo Station 3

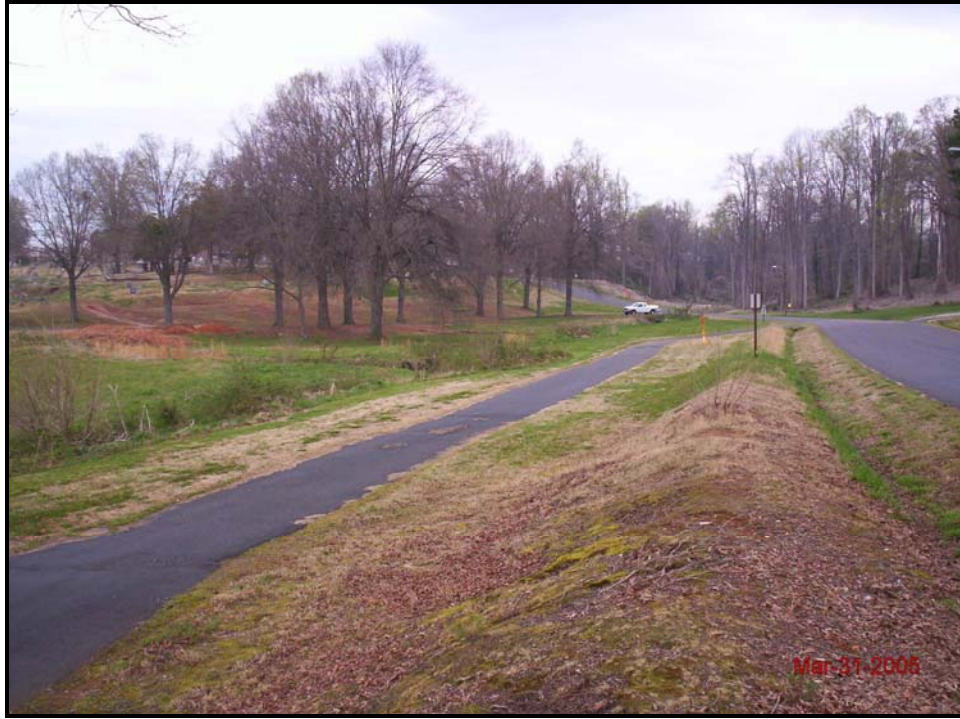
Dye Branch  
Pre-construction conditions in proximity to Photo Station 4

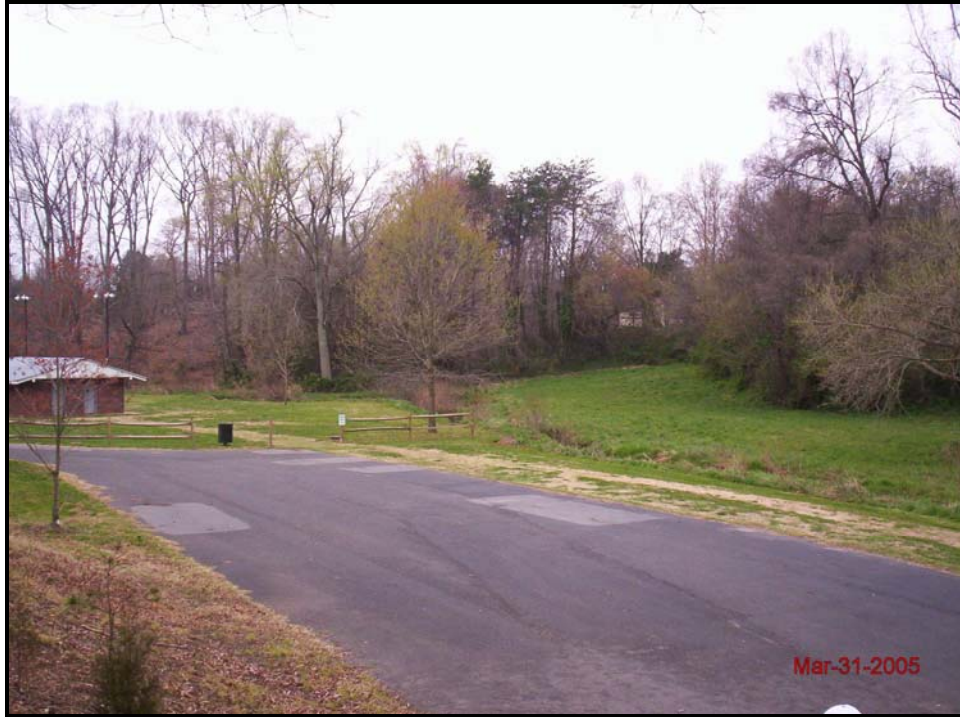
Cemetery Branch  
Pre-construction conditions in proximity to Photo Station 5

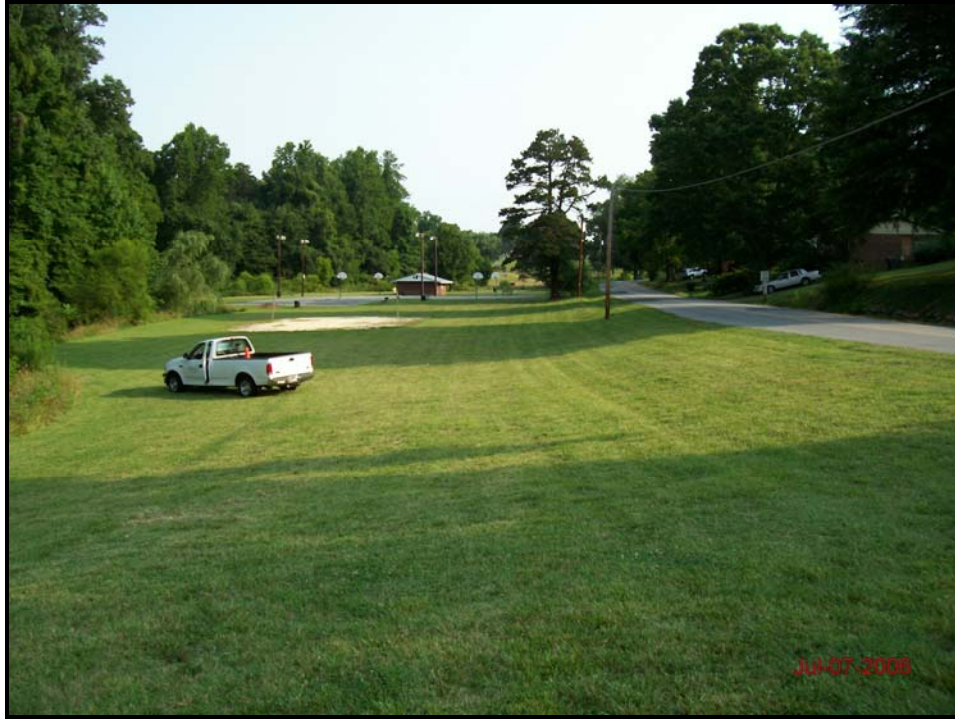
Cemetery Branch  
Pre-construction conditions in proximity to Photo Station 6

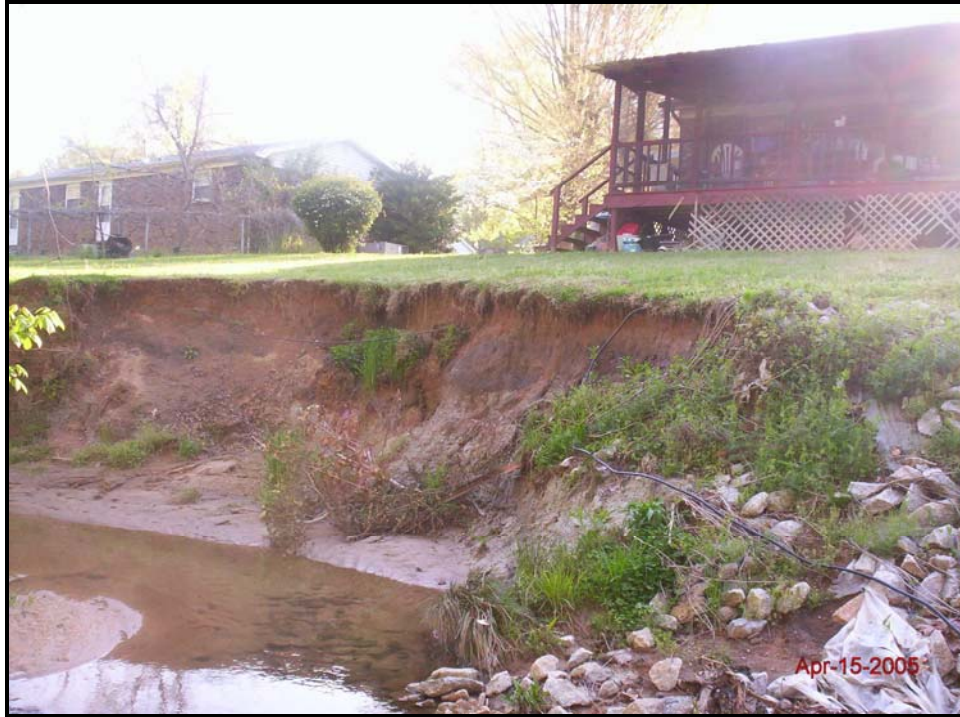
Cemetery Branch  
Pre-construction conditions in proximity to Photo Station 8
