**Dye Branch II  
Stream Restoration  
NCEEP Project Number: 92255  
Monitoring Year 1  
2011 Final Report**

**Submitted to  
North Carolina Ecosystem Enhancement Program  
North Carolina Department of Environment and Natural Resources  
January 2012**

**Dye Branch II Stream Restoration  
2011 Monitoring Report (MY 1)**

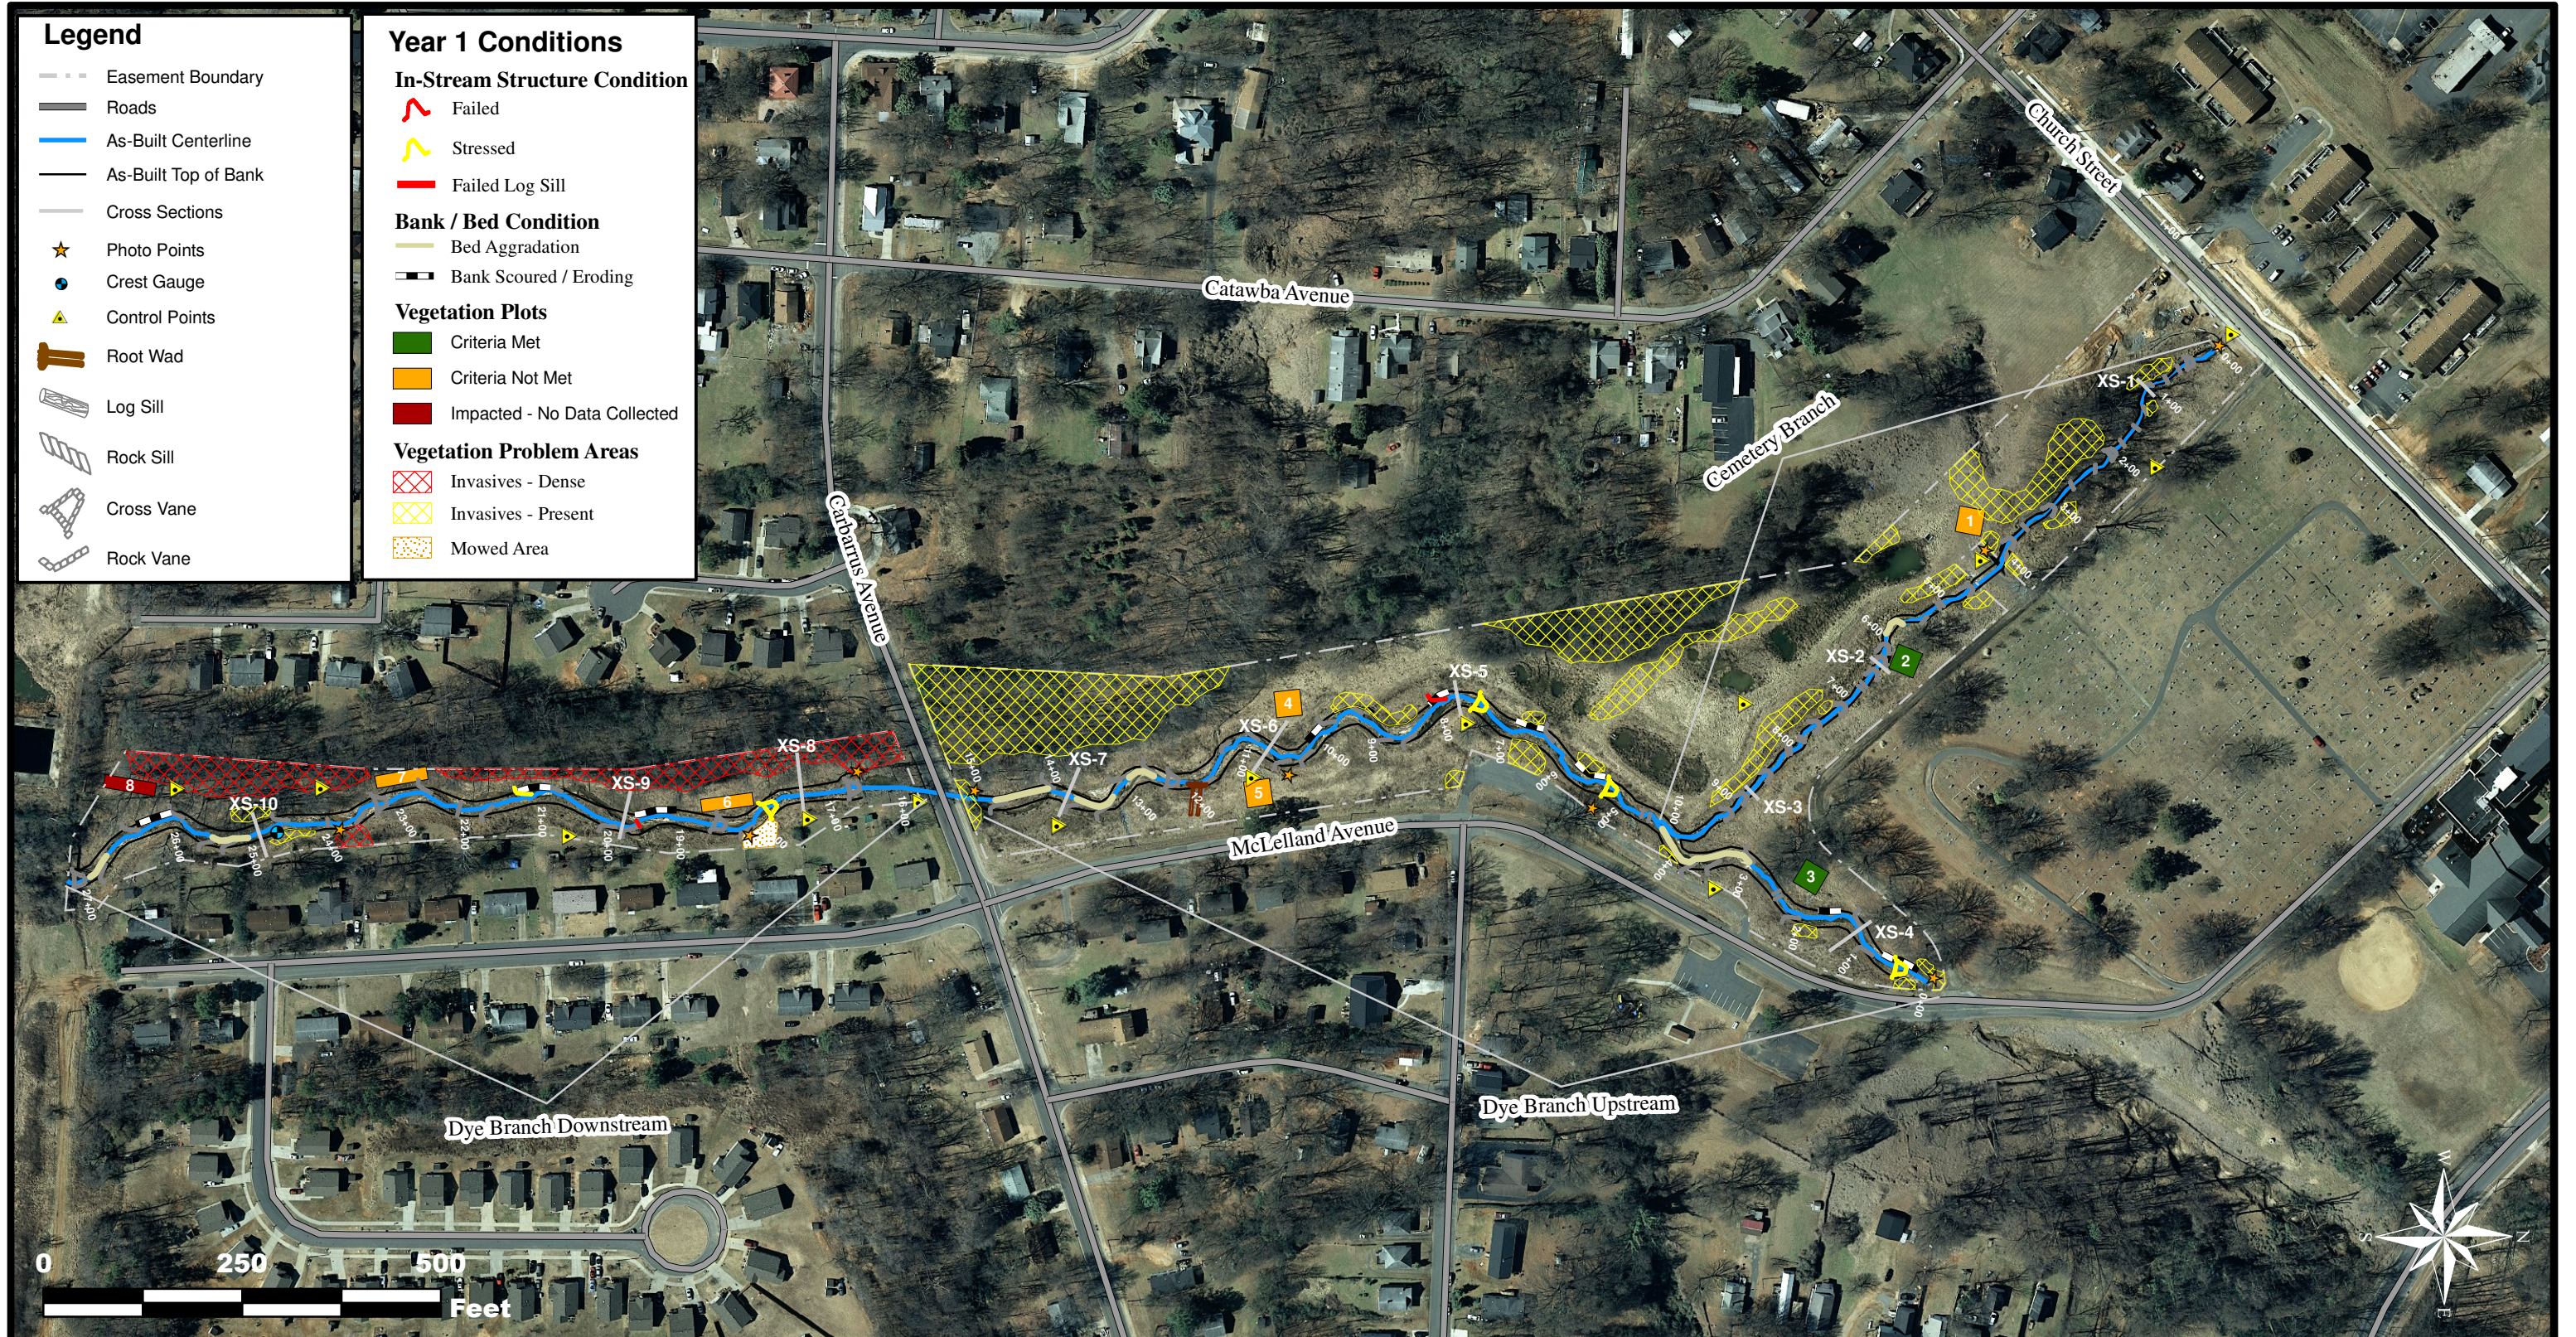
Figure 2. Integrated Current Condition Plan View

Stream longitudinal profiles within the Cemetery Branch reach have remained stable among monitoring years. The primary stream issues observed during MY1 along Dye Branch include structure degradation, bank erosion, and bed aggradation. The water level logger recorded three bankfull events during MY1.
