**Dye Branch II
Stream Restoration
NCEEP Project Number: 92255
Monitoring Year 2
Monitoring Contract Number: 004523
2012 Final Report**

**Submitted to
North Carolina Ecosystem Enhancement Program
North Carolina Department of Environment and Natural Resources
November 2012**

Dye Branch II Stream Restoration 2012 Monitoring Report (MY 2)

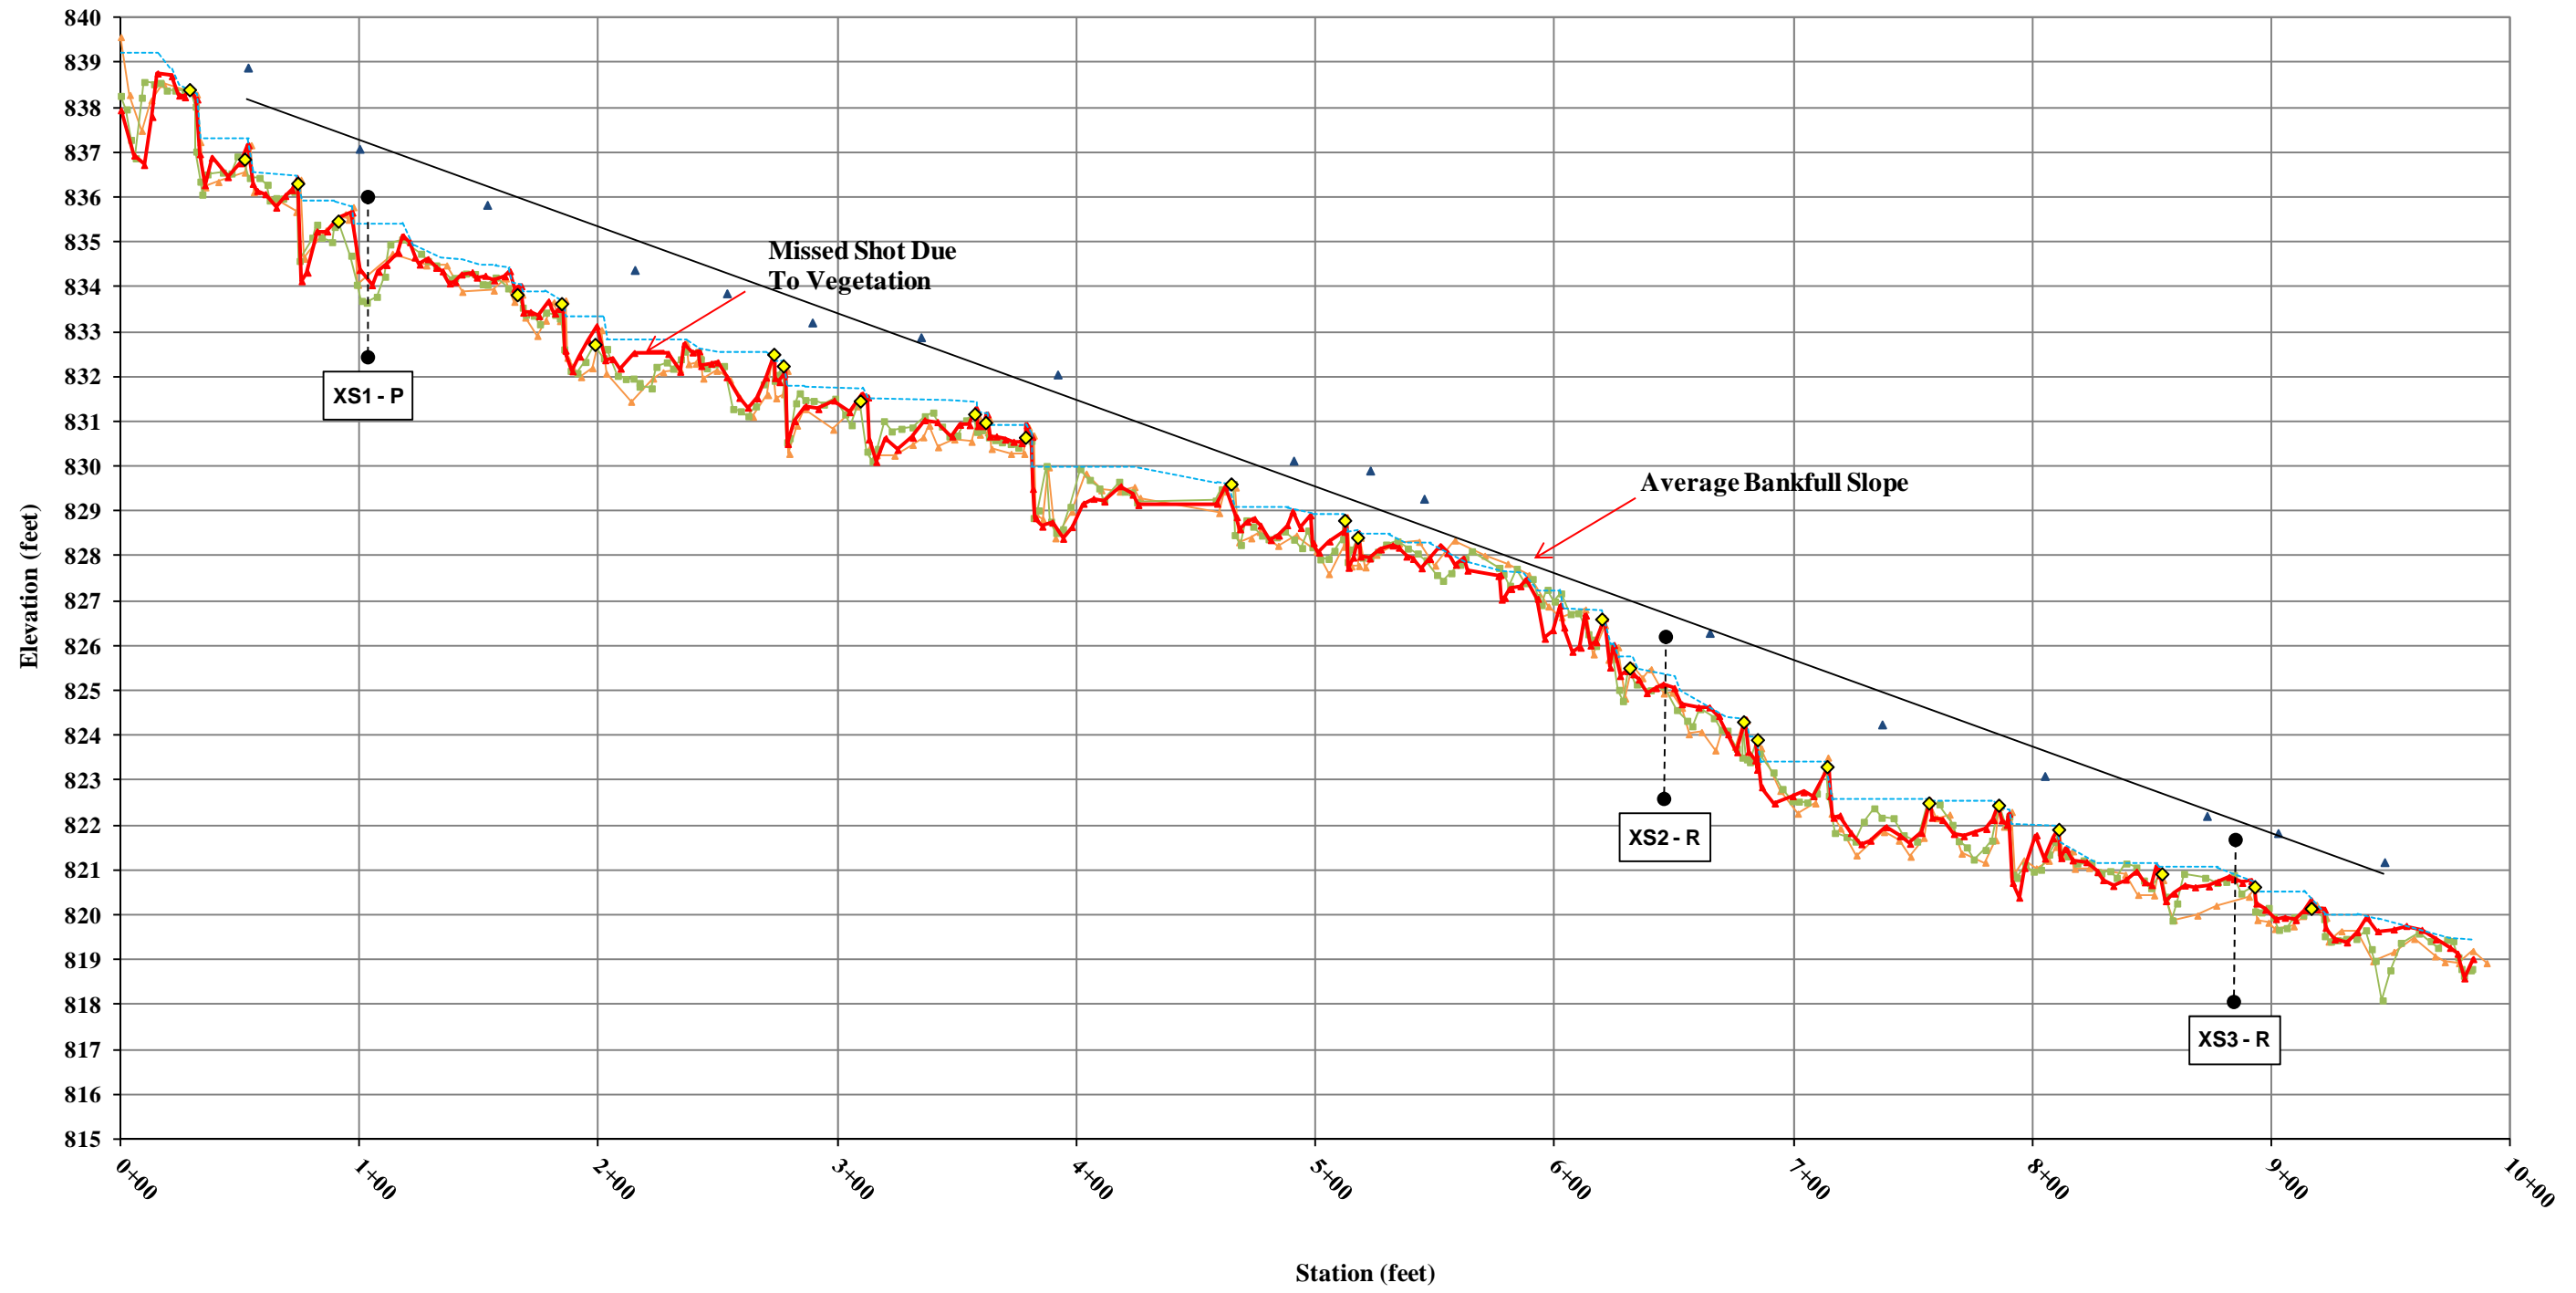
**Cemetery Branch
Longitudinal Profile
0+00 to 9+89.93**

Stream longitudinal profiles within the Cemetery Branch reach have remained stable among monitoring years with the exception of a few isolated areas of bed degradation and aggradation. The primary stream issues observed during MY2 along Dye Branch include structure degradation, bank erosion, bed degradation, and bed aggradation. Significant portions of the downstream reach on Dye Branch appear to have downcut between monitoring years. A water level logger was installed in December of 2010 and has since recorded a total of six bankfull events including three during the MY2 monitoring period.

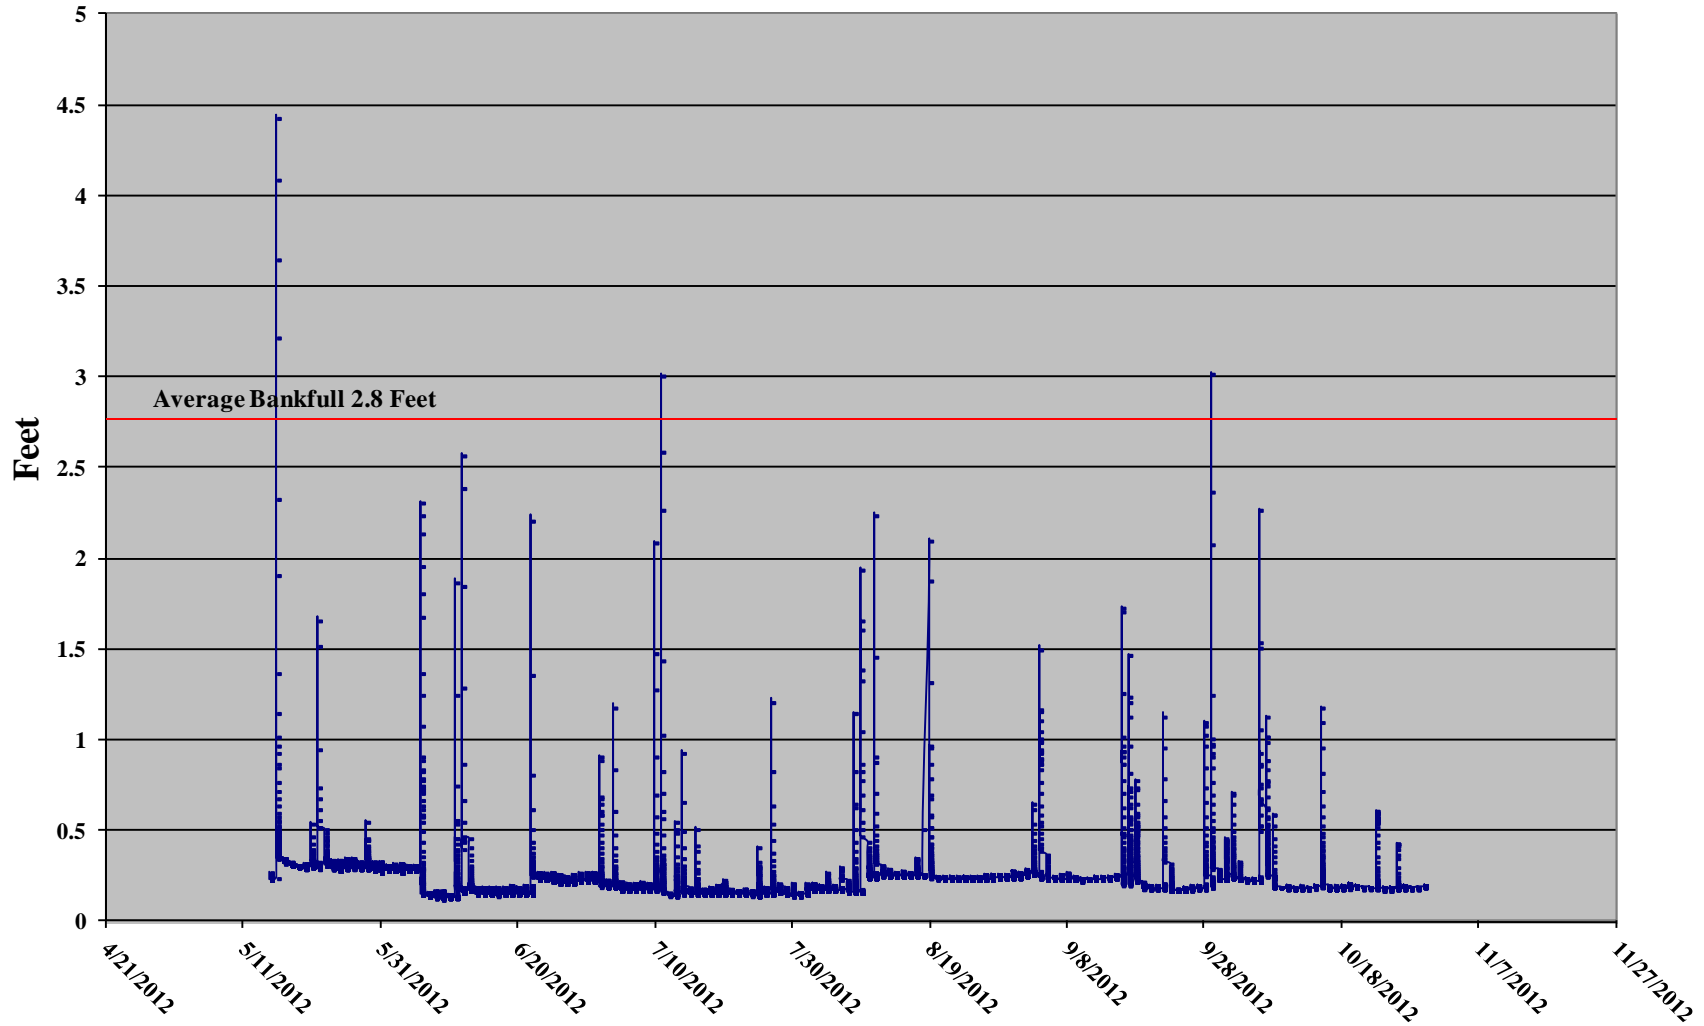
Figure 3. Dye Branch Water Level Logger Chart

Table 12. Verification of Bankfull Events Dye Branch II / Project No. 92255		
Date of Occurrence	Method	Feet Above Average Bankfull Elevation
7/8/2011	Water level logger	1.07
9/21/2011	Water level logger	1.14
9/24/2011	Water level logger	0.52
5/16/2012	Water level logger	1.63
7/11/2012	Water level logger	0.21
9/29/2012	Water level logger	0.22
