**Dye Branch II  
Stream Restoration  
NCEEP Project Number: 92255  
Monitoring Year 3  
Monitoring Contract Number: 004523  
2013 Final Report**

**Submitted to  
North Carolina Ecosystem Enhancement Program  
North Carolina Department of Environment and Natural Resources  
November 2013**

# **Dye Branch II Stream Restoration 2013 Monitoring Report (MY 3)**

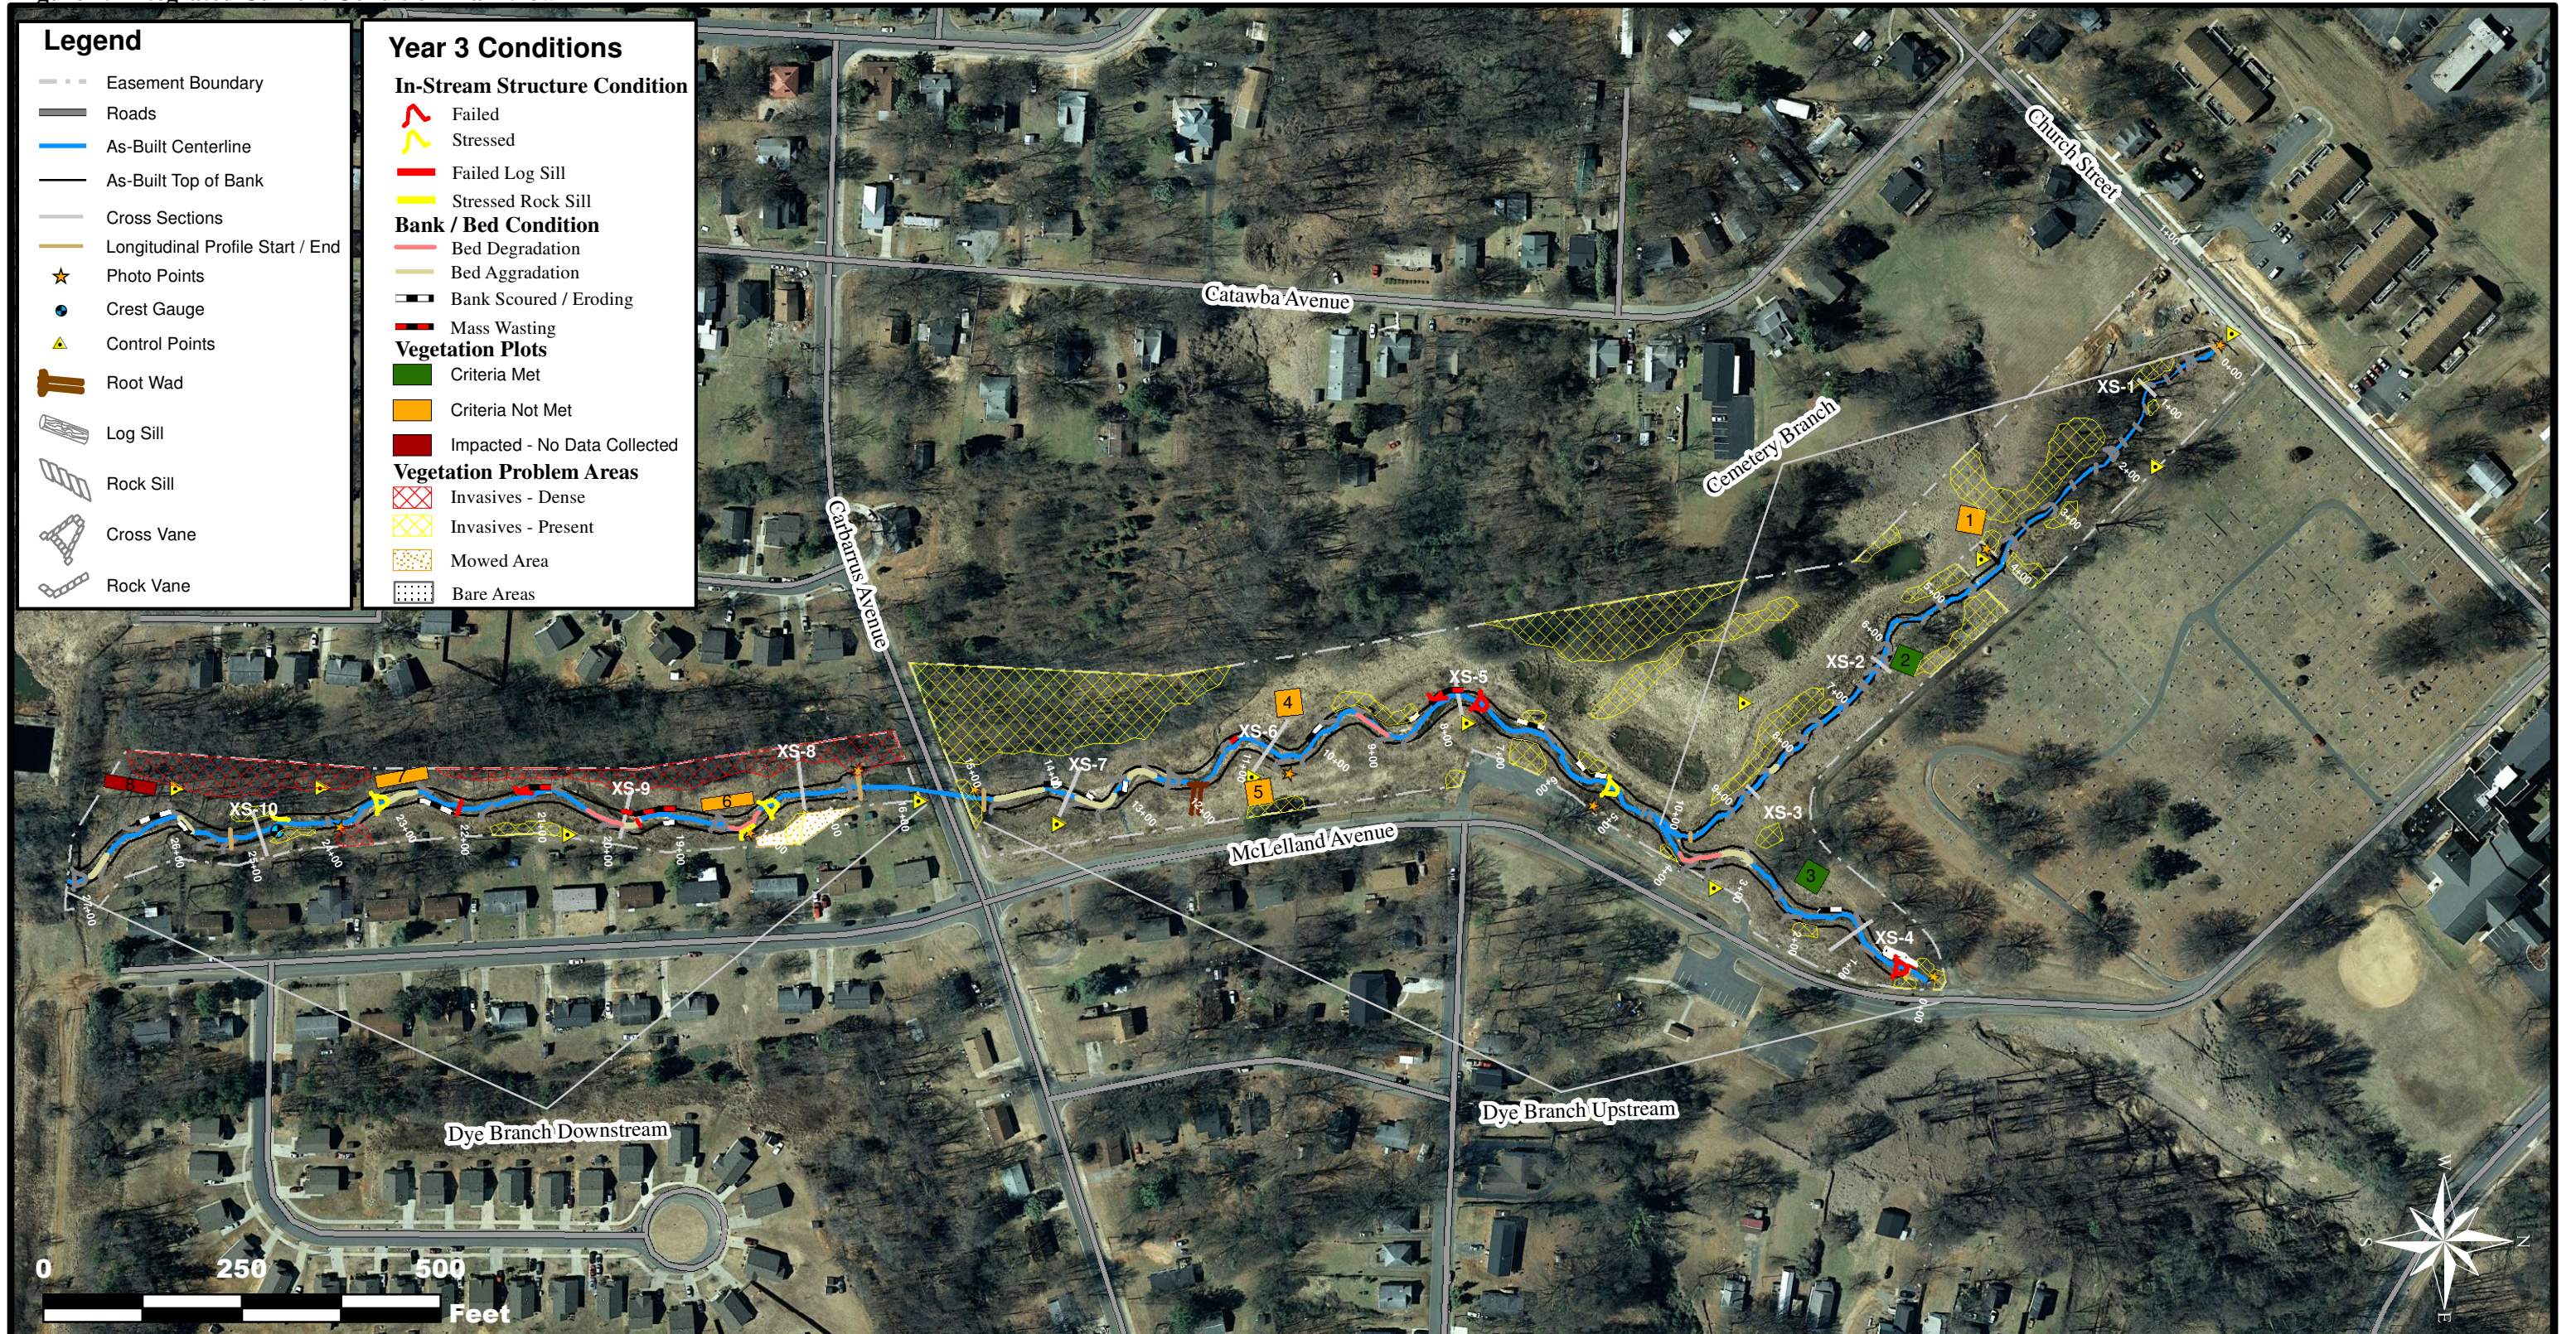
Figure 2. Integrated Current Condition Plan View

Monitoring Year 3 - Integrated Current Condition Plan View Draft Iredell County, North Carolina	2) NC OneMap 2010 Aerial Photo 3) Dominant Invasive Species Include Ligustrum sp., Lonicera japonica, Pueraria montana var. lobata, and Lespedeza cuneata.
