**Dye Branch II
Stream Restoration
Annual Monitoring Report
Monitoring Year 4
NCEEP Project Number: 92255
Monitoring Contract Number: 004523**

**Submitted to
North Carolina Ecosystem Enhancement Program
North Carolina Department of Environment and Natural Resources
January 2015**

Dye Branch II Stream Restoration 2014 Monitoring Report (MY 4)

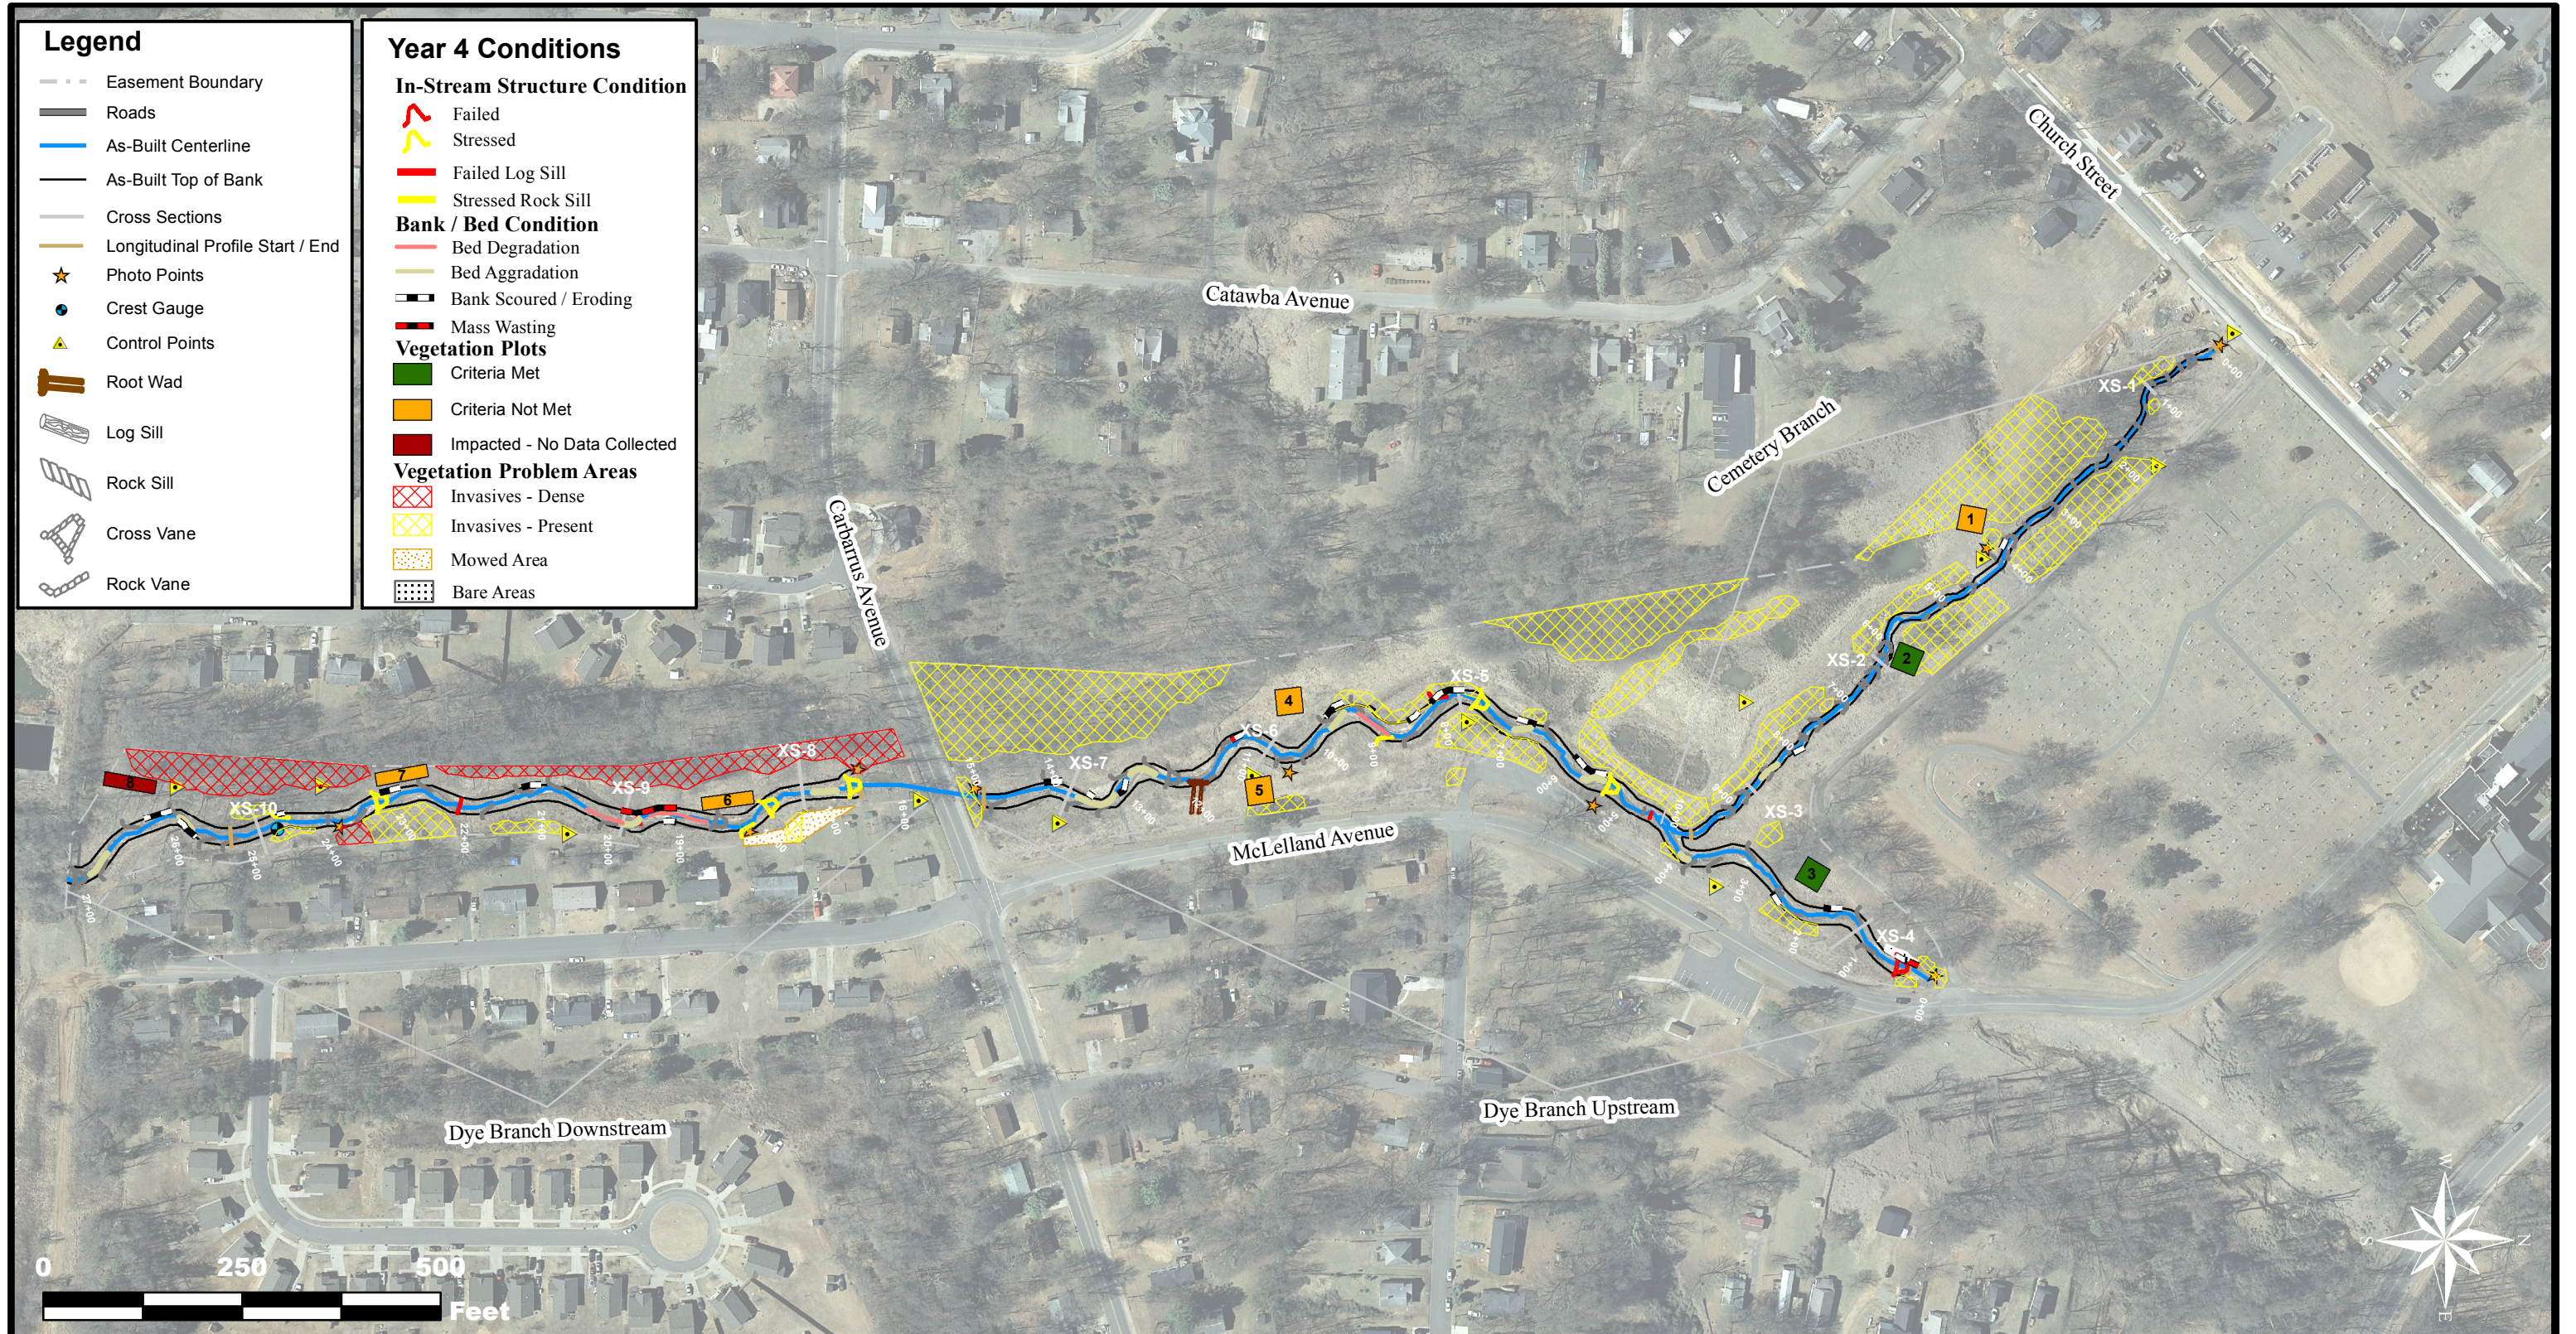
Figure 2. Integrated Current Condition Plan View

Morphologic monitoring of the upstream reach of Dye Branch includes four cross-sections, four pebble counts, and 1,473 feet of longitudinal profile. The upstream reach of Dye Branch has multiple areas of aggradation and degradation, as well as structures with compromised structural integrity. An additional failed structure was documented downstream of the confluence with Cemetery Branch, bringing the failed structure total to four for this reach. In addition, two structures were noted as piping, five were noted as having bank erosion within the structure's zone of influence, and three were noted as not providing appropriate habitat (Appendix B, Table 5). Substrate has remained in the fine gravel to sand size class throughout the monitoring period. Visual observations of this reach noted large, shifting deposits of fine sand material filling several pools throughout the reach. Approximately 10% of the reach is actively eroding.

Morphologic monitoring of the downstream reach of Dye Branch includes three cross-sections, three pebble counts, and 882 feet of longitudinal profile. The downstream reach of Dye Branch showed a significant downcutting between MY1 and MY2. Since then the reach has showed indications of instability between monitoring years. Significant aggradation, degradation, and compromised structures persist throughout the reach. The most severely affected area is between Station 18+77 and 20+74 as well as between Station 21+20 and 23+16, where multiple structures have failed, resulting in loss of grade control and significant shifts in bedform. A total of seven structures have failed as well as two showing signs of lost grade control, four noted as piping, and two with bank erosion within the structure's zone of influence. Substrate has remained relatively fine with D_{50} falling in the sand size class throughout the monitoring period.

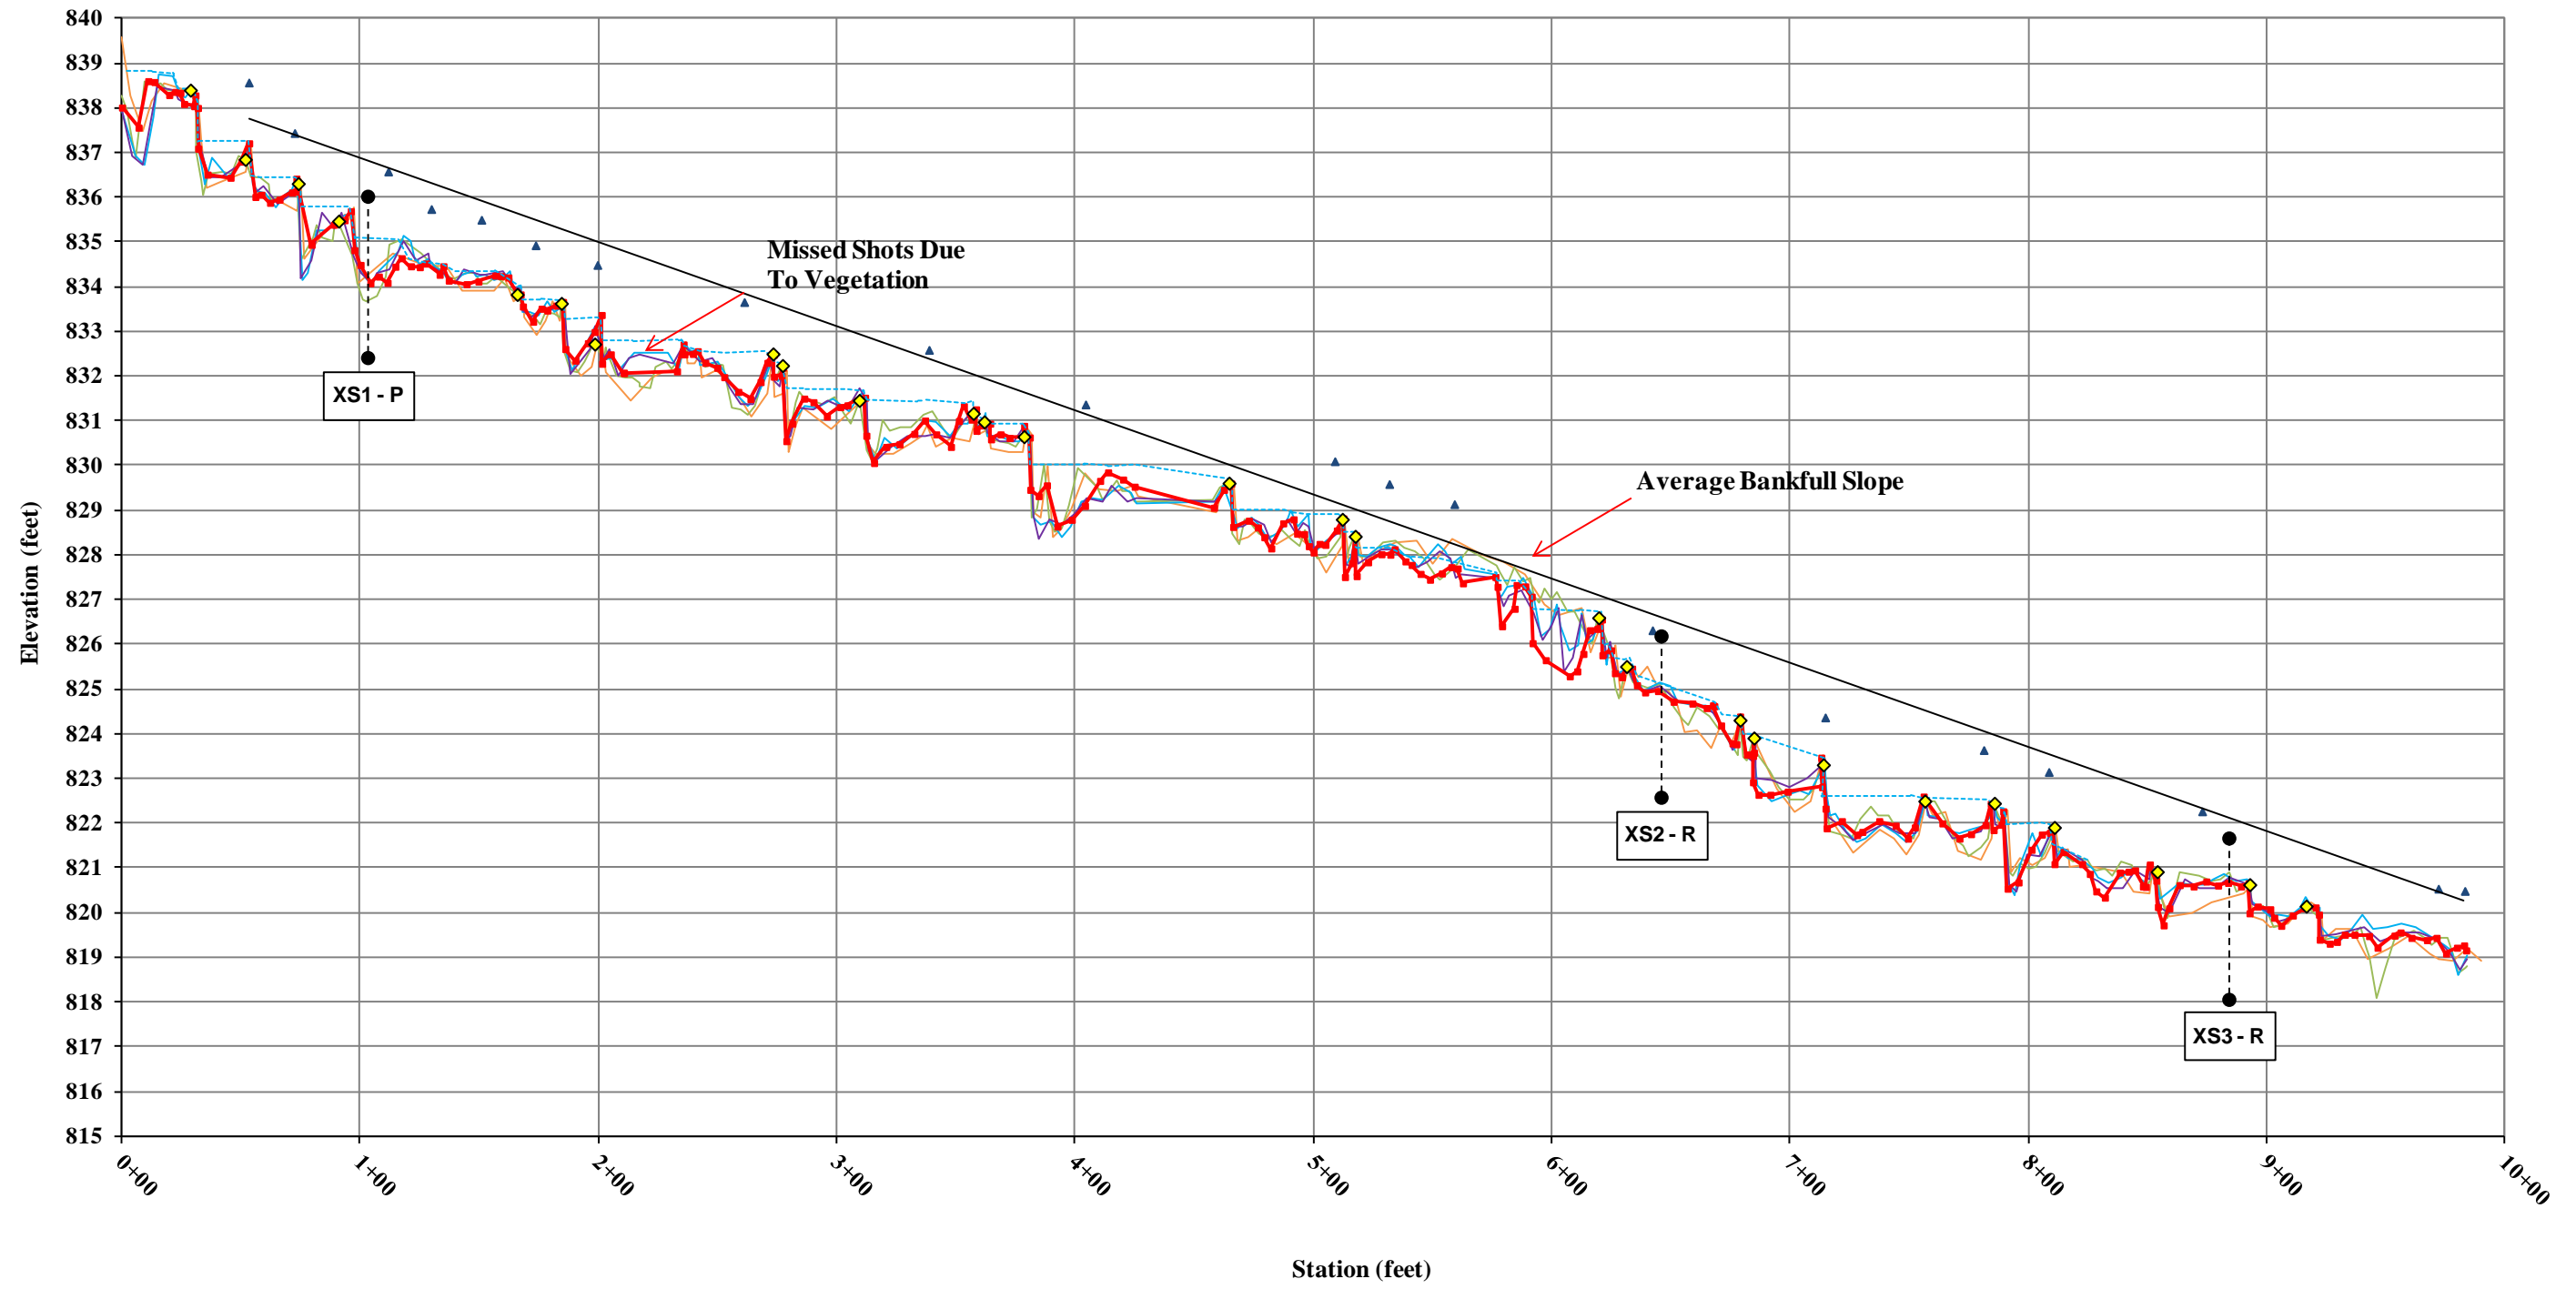
**Cemetery Branch
Longitudinal Profile
0+00 to 9+89.93**

Morphologic monitoring of the Cemetery Branch Reach includes three cross-sections, three pebble counts, and 989 feet of longitudinal profile (Appendix D). As expected, some channel adjustment is noticeable in cross-section data between MY0 and MY1; however, more recent years have remained stable. Stream longitudinal profiles within the Cemetery Branch reach have remained stable among monitoring years with the exception of a few isolated areas of scour and deposition between structures, such as deposition at Station 0+75 or scour at Station 6+00. However, these are isolated and do not give any indication of reach-wide instability. Riffle substrates have been stable over the course of the monitoring period with D_{50} in the fine gravel size class while pool substrate has become gradually finer over the monitoring period with the D_{50} falling in the sand size class during MY4.

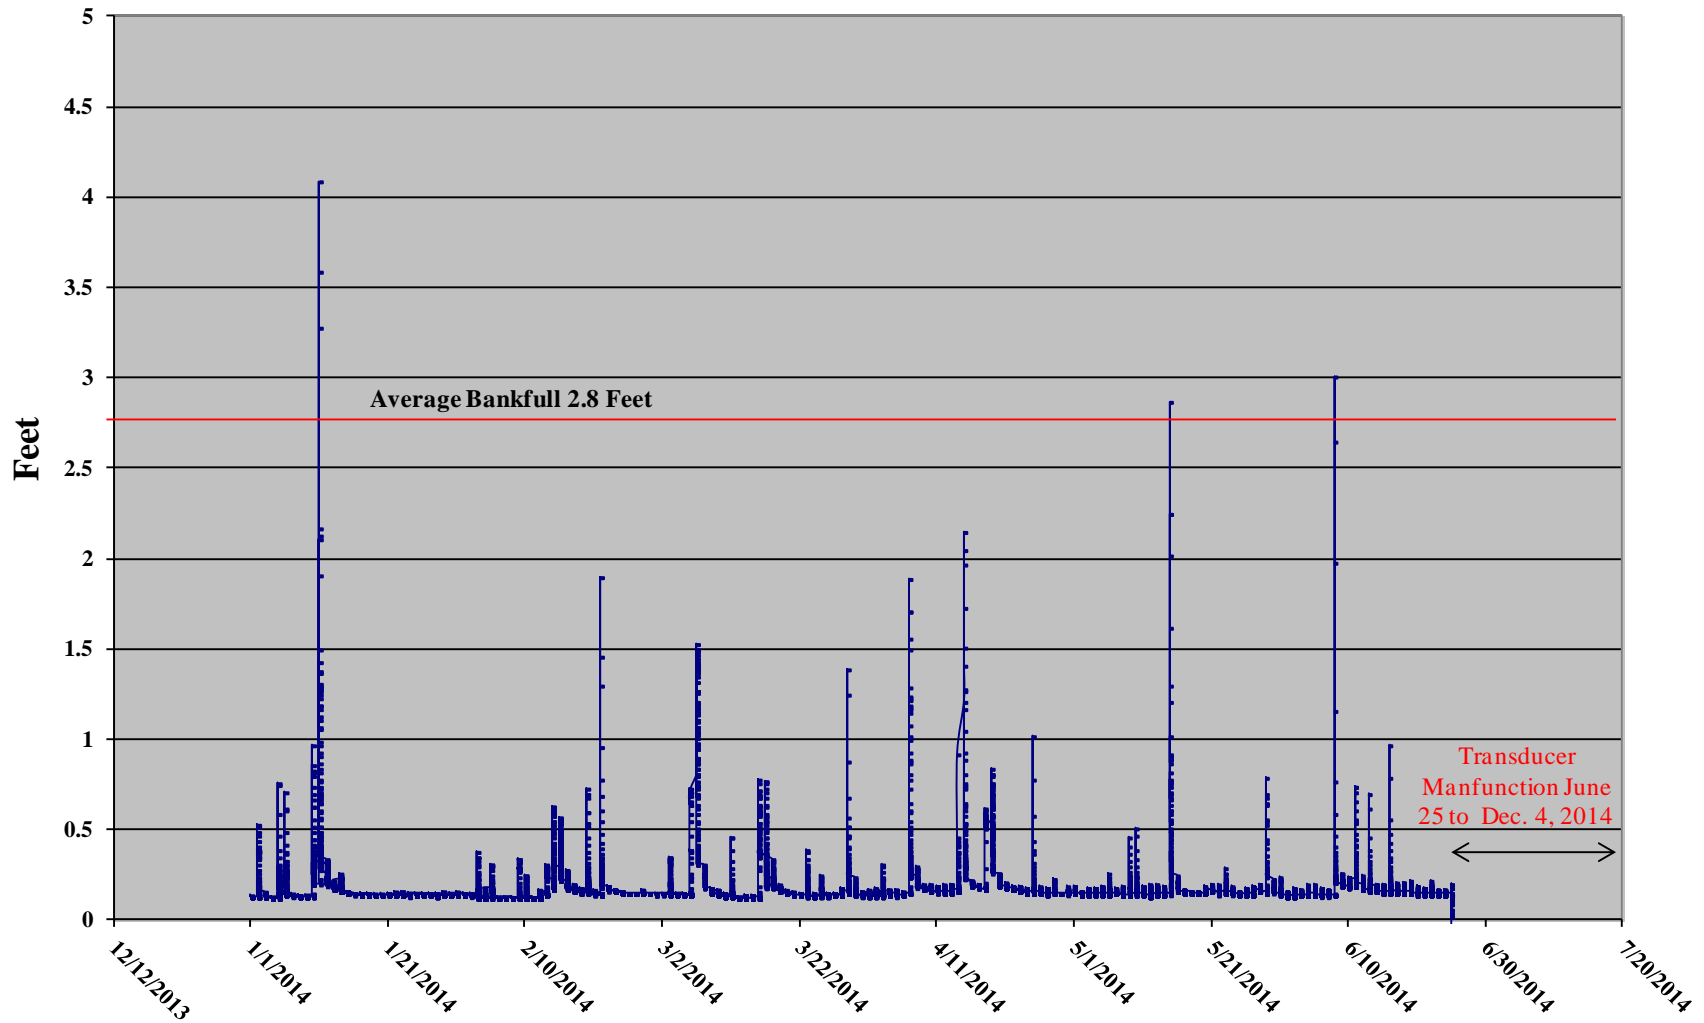
Figure 3. Dye Branch Water Level Logger Chart

A water level logger was installed in December of 2010 and has since recorded a total of 14 bankfull events including three in MY4. An equipment malfunction led to the loss of pressure transducer data between June and December of 2014. Bankfull events may be underrepresented during this monitoring year.
