**Dye Branch II
Stream Restoration
Annual Monitoring Report
Monitoring Year 5
NCDMS Project Number: 92255
Monitoring Contract Number: 004523**

**Submitted to
North Carolina Division of Mitigation Services
North Carolina Department of Environmental Quality
November 2015**

Dye Branch II Stream Restoration 2015 Monitoring Report (MY 5)

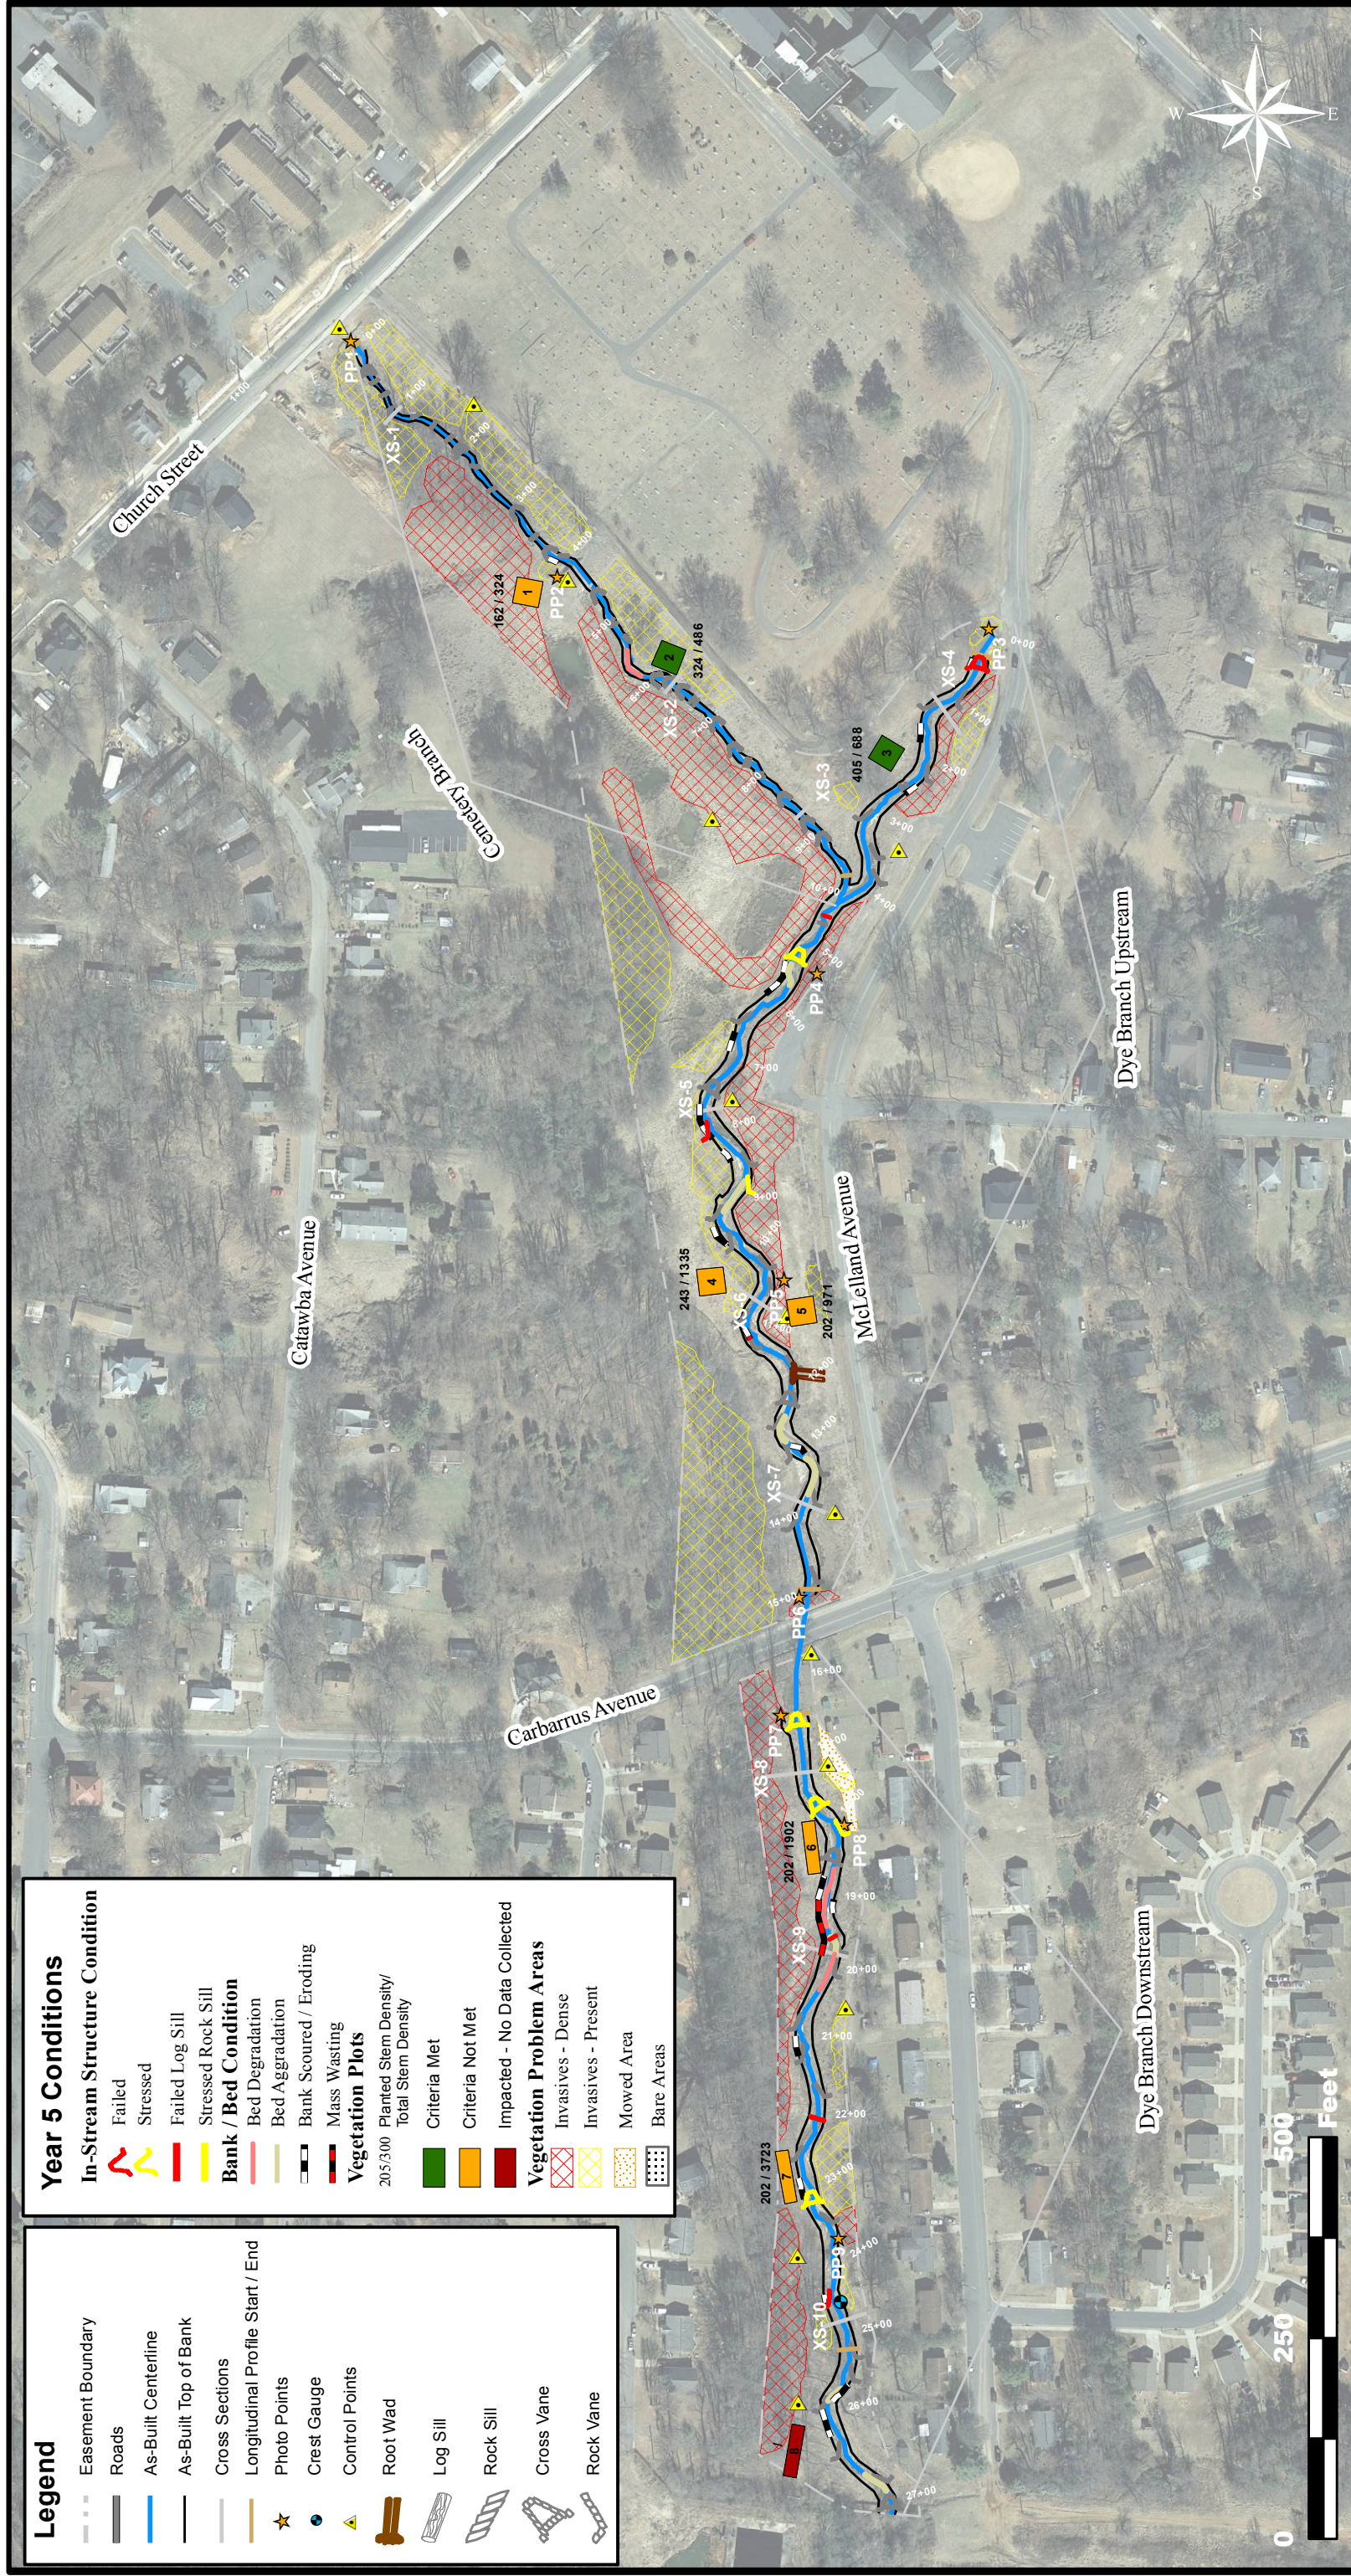
Figure 2. Integrated Current Condition Plan View

channel. There are a total of four failed structures and three stressed structures, which are documented in the Current Condition Plan View (Figure 2). Substrate has remained in the fine gravel to sand size class throughout the monitoring period. Approximately 10% of the reach is actively eroding (Table 5).

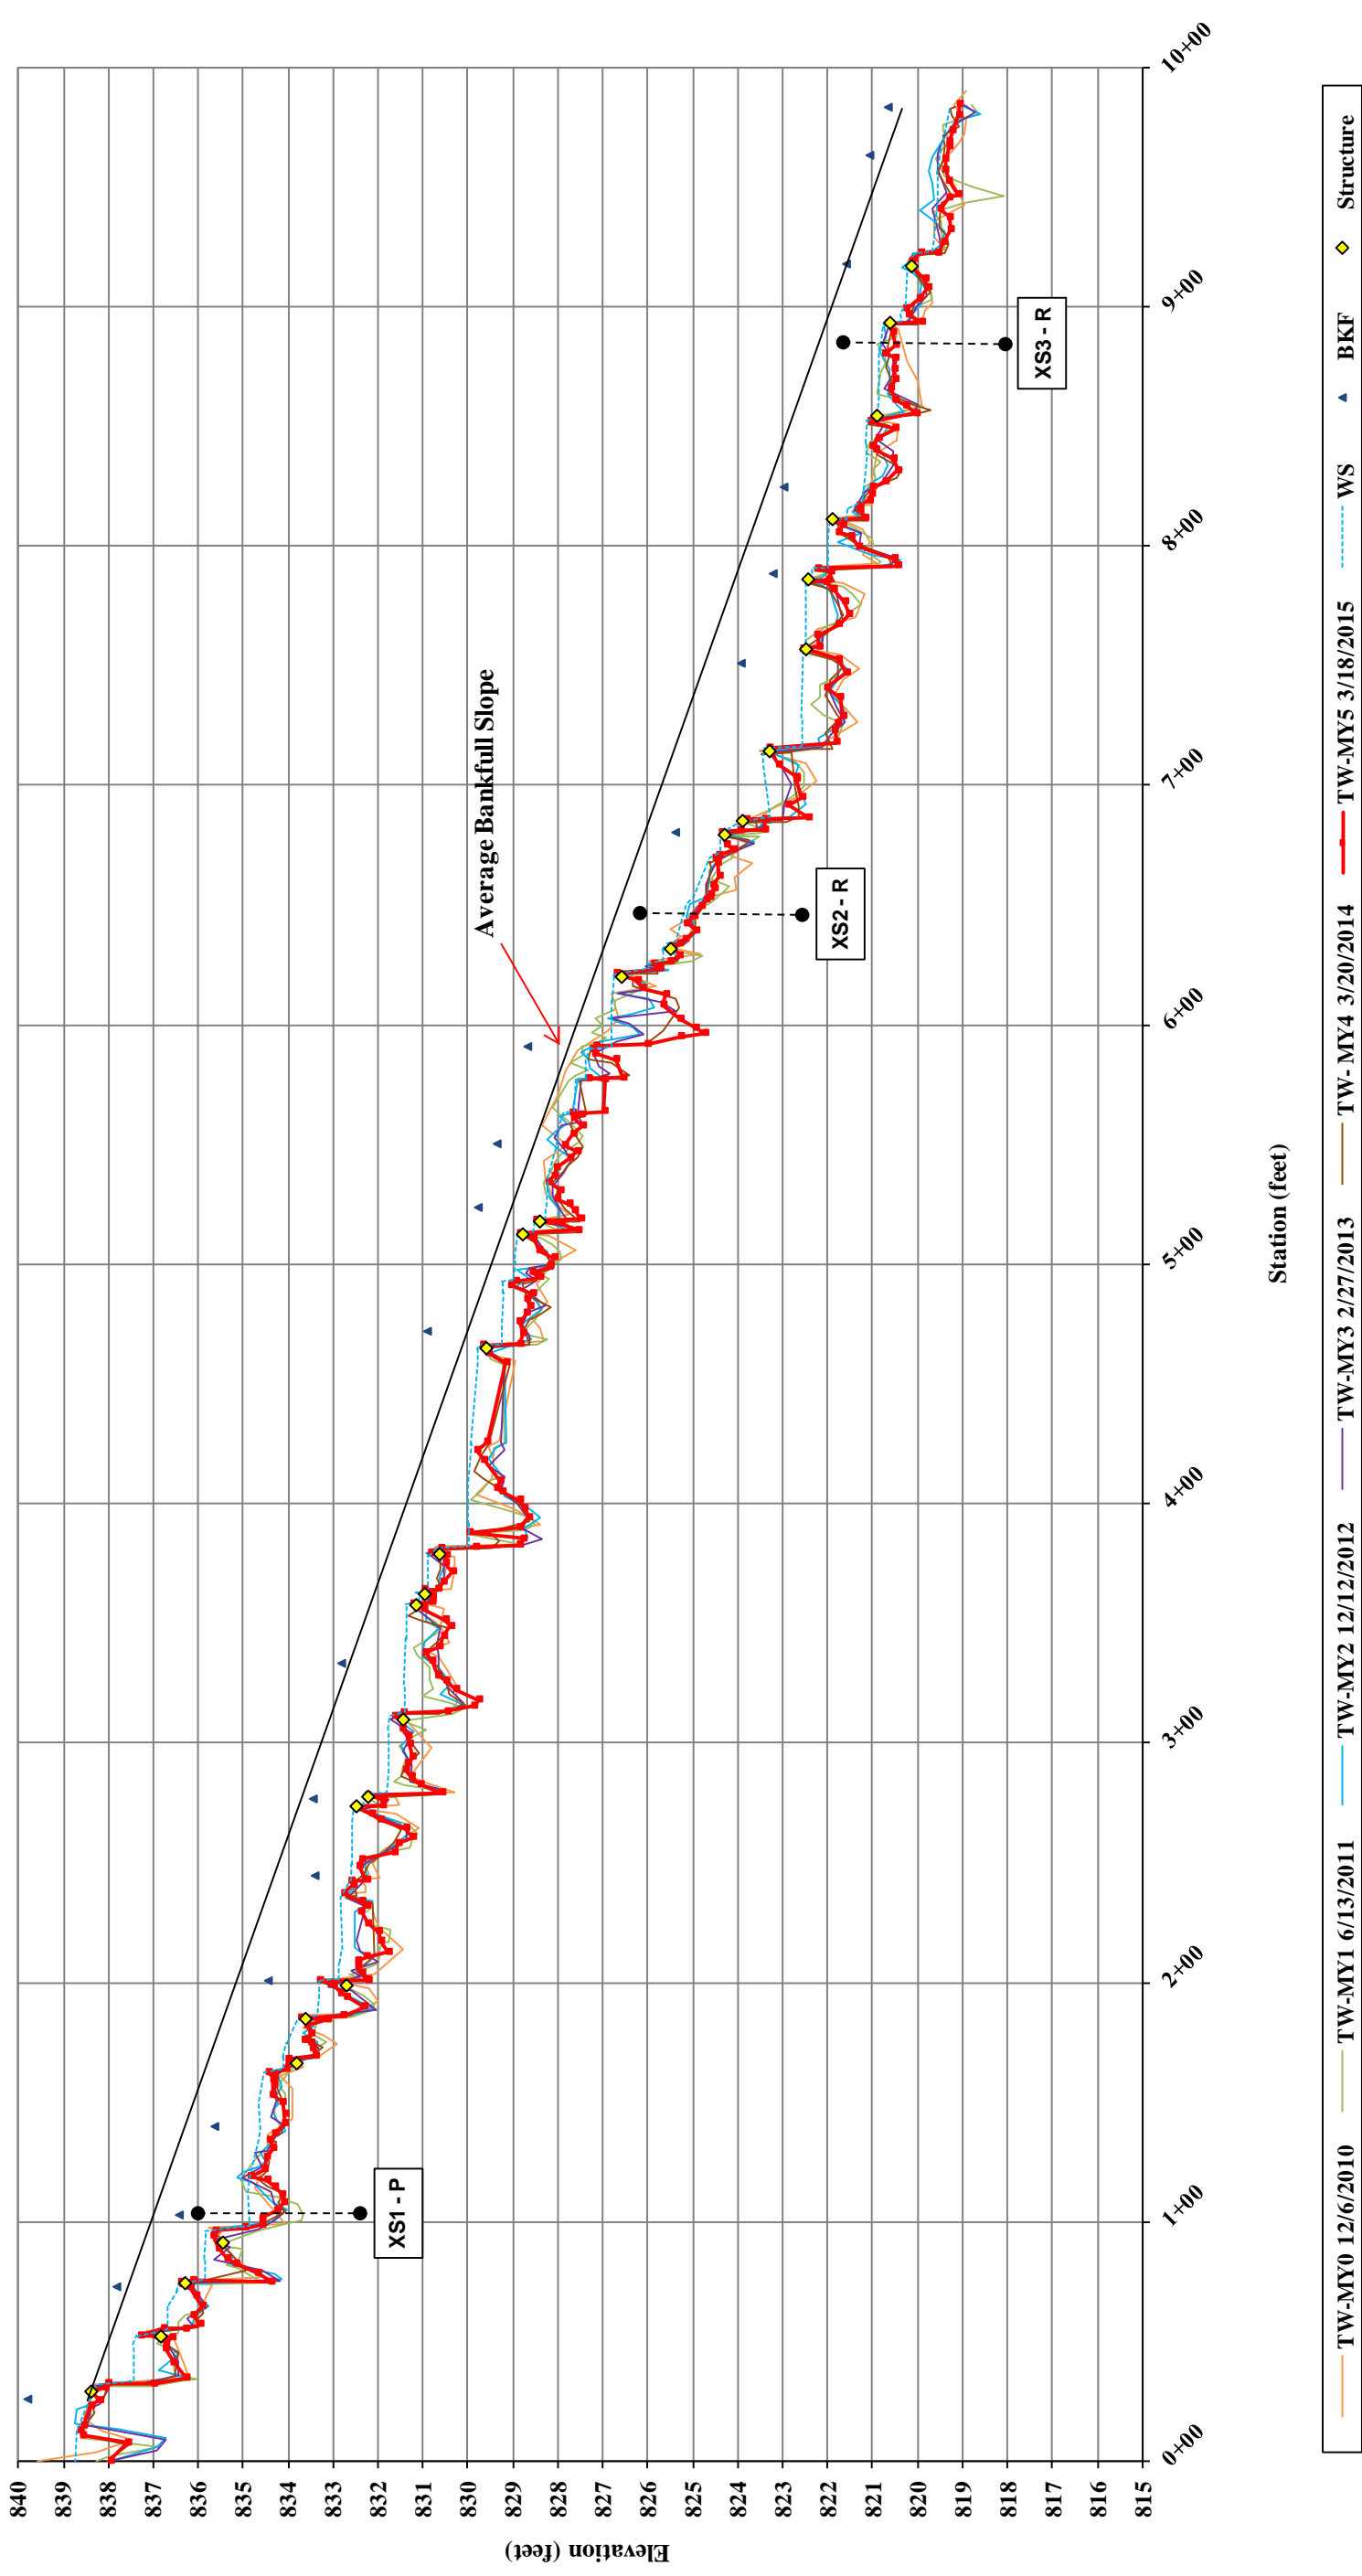
**Cemetery Branch
Longitudinal Profile
0+00 to 9+89.93**

Morphologic monitoring of the Cemetery Branch Reach included three cross-sections, three pebble counts, and 989 feet of longitudinal profile (Appendix D). As expected, some channel adjustment was noticeable in cross-section data between MY0 and MY1; however, more recent years have remained stable. Stream longitudinal profiles within the Cemetery Branch reach have remained stable among monitoring years with the exception of a few isolated areas of scour and deposition. These are isolated areas and do not give any indication of reach-wide instability. Riffle substrates have been stable over the course of the monitoring period with D_{50} in the coarse gravel size class whereas pool substrate has become gradually finer over the monitoring period with the D_{50} falling in the sand size class during MY5.

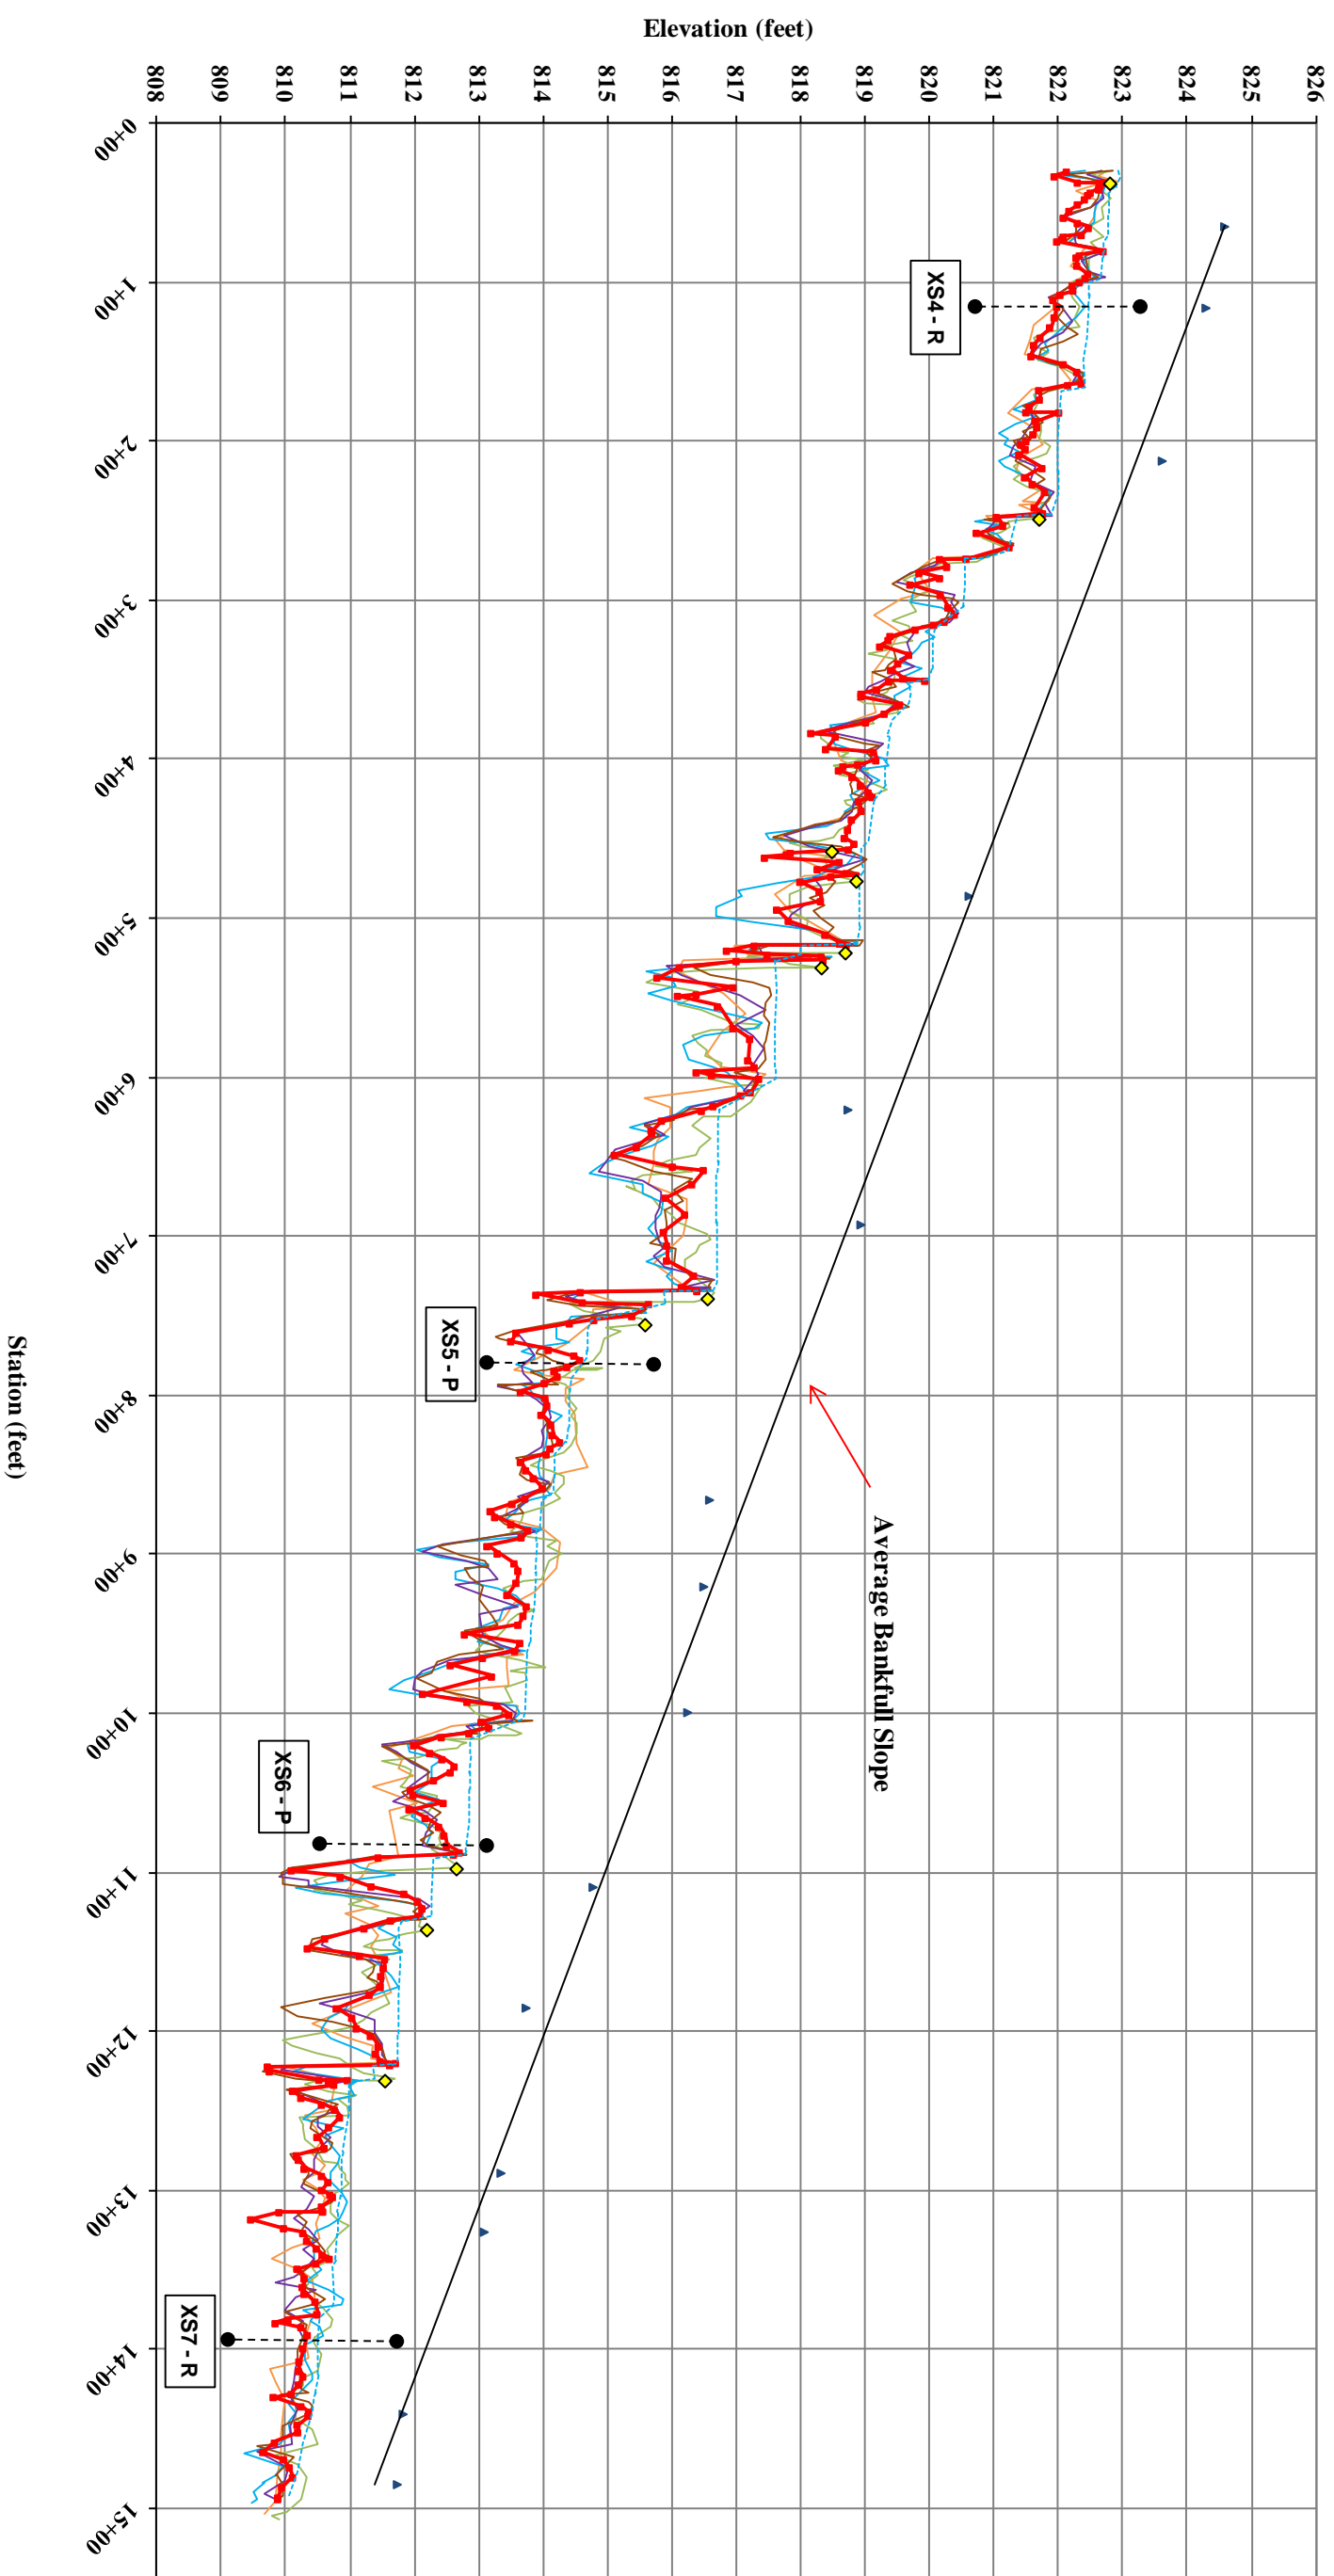
**Dye Branch - Upstream
Longitudinal Profile
0+30.36 to 15+03.3**

Morphologic monitoring of the upstream reach of Dye Branch included four cross-sections, four pebble counts, and 1,473 feet of longitudinal profile. Cross-sections have remained stable with minimal adjustments from MY2 through MY5 (Table 11a). The upstream reach of Dye Branch has multiple areas of aggradation and degradation, as well as structures with compromised structural integrity. Areas of aggradation and degradation shown in the profile consist of mostly fine material, transported from contributing areas upstream of the watershed, shifting within the

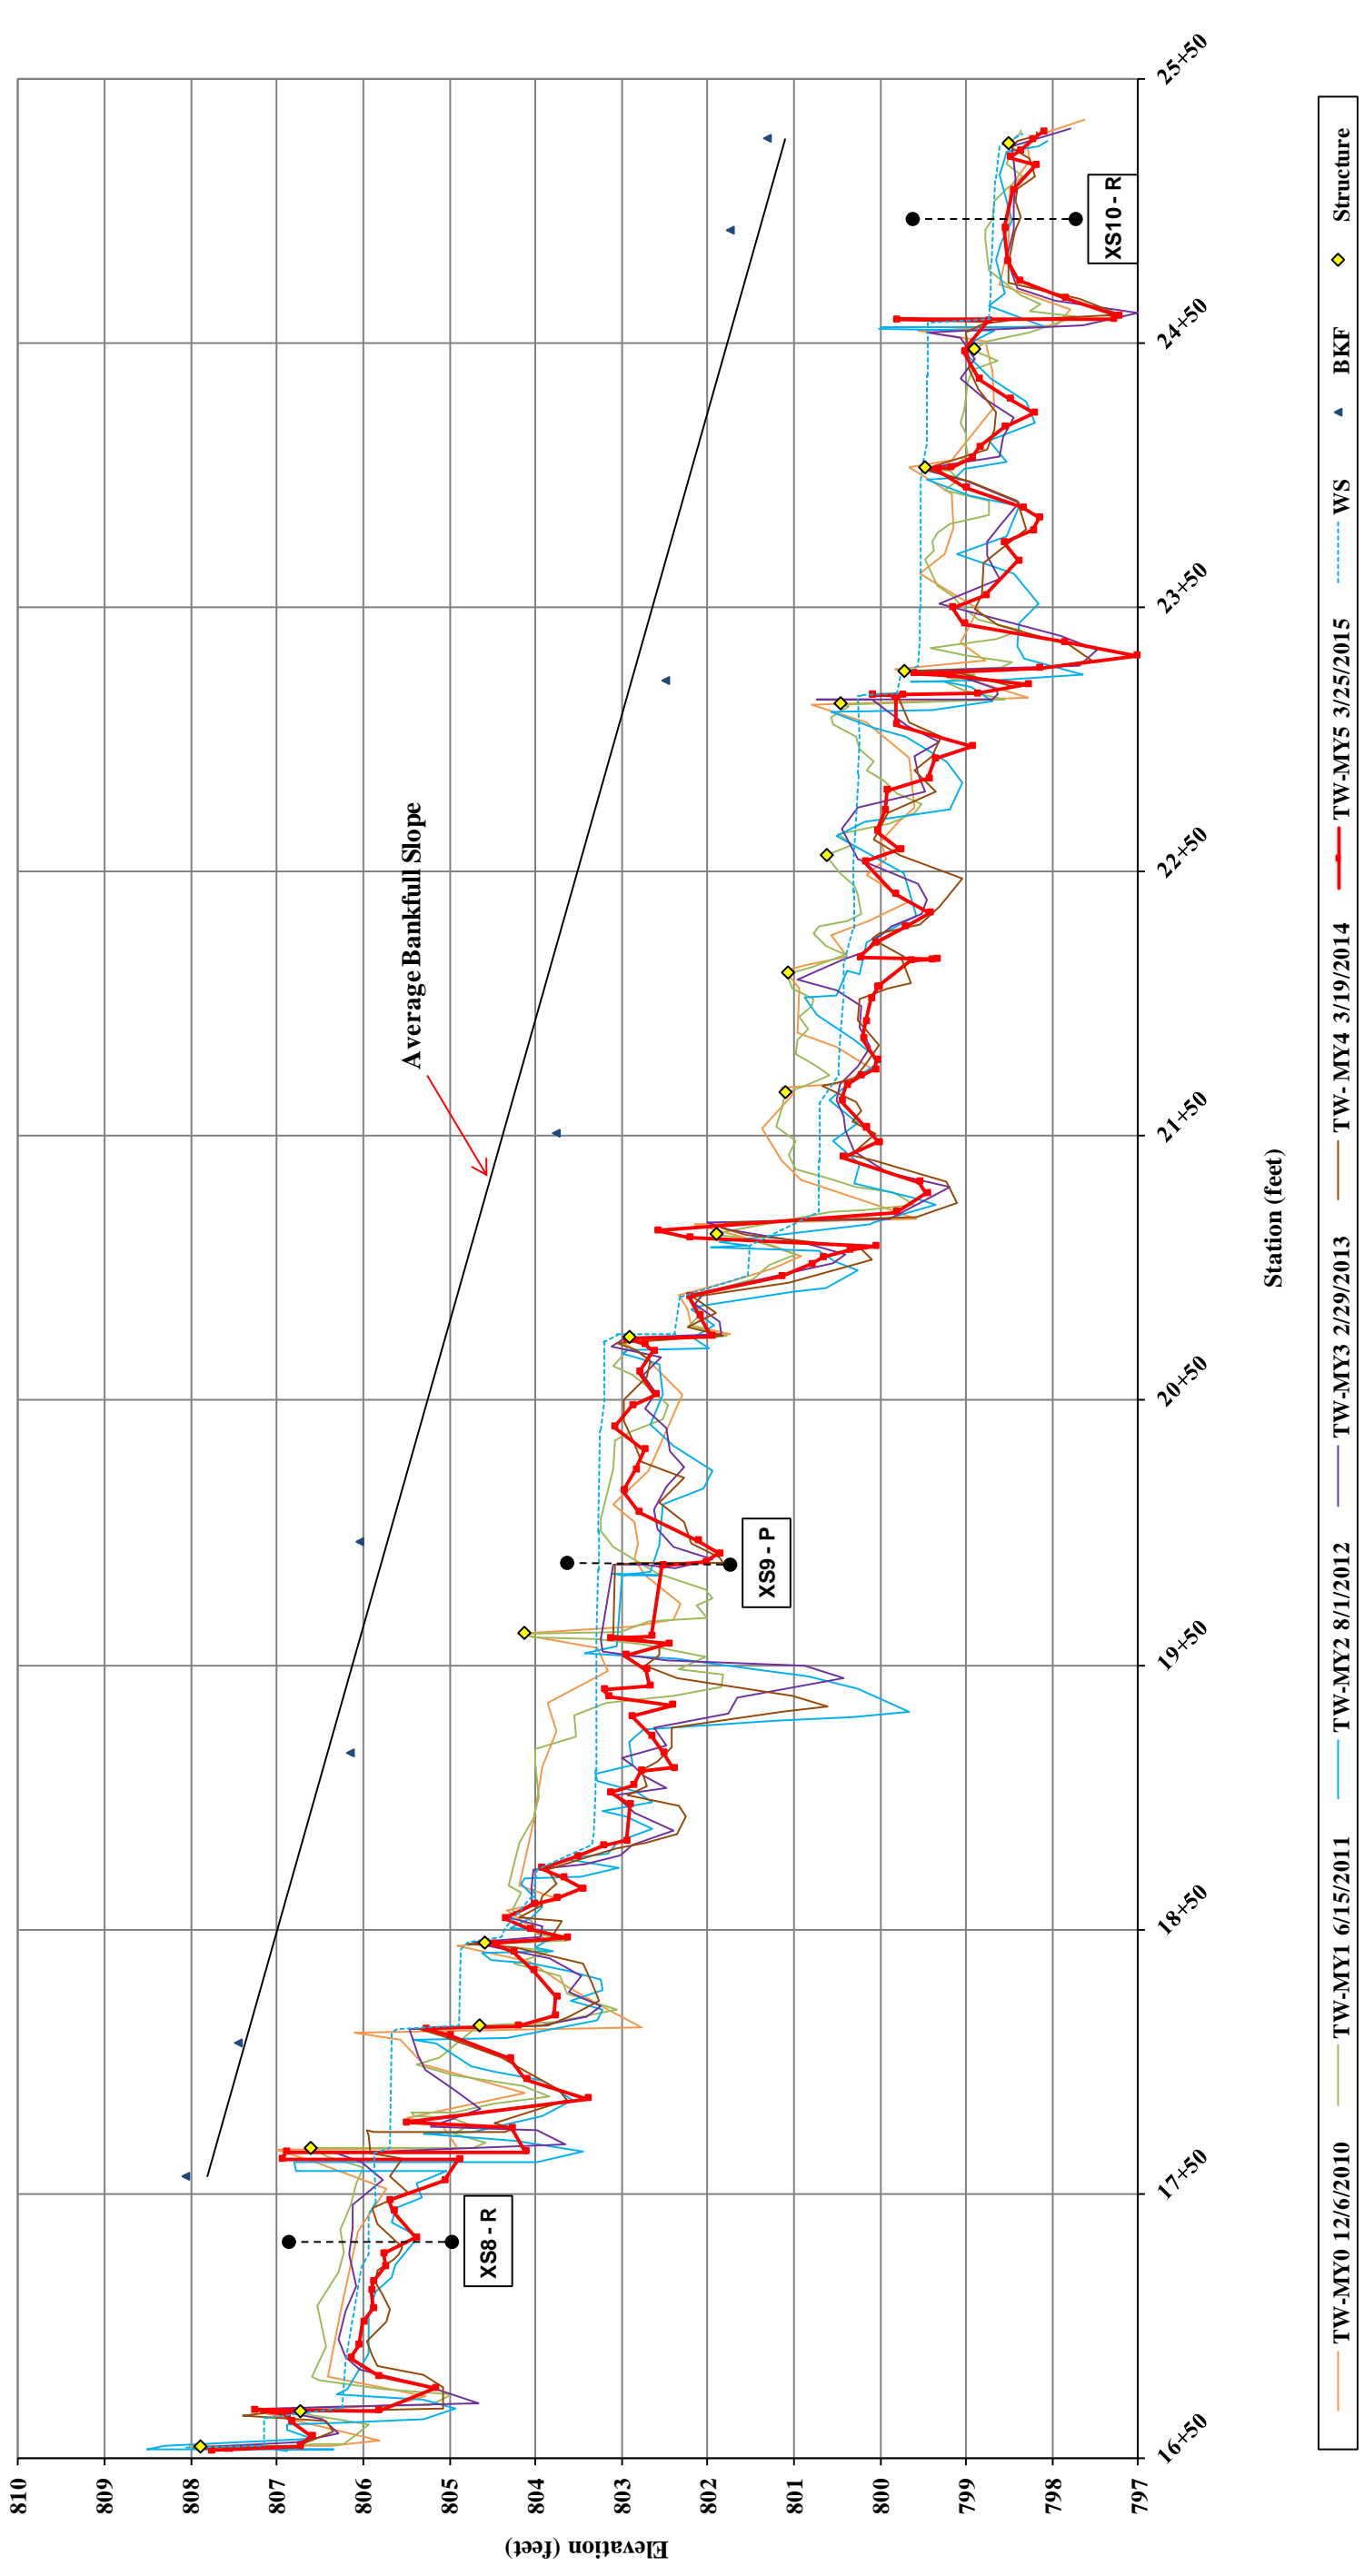
Dye Branch - Downstream
Longitudinal Profile
16+52.72 to 25+34.71

Morphologic monitoring of the downstream reach of Dye Branch includes three cross-sections, three pebble counts, and 882 feet of longitudinal profile. The downstream reach of Dye Branch showed a significant downcutting between MY1 and MY2. Since then the reach has showed indications of instability between monitoring years. Aggradation, degradation, bank erosion, and compromised structures persist throughout the reach. The most severely affected area is between stations 18+77 and 20+74 as well as between stations 21+20 and 23+16, where multiple structures have failed, resulting in loss of grade control and significant shifts in bedform. A total of seven structures have either failed or are stressed. Substrate has remained relatively fine with D_{50} falling in the sand size class throughout the monitoring period.

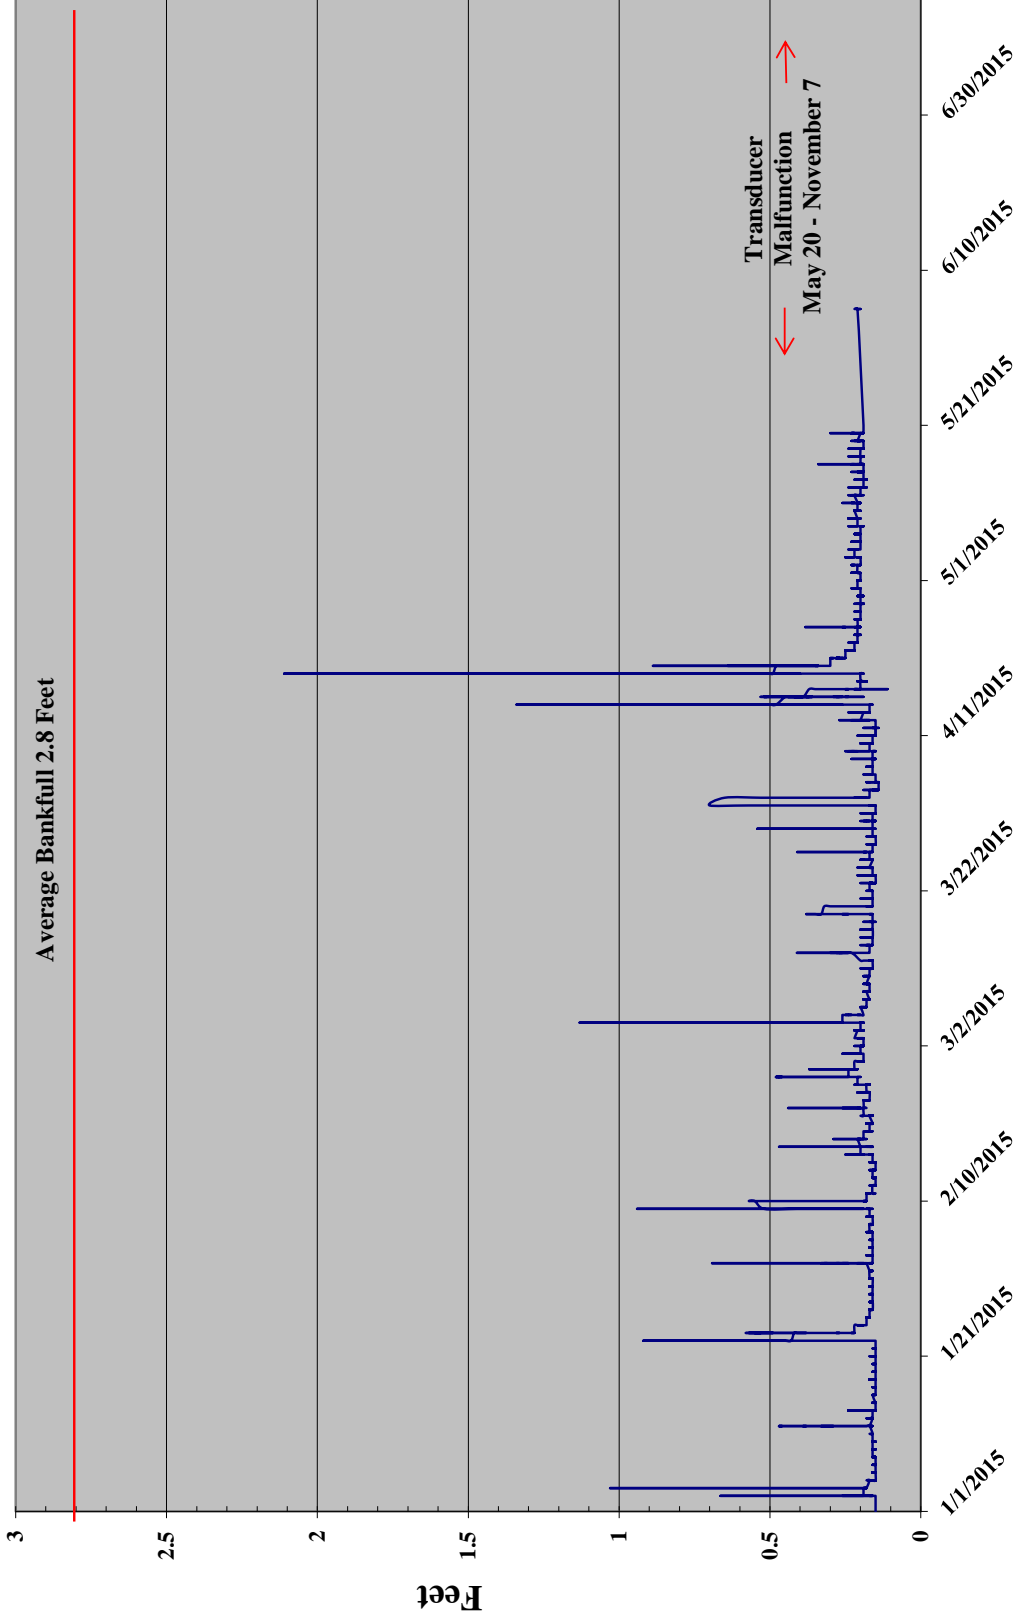
Figure 3. Dye Branch Water Level Logger Chart

A water level logger was installed in December of 2010 and has since recorded a total of 14 bankfull events. An equipment malfunction led to the loss of pressure transducer data between June and November of 2015. One bankfull event was documented through wrack lines between June and November of 2015. Bankfull events may be underrepresented during this monitoring year.
