**Dye Branch II  
Stream Restoration  
Post-Repair Monitoring Report (2017)  
NCDMS Project Number: 92255**

**Submitted to  
North Carolina Division of Mitigation Services  
North Carolina Department of Environmental Quality  
February 2018**

# **Dye Branch II Stream Restoration 2017 Post-Repair Monitoring Report**

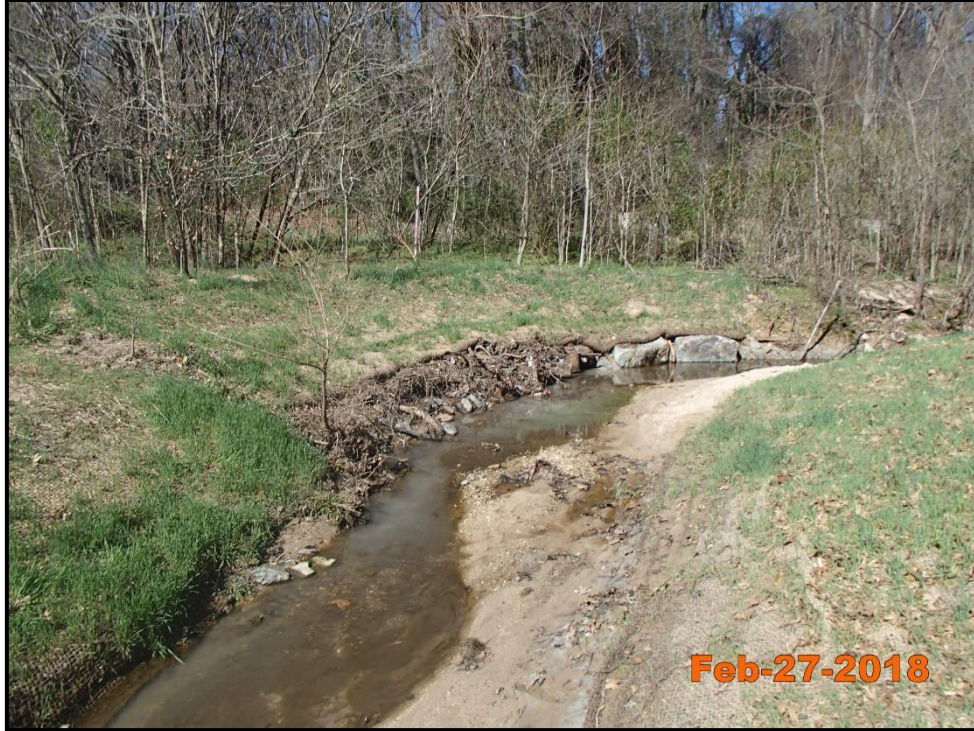
Dye Branch – Permanent Photo Station 10  
Upstream Repair Area 6 STA 10+50

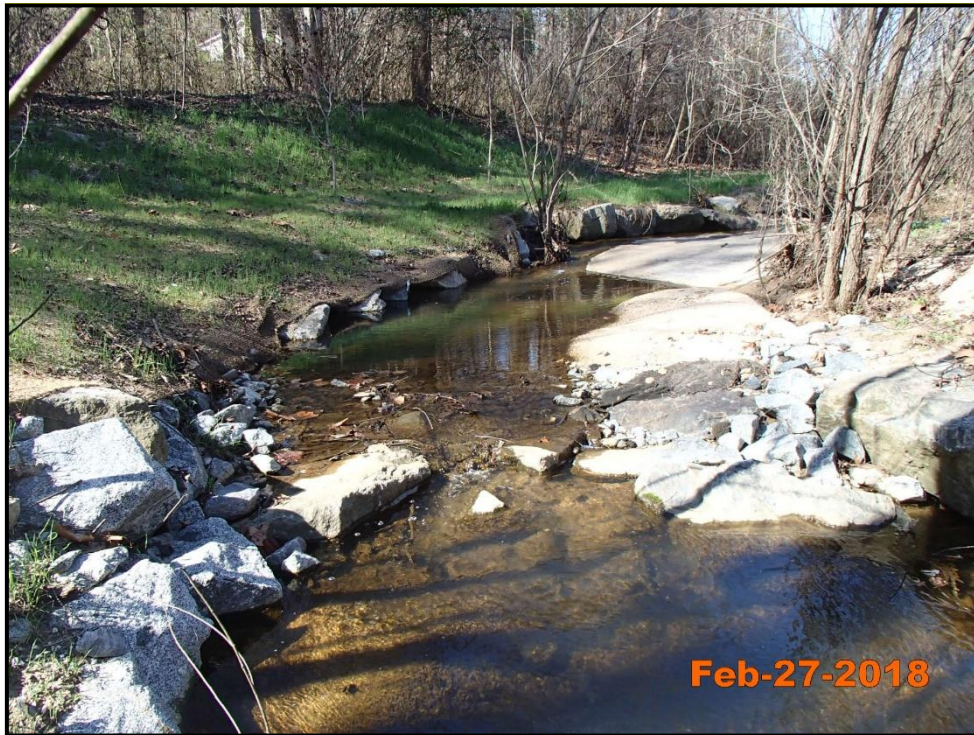
Dye Branch – Permanent Photo Station 11  
Downstream Repair Area STA 19+00
