**Dye Branch II
Stream Restoration
MY7 Monitoring Report (2018)
NCDMS Project Number: 92255**

**Submitted to
North Carolina Division of Mitigation Services
North Carolina Department of Environmental Quality
November 2018**

Dye Branch II Stream Restoration 2018 MY7 Monitoring Report

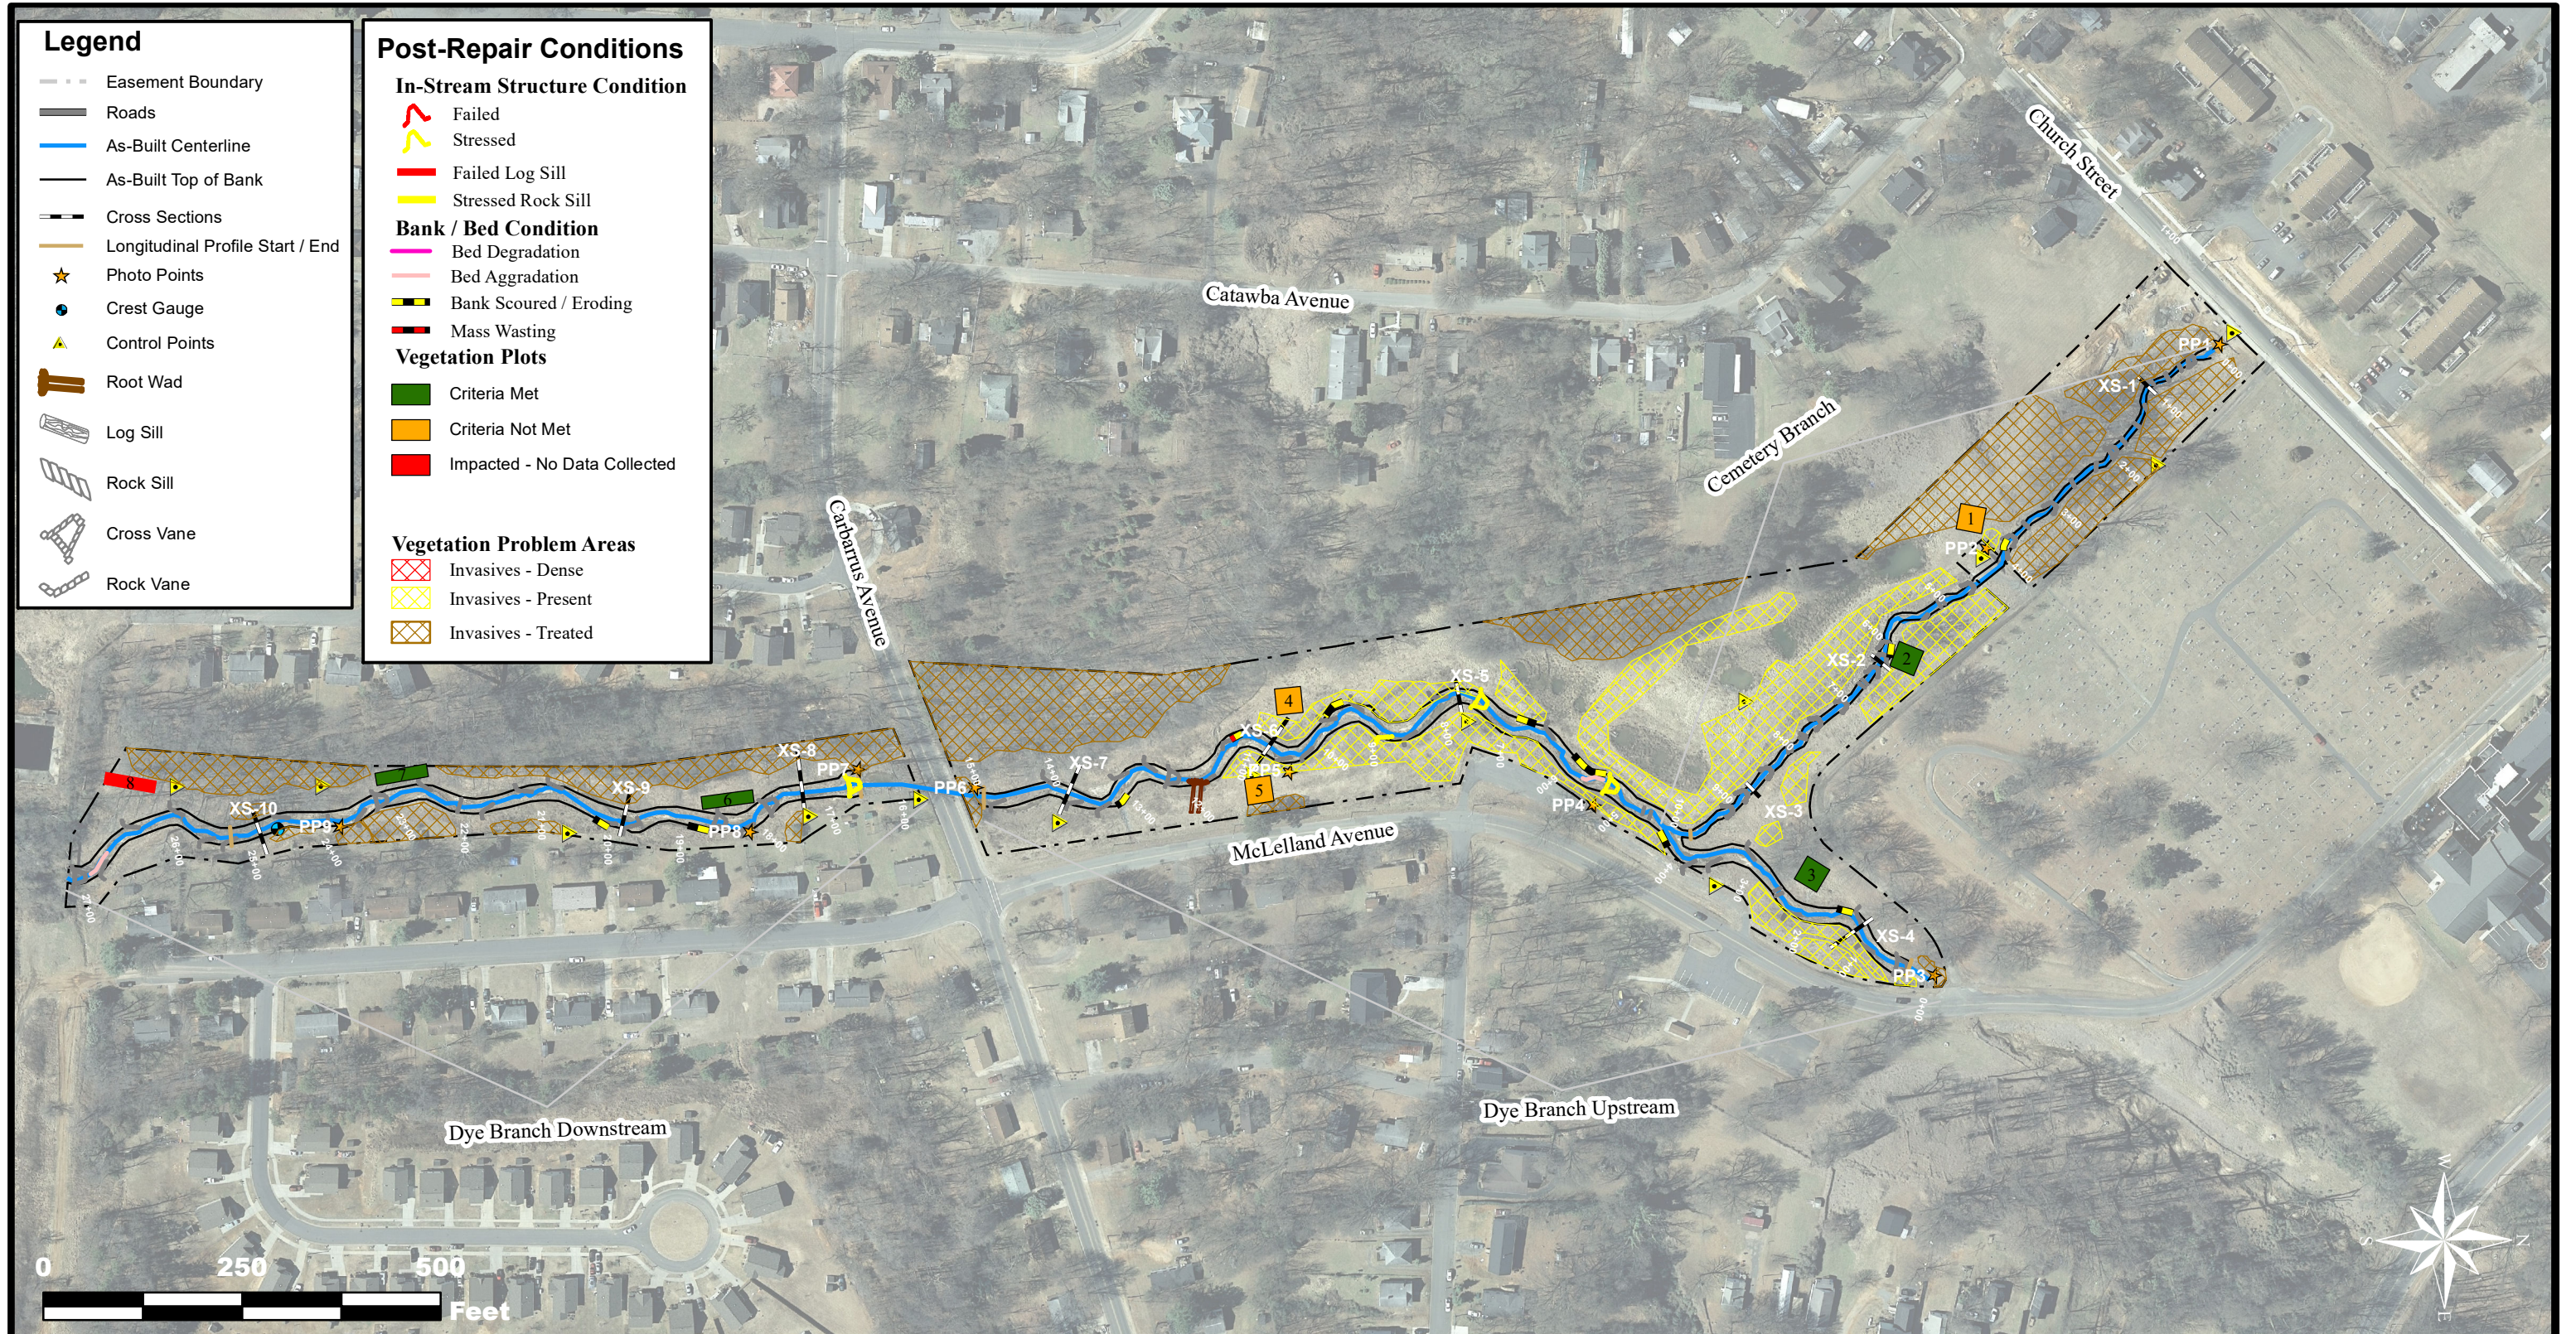
Figure 2. Integrated Current Condition Plan View

Visual assessment of the stream channel was performed to document signs of instability, such as eroding banks, structural instability, or excessive sedimentation. Multiple areas of bank erosion were noted on all reaches (Figure 2, CCPV). All of these problem areas have existed since before the repair work was completed in late 2017. All of the implemented repairs completed in late 2017 are intact and performing as designed. Photos of all stream problem areas can be seen in the digital submission.

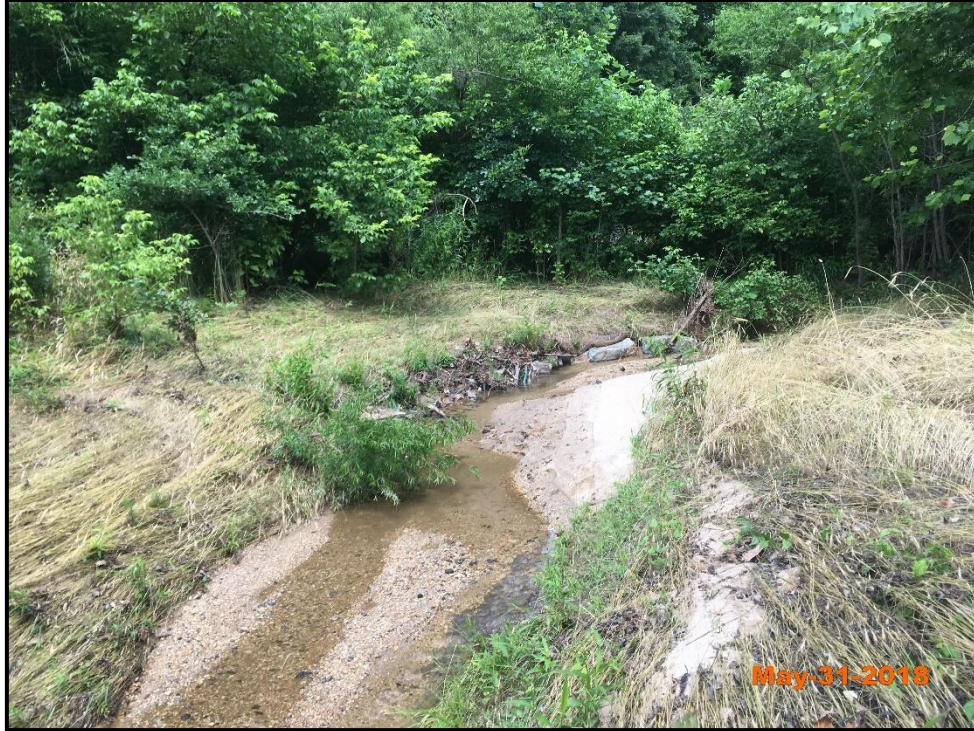
Dye Branch – Permanent Photo Station 10
Upstream Repair Area 6 STA 10+50

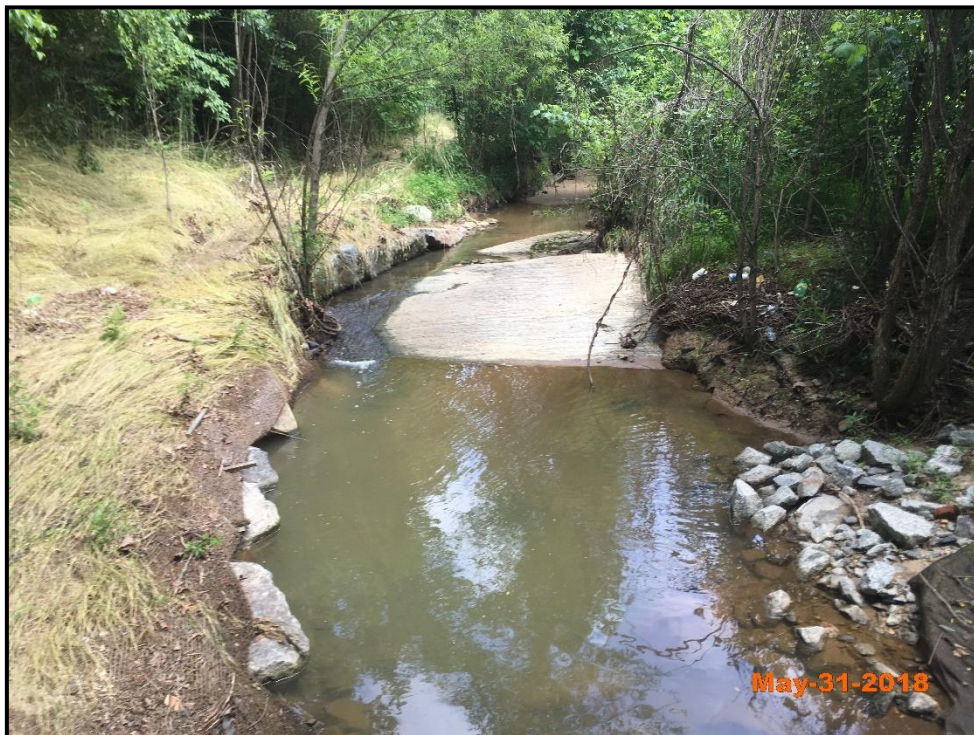
Dye Branch – Permanent Photo Station 11
Downstream Repair Area STA 19+00

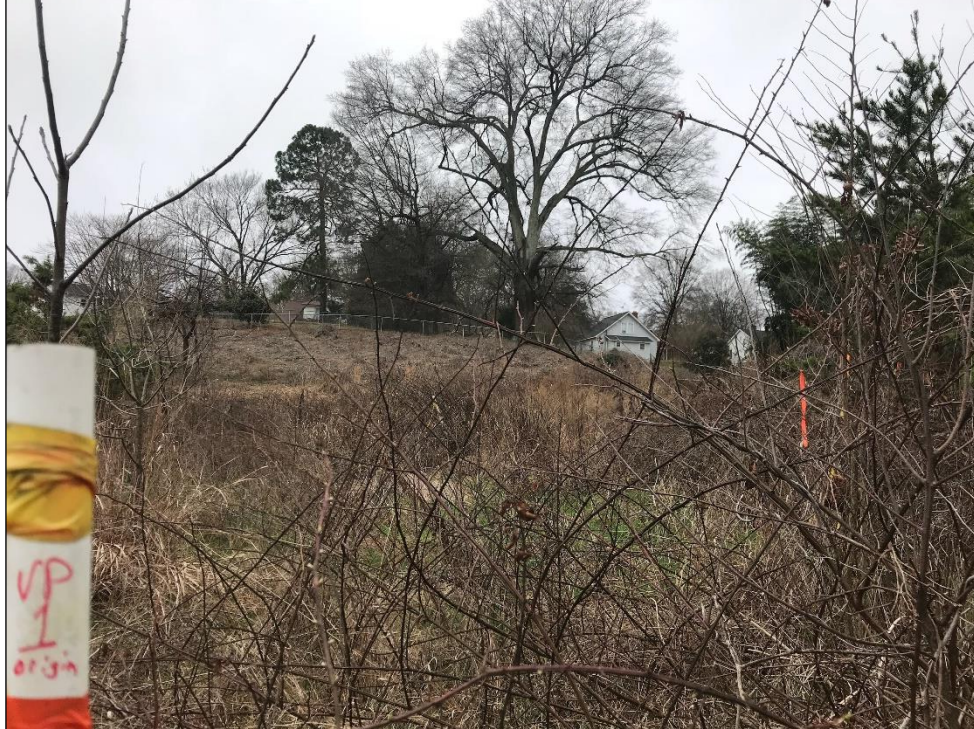
Vegetation Monitoring Plot 1
MY7 Monitoring – October 9th, 2018
(MY6 2017 Photo) (2018 Photo Missing)
