**Dye Branch II
Stream Restoration
MY8 Monitoring Report (2019)
NCDMS Project Number: 92255**

**Submitted to
North Carolina Division of Mitigation Services
North Carolina Department of Environmental Quality
March 2020**

Dye Branch II Stream Restoration 2019 MY8 Monitoring Report

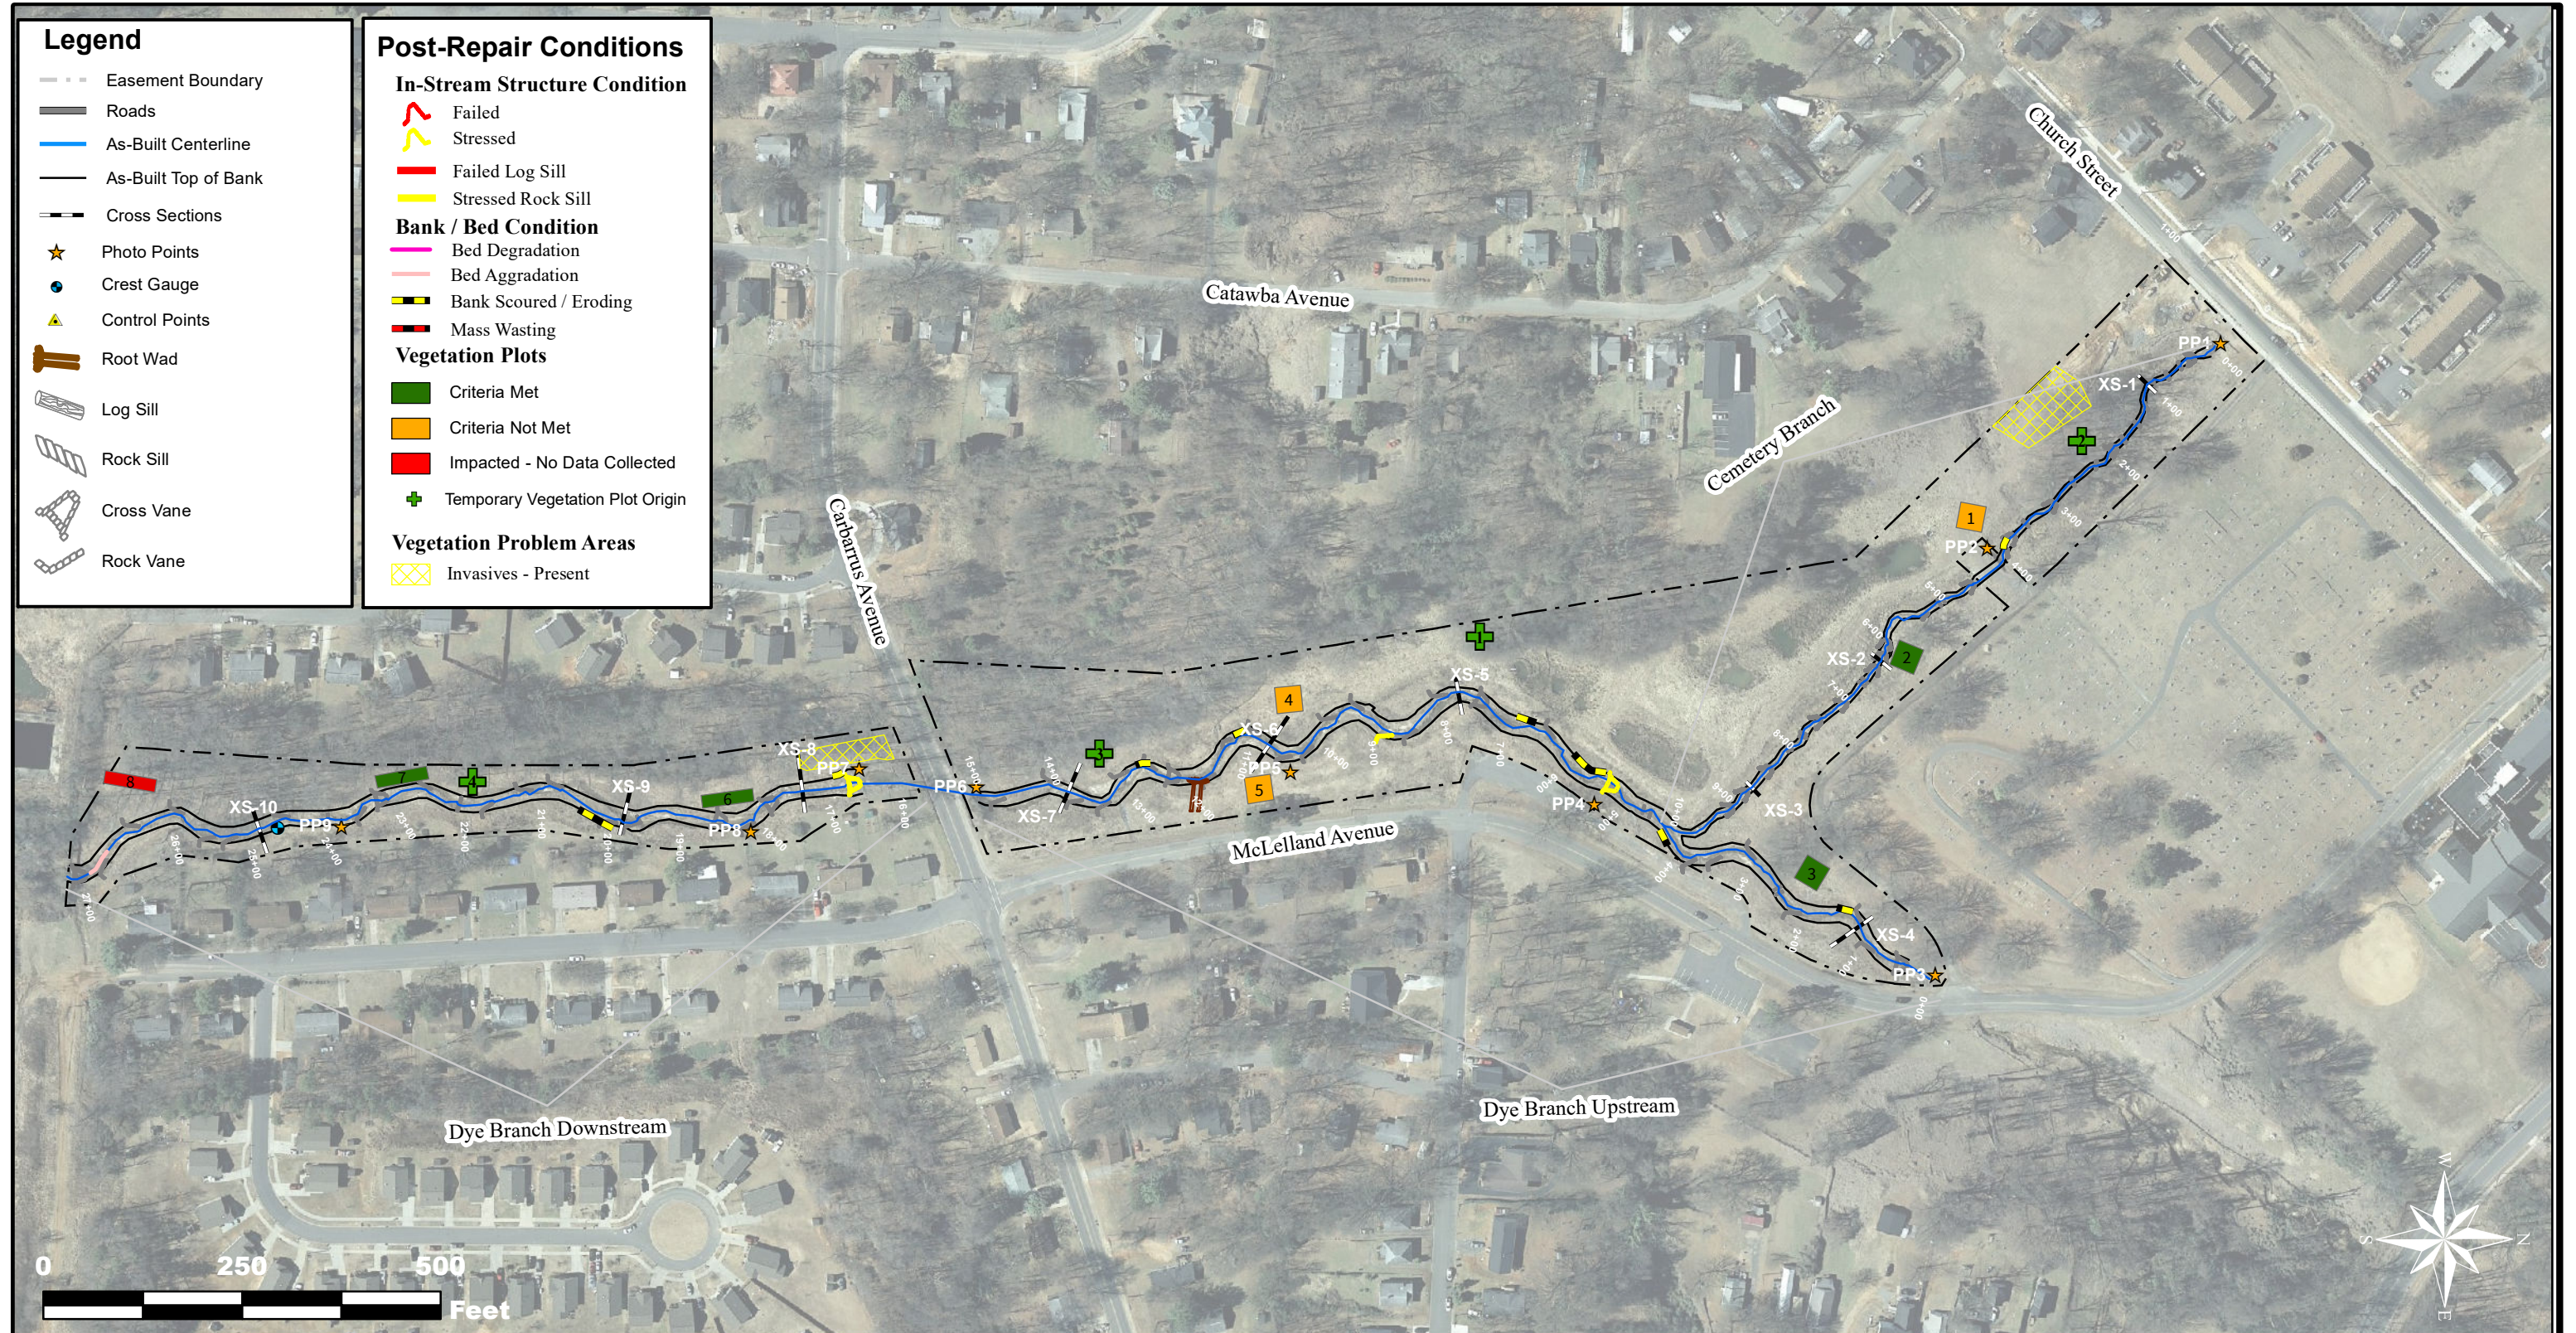
Figure 2. Integrated Current Condition Plan View

Monitoring Year 8 - Integrated Current Condition Plan View Iredell County, North Carolina Sheet 1 of 1 March 2020	1) Base Map Data Provided by Mulkey Engineers & Consultants 2) NC OneMap 2010 Aerial Photo 3) Areas of Lonicera japonica also on site Project Number NCDMS # 92255

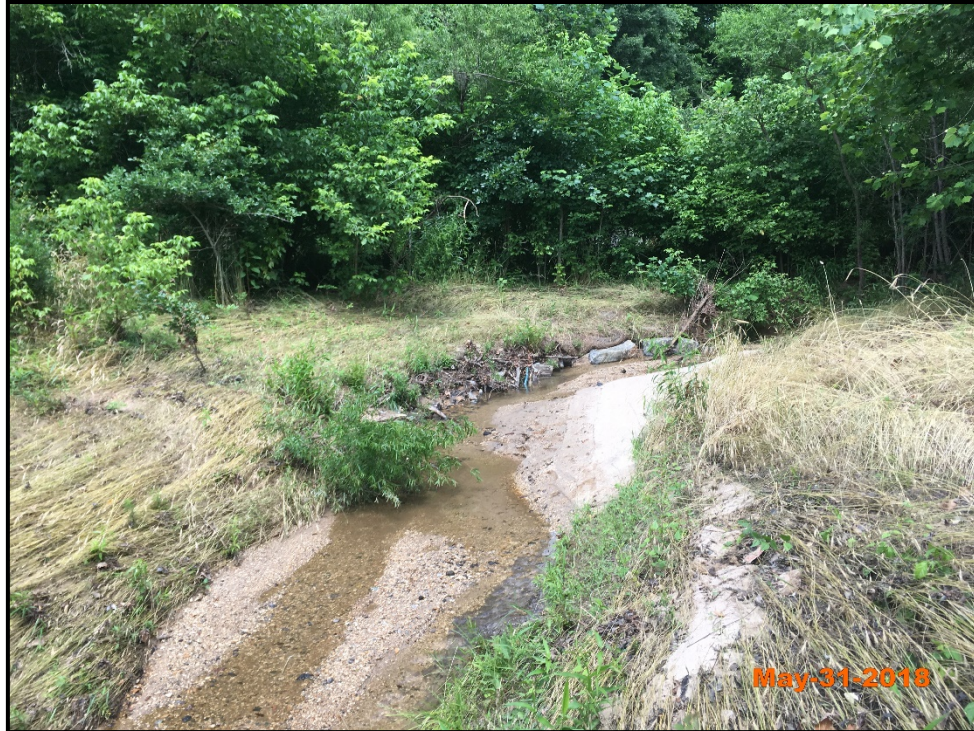
Dye Branch – Permanent Photo Station 10
Upstream Repair Area 6 STA 10+50 (Photo from 2018)

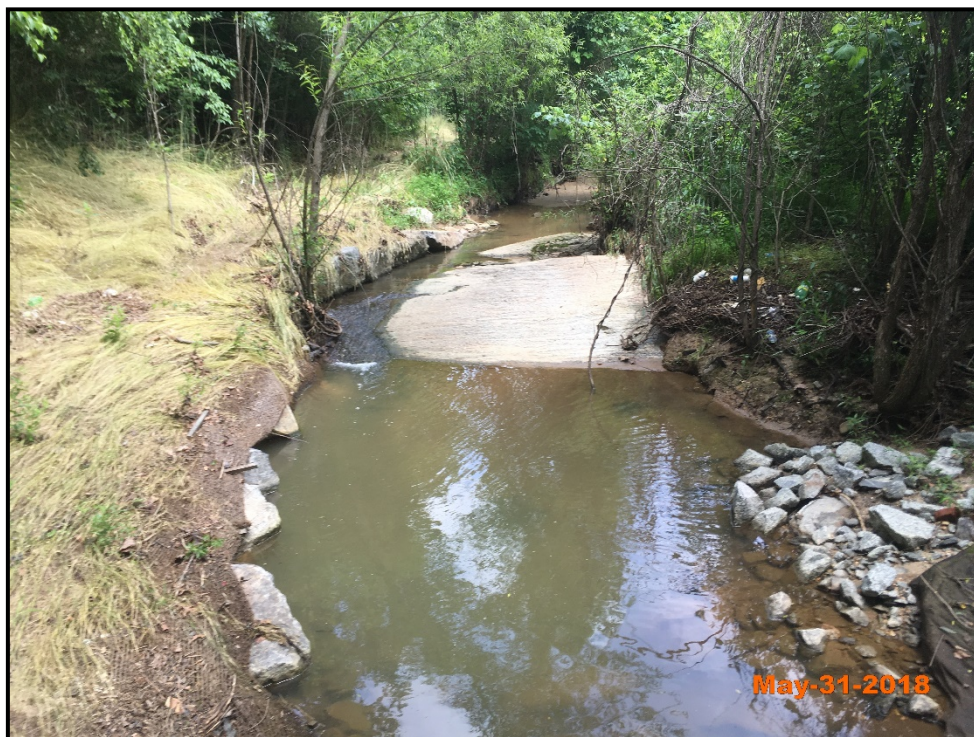
Dye Branch – Permanent Photo Station 11
Downstream Repair Area STA 19+00 (Photo from 2018)

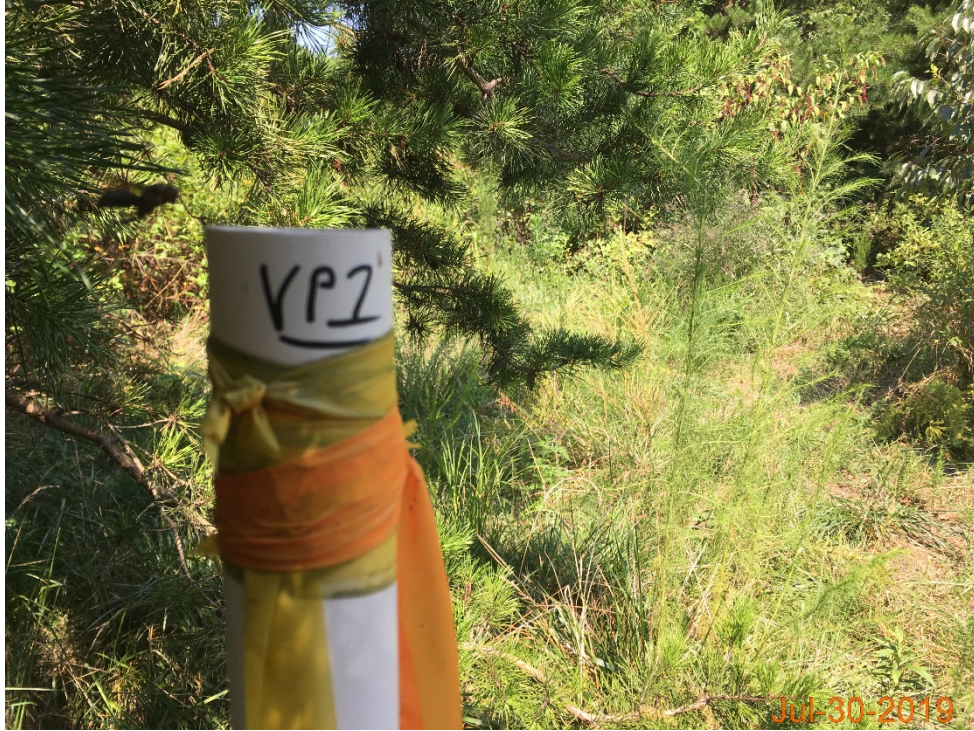
Vegetation Monitoring Plot 1
MY8 Monitoring – July 30th, 2019

Table 7. Vegetation Plot Criteria Attainment Dye Branch II / Project No. 92255		
Vegetation Plot ID	Vegetation Survival Threshold Met?	Tract Mean
1	No	57%
2	Yes	
3	Yes	
4	No	
5	No	
6	Yes	
7	Yes
