# **MONITORING YEAR 2 ANNUAL REPORT FINAL**

## **DYNAMITE CREEK MITIGATION SITE**

Rockingham County, NC  
Roanoke River Basin  
HUC 03010103

**DYNAMITE CREEK MITIGATION SITE**  
Monitoring Year 2 Annual Report

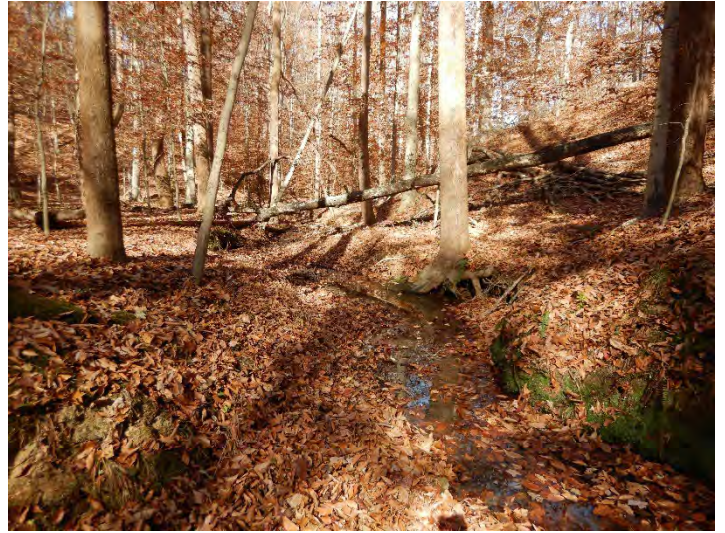
**PHOTO POINT 16\* Dynamite Creek Confluence with UT1 –  
upstream (11/16/2023)**

Additionally at the confluence of UT1 and Dynamite Creek, the stream was observed flowing through a hole on the downstream right side of the channel, behind an old fallen tree that had been acting as grade control. The IRT requested an additional photo point be added to monitor the area and confirm stream stability. The photo point (PP16) was installed, and photos were taken on November 16, 2023. Please see Stream Photographs in Appendix A and Figure 1a for the location.

\*Photo Point 16 was added 11/16/2023 to monitor stability around the natural log sill seen in the upstream view as requested by the IRT.

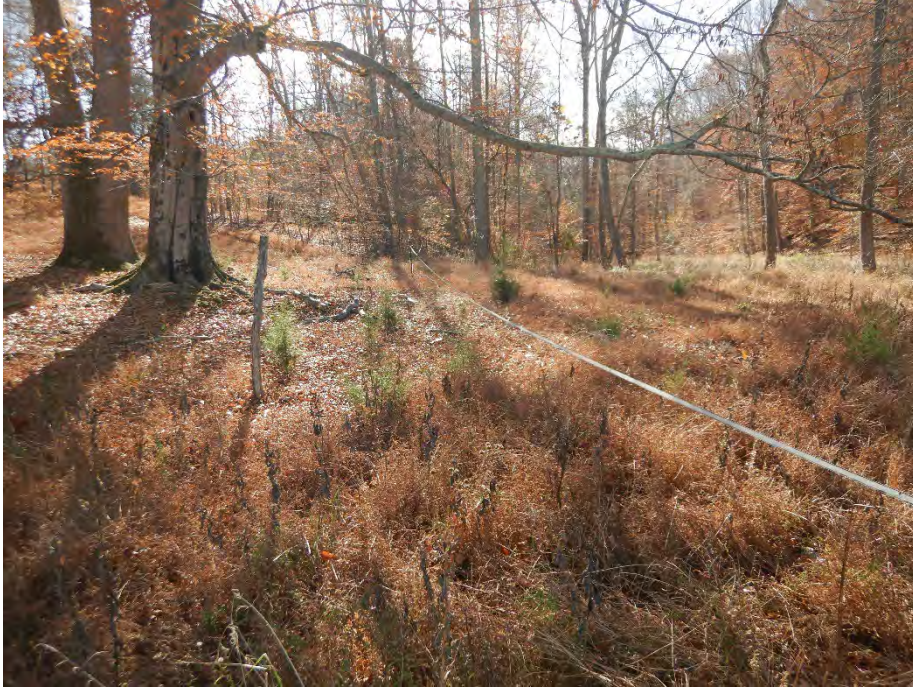
## Easement Encroachment – Vehicle Access

A small vehicular access encroachment was discovered near the bridge crossing in January 2023 (see Figure 1b for location). We believe one of the landowner's family members did not see the signs and followed an old dirt path down the hill from the house to the bridge crossing. Another t-post was added

in the middle of the old path, and polytape was strung between the t-post signs to make the edge of the conservation easement obvious. No other vehicular encroachments have occurred since, vegetation is growing well, and this area is no longer a concern. See Vegetation Area of Concern Photographs– Conservation Easement Encroachment in Appendix A for current photographs from November 2023.

Photo taken November 16, 2023 along the edge of the easement showing the polytape clearly marking the edge of the conservation easement. Dirt path is to the left and comes down the hill behind the large trees, the easement is to the right.

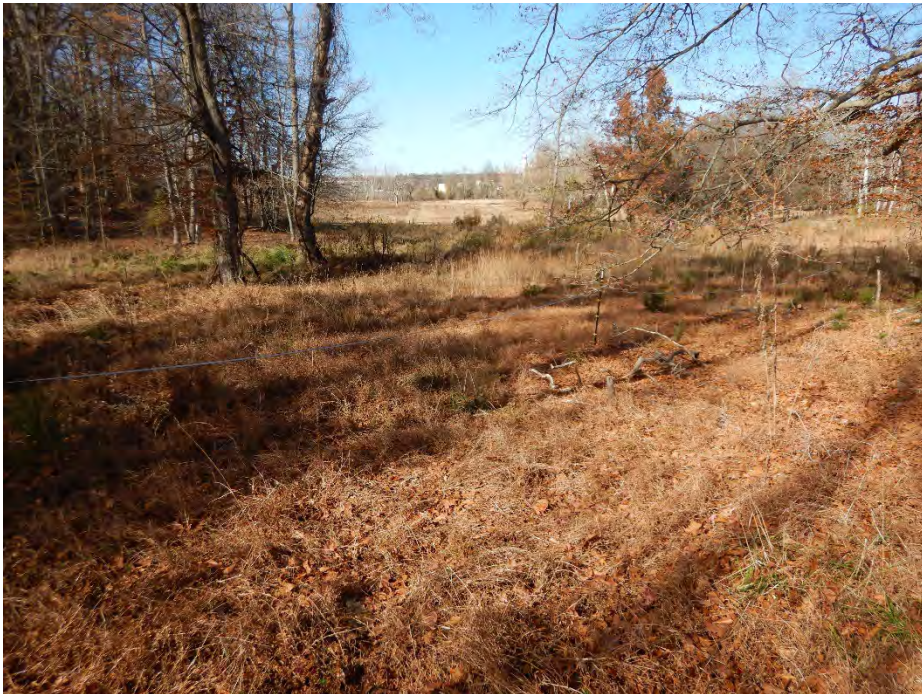
Photo taken November 16, 2023 standing in the dirt path, facing into the easement toward Dynamite Creek and the bridge crossing. The added t-post and polytape marking the easement boundary are visible. Vegetation is growing well and no new vehicle tracks have been observed.
