East Buffalo Creek Mitigation Project

Year 1 Monitoring Report - Final Graham County, North Carolina

Monitoring Firm: Michael Baker
Engineering, Inc. (Baker)

Prepared for: North Carolina Ecosystem
Enhancement Program (NCEEP)

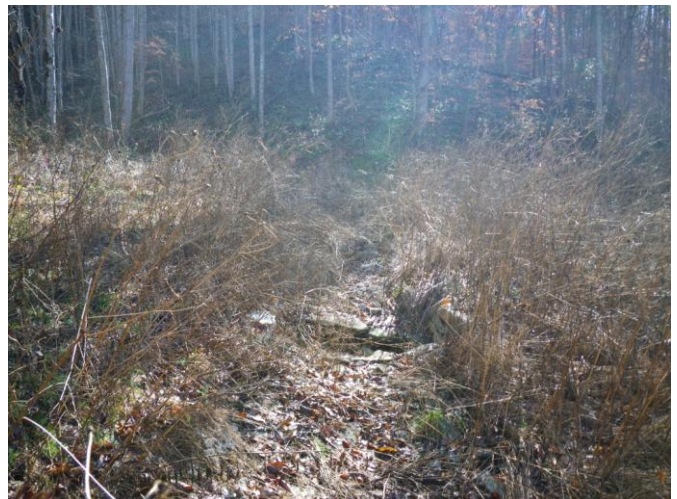
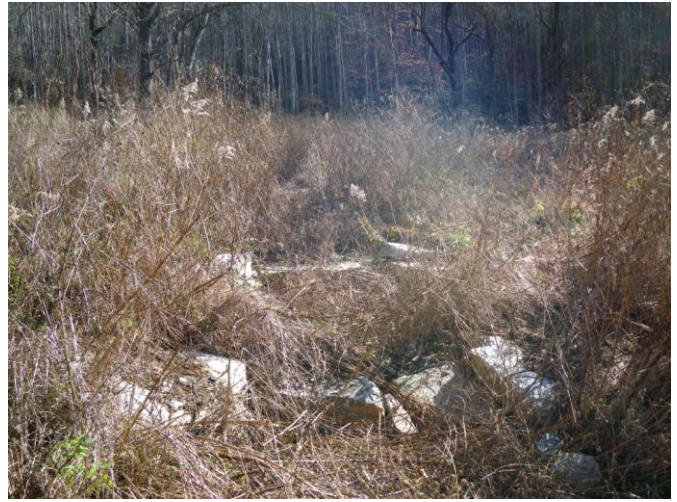
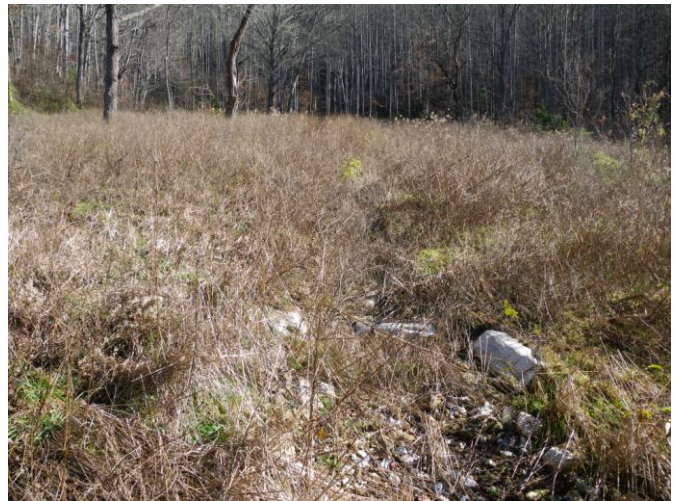
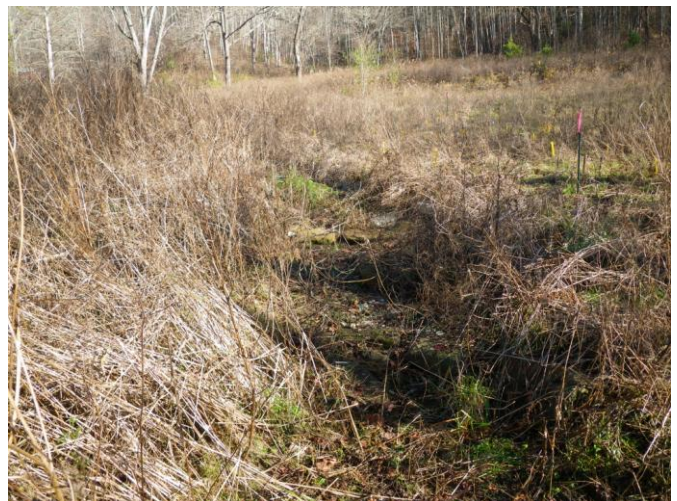
At this time, the only item that is being monitored beyond the success criteria noted in this report is the dry segment of UT2. As noted in Section 2.1.1.2 of the Baseline Monitoring Report, we believe that the surface flow is presently flowing beneath and through the channel bed material. The flow should surface as organic material and fine particles reduce interstitial spaces in the constructed channel. If necessary, modifications will be made to establish surface flow throughout the project reach if flow does not return by the Spring of 2012.

Feature Issue	Station No.	Suspected Cause	Photo Number
Other	0+39 to 5+72 and 5+87 to 6+34 (downstream limits of project reach)	Channel is dry from flow going subsurface in two areas probably due to lack of seal behind upstream drop structure.	UT2 Photo Points 2 - 5 in Appendix B
