East Buffalo Creek Mitigation Project

Year 2 Monitoring Report - Final Graham County, North Carolina

Monitoring Firm: Michael Baker
Engineering, Inc. (Baker)

Prepared for: North Carolina Ecosystem
Enhancement Program (NCEEP)

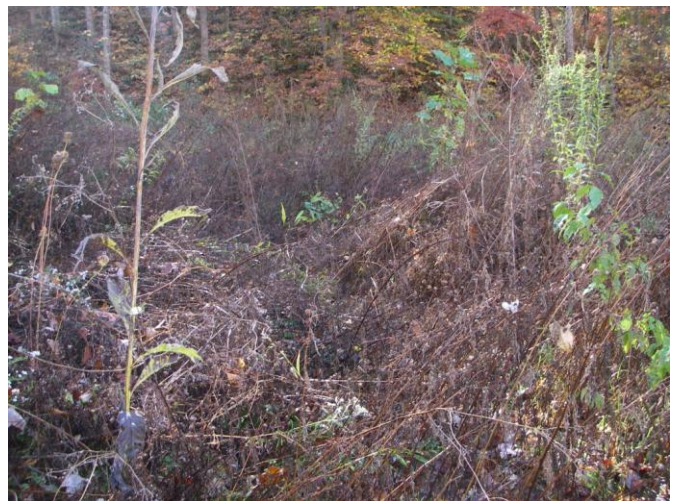
Photo Point 2: looking downstream

Feature Issue	Station No.	Suspected Cause	Photo Number
Other	1+57 to 1+69, 1+90 to 2+01, 2+03 to 2+13, 2+23 to 5+66	Flow is subsurface	UT2 Photo Point 2 in Appendix B

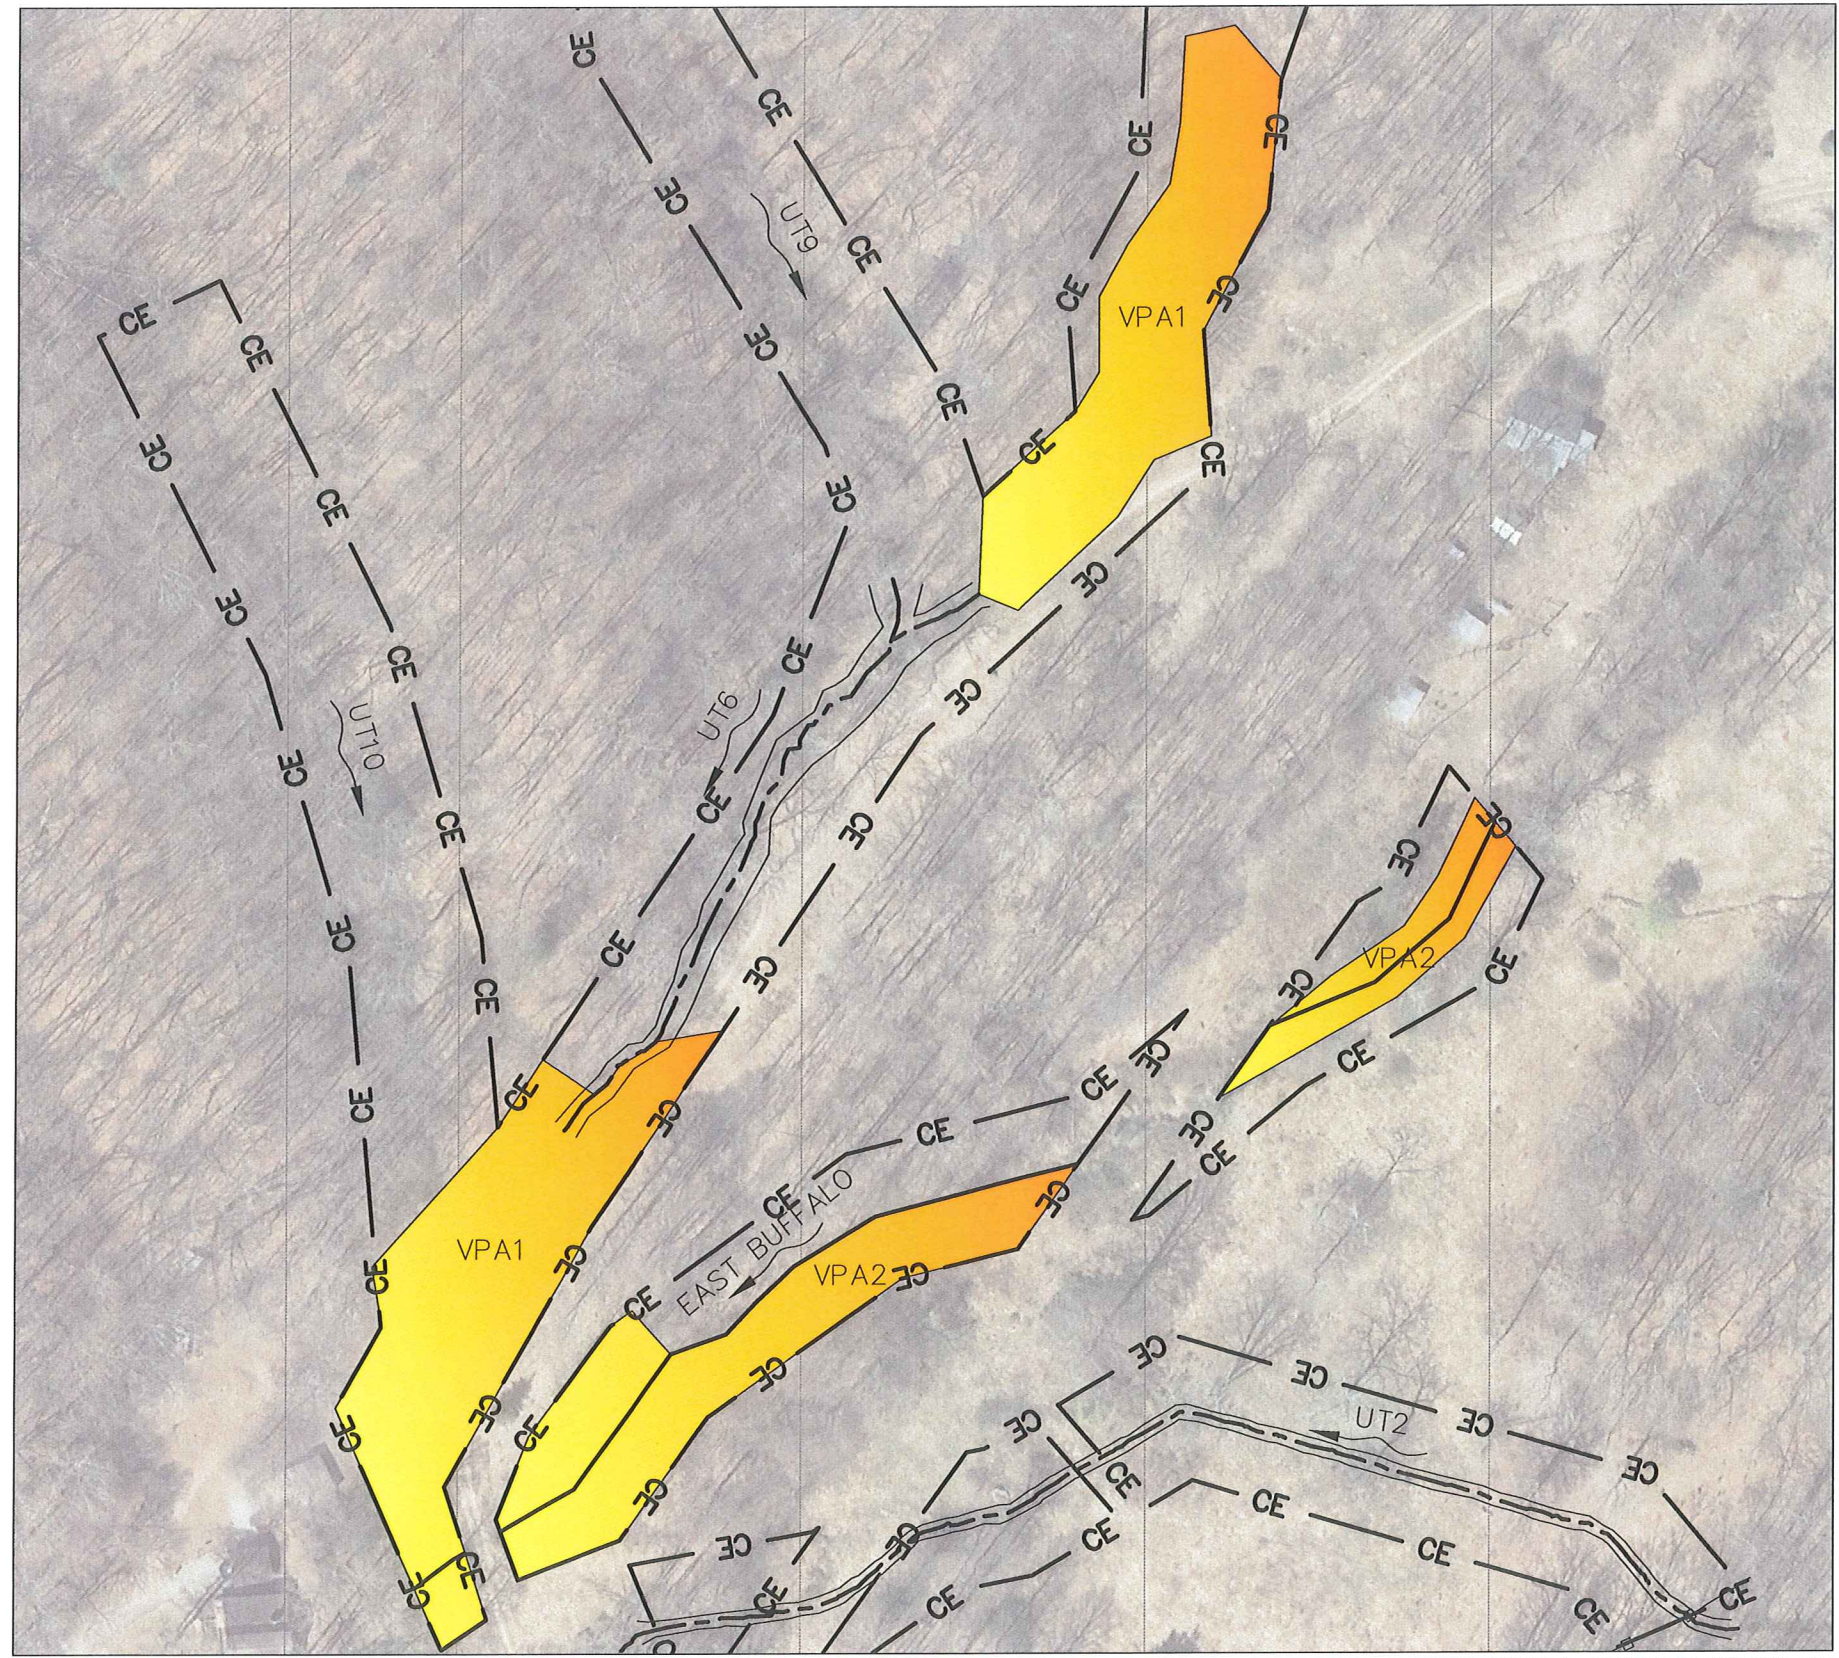
EAST BUFFALO
CURRENT CONDITION PLAN VIEW
VEGETATION PROBLEM AREAS
YEAR 2 MONITORING

There were three vegetation problem areas identified during Year 2 monitoring that related to the presence of invasive vegetation along Reaches 2 of UT5, UT6, and East Buffalo Creek. Multiflora Rose and Chinese Privet found along portions of these reaches appear to be a result of invasives that have persisted after prior treatment (and not from new growth) as evidenced by the similar age of these species to those in close proximity that have been effectively treated which have withered and died. The large area of withered and dead Multiflora Rose and Chinese Privet observed along these reaches, especially along UT5 Reach 2, is indicative that prior spray treatment was effective. However, the current extent of persistent invasives (Figure 3 in Appendix F) warrants immediate follow-up treatment to limit potential proliferation and will be scheduled with the contractor very soon; an updated status of these vegetation problem areas will be provided in the Year 3 monitoring report. Photos of these vegetation problem areas can be found in Exhibit 6 of Appendix F.

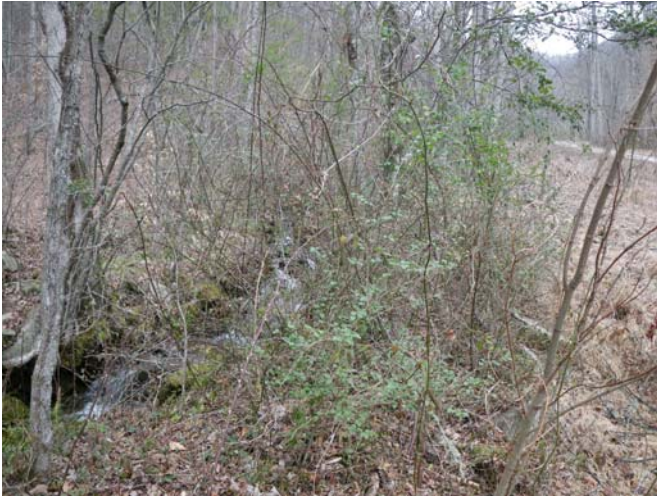
UT6 Reach 2 (565 LF)			
Feature Issue	Station No.	Suspected Cause	Photo Number
Invasive/Exotic Populations	See Plan View	<i>Rosa multiflora</i> , and <i>Ligustrum sinense</i> : persisting after treatment	VPA1
East Buffalo Reach 2 (932 LF)			
Feature Issue	Station No.	Suspected Cause	Photo Number
Invasive/Exotic Populations	See Plan View	<i>Rosa multiflora</i> , and <i>Ligustrum sinense</i> : persisting after treatment	VPA2
UT5 Reach 2 (607 LF)			
Feature Issue	Station No.	Suspected Cause	Photo Number
Invasive/Exotic Populations	See Plan View	<i>Rosa multiflora</i> , and <i>Ligustrum sinense</i> : persisting after treatment	VPA3

VPA1 – Multiflora Rose and Chinese Privet persisting after treatment along the downstream portion of UT6 Reach 2 (looking upstream from the left bank)

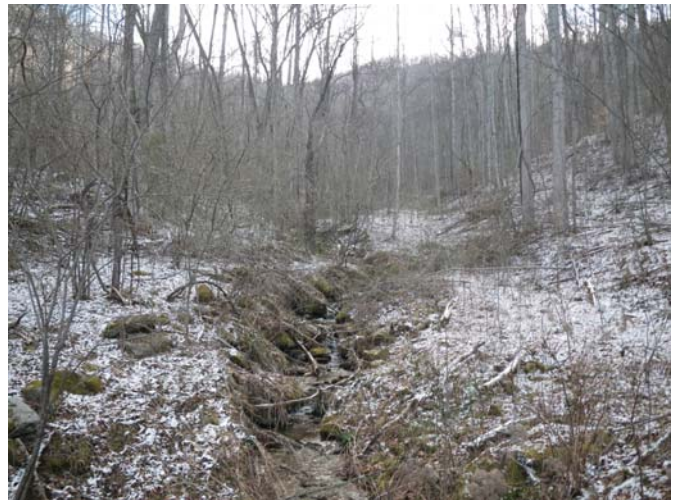
VPA2 – Multiflora Rose and Chinese Privet persisting after treatment on the upstream portion of E. Buffalo Reach 2 (looking upstream)
