East Buffalo Creek Mitigation Project

Year 4 Monitoring Report - Final Graham County, North Carolina

Monitoring Firm: Michael Baker
Engineering, Inc. (Baker)
Monitoring Firm POC: Micky Clemmons

Prepared for: NCDENR – Division of
Mitigation Services
DMS Project Manager: Paul Wiesner

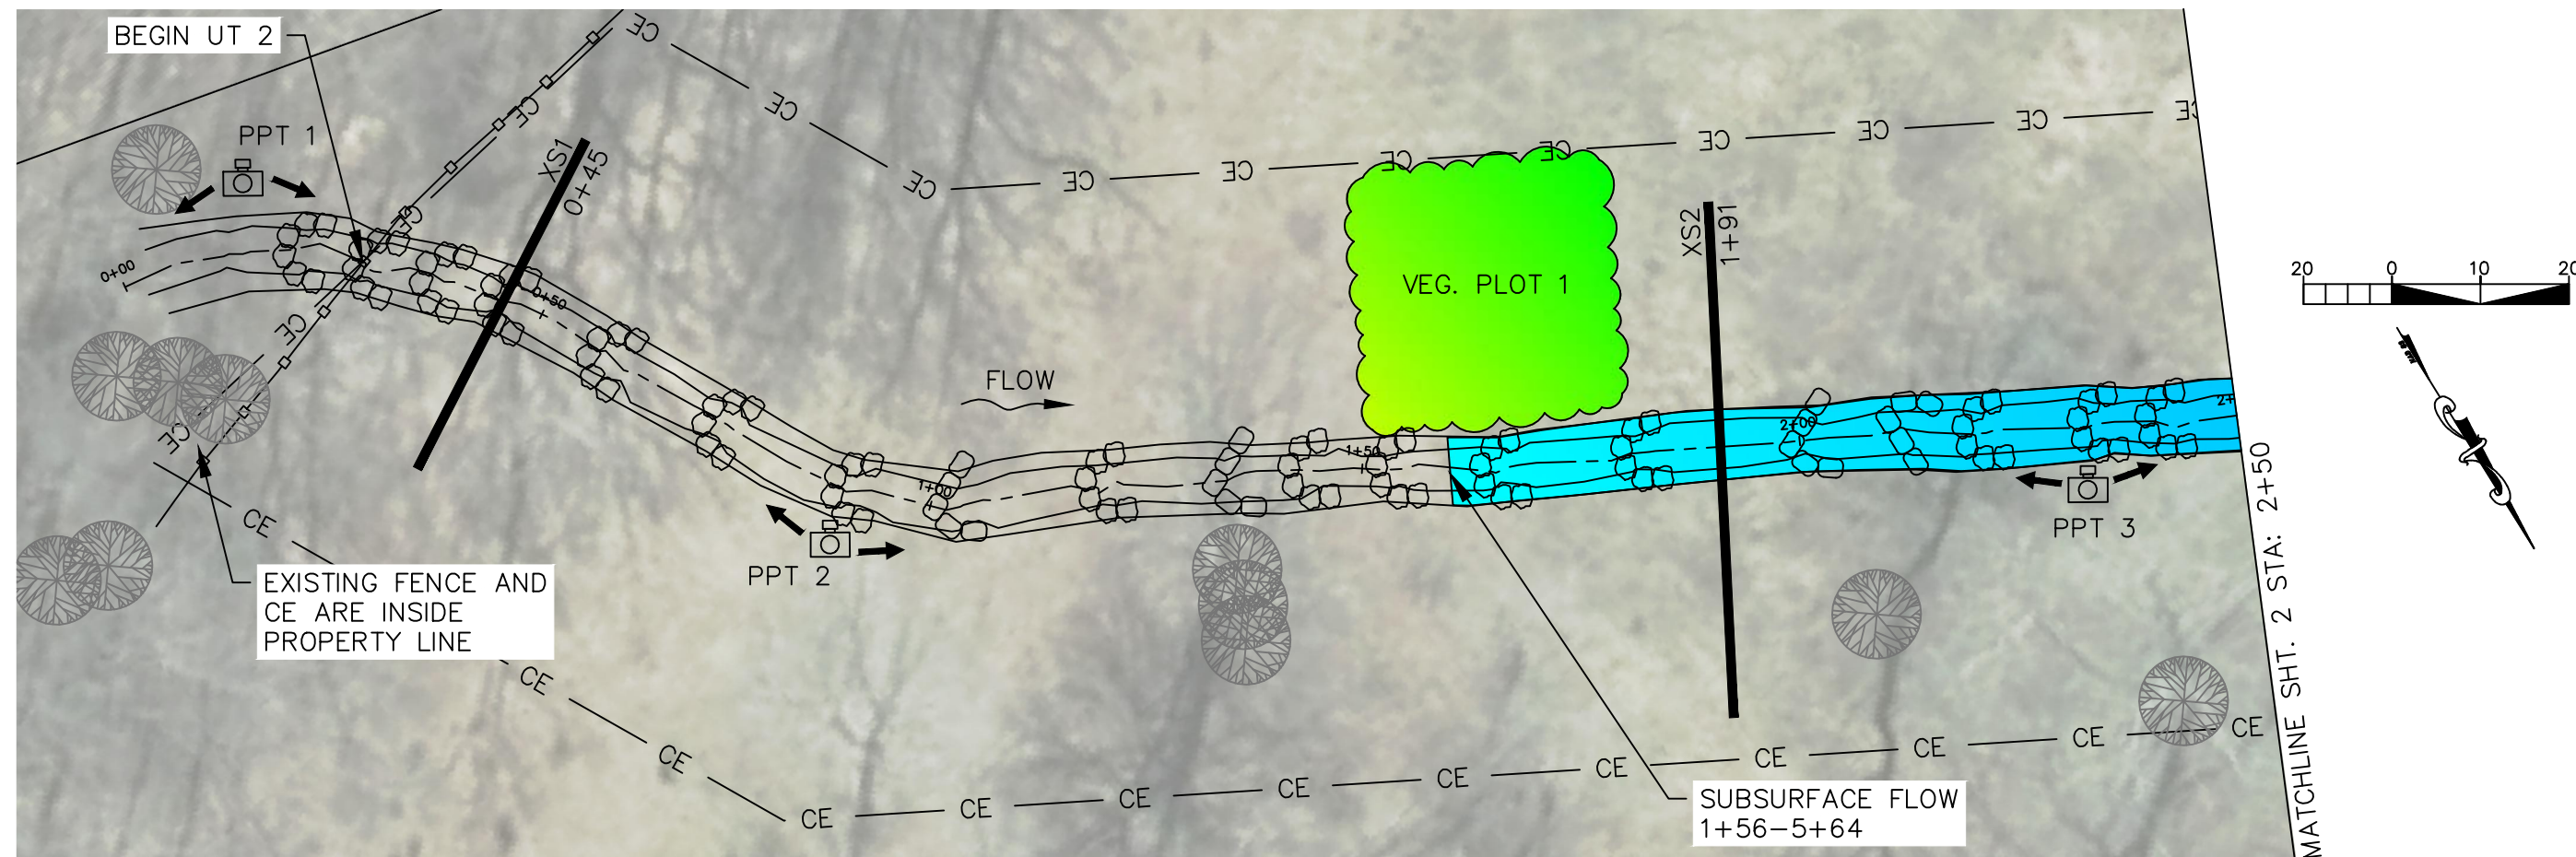
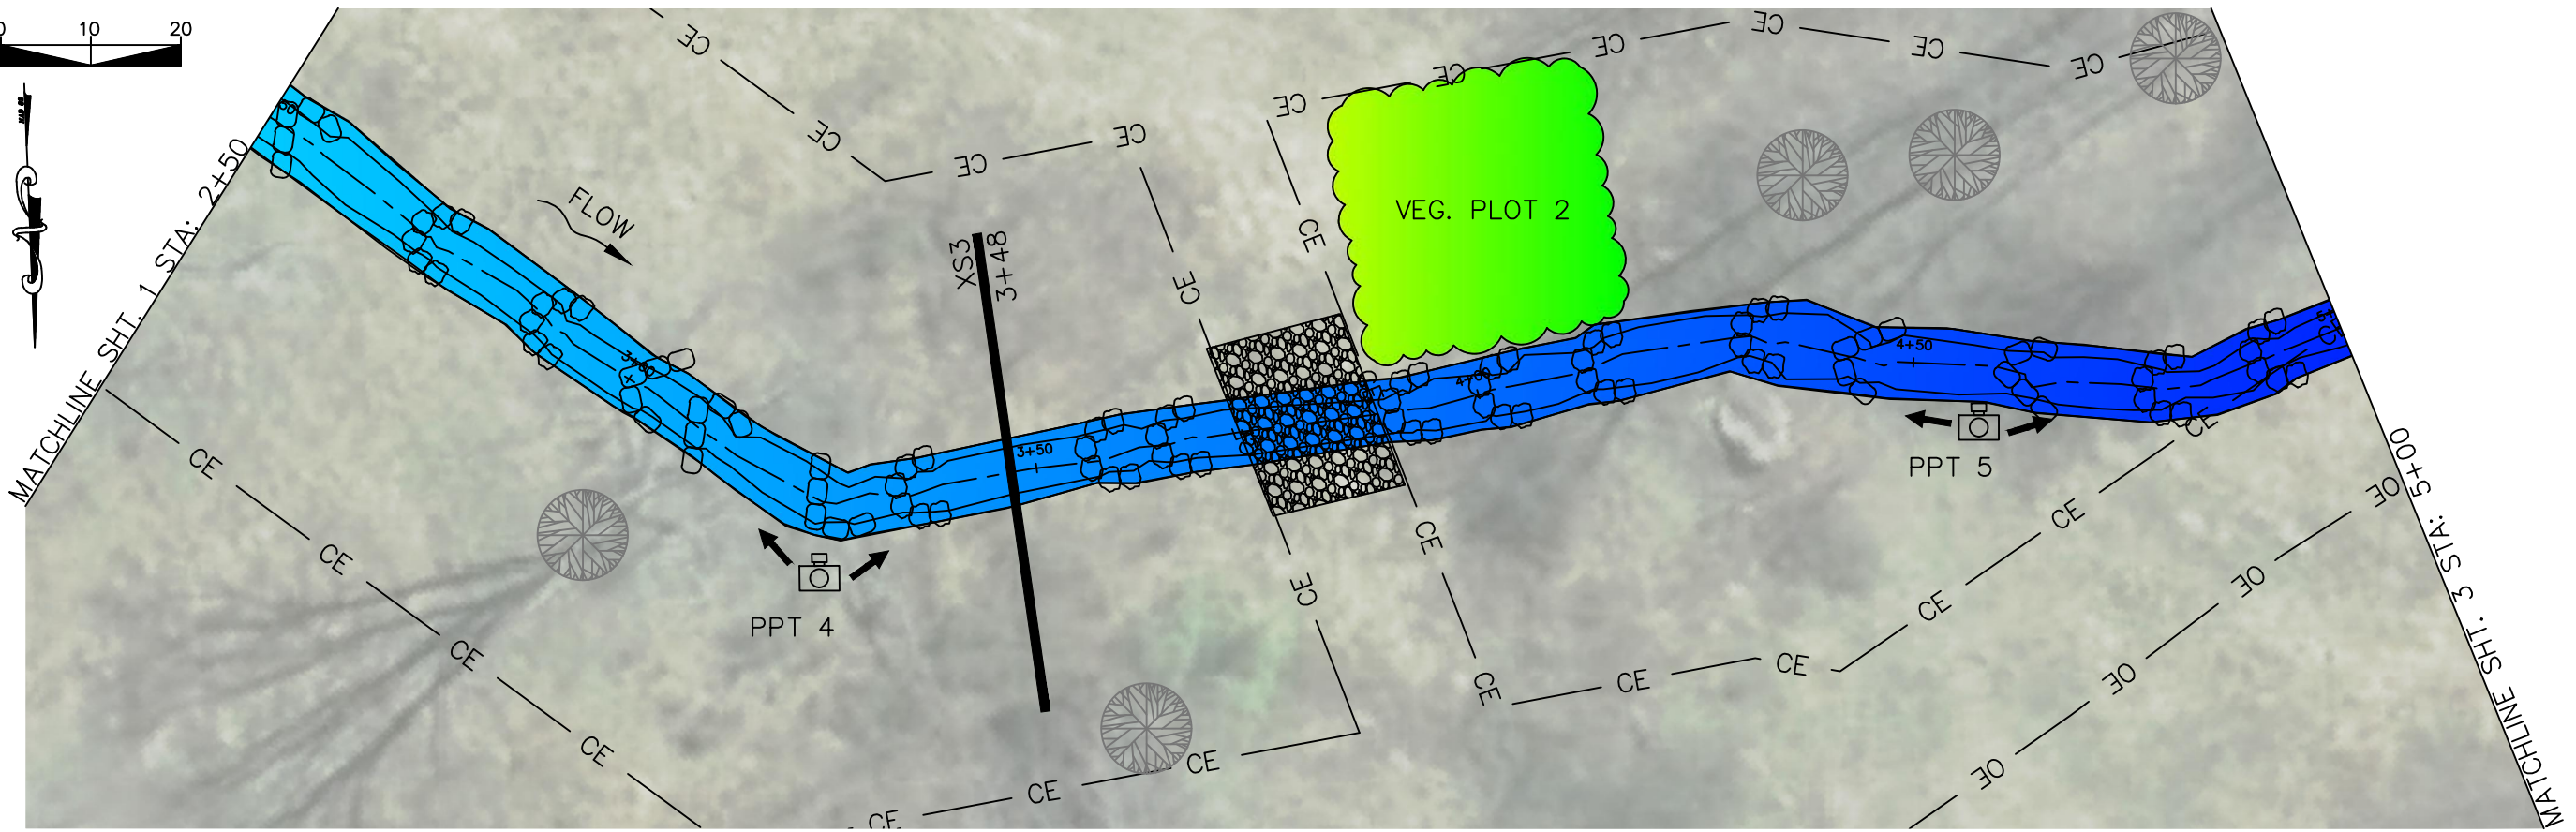
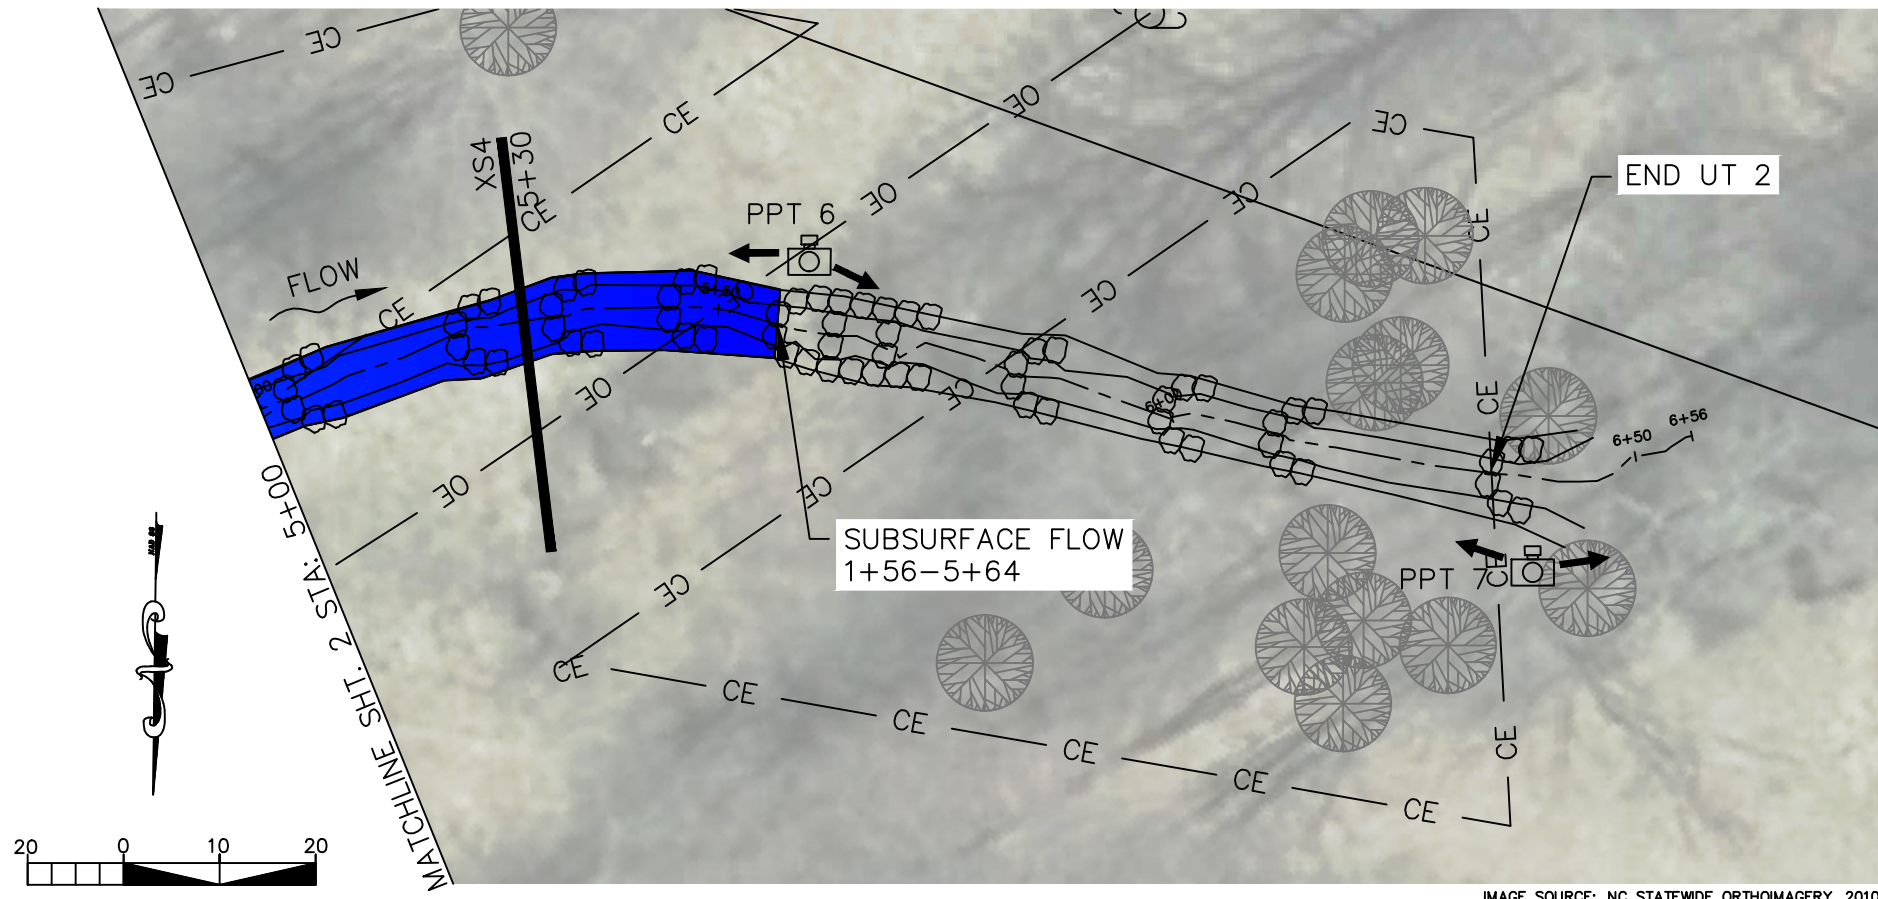
EAST BUFFALO-UT2
CURRENT CONDITION
PLAN VIEW
YEAR 4 MONITORING

There was also little to no change in the profile of UT2 to East Buffalo Creek. Although the profile appears stable, there is a section of UT2 where the stream flow goes subsurface; this section is illustrated on the current condition plan view and documented in Tables 11 and 12 in

Appendix F. Given the steepness in slope and the relatively large riffle material used to construct the step-pool channel system, it is likely that the flow will remain subsurface until interstitial spaces between the stones of the constructed channel bed become filled by smaller particles and organic material. Particle sorting was observed in the channel during the Year 3 & 4 survey, indicating that there is flow in the channel at times. However, the presence of rooted plant material indicates that the baseflow remains under the bed material most of the time. During the 2013-2014 monitoring period, it was observed during at least 3 different visits to the site that surface flow was continuous over approximately half of the restored reach. This was also observed during visits for Year 4 monitoring. This distance over which flow is at the surface appears to be increasing and we believe that in time it will continue across the reach. The subsurface flow condition on UT2 will be monitored and managed as we assess the progress of this surface flow condition. No areas of instability were noted during Year 4 monitoring.

Feature Issue	Station No.	Suspected Cause	Photo Number
Other	1+56 to 5+64	Flow is subsurface	----

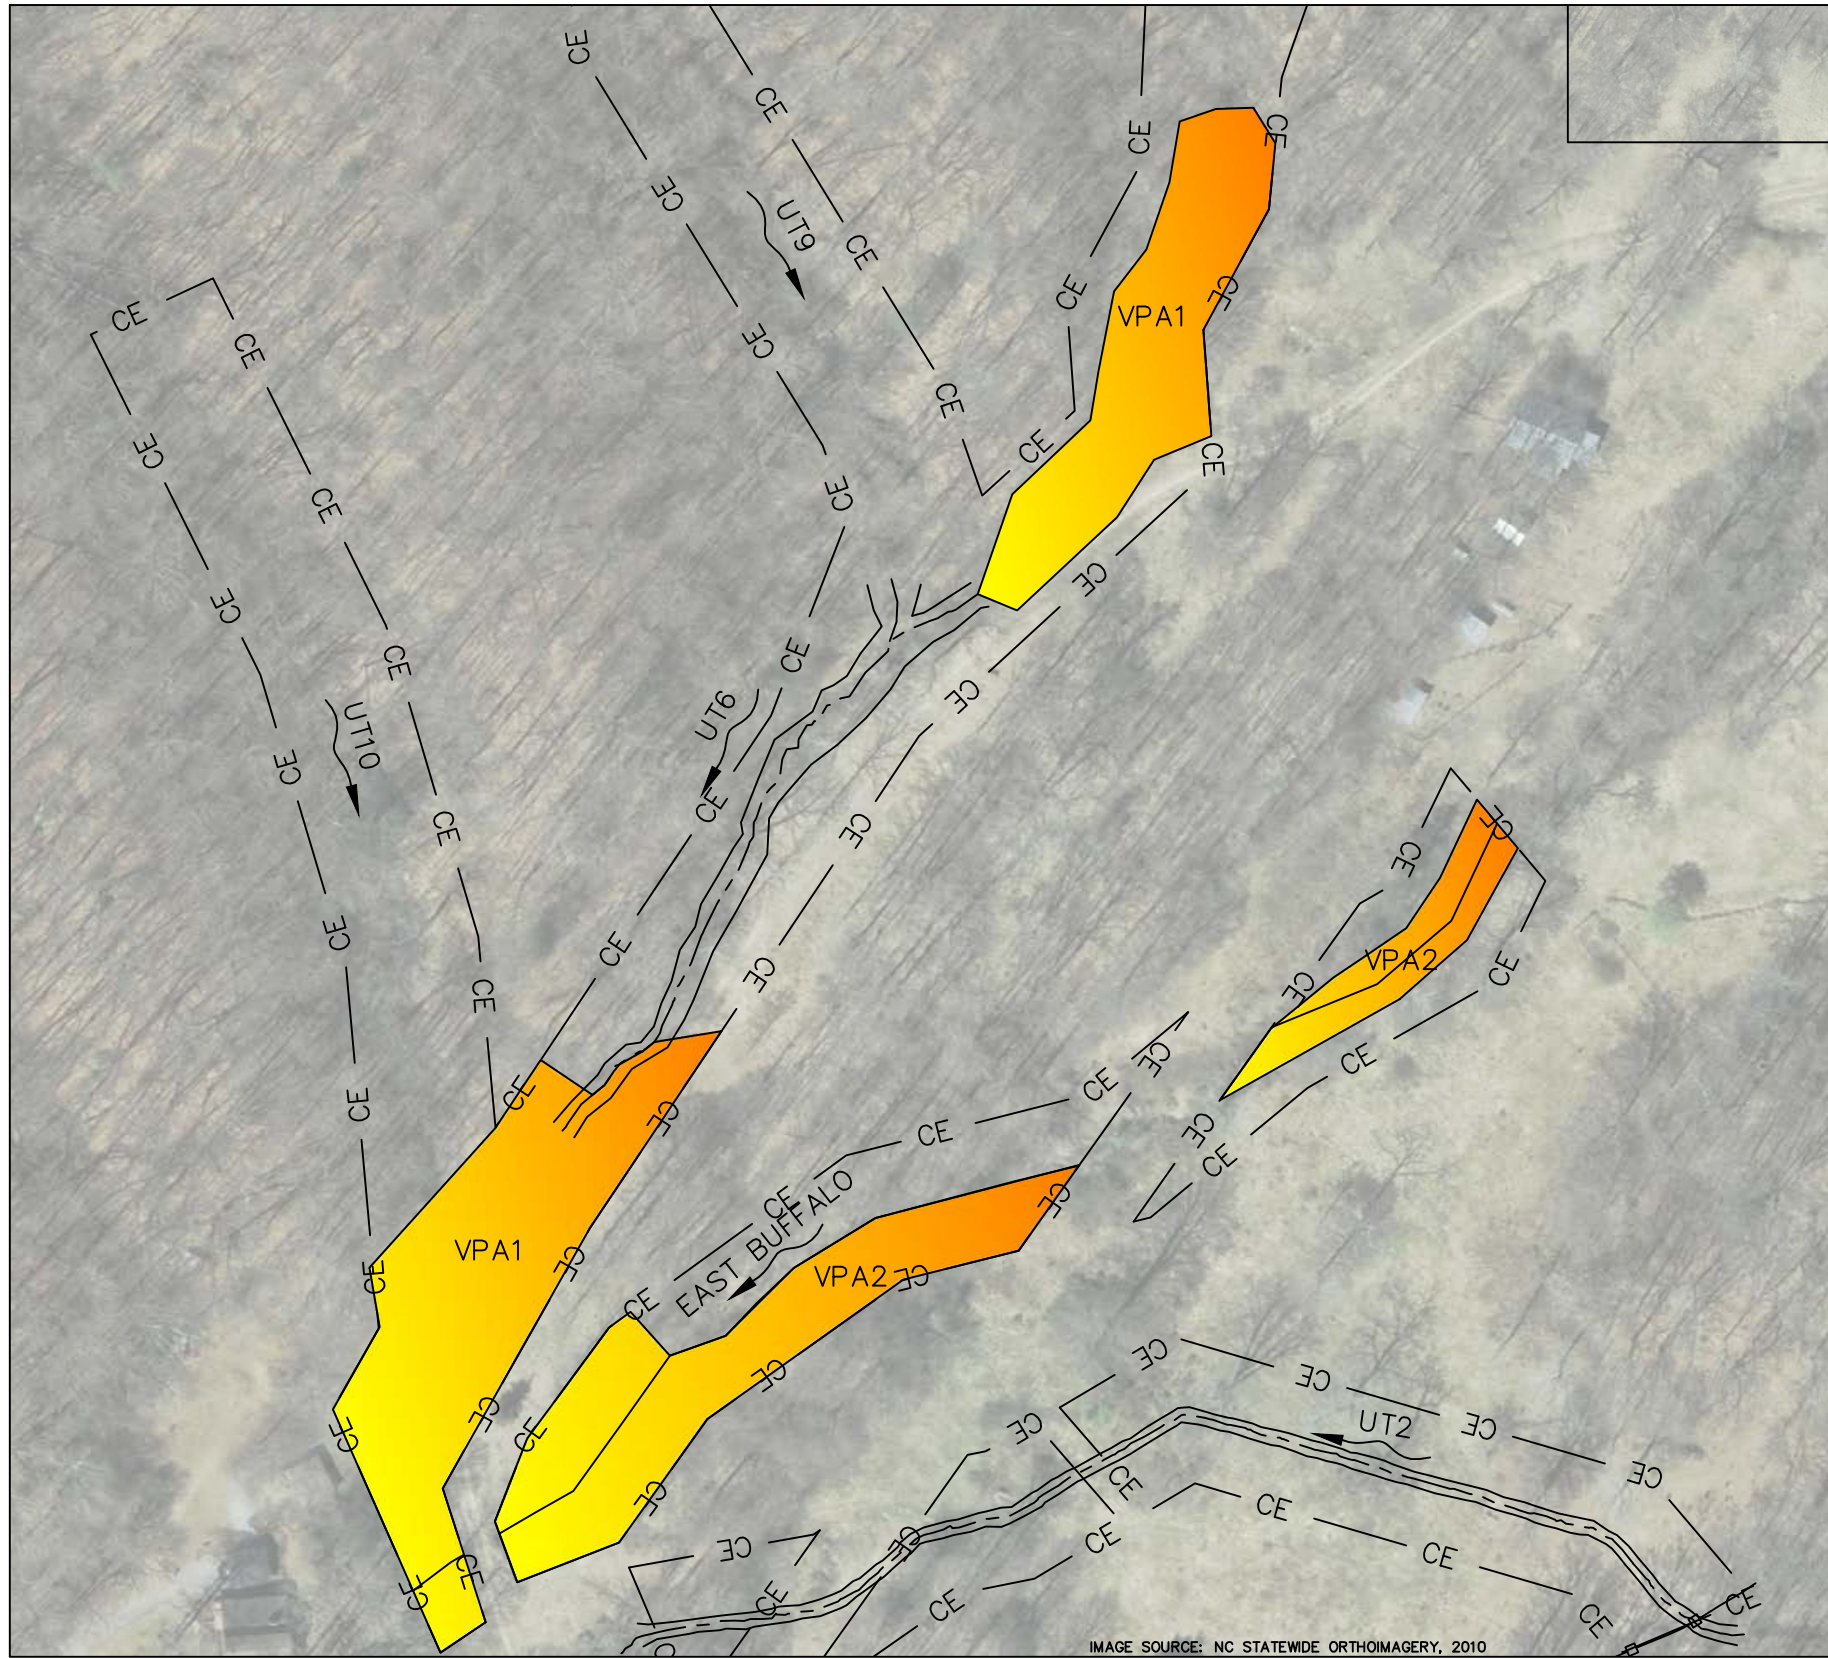
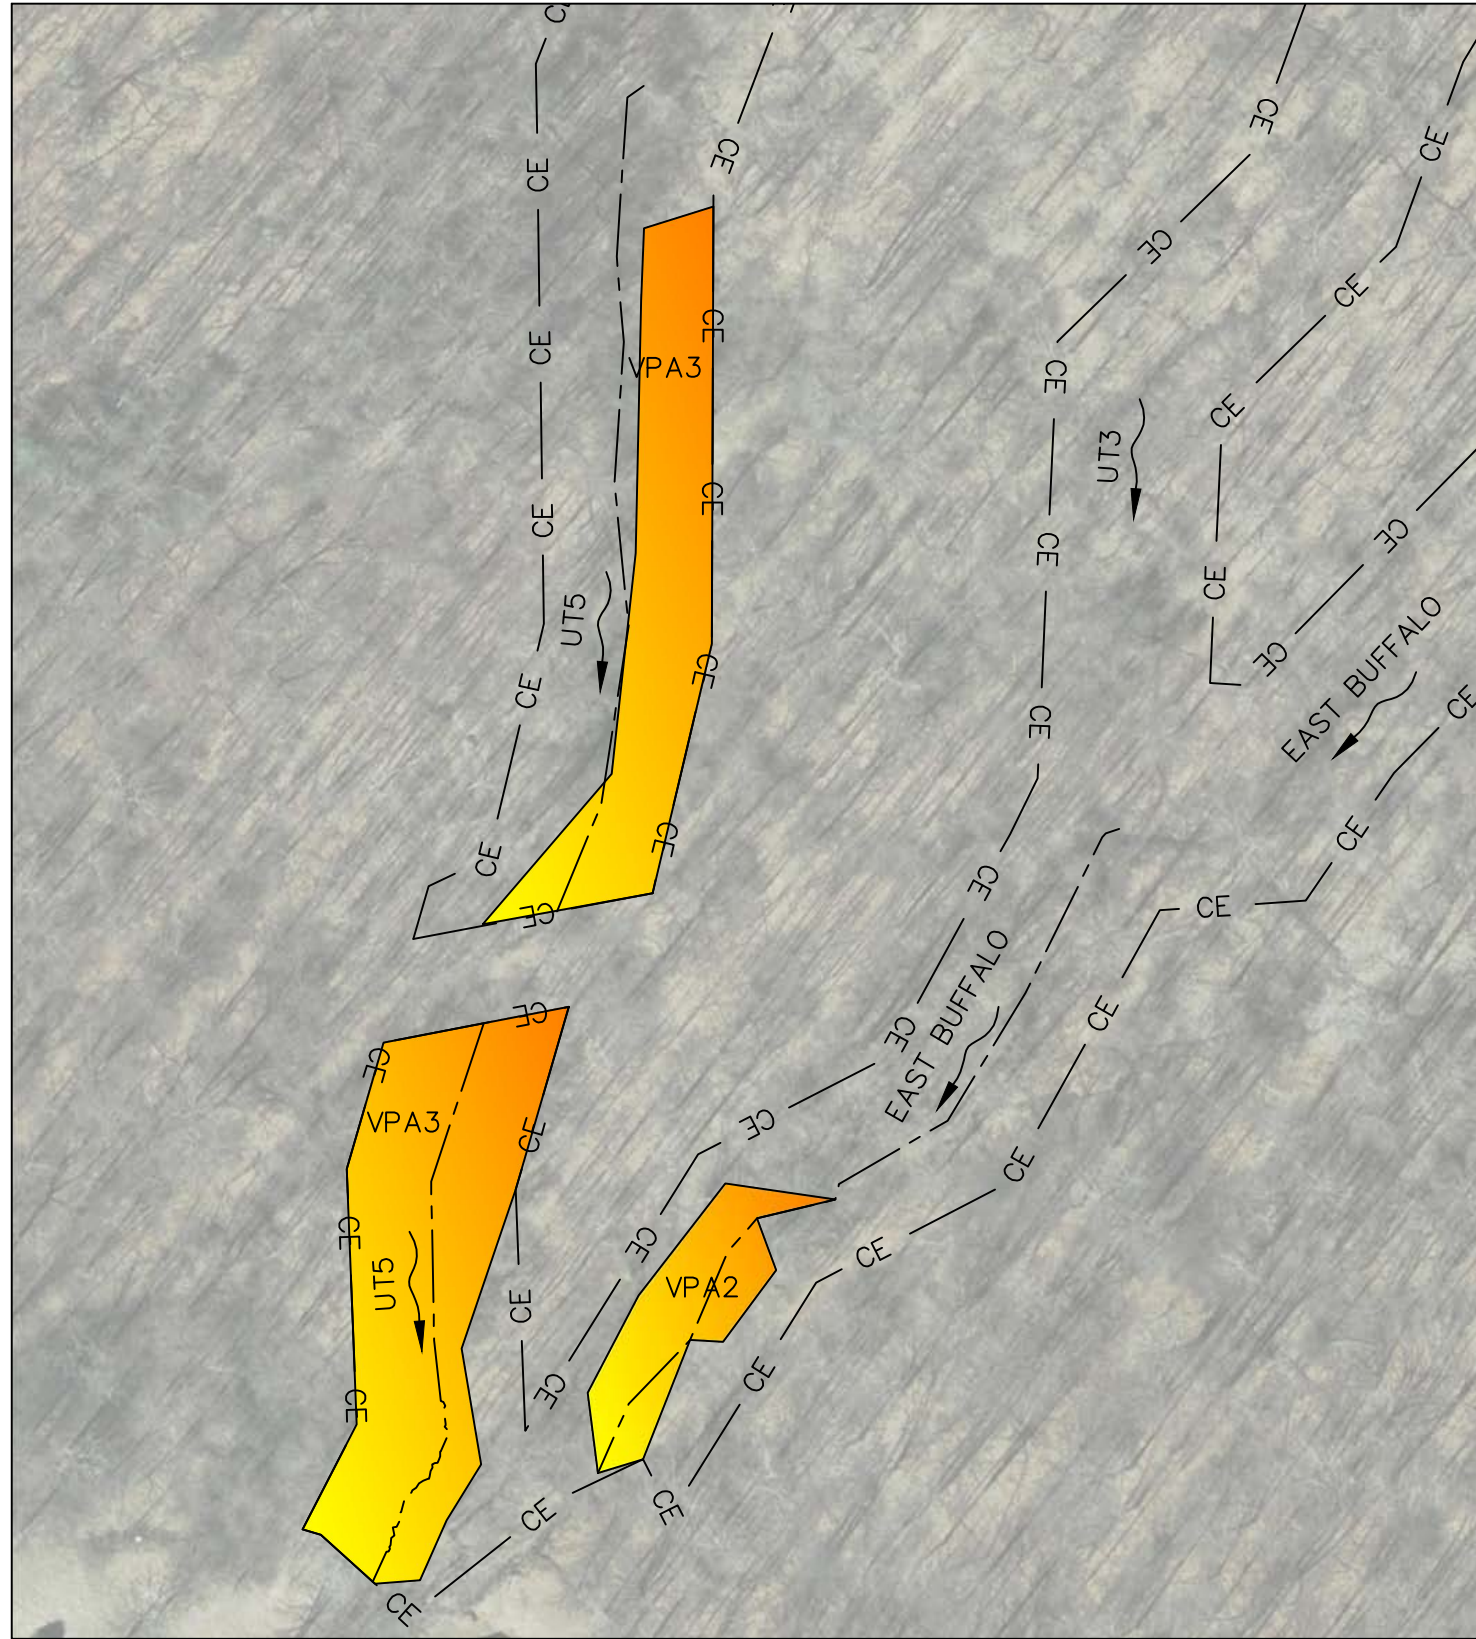
There were three vegetation problem areas identified during Year 4 monitoring that related to the presence of invasive vegetation along Reaches 2 of UT5, UT6, and East Buffalo Creek. Multiflora Rose and Chinese Privet found along portions of these reaches appear to primarily be a result of invasives that have persisted after prior treatment. We have retained the same areas of concern that were reported last year in this year's report; however, a significant reduction in the density of invasives has been made in these areas as evidenced by the photos that are presented (Appendix F). The large area of withered and dead Muliflora Rose and Chinese Privet observed along these reaches, especially along UT5 Reach 2, is indicative that prior spray treatment was effective for much of the cover. However, the current extent of persistent invasives (CCPV in Appendix F) warrants immediate follow-up treatment to limit potential proliferation and will be scheduled to be conducted in the spring and summer of 2015; an updated status of these vegetation problem areas will be provided in the Year 5 monitoring report.

VEGETATION PROBLEM AREA (VPA)
(INVASIVE SPECIES PRESENT)

At this time, the only items that are being monitored beyond the success criteria noted in this report is the dry segment of UT2 and the invasive vegetation problem areas documented on Reaches 2 of UT5, UT6, and East Buffalo Creek. As noted in Section 2.1.1.2 of the Baseline Monitoring Report, we believe that the surface flow of UT2 is presently flowing beneath and through the channel bed material along the lower half of the restored reach. This is not unusual for steep, rocky, low flow channels in this area. The flow along UT2 should surface as organic material and fine particles reduce interstitial spaces in the constructed channel. We plan to add fine grain material to this channel in the spring of 2015 to promote the closing off of interstitial spaces and activation of surface flow. We will continue to monitor the flow condition of UT2 and the presence of invasives on Reaches 2 of UT5, UT6, and East Buffalo Creek, and manage these reaches as seems most appropriate. Baker will provide an updated status of these stream and vegetation problem areas in the Year 5 monitoring report.

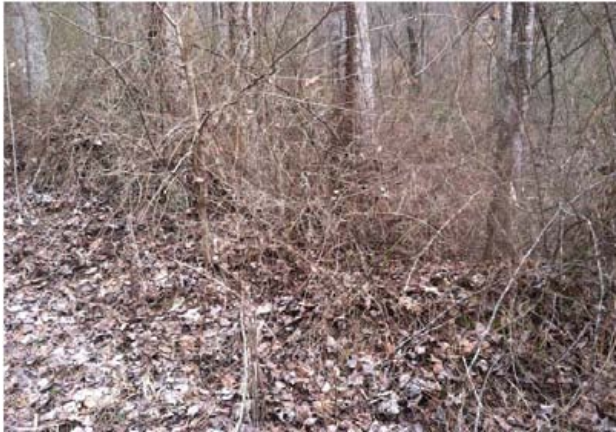
Invasive/Exotic Populations	See Plan View	<i>Rosa multiflora</i> , and <i>Ligustrum sinense</i> : significantly reduced but still persisting after treatment in some areas. We are continuing to show these areas and will continue to treat these areas to kill surviving invasives.	Photo 3

Photo 1. Dead multiflora along driveway in VPA1.
