# East Buffalo Creek Mitigation Project

## Year 5 Monitoring Report Graham County, North Carolina

Monitoring Firm: Michael Baker  
Engineering, Inc. (Baker)

Report Submitted: March 2016

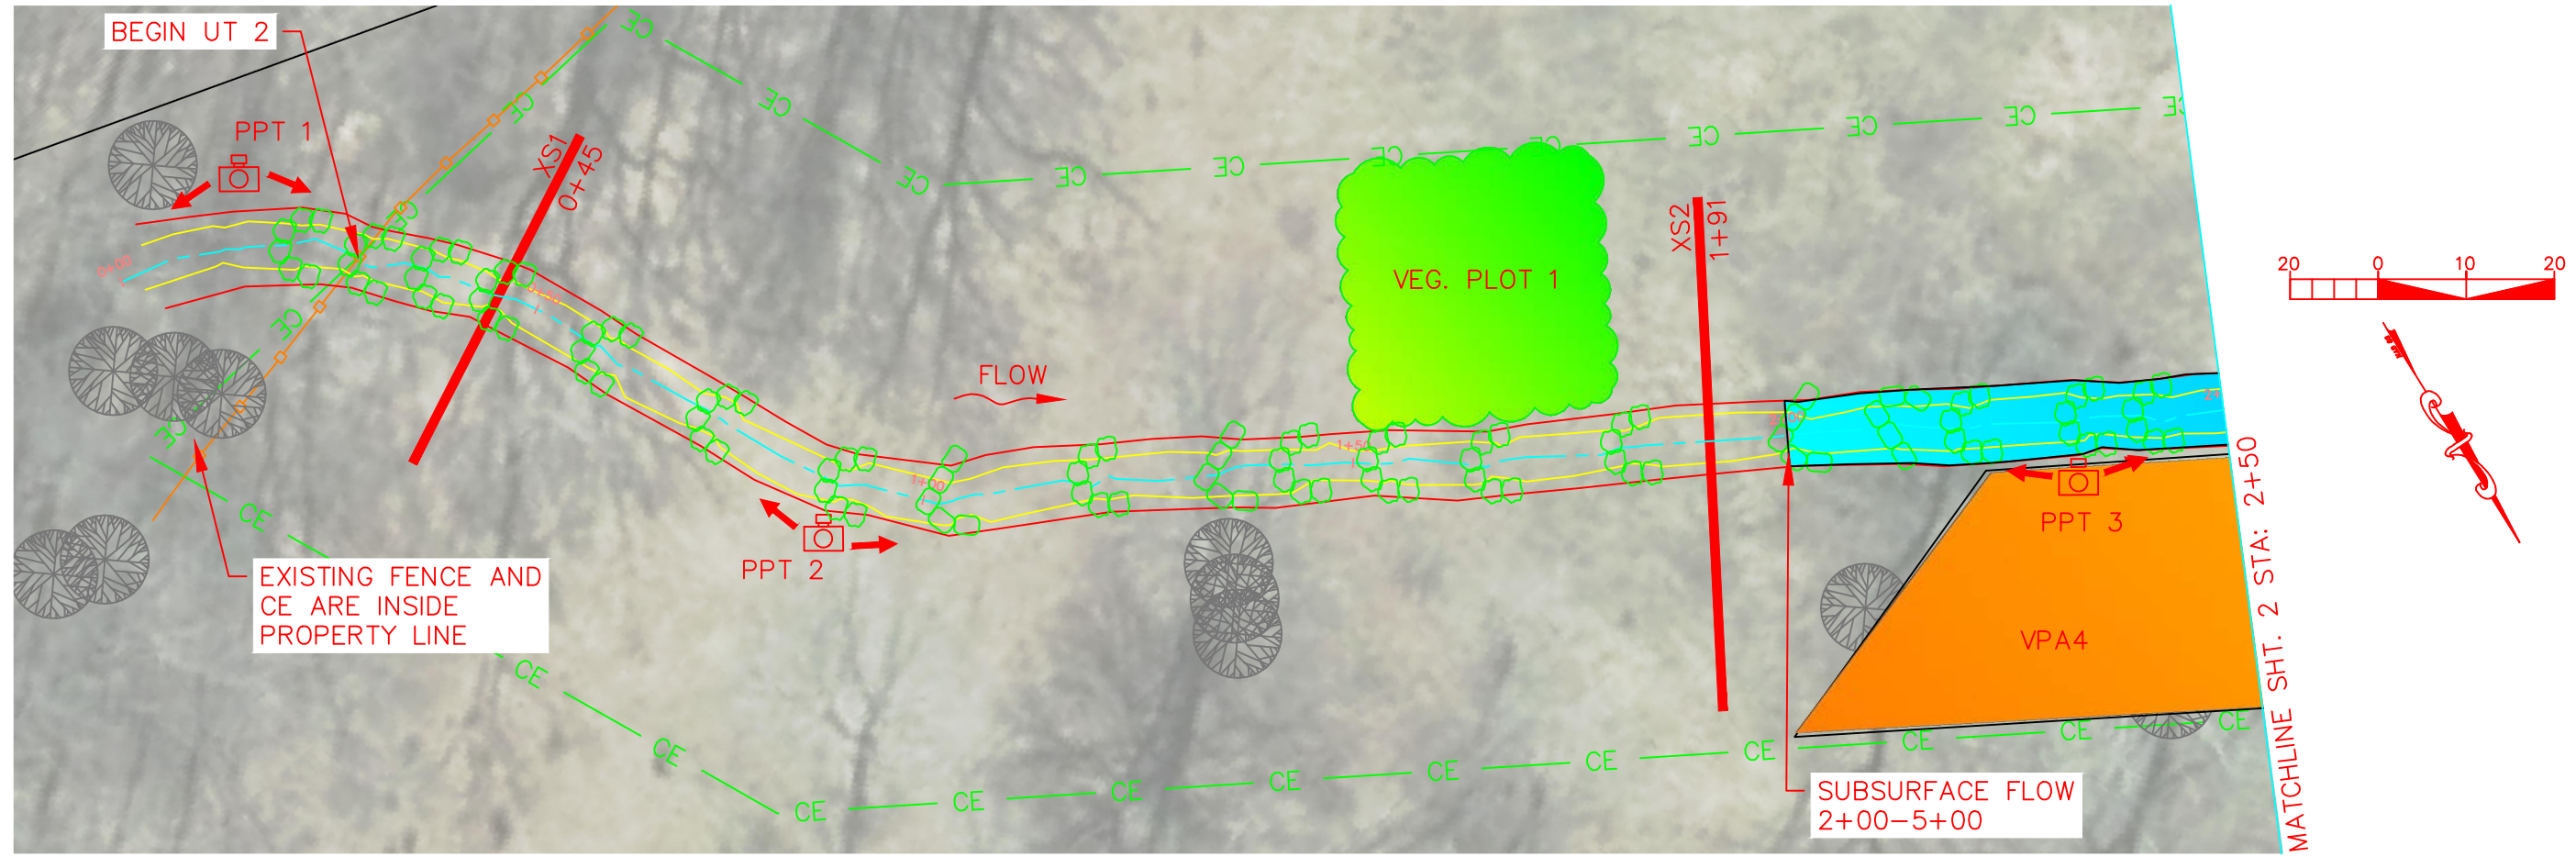
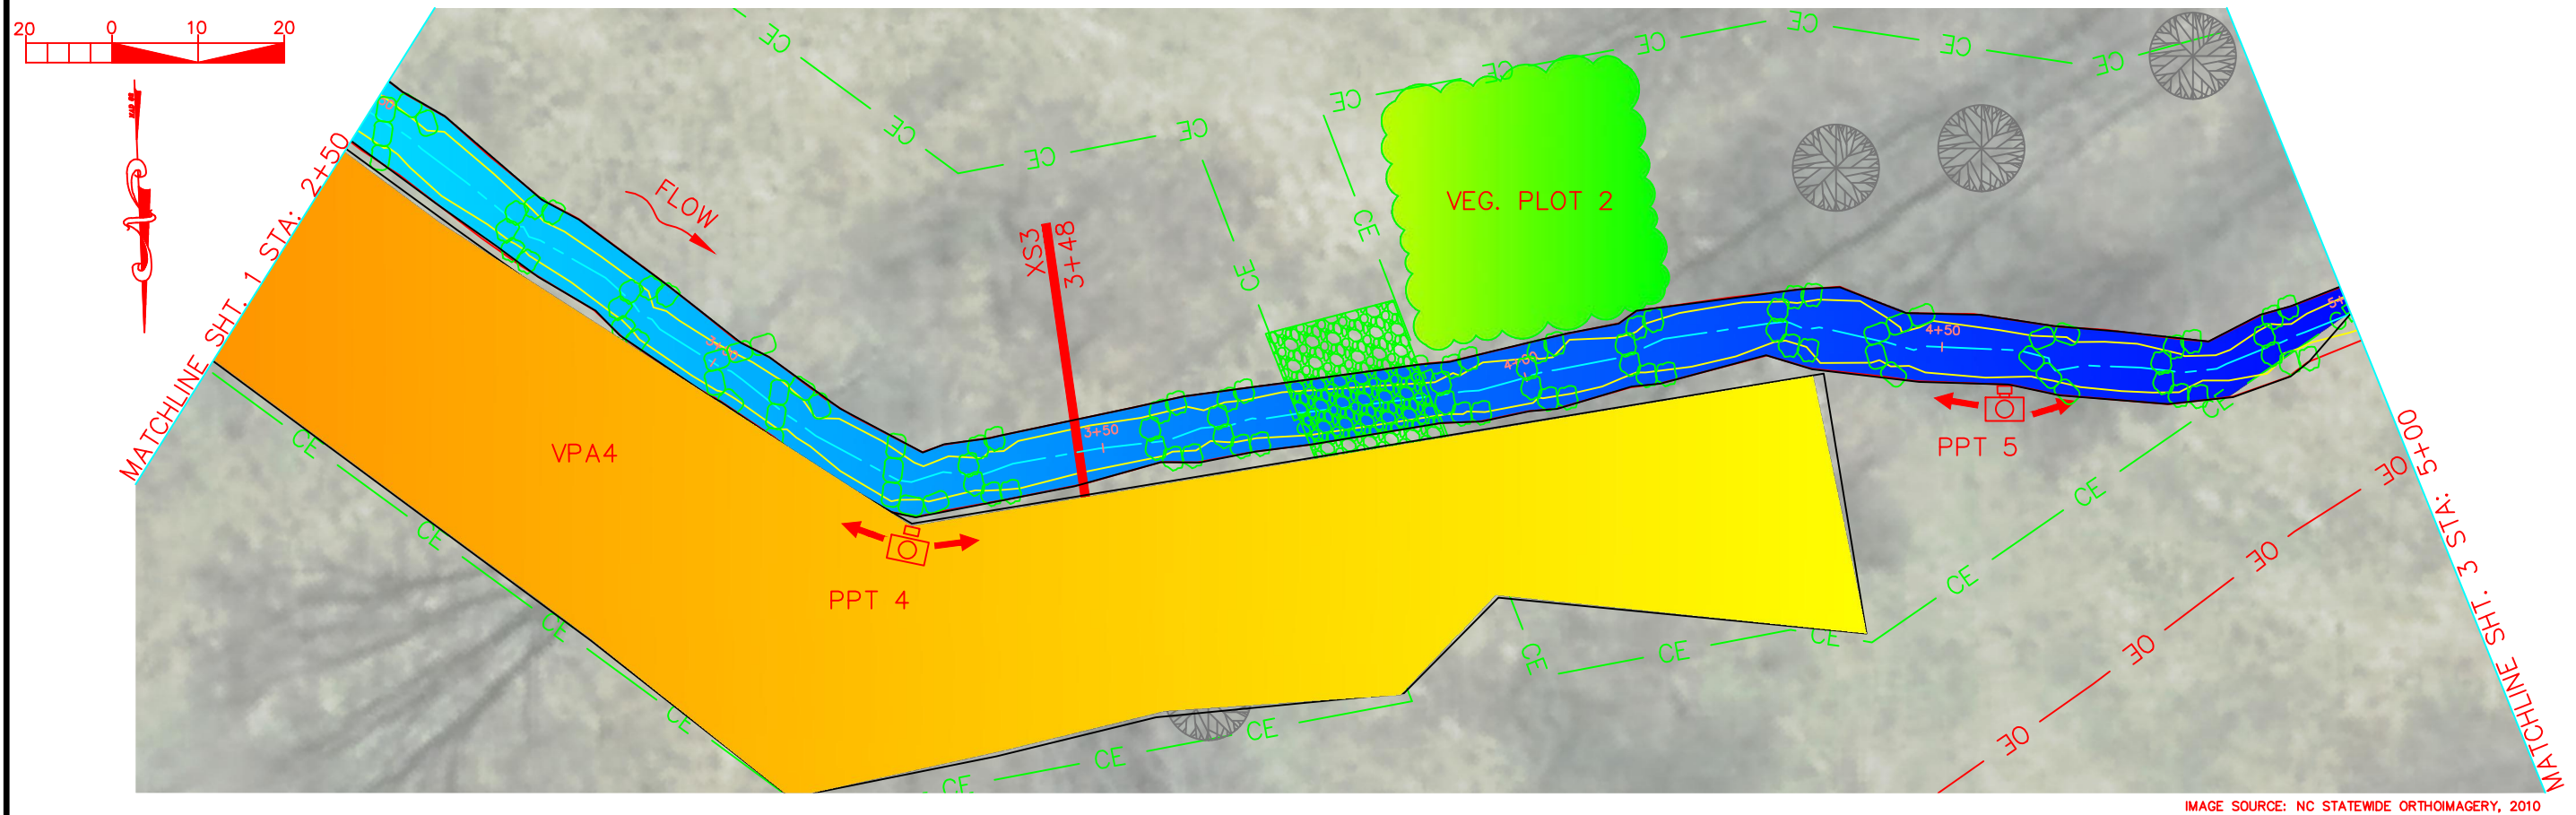
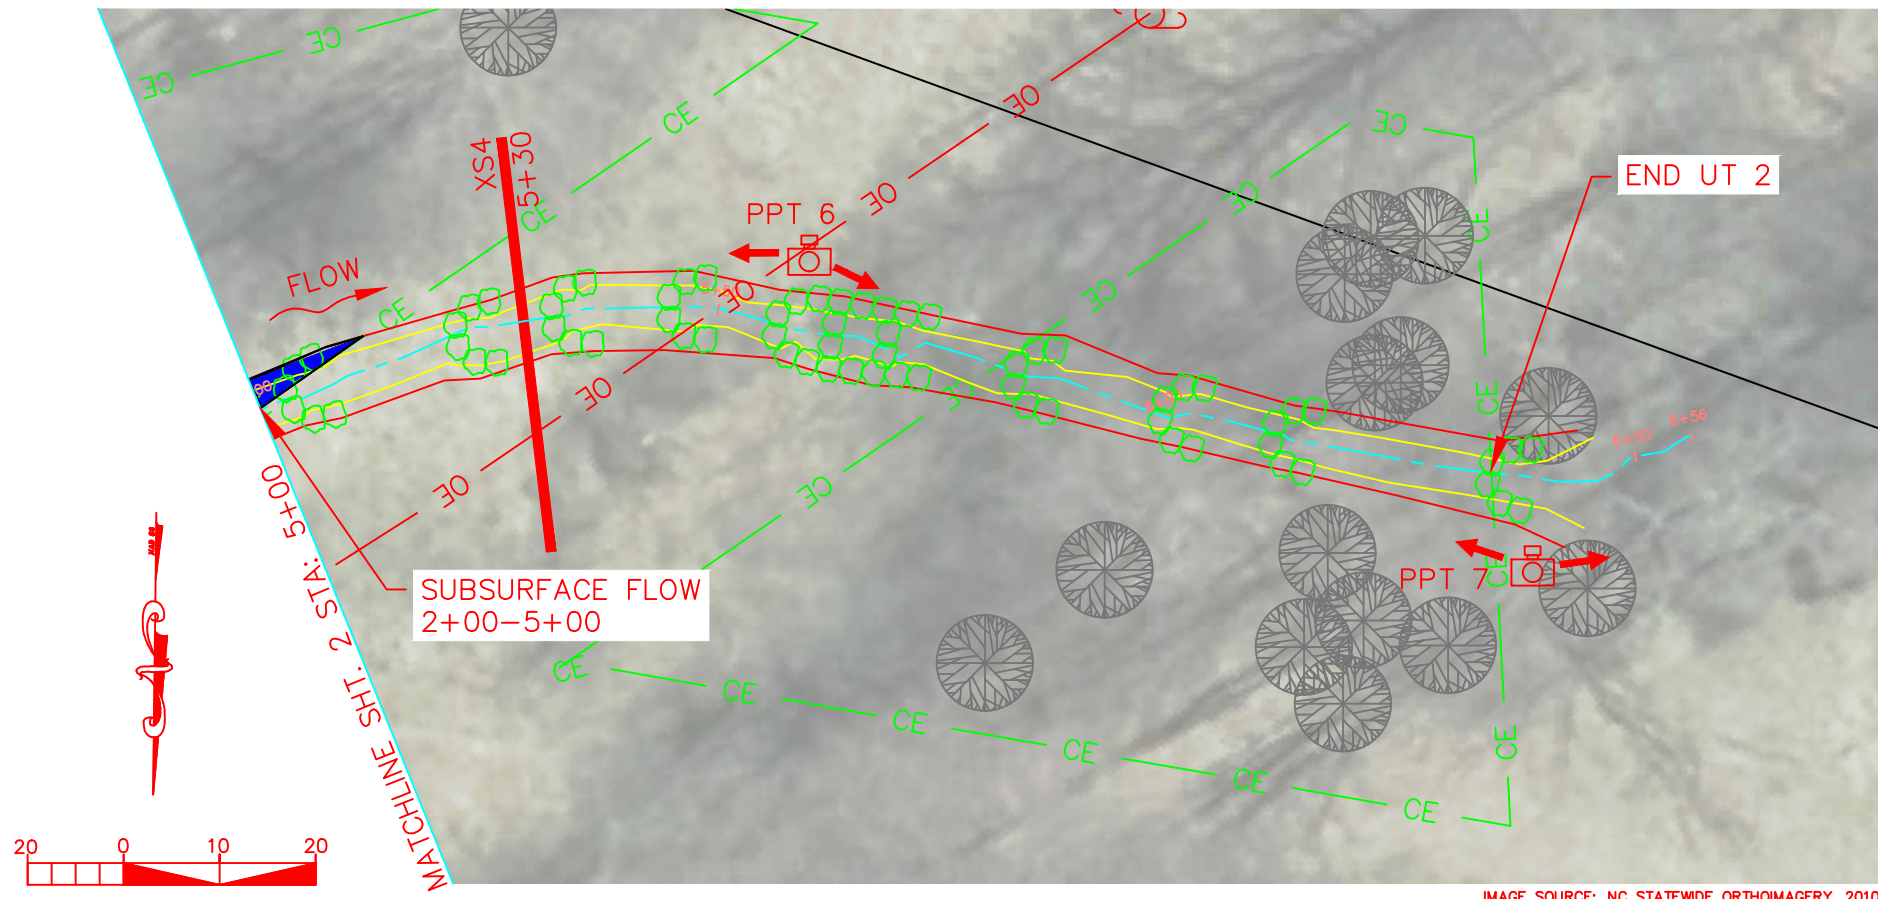
EAST BUFFALO-UT2  
CURRENT CONDITION  
PLAN VIEW  
YEAR 5 MONITORING

There was also little to no change in the profile of UT2 to East Buffalo Creek. Although the profile appears stable, there is a section of UT2 where the stream flow goes subsurface; this section is illustrated on the current condition plan view and documented in Tables 11 and 12 in Appendix F. Given the steepness in slope and the relatively large riffle material used to construct the step-pool channel system, it is likely that the flow will remain subsurface until interstitial spaces between the stones of the constructed channel bed become filled by smaller particles and organic material. Baker has taken efforts to add sediment materials to the channel in the upstream area where flow begins to go subsurface to promote the filling interstitial space in the channel bed. While this has made some minor improvements and flow has progressed to approximately station 2+00, the channel area shown to have subsurface flow in the CCPV has, except on storm flows, remained dry. Particle sorting was observed in the channel during the Year 3, 4 and 5 surveys, indicating that there is flow in the channel at times. During the Fall of 2015 this evidence of flow

during a high water event was seen throughout the channel. However, the presence of rooted plant material indicates that the baseflow remains under the bed material most of the time. There have been many observations during the monitoring period that surface flow has been continuous over approximately half of the restored reach. This was also observed during visits for Year 5 monitoring. No areas of instability were noted during Year 5 monitoring.

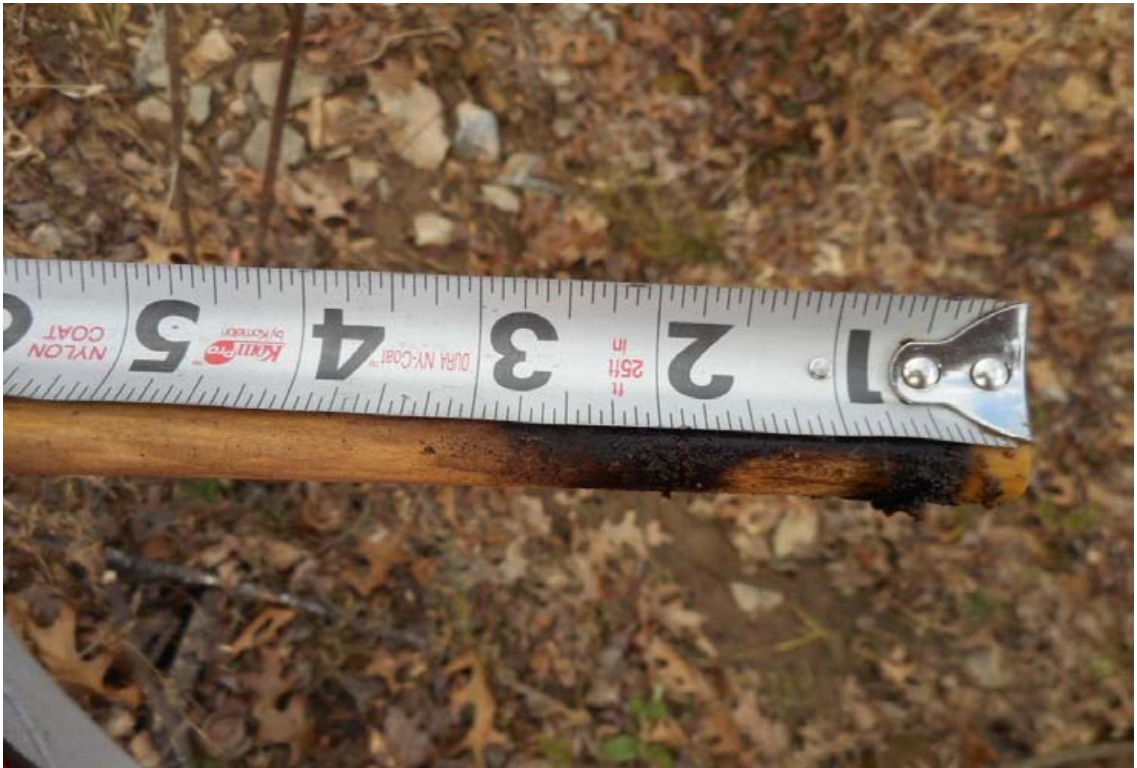
During the Year 5 monitoring period, the site was found to have had at least one bankfull event based on the crest gauge reading obtained on UT2. A reading was not taken from the crest gauge on UT6 because the measuring staff in the gauge was broken and a reading could not be obtained. Since project completion, UT2 has had four recorded bankfull events, and UT6 has had four recorded bankfull events during different years for each gauge. Information on these events is provided in Table 10 of Appendix E. At this point more than two bankfull flow events have been documented on each crest gauge within the 5-year monitoring period. The hydrology success criterion has been met.

Photo of staff and cork at 2.25 inches above bankfull, from UT2 crest gauge.

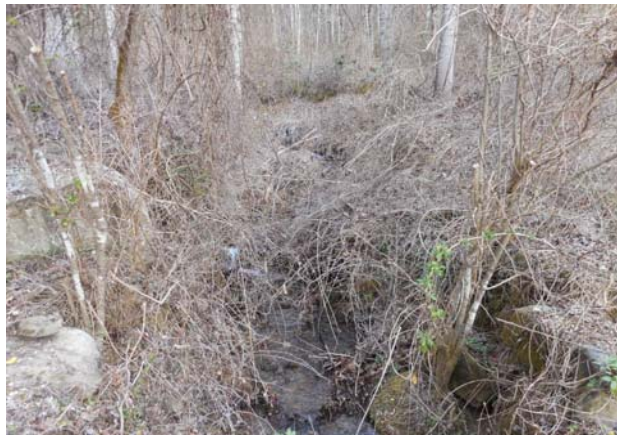
There were four vegetation problem areas identified during Year 5 monitoring that related to the presence of invasive vegetation along Reaches 2 of UT5, UT6, UT2 and East Buffalo Creek. The VPA 4 was added this year as a thick stand of Multiflora rose has developed along the lower right bank of UT2. Multiflora rose and Chinese Privet found along portions of these reaches appear to be primarily a result of invasives that have persisted after prior treatment. We have retained the same areas of concern that were reported in previous years in this year's report; however, a significant reduction in the density of invasives has been made in these areas as evidenced by the photo that is presented (Appendix F). The large area of withered and dead multiflora rose and Chinese Privet observed along these reaches, especially along UT5 Reach 2, is indicative of the success of prior herbicide treatment. However, the current extent of persistent invasives (CCPV in Appendix F) warrants follow-up treatment to limit continued growth and treatment will be scheduled in the spring of 2016.

Photo 1. Dead multiflora above driveway in VPA2.
