**East Tarboro Canal Stream Restoration Project  
Edgecombe County  
North Carolina**

**CU: 03020103  
SCO# 030603101  
EEP Project No. 123**

**Year 1 Monitoring Report  
January 22, 2009**

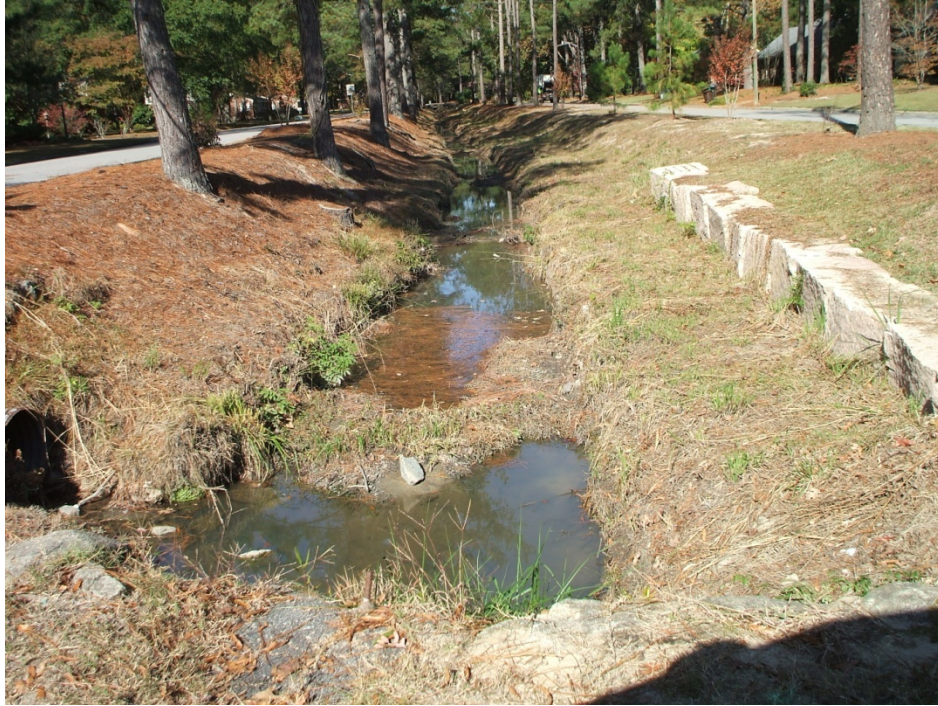
During the geomorphic assessment, some parts of Reach 1 were dry. There also has been mowing activity within riparian area destroying many of the planted seedlings. Reach 2 is overgrown with vegetation in many areas suggesting that there is not a consistent flow of water. The lack of flow is likely due to the drought. Overall the stream reaches at East Tarboro Canal are stable and are showing few signs of instability. Reach 2 has a structure failure that requires immediate attention. The amount of structure in failure is fifty (50) linear feet.

VPA 1 Reach 1 mowed riparian area

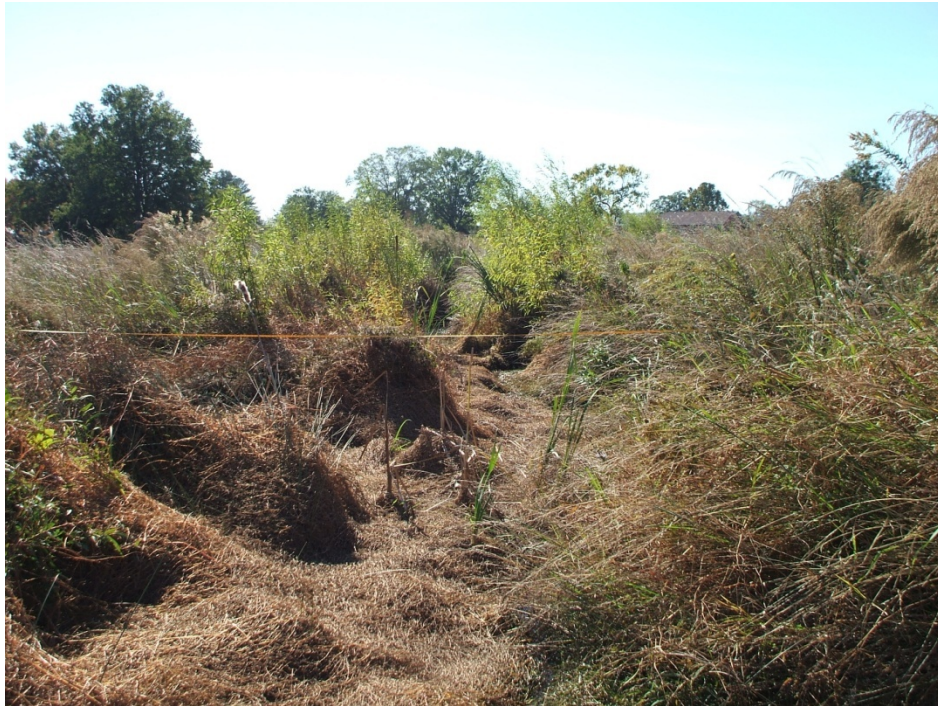
The channel is overgrown with vegetation in many areas suggesting that there is not a consistent flow of water in the channel and also an occurrence of an exotic species (*Murdannia keisak*). The identity of the exotic species can not be confirmed because it had died off due to frost during the assessment (Appendix B.4 Photo 7). The lack of flow is likely due to the extreme drought during the 2007 and 2008 growing seasons. A detailed table and photos can be found in Appendix B. Current problem areas are:

VPA 2 Reach 2 Vegetation Growing in the stream bed

RK&K recommends that the rock vein at station 21+50 (Photo B.3 SP3) be removed and replaced immediately to prevent more damage to the stream in this area. It is also recommended that all exotic species found within the stream channel be treated with herbicide.

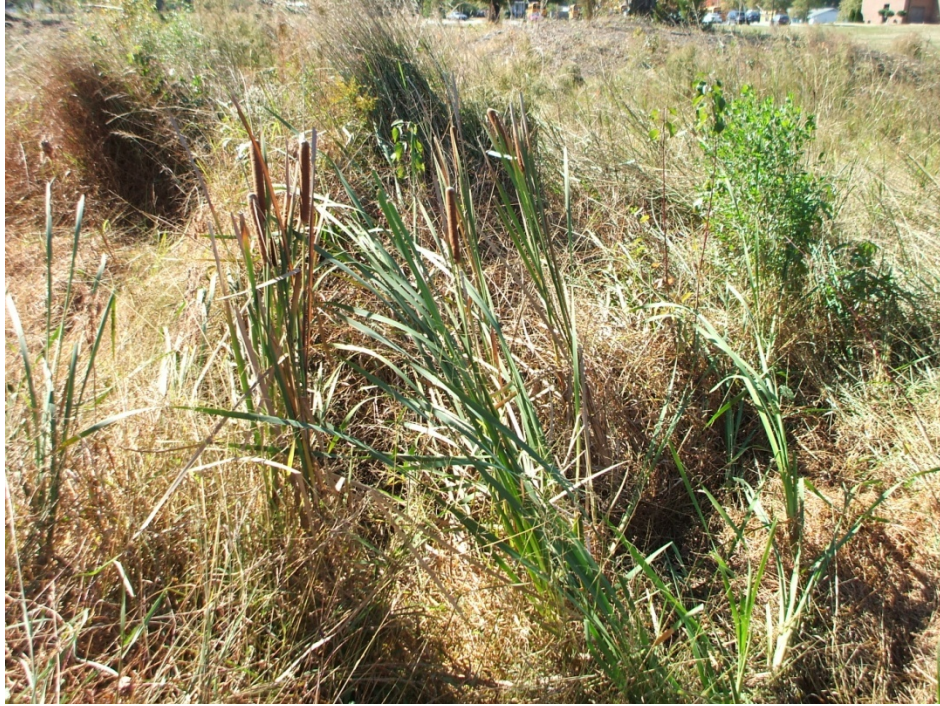
VPA 3 Reach 2 (throughout) Cattails growing in stream bed

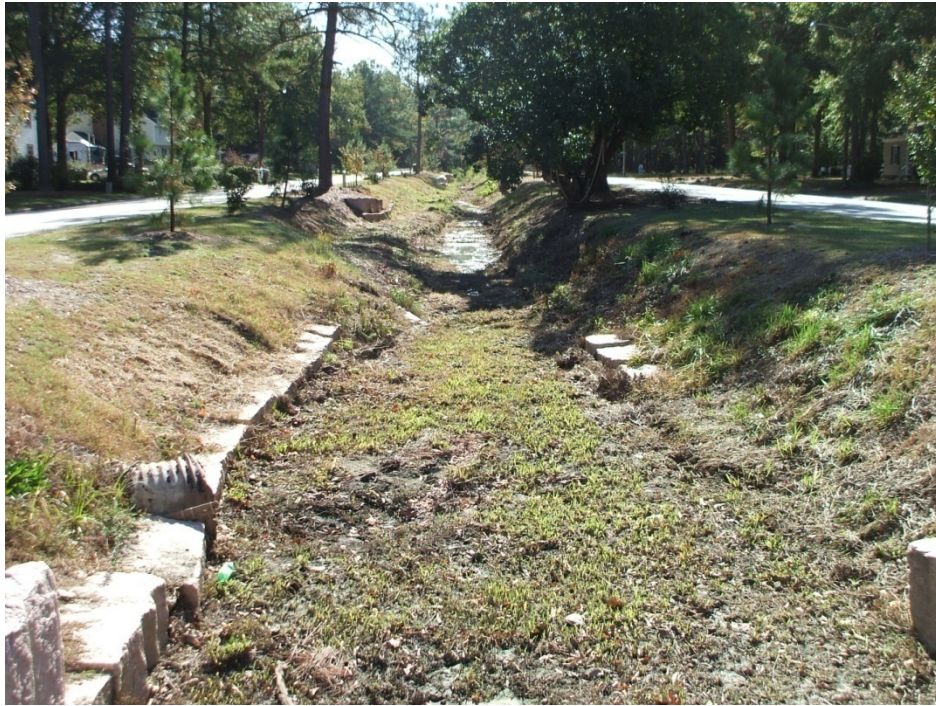
SP1 Reach 1 Station 20+25 Aggradation

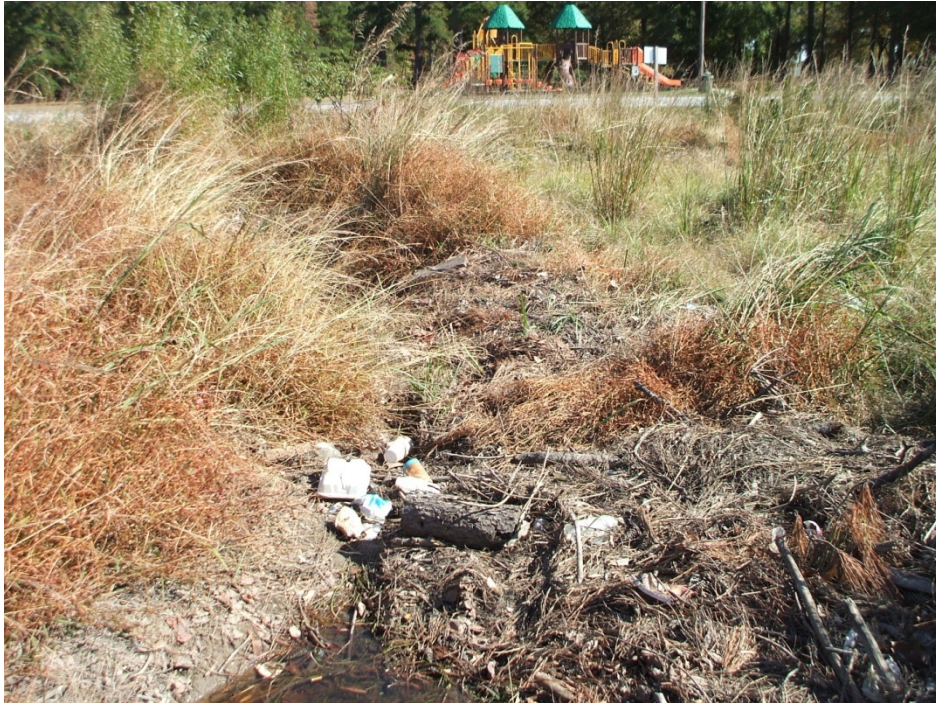
SP2 Reach 2 Station 10+100 Debris in channel

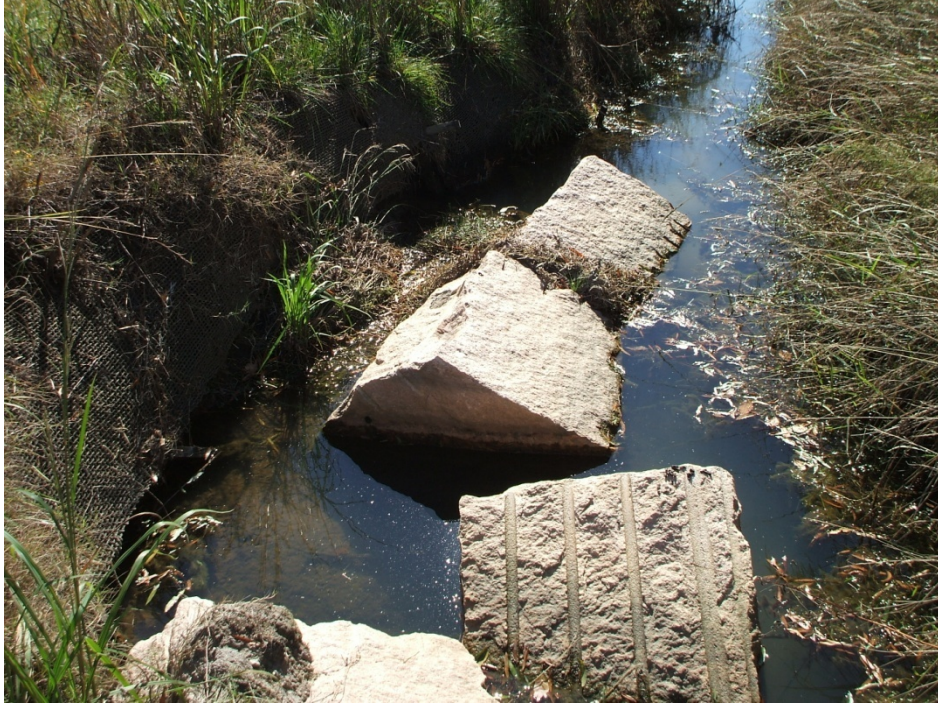
- Rock Vein Structure Failure at Station 21+50
- Invasive and exotic vegetation found throughout the stream channel of Reach 2

SP3 Reach 2 Station 21+ 50 Rock Vein Failure

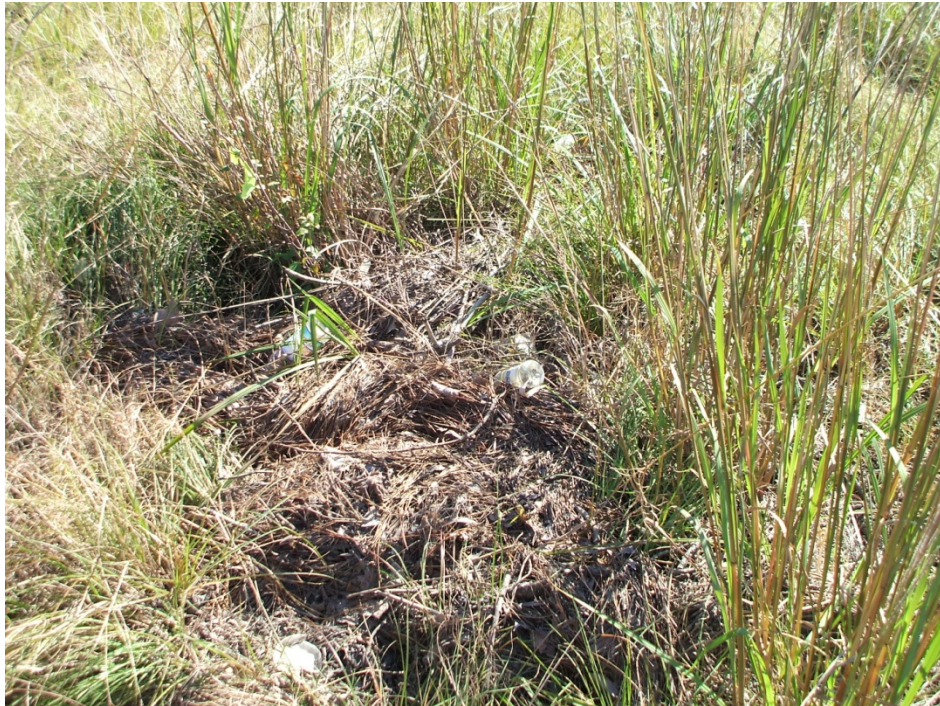
As per the project scope, RK&K did not measure flows with peak stage recorders. However, during the most recent field visit, racklines were observed and photographed (Appendix B.4 Photo 12). A crest gauge will be installed on Reach 2 during 2009 to monitor flow activity.

12 Rack line in the floodplain
