**East Tarboro Canal Stream Restoration Project  
Edgecombe County  
North Carolina  
EEP Project No. 123  
CU: 03020103  
SCO# 030603101**

**Year 3 of 5 Monitoring Report  
Data Collection: May through October 2010  
Submission Date: March 31, 2011**

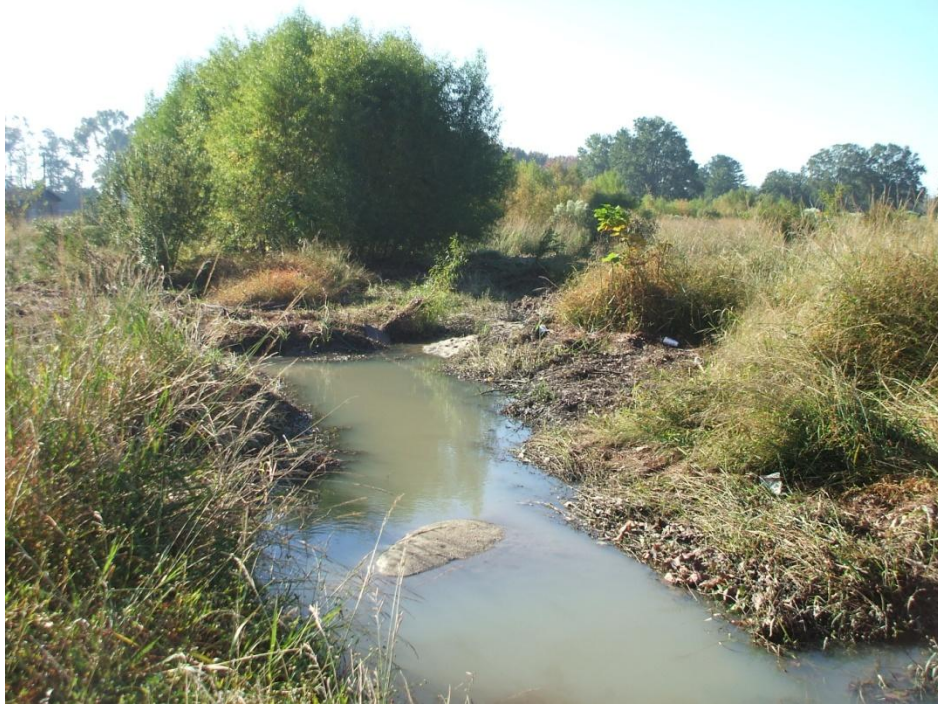
SP1 – Area of stream reroute and aggradation - Station 34+00 – Reach 2

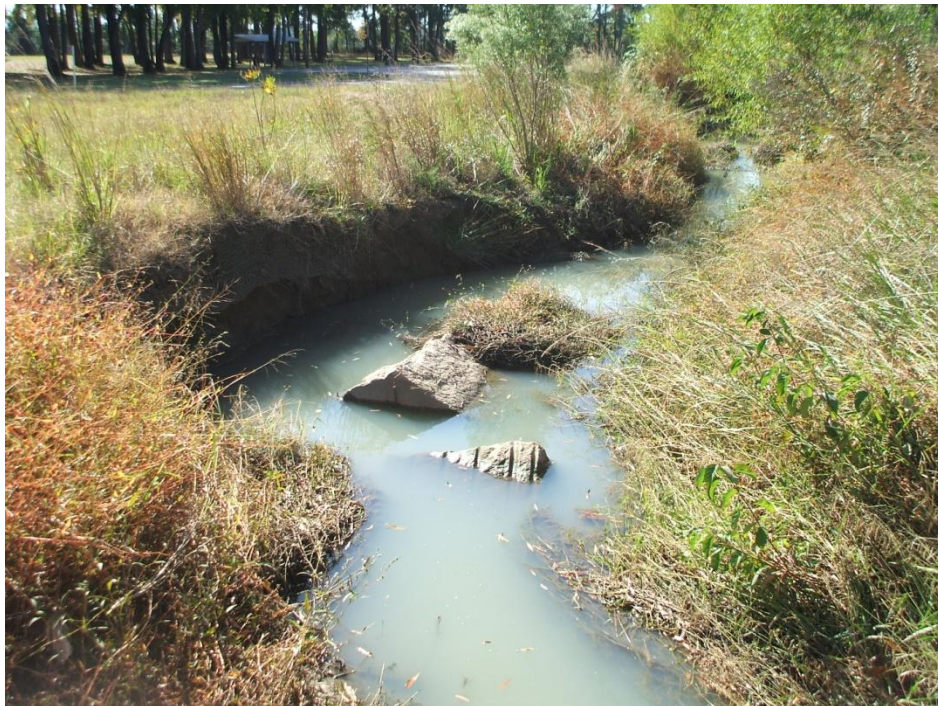
SP2 – Structure Failure - Sta. 21+50 - Reach 2

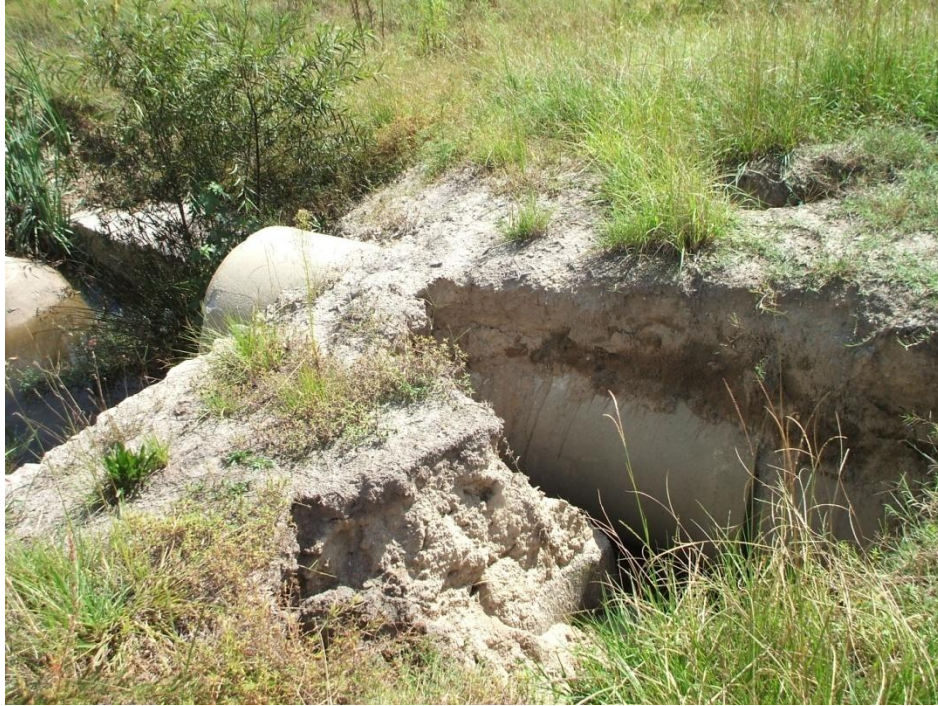
SP3 – Soil Erosion Station – Station 34+00 – Reach 2

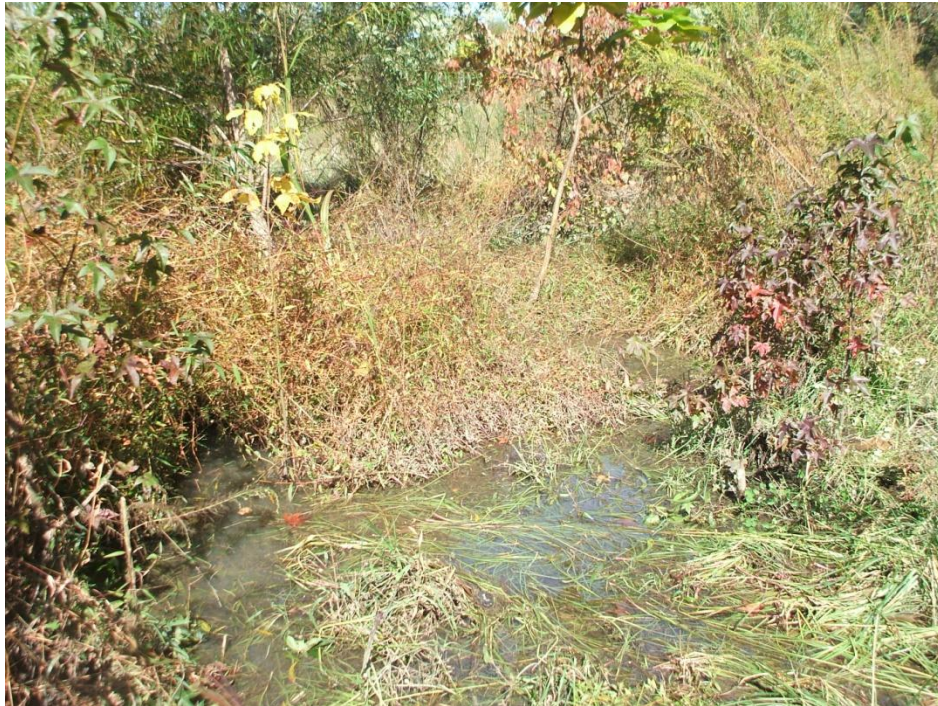
SP4 – Beaver Ponding – Locations depicted in CCPV – Reach 2

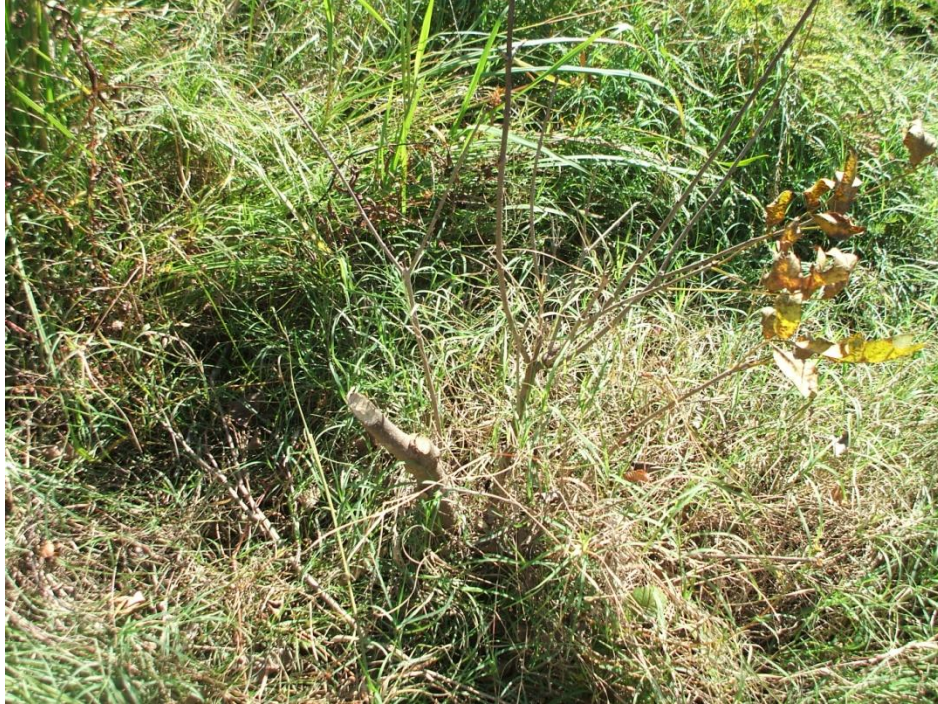
VPA1 - Beaver Harvest – Adjacent to Vegetation Plot 10 – Reach 2

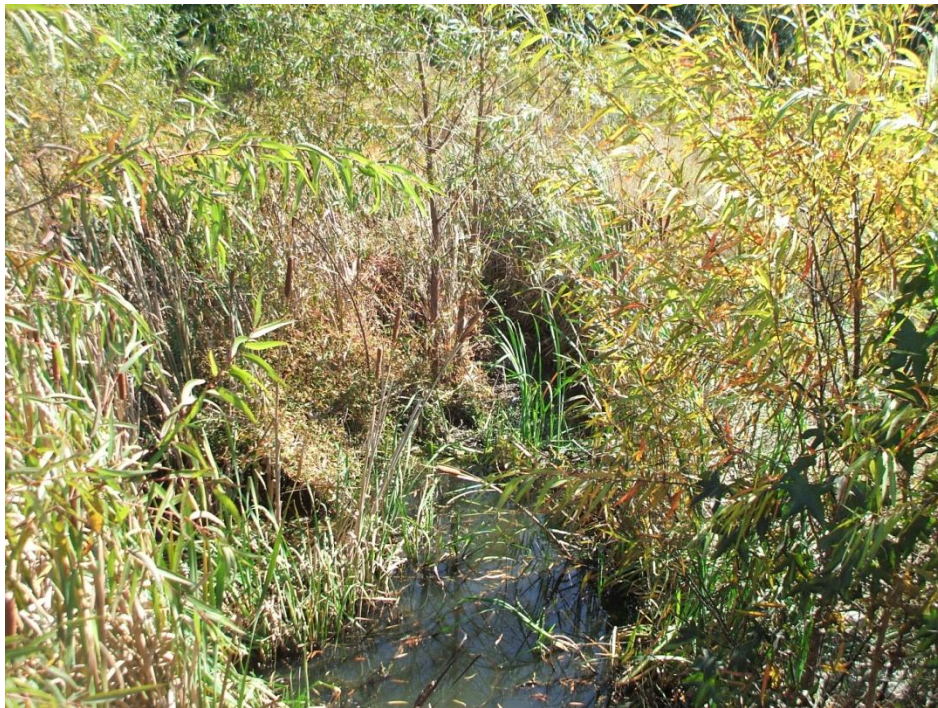
VPA2 – Cattails – Station 34+00 – Reach 2

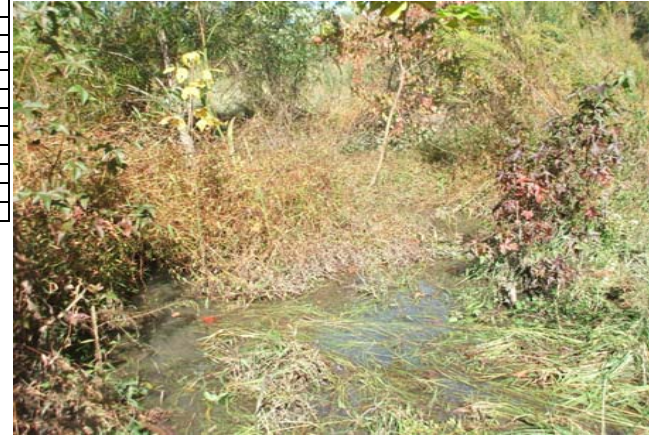
Photo of Cross-Section #10 - Picture not taken to spec. due to flooding caused by beaver dam.

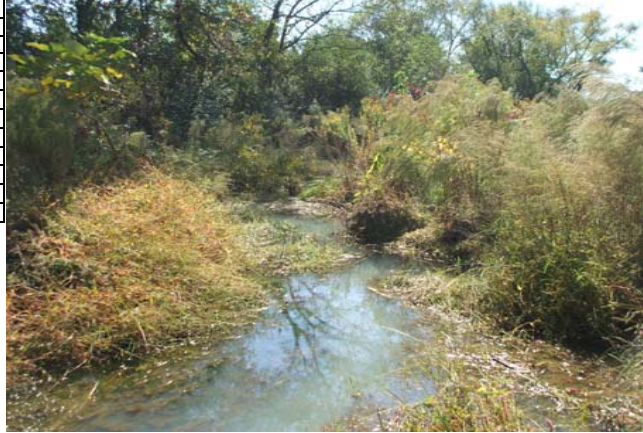
Photo of Cross-Section #12 - Looking Downstream - Unable to stretch tape across stream due to beaver flooding
