**East Tarboro Canal Stream Restoration Project**  
**Edgecombe County**  
**North Carolina**  
**EEP Project No. 123**  
**CU: 03020103**  
**SCO# 030603101**

**Year 4 of 5 Monitoring Report**  
**Data Collection: May through October 2011**  
**Submission Date: October 26, 2011**

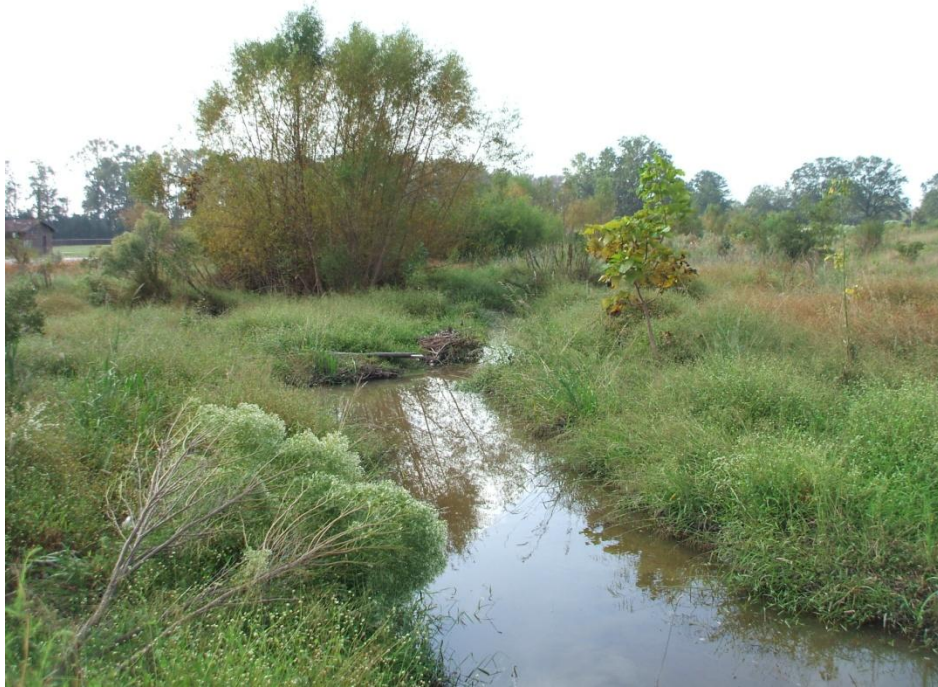
Stream Problem Areas East Tarboro Canal Stream Restoration Site EEP Project No. 123				
Feature Issue	Reach	Station Number	Suspected Cause	Photo Number
Stream has been re-routed through the adjacent wetland depression	Reach 2	34+00	Beavers	SP1
Bank Scour/Erosion	Reach 2	21+50	Rock vain failed	SP2
Beavers	Reach 2	Throughout – See figure 2	Beavers	SP3

SP1 – Area of stream reroute and aggradation - Station 34+00 – Reach 2

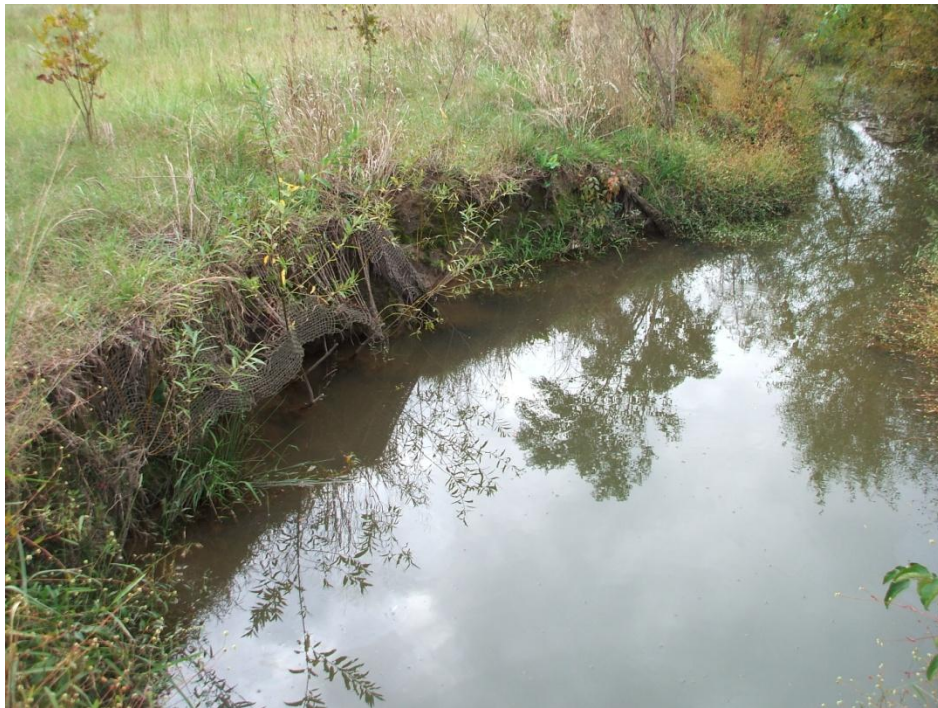
SP2 – Bank Erosion - Sta. 21+50 - Reach 2

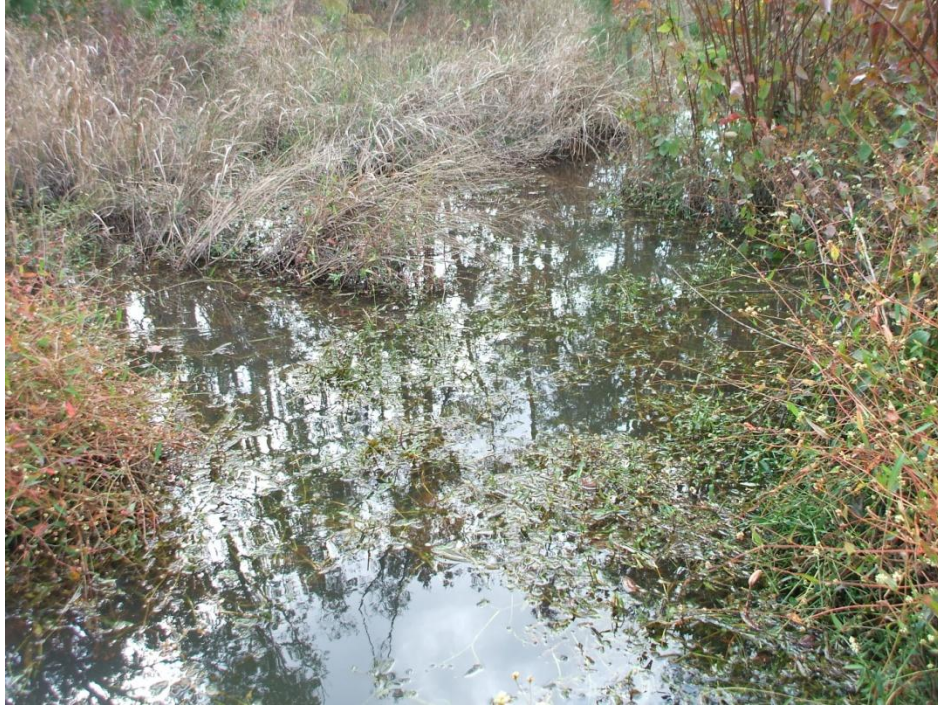
SP3 – Beaver Ponding – Locations depicted in CCPV – Reach 2

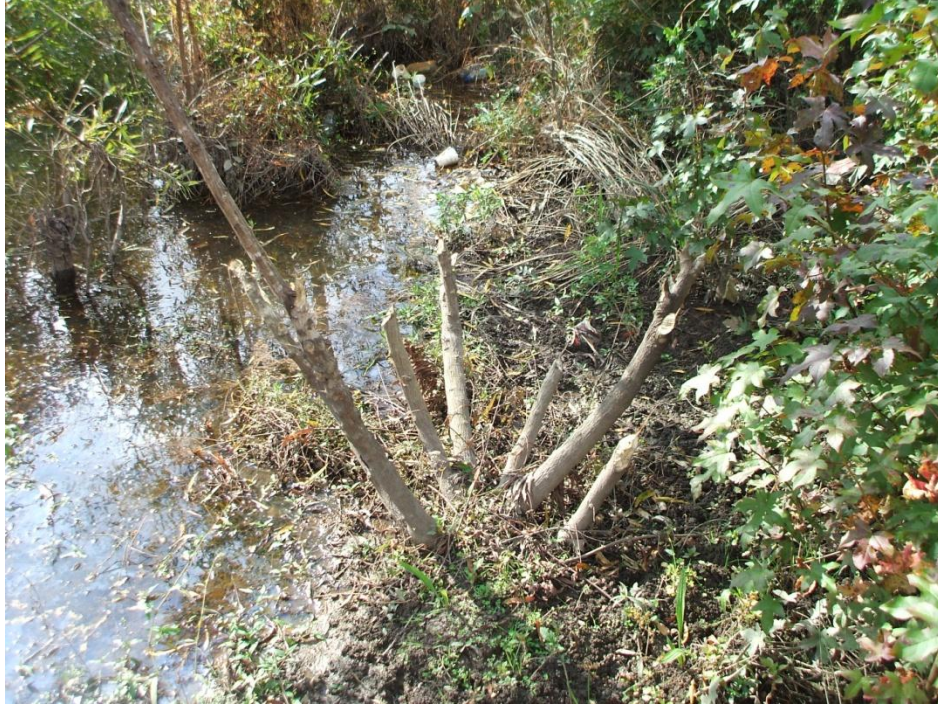
VPA1 – Beaver Harvest – Adjacent to Cross Section 10 – Reach 2

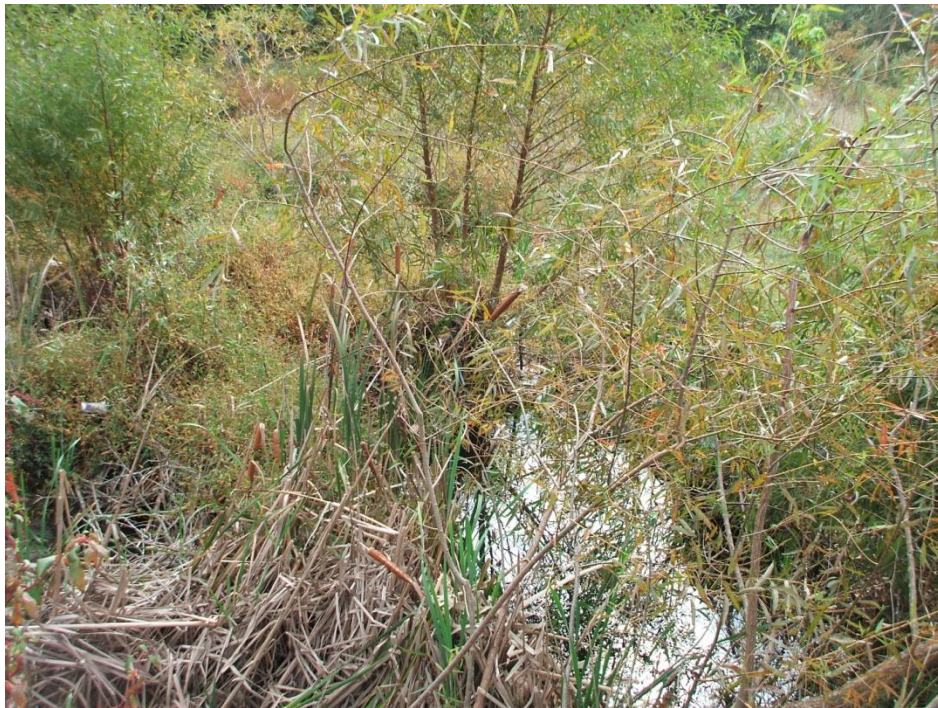
VPA2 – Cattails – Station 34+00 – Reach 2

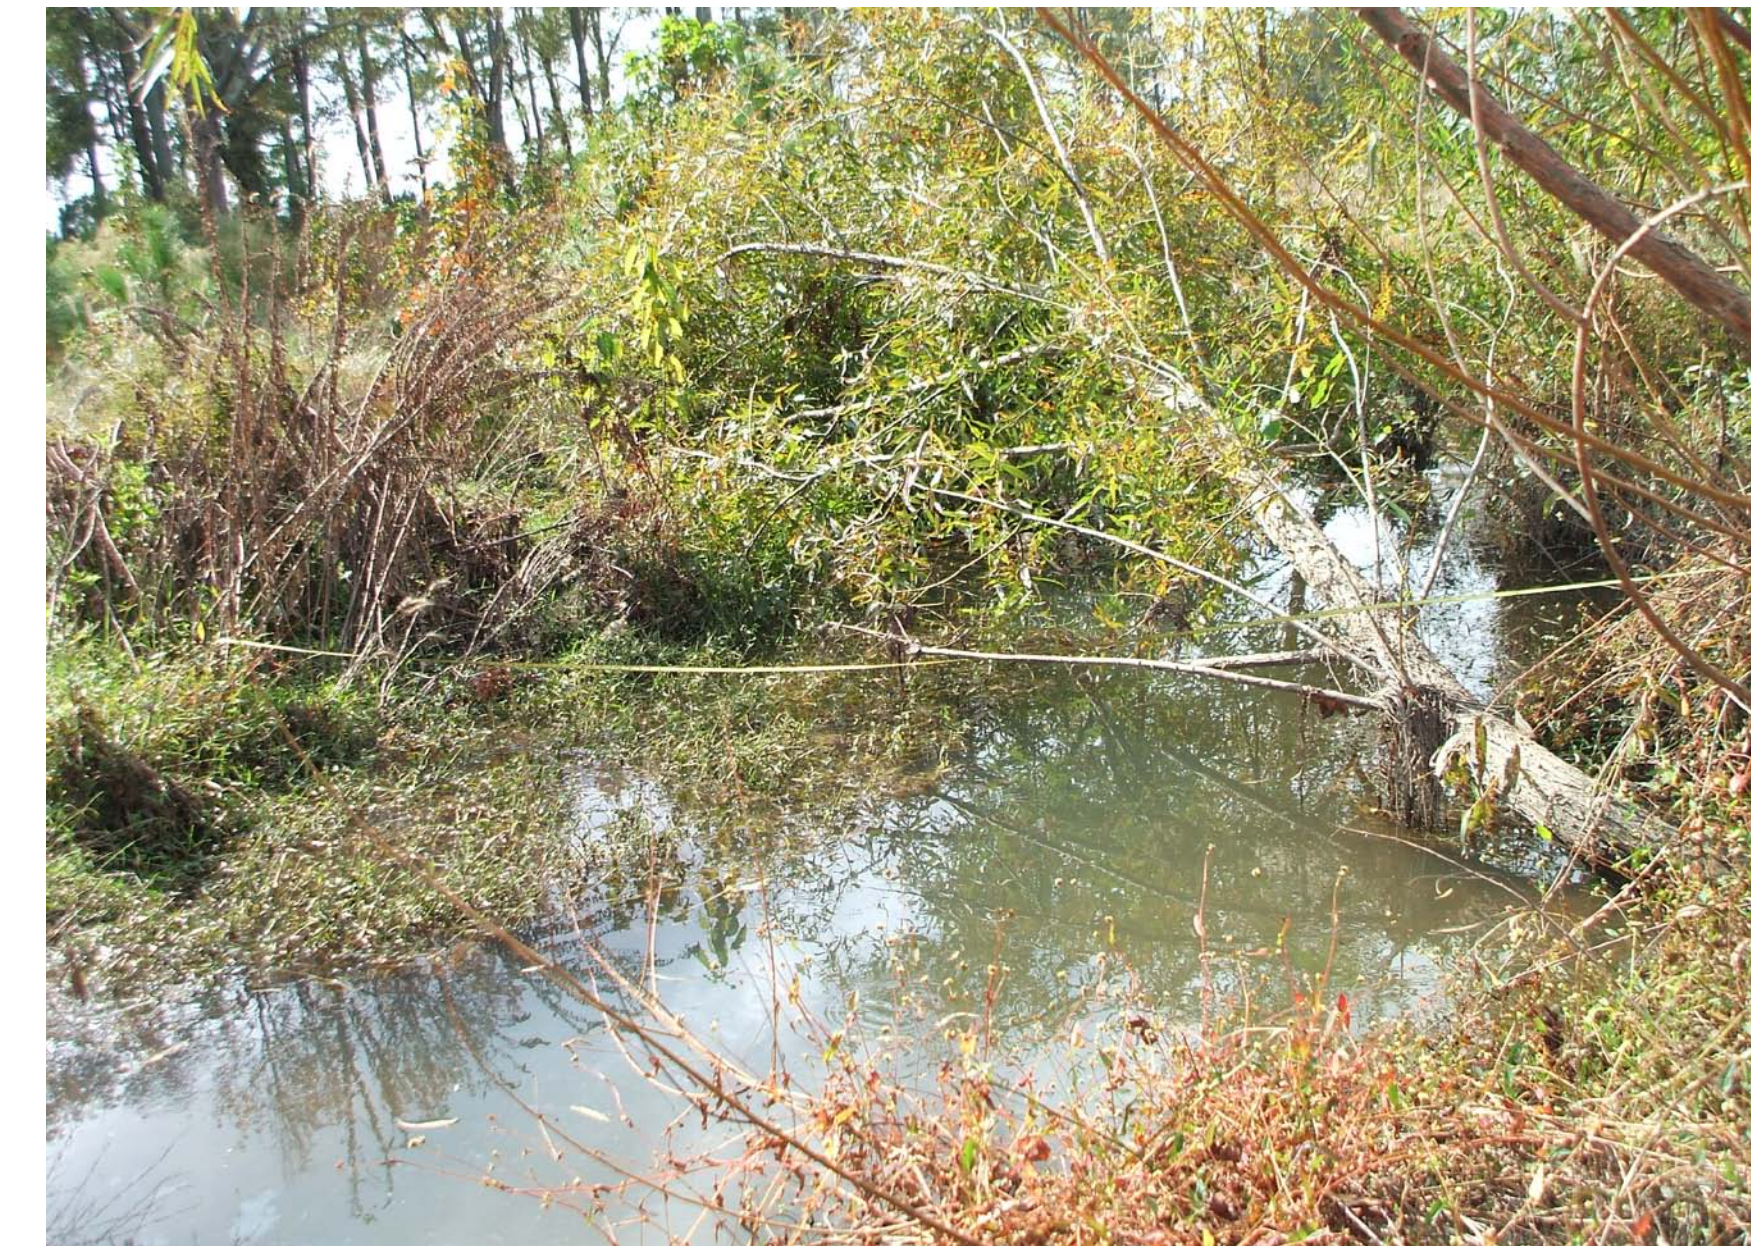
Photo of Cross-Section #10 - Unable to stretch tape across stream due to beaver flooding

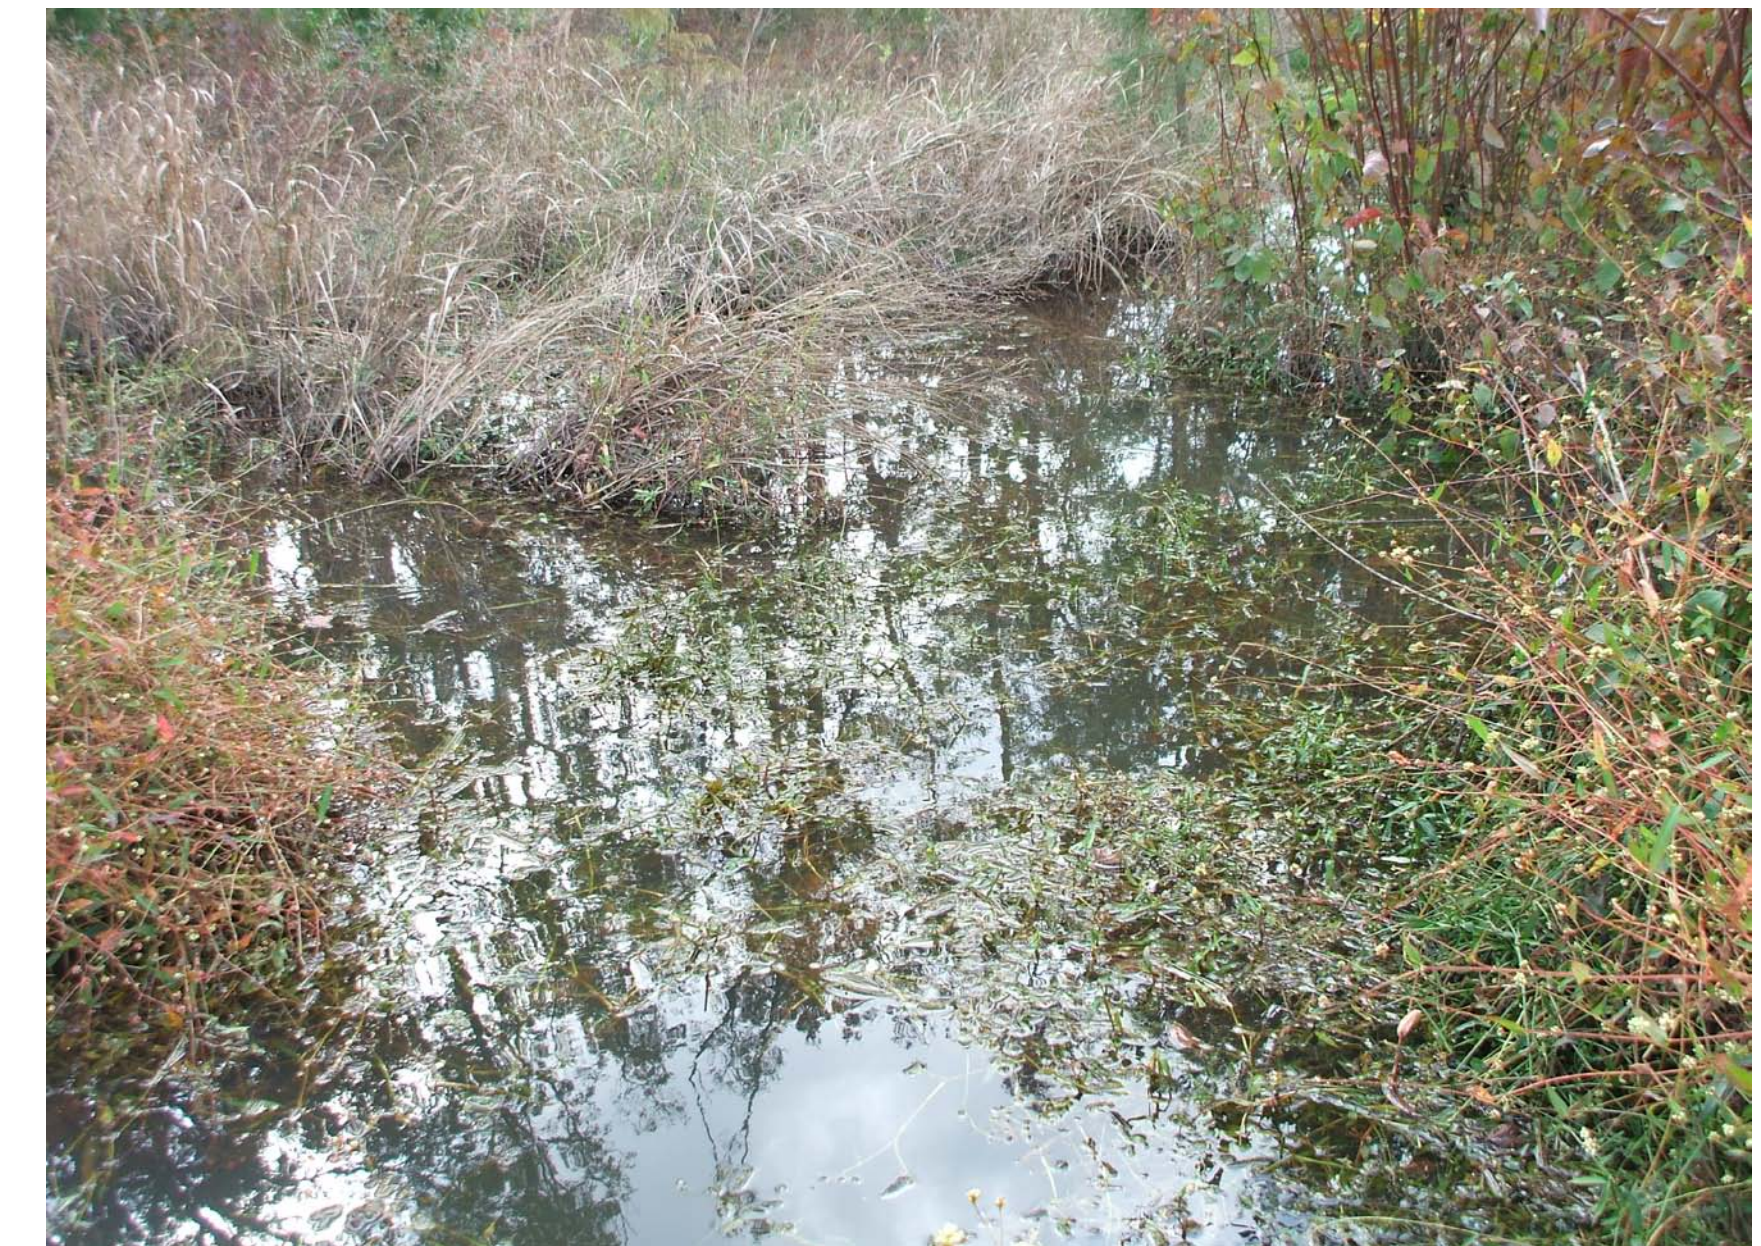
Photo of Cross-Section #11 - Looking Downstream - Beaver Dam located on cross section
