**East Tarboro Canal Stream Restoration Project
Edgecombe County
North Carolina**

**EEP Project No. 123
DENR Contract No. D08030S
CU: 03020103**

**Year 5 of 5 Monitoring Report
Data Collection: September through November 2012
Submission Date: November 30, 2012**

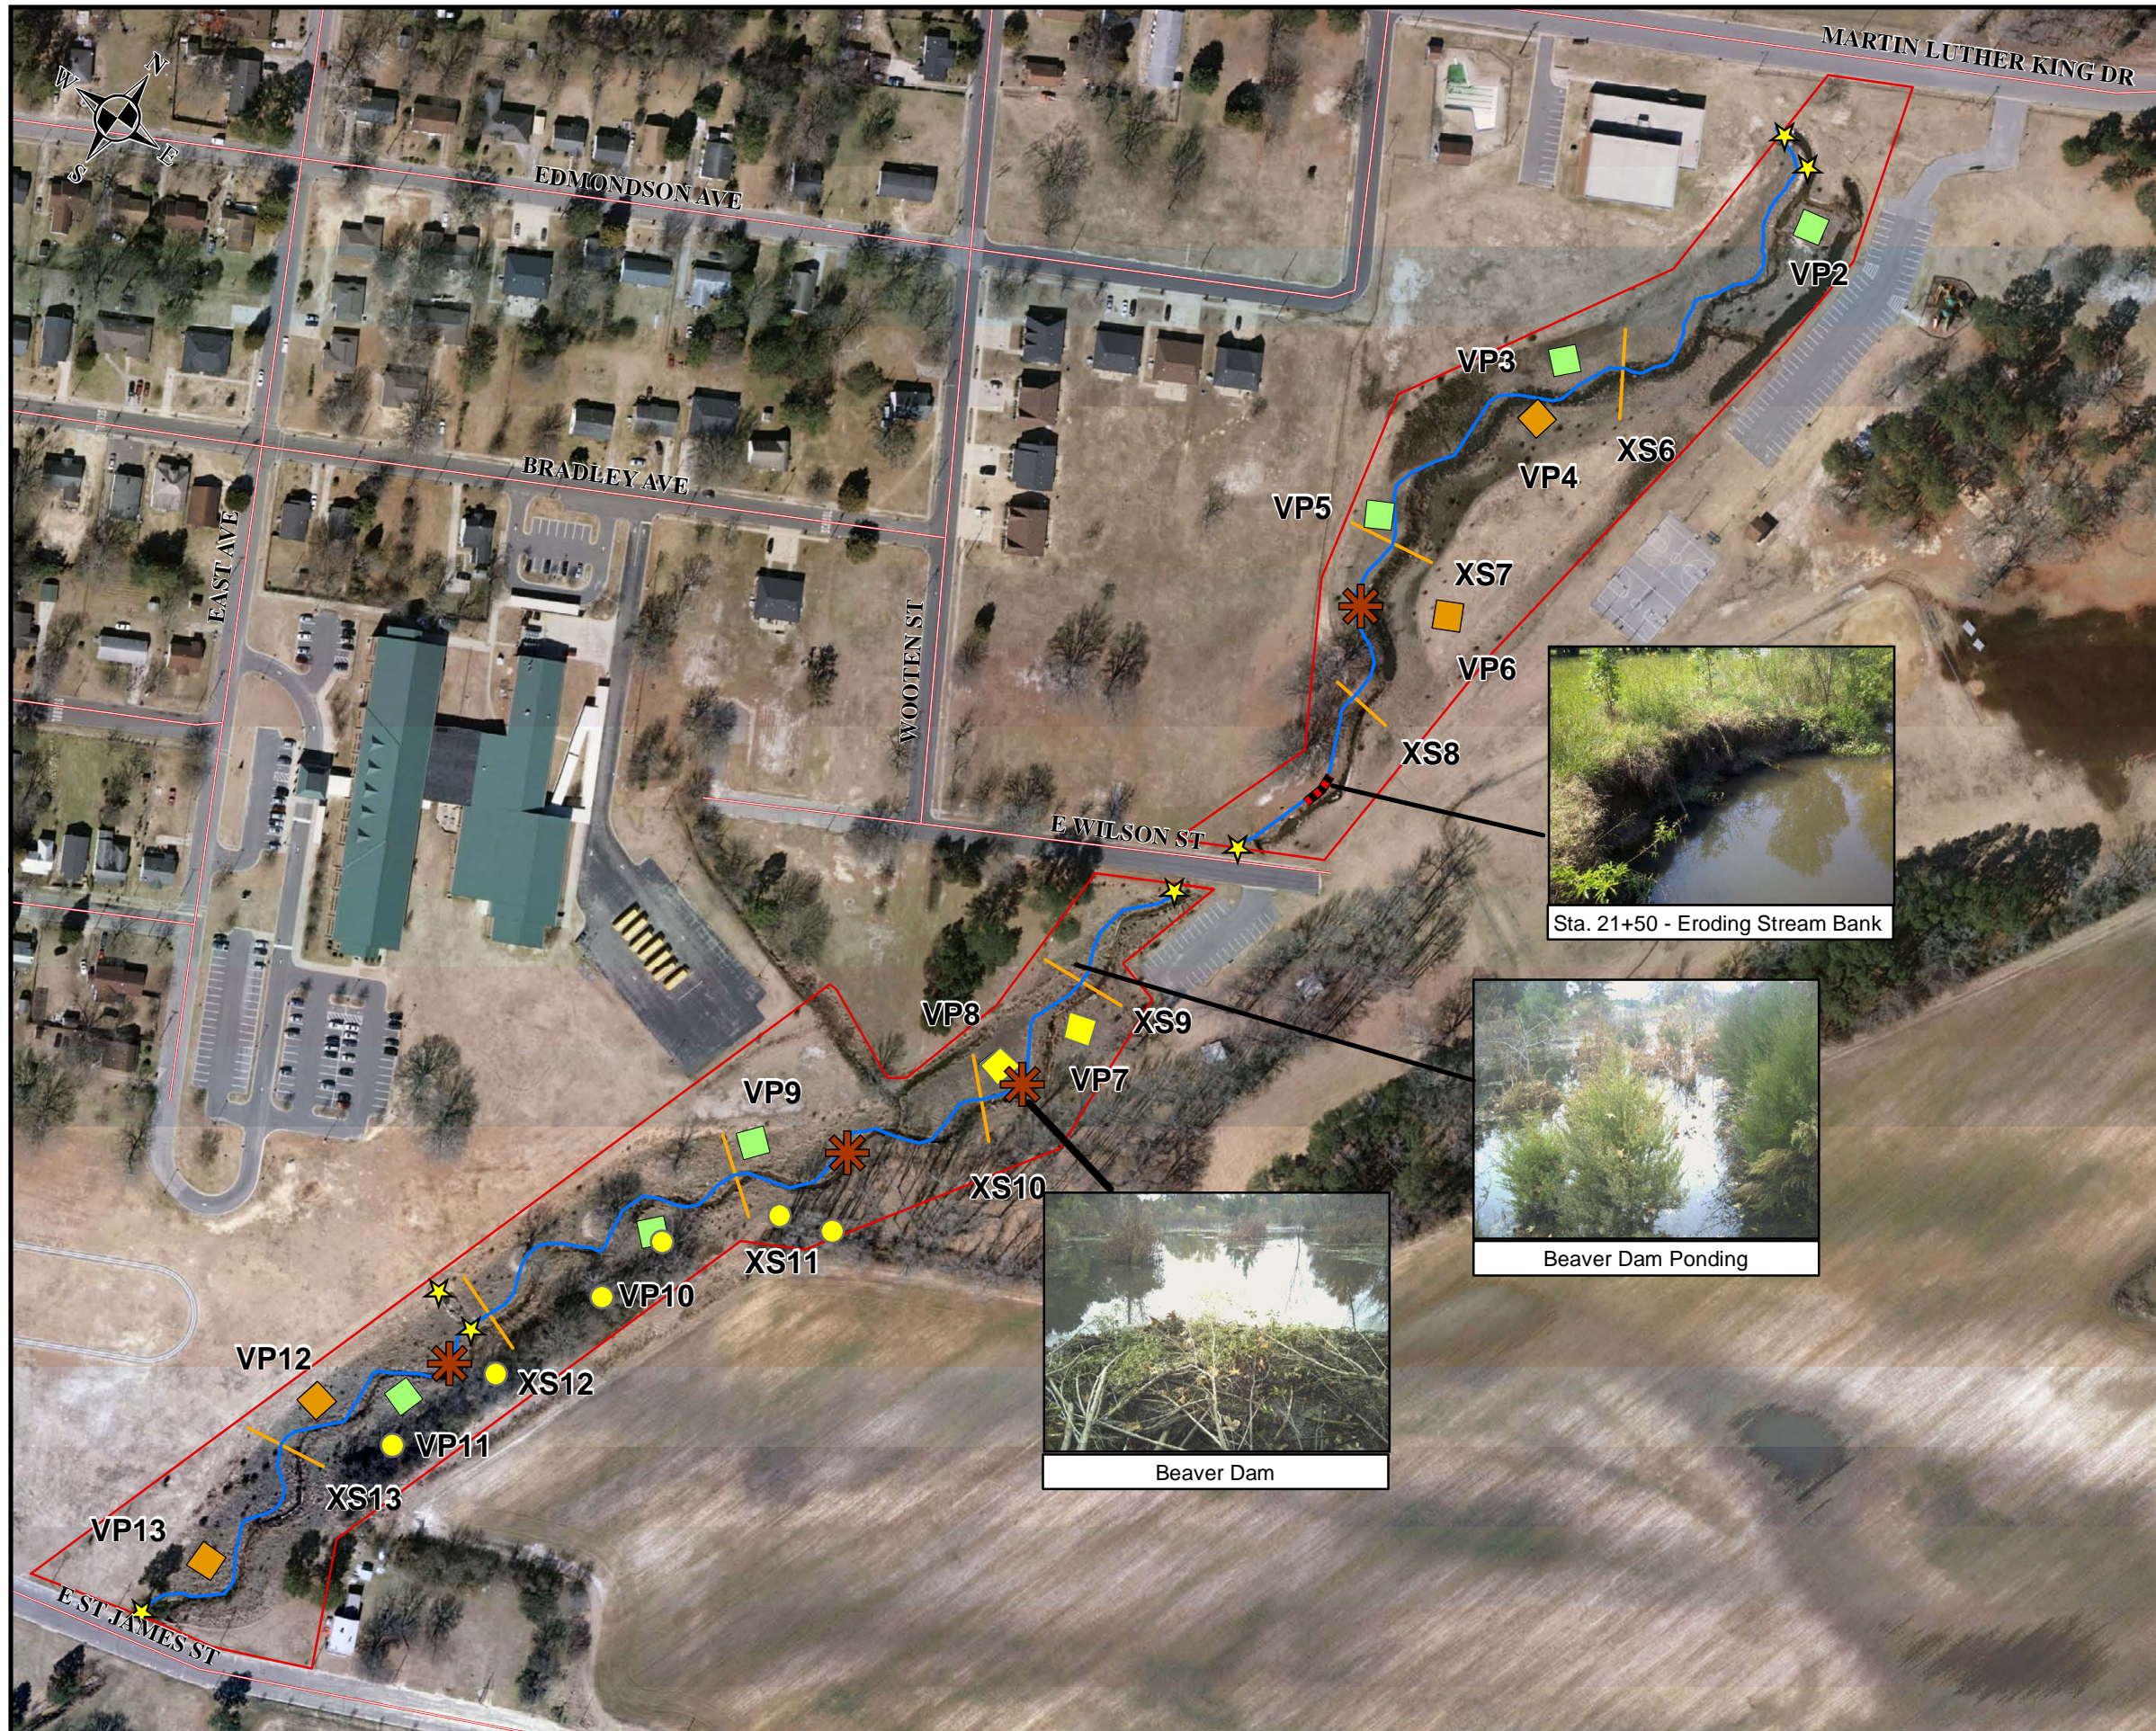
FIGURE 2

The restored stream is functioning well and holding grade while maintaining bedform features. Overall the project is performing adequately. However, the stream has two areas of concern that require immediate repair. Channel dimension and pattern are similar to as-built conditions with the exception of bank erosion at station 21+50 and the stream section south of East Wilson Street. Bank erosion at station 21+50 needs stabilization and the beaver dams located throughout the project, but specifically the large dam located in the vicinity of Cross Section 10 (Figure 2), requires immediate removal. The problems associated with beaver infestation have been reported to EEP and remedial action is underway. The damaged stormwater outfall entering Reach 2 between Wilson and St. James streets has been repaired and

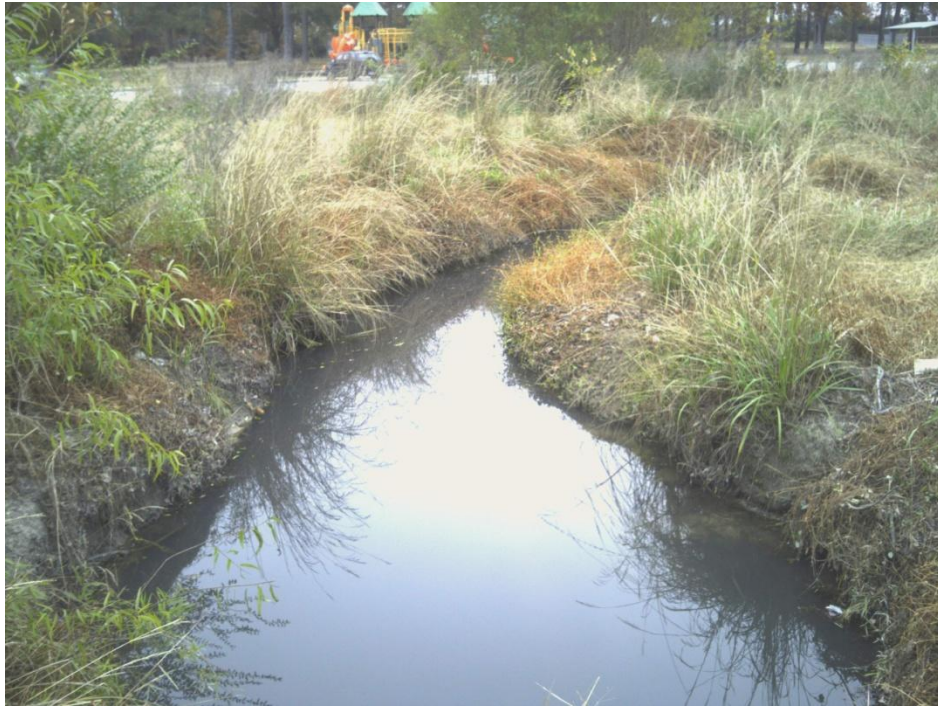
SP1 – Marginal bank erosion near culvert - Station 10+00 – Reach 2

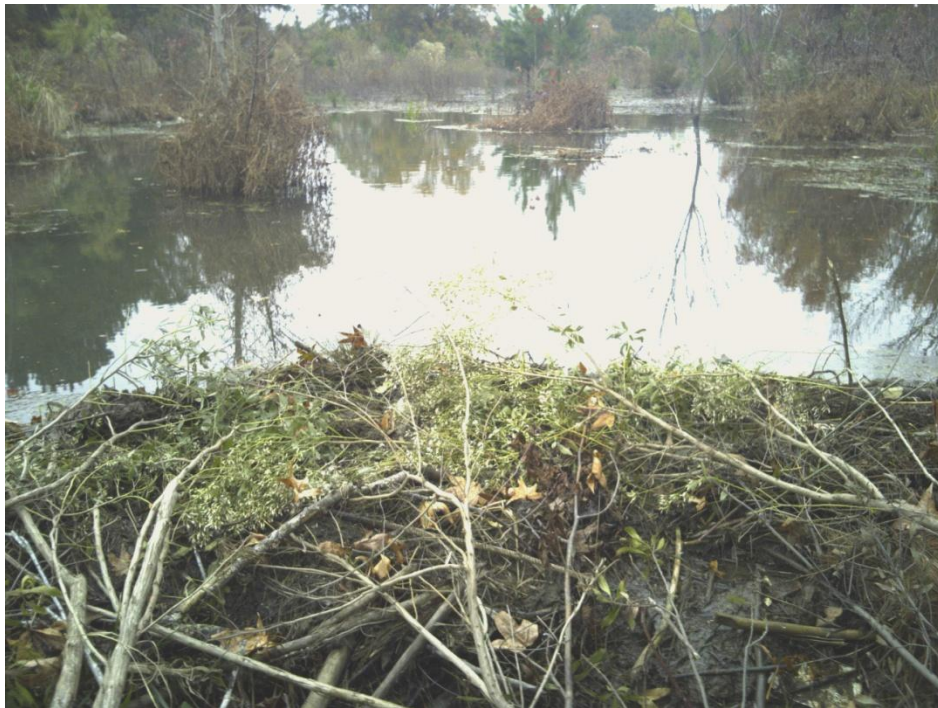
SP2 – Beaver Dam and ponding - Sta. 29+50 - Reach 2

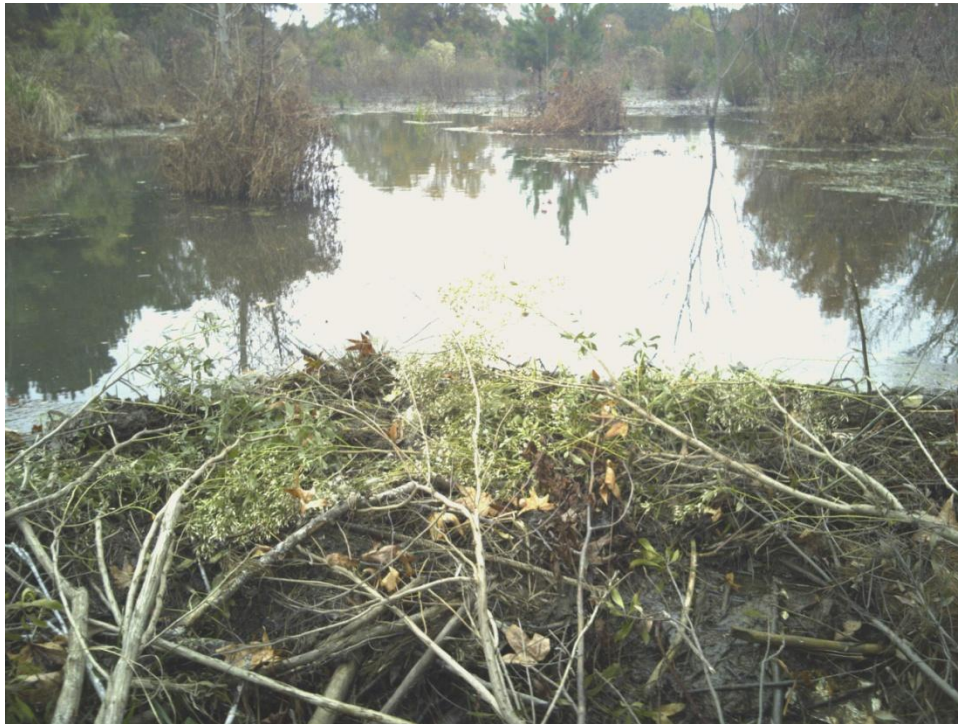
Vegetation Plot 7 – Plot 7 is underwater due to beaver dam flooding and not accessible for pictures.

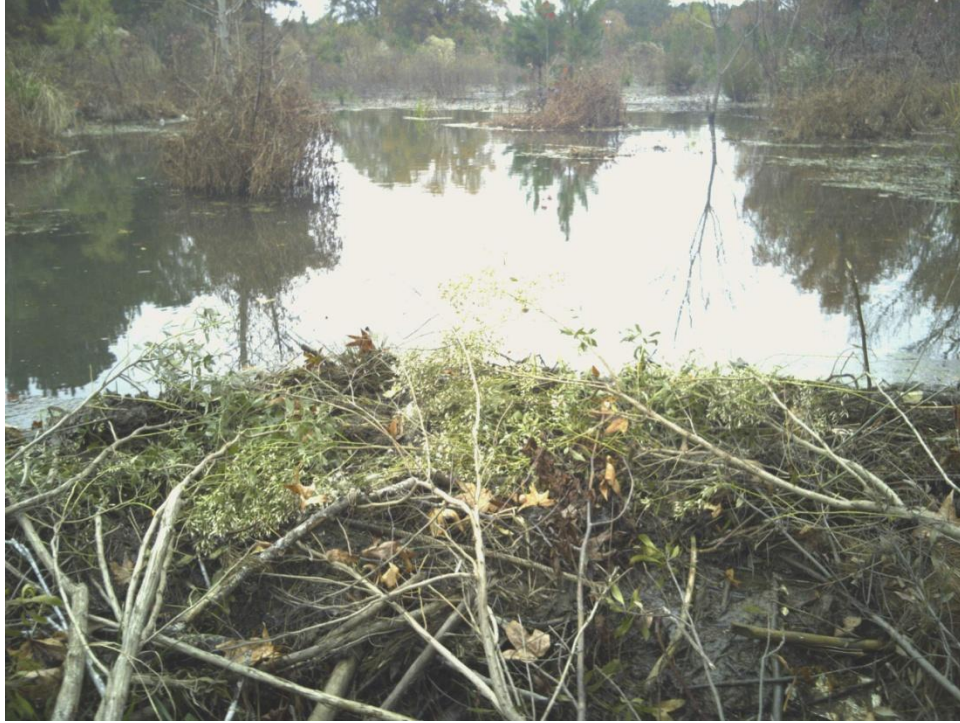
Vegetation Plot 8 – Plot 8 is underwater due to beaver dam flooding and not accessible for pictures.

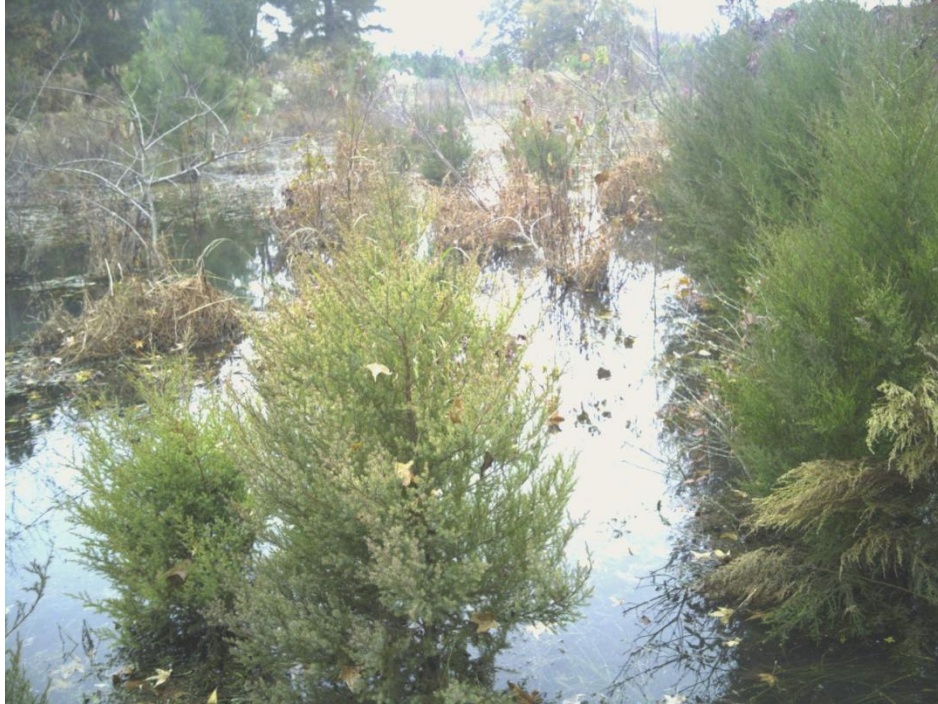
VPA1 – Beaver dam ponding – Vegetation Plots 7 and 8 – Reach 2

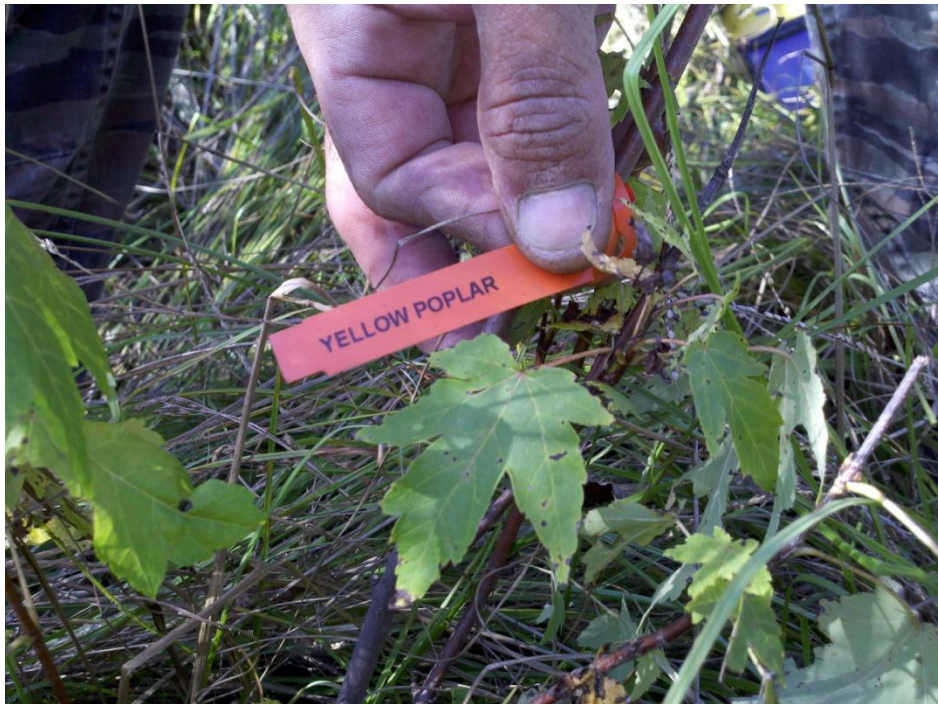
VPA2 – Planted red maple (*Acer rubrum*) and tagged as yellow poplar (*Liriodendron tulipifera*)

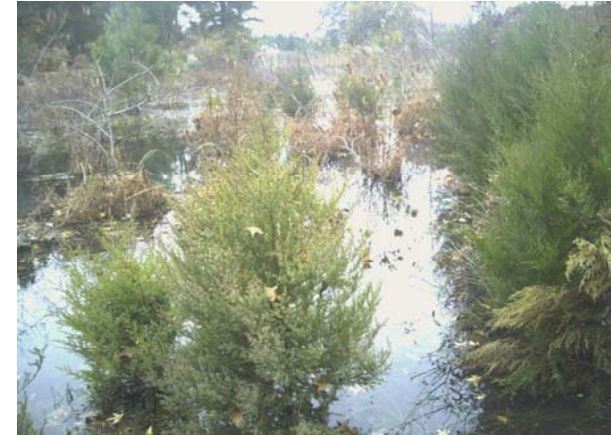
Photo of Cross-Section #10 - Unable to stretch tape across stream due to beaver flooding

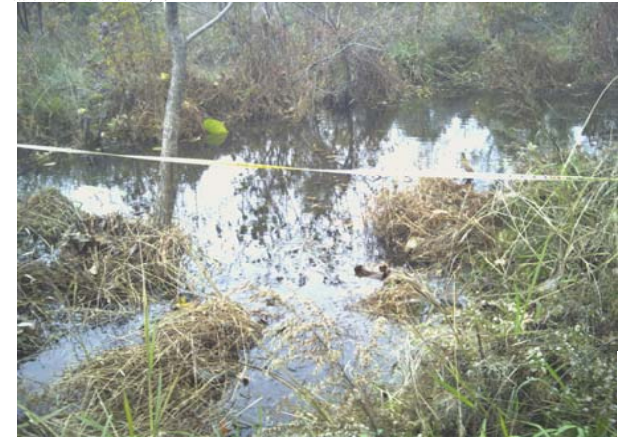
Photo of Cross-Section #11 - Looking Downstream - Beaver Dam located on cross section
