Monitoring Report – Year 4  
FINAL VERSION  
Edwards-Johnson Mitigation Project  
Calendar Year of Data Collection: 2021

NCDEQ DMS Project Identification # 97080  
NCDEQ DMS Contract # 6825  
Neuse River Basin (Cataloging Unit 03020201)  
USACE Action ID Number: SAW-2016-00883  
NCDEQ DWR Project # 2016-0404 V2  
Johnston County, NC  
Contracted Under RFP # 16-006477  
Data Collection Period: September 2021  
Submission Date: October 20<sup>th</sup>, 2021

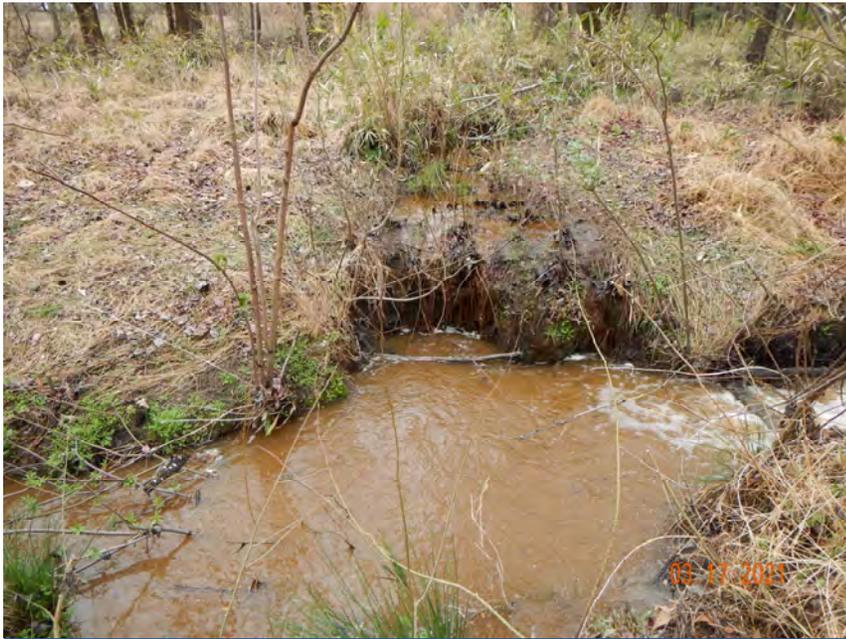
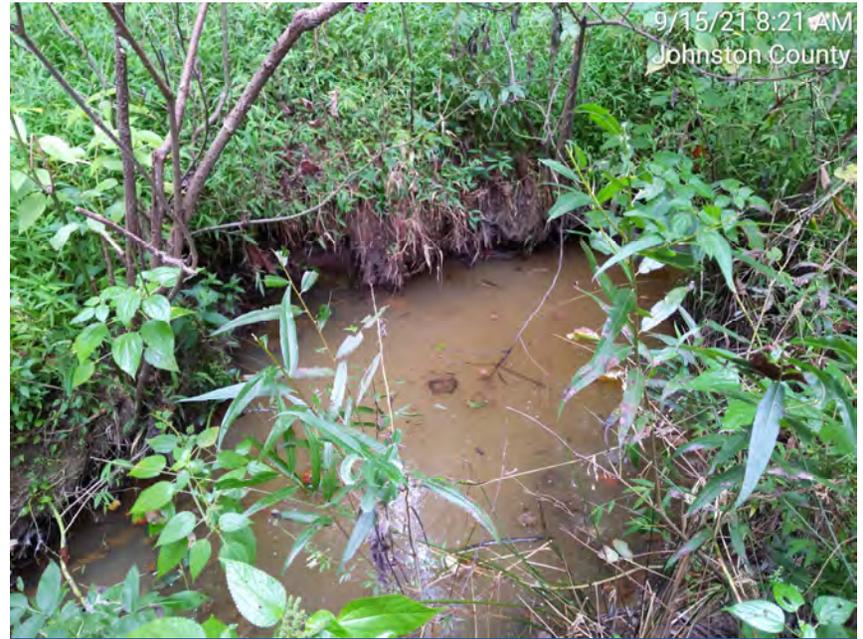
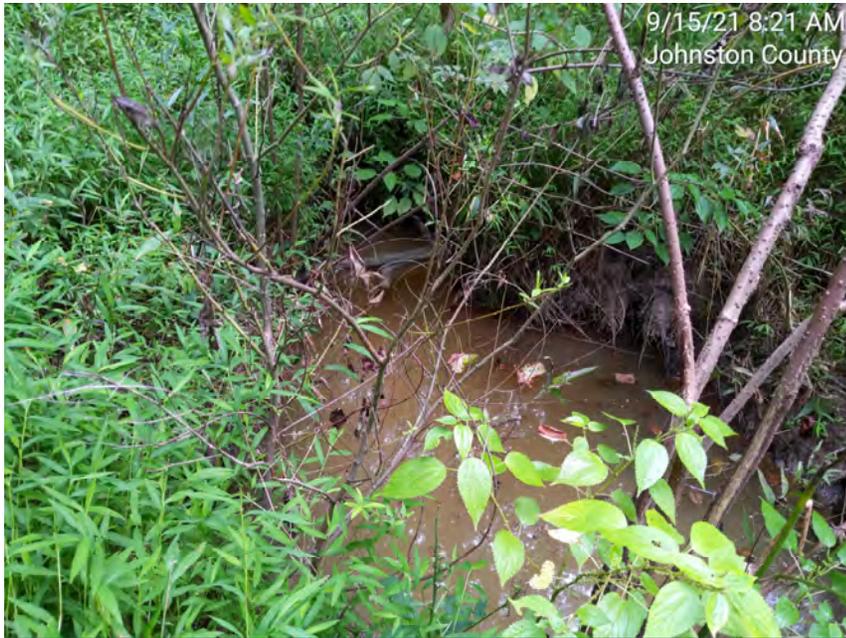
An area on the right bank of R2 located at the transition of R1 to R2 at station 16+13 has approximately 10 linear feet of undercut bank and was noted during a MY3 visual assessment (SPA1). This area is where the transition from preservation to restoration occurred. This area was planted with livestakes and has stabilized throughout MY4 and will continue to be monitored in MY5. Photographs of the area can be found in Appendix B. Overall, only minor (non-systemic) channel adjustments in riffle slopes, pool depths and pattern were observed and therefore did not present a stability concern or indicate a need for immediate remedial action.

SPA1, Erosion on R2, March 17, 2020 (MY-03)

SPA1, Erosion on R2, September 15, 2021 (MY-04)

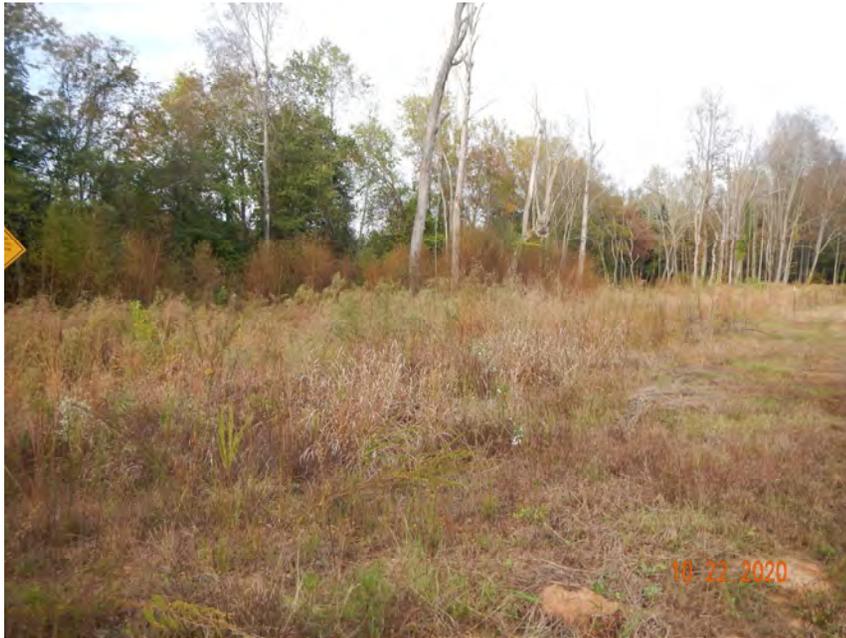
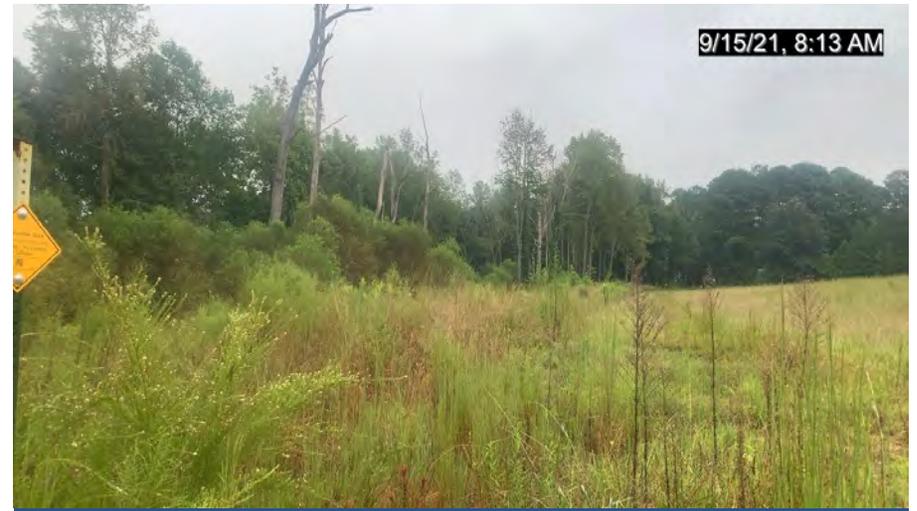
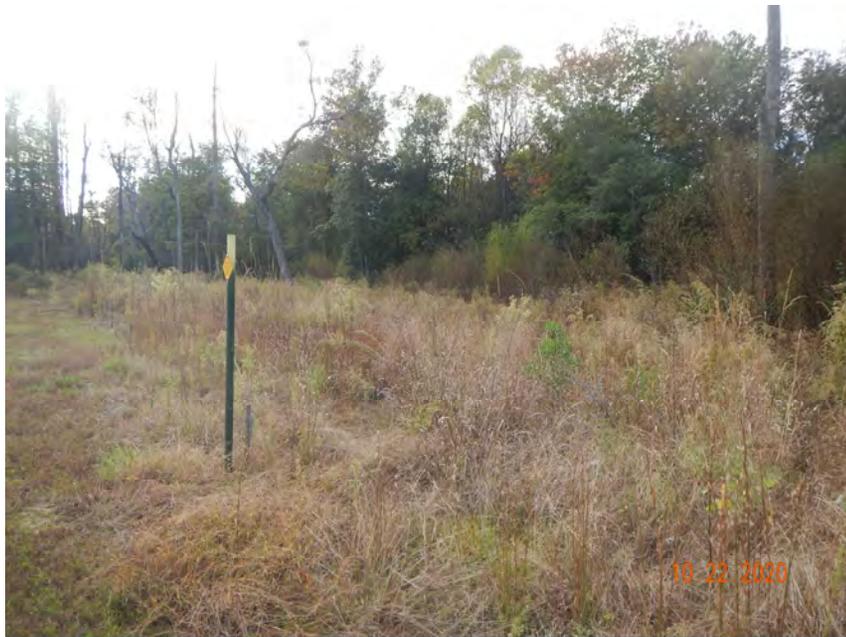
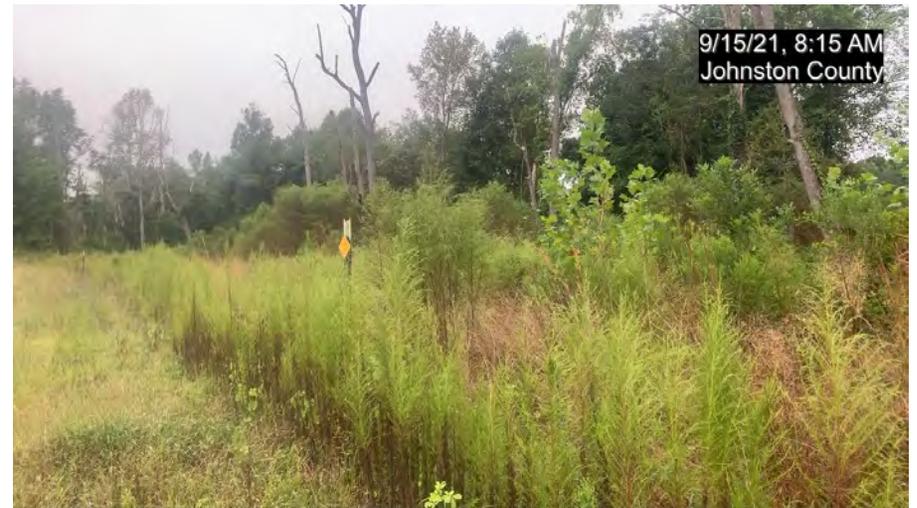
Vegetation plot surveys were not required during MY4 per the mitigation plan, surveys will continue in MY5. The MY4 vegetation monitoring was conducted utilizing visual assessment throughout the easement. One area of concern located on the left bank of R2 totaling approximately 0.35 acres was noted in MY3. Replanting of the area using containerized trees to increase survivability occurred on February 1<sup>st</sup>, 2021, to meet success criteria for MY5 with species from the approved planting list from the mitigation

VPA1, Low Stem Density Area, October 22, 2020 (MY-03)

VPA1, Low Stem Density Area, September 15, 2021 (MY-04)
