Monitoring Report – Year 5
FINAL VERSION
Edwards-Johnson Mitigation Project
Calendar Year of Data Collection: 2022

NCDEQ DMS Project Identification # 97080
NCDEQ DMS Contract # 6825
Neuse River Basin (Cataloging Unit 03020201)
USACE Action ID Number: SAW-2016-00883
NCDEQ DWR Project # 2016-0404 V2
Johnston County, NC
Contracted Under RFP # 16-006477
Data Collection Period: September 2022
Submission Date: November 30th, 2022

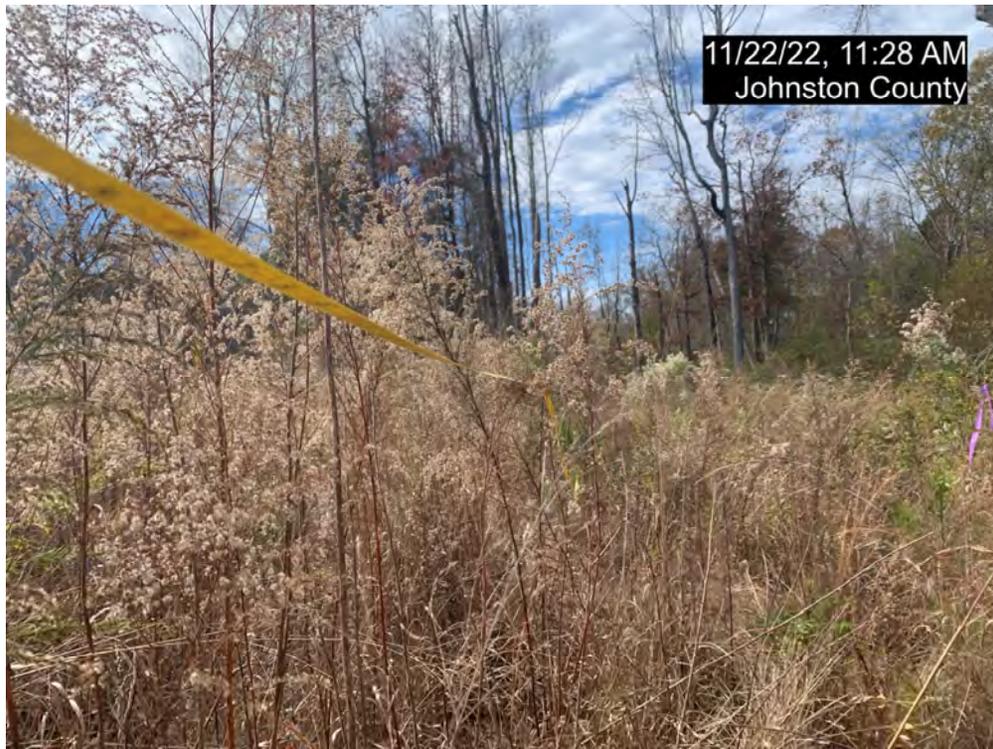
The MY5 vegetation monitoring was conducted utilizing visual assessment throughout the easement. An area of pine establishment (~0.82 acres) was noted during the IRT site visit in October 2022. Pine in this area were thinned on November 22nd, 2022, using hand tools to allow desirable planted and volunteer species to establish. Future management in this area will be documented in annual reports as needed. The results of the visual assessment did not indicate any additional significant negative changes to the existing vegetation community.

Random Veg Plot, November 22, 2022 (MY-05)

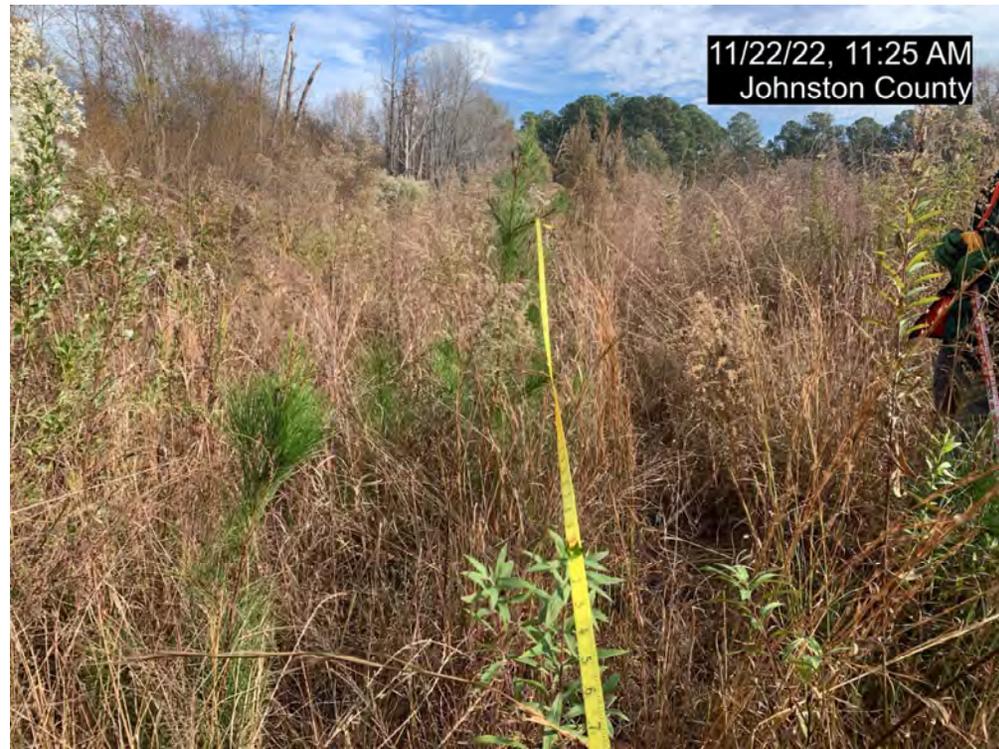
Random Veg Plot, November 22, 2022 (MY-05)

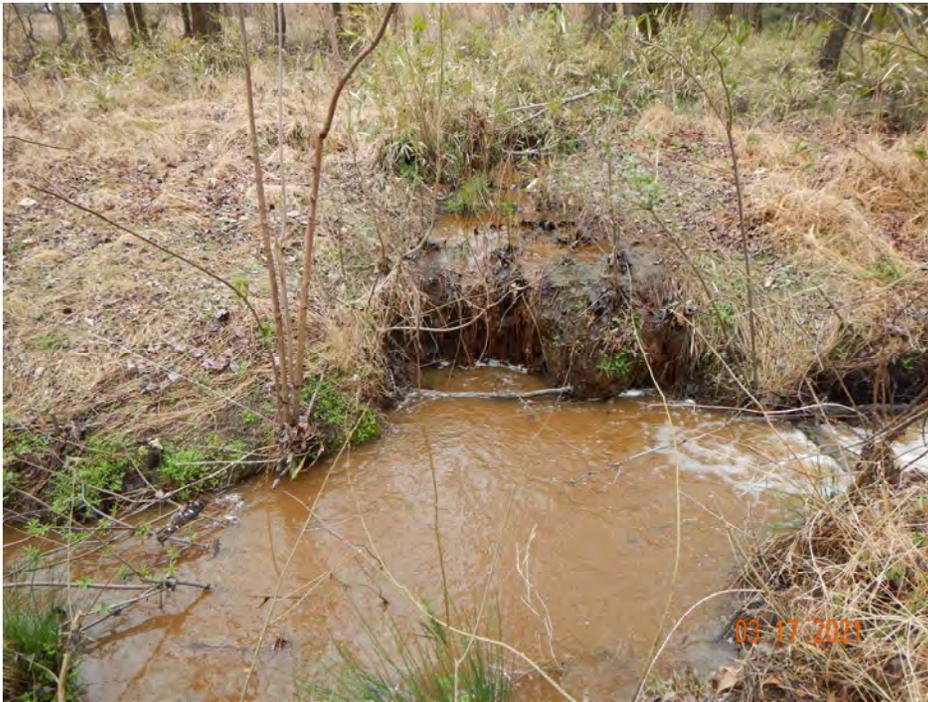
An area on the right bank of R2 located at the transition of R1 to R2 at station 16+13 has approximately 10 linear feet of undercut bank and was noted during a MY3 visual assessment (SPA1). This area is where the transition from preservation to restoration occurs. This area was planted with livestakes in MY4 and has stabilized throughout MY4/MY5 and will continue to be monitored in MY6. Photographs of the area can be found in Appendix B. Cross-section 7 is in a headwater system and standard geomorphological measurements are not necessarily relevant for stability. Overall, only minor (non-systemic) channel adjustments in riffle slopes, pool depths and pattern were observed and therefore did not present a stability concern or indicate a need for immediate remedial action. Maximum riffle depths are expected to fluctuate slightly throughout the monitoring period as the channels adjust to the new flow regime. It is expected over time that some pools may accumulate fine sediment and organic matter, however, this may not be an indicator of channel instability.

SPA1, Erosion on R2, March 17, 2020 (MY-03)

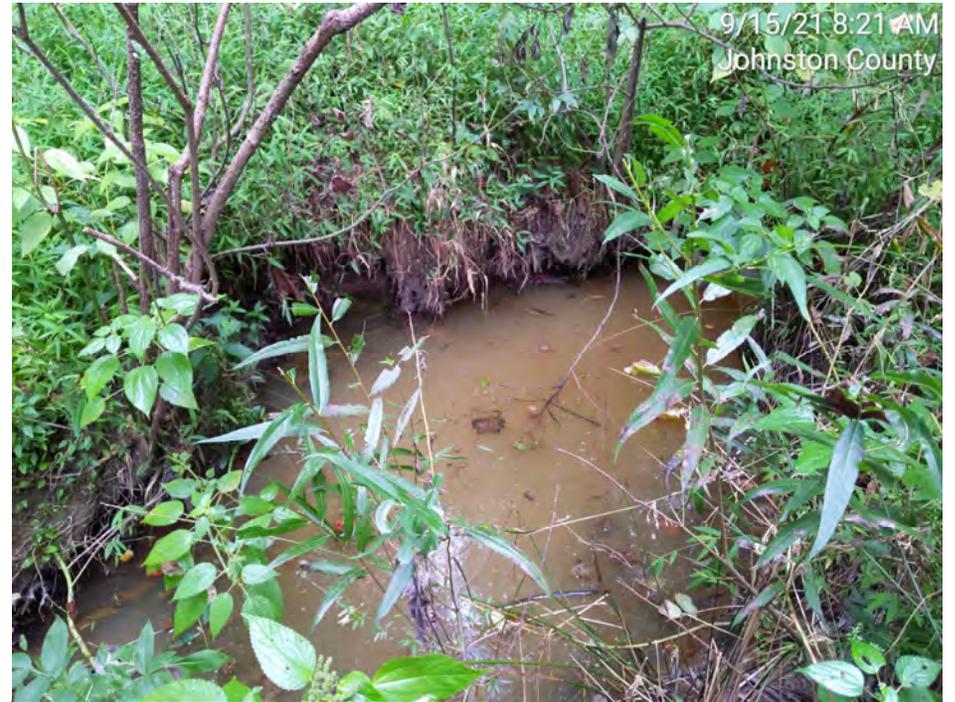
SPA1, Erosion on R2, September 15, 2021 (MY-04)

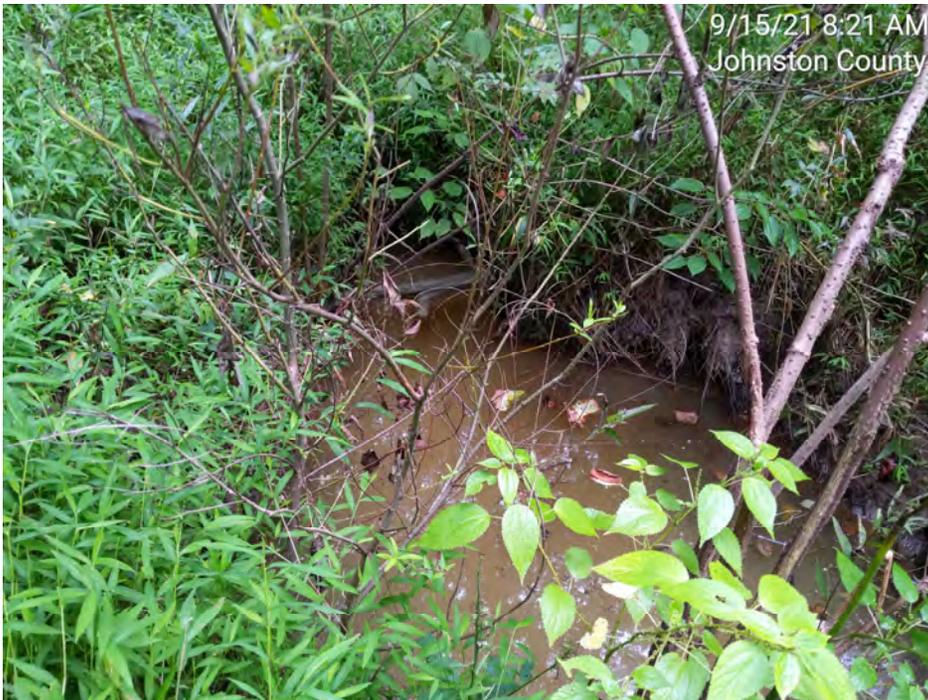
SPA1, Erosion on R2, September 15, 2021 (MY-04)

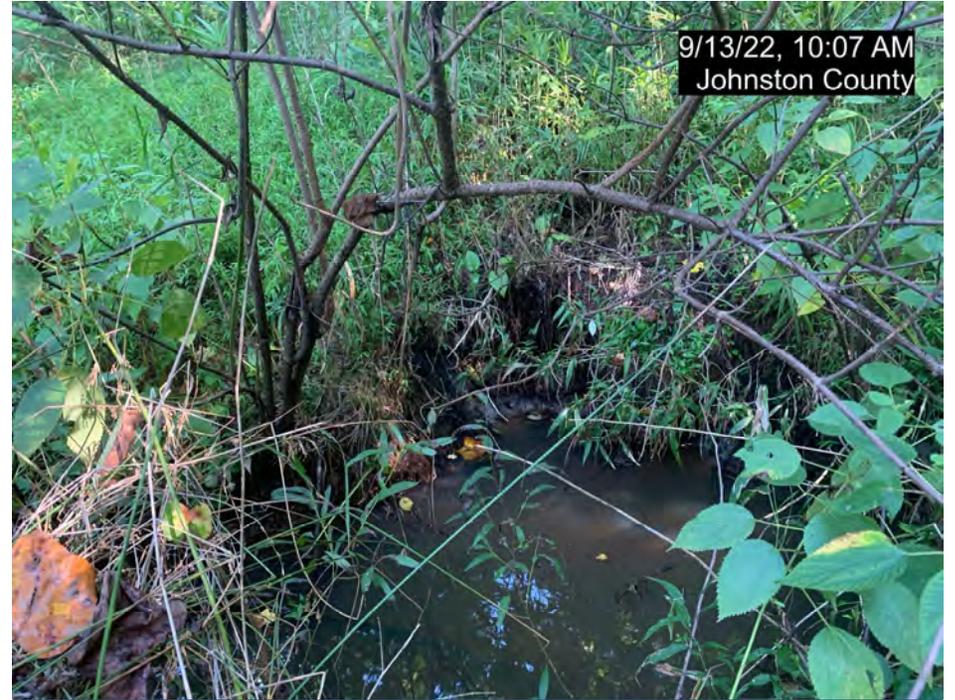
SPA1, Erosion on R2, September 13, 2022 (MY-05)
